## MS4 Annual Report Transmittal Form

### For the General Permit to Discharge Stormwater from Small Municipal Separate Storm Sewer Systems (MS4)

1. Registrant (Name of Municipality or State or Federal Institution/Agency): <u>Town of Simsbury</u>	
Mailing Address: <u>933 Hopmeadow Street</u>	
City/Town: <u>Simsbury</u>	State: <u>CT</u> Zip Code: <u>06070</u>
Business Phone: <u>860-658-3200</u>	ext.:
Contact Person: <u>Tom Roy</u>	Phone: <u>860-658-3200</u> ext.
*E-mail: <u>troy@simsbury-ct.gov</u>	
*By providing this e-mail address you are agreeing to receive official correspondence from DEEP, at this electronic address, concerning the subject registration. Please remember to check your security settings to be sure you can receive e-mails from "ct.gov" addresses. Also, please notify DEEP if your e-mail address changes.

This report documents the Town of Simsbury’s efforts to comply with the conditions of the MS4 General Permit to the maximum extent practicable (MEP) from January 1, 2021 to December 31, 2021.

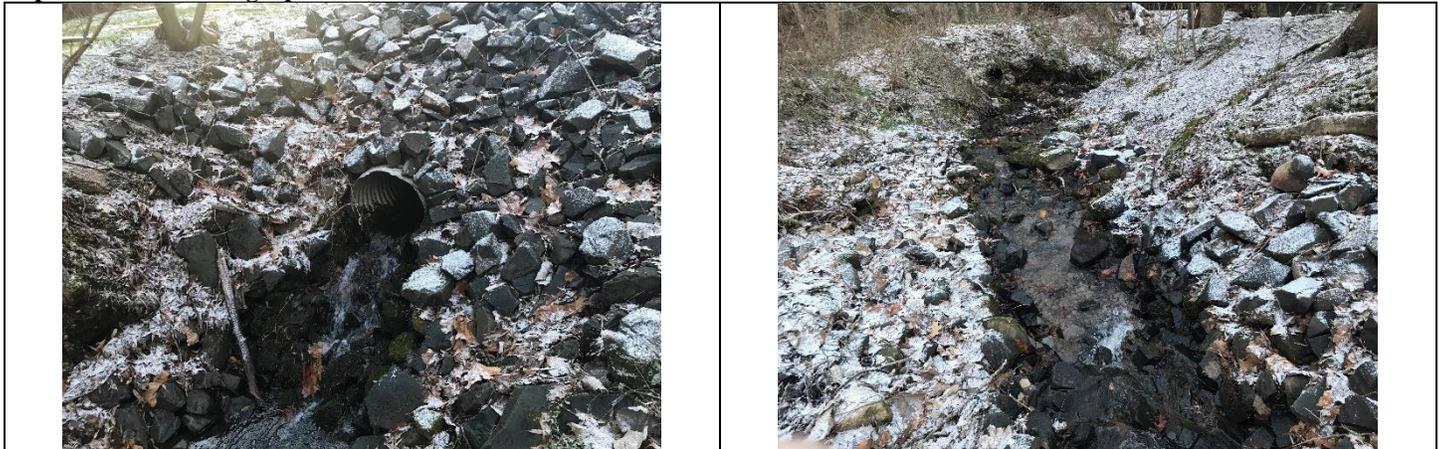
**Outfall Details** (piping material/diameter, structural condition, erosion, trash present, sediment, etc.): 24" precast concrete pipe in good condition, heavy amounts of rip rap from outlet to Hop Brook. Possible influx of groundwater into outlet. Extremely wet soil surrounding area, with corresponding catch basins lighter flow.

**Receiving Water Body Observations** (murky, solids, sheen, trash present, bubbles, odor, etc.): clear, no trash present, odor or foam not present. Little sediment observed.

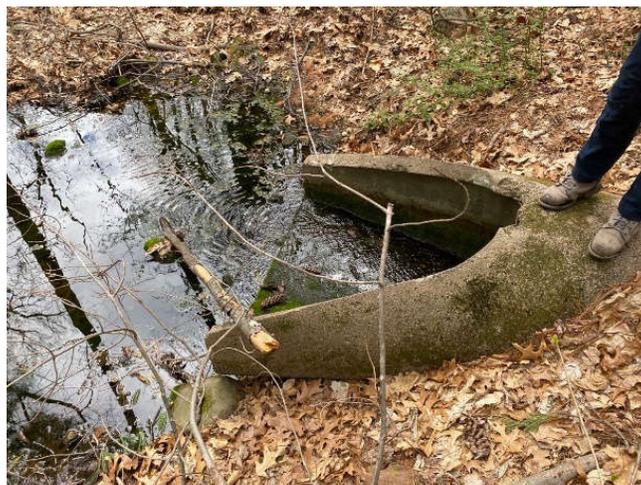
Discharge comes from Kerr Farm Rd and Hearthstone Dr. Kerr Farm rd. CB dry, no discharge. Very slight discharge from CBs on Hearthstone. Possible broken pipe with GW discharge.

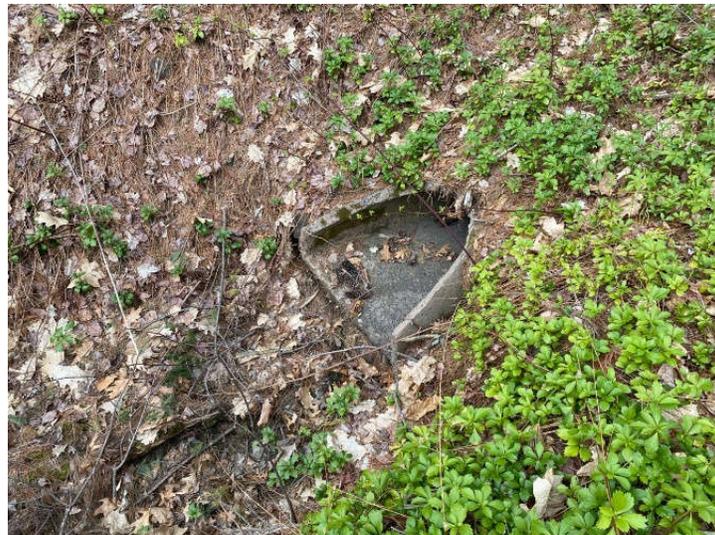
Good condition. Some trash/debris present.

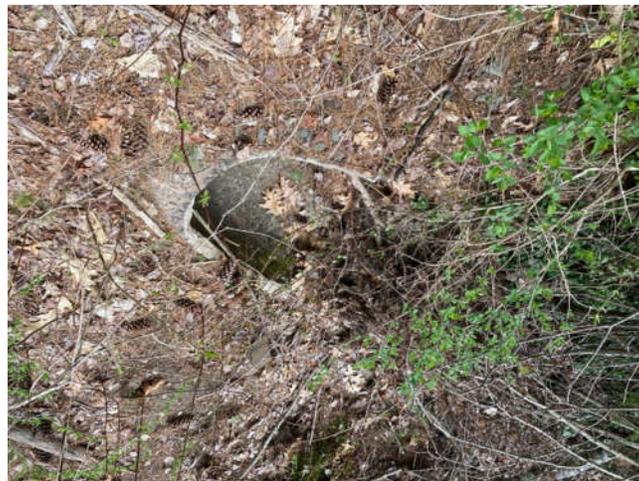
Flared end slightly broken. Many fallen trees in the vicinity of outfall.

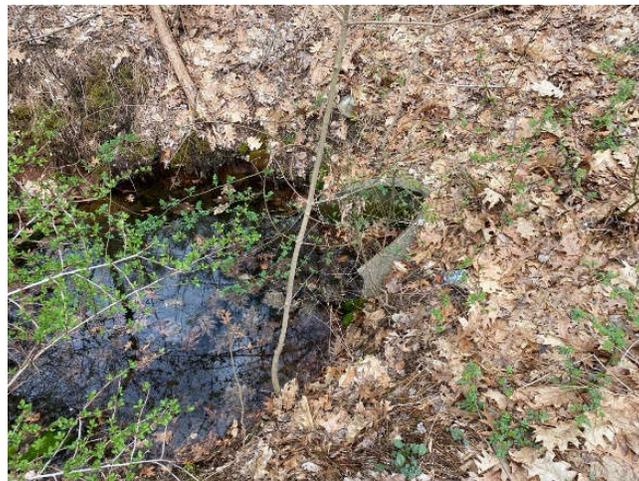
Culvert under Owens Brook Blvd. Concrete flared end broken.

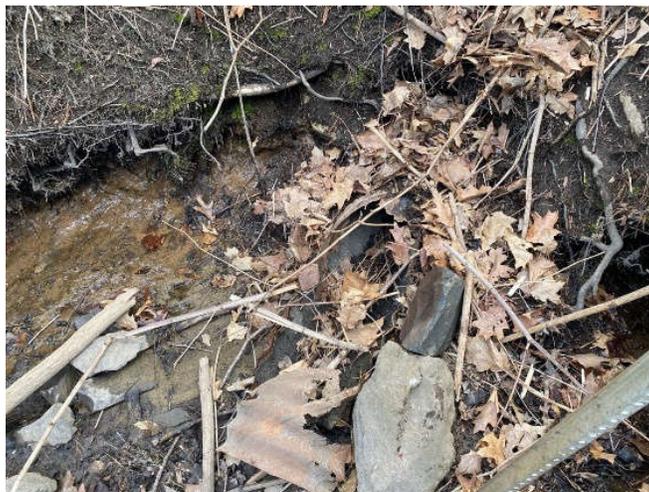
Corrugated metal, highly corroded, broken at end.

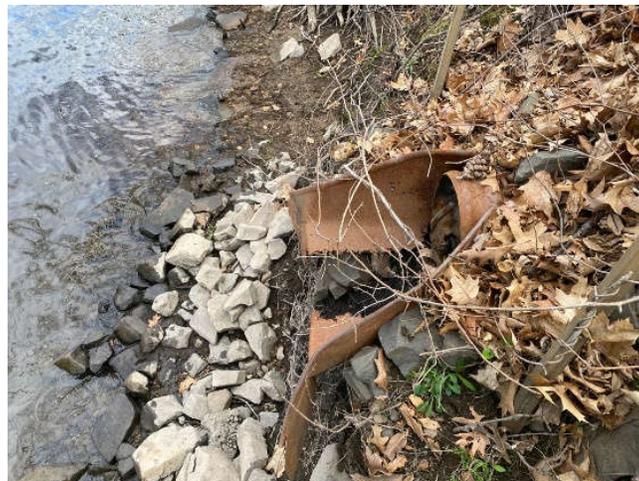
Corrugated metal, corroded at end. Flared end heavily corroded.

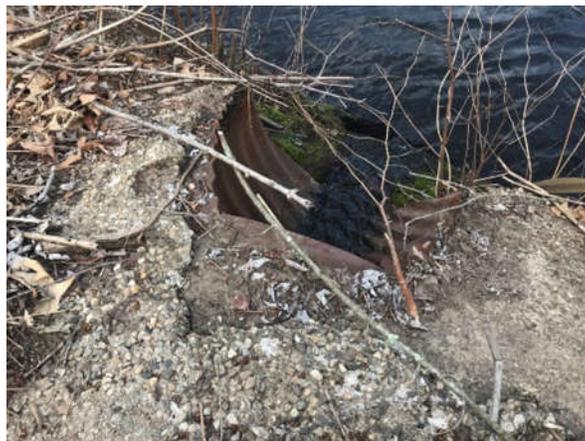
Outfall in good condition. While there is discharge, the discharge comes from a stream- this outfall is connected to a culvert.

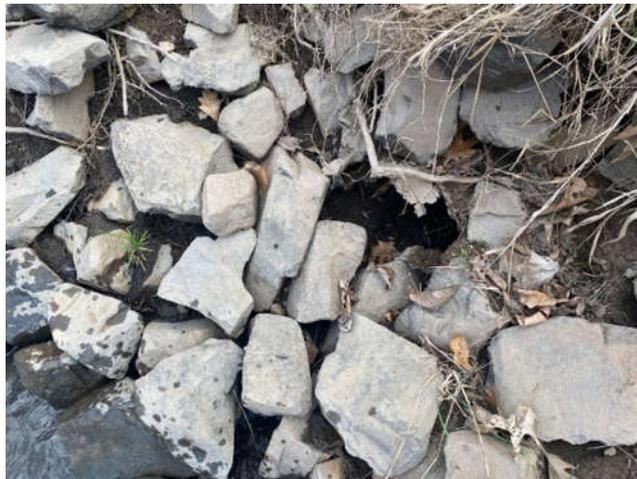
Corrugated metal corroded at end. Slightly silted in.

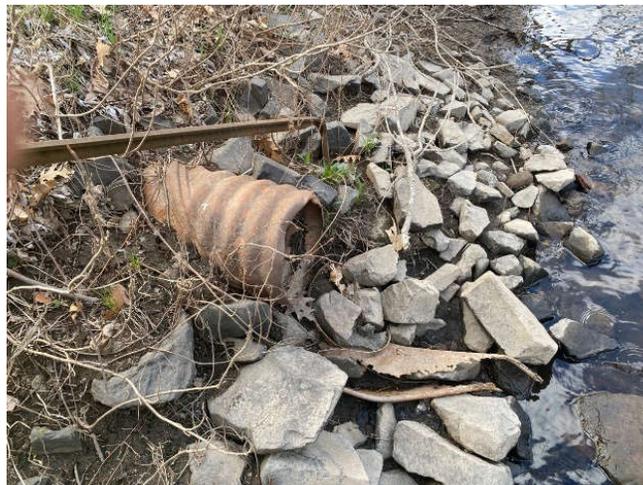
Corrugated metal pipe, corroded and broken at end.

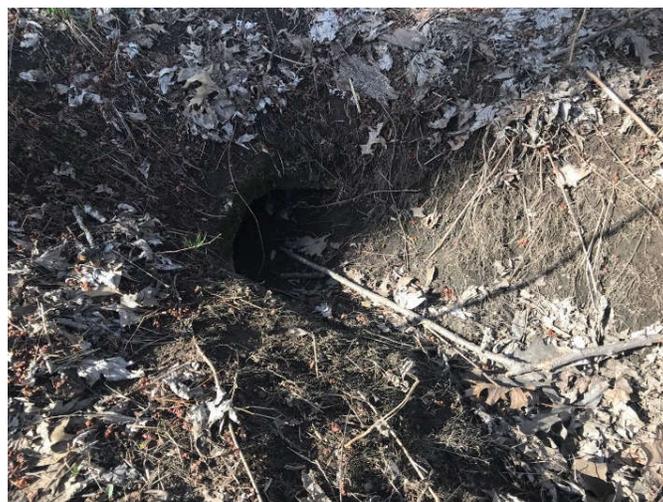
Outfall in very poor condition. Mostly silted in, and no erosion control to be seen.  
Outfall needs to be cleared out and riprap put in.

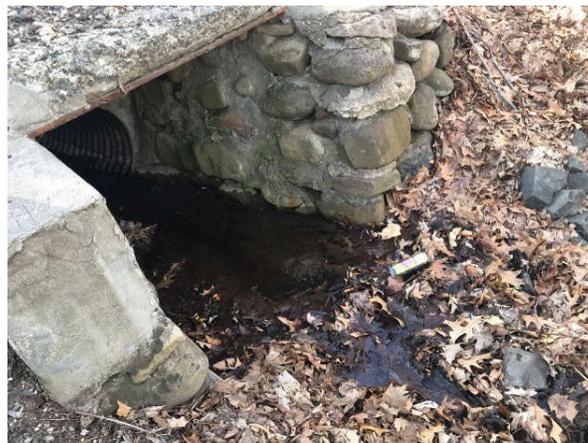
Outfall is a corrugated metal pipe. This outfall is a an outlet. Riprap is in OK condition. Some erosion along stream channel. Some refuse observed.

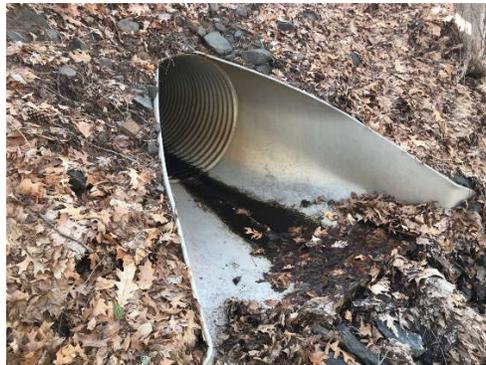
Outfall in good condition. While there is discharge, after further investigation a sinkhole was found, where it is suspected that the pipe is broken and groundwater is seeping. The angle of the pipe is sloped steeply down words, making for a steady flow.

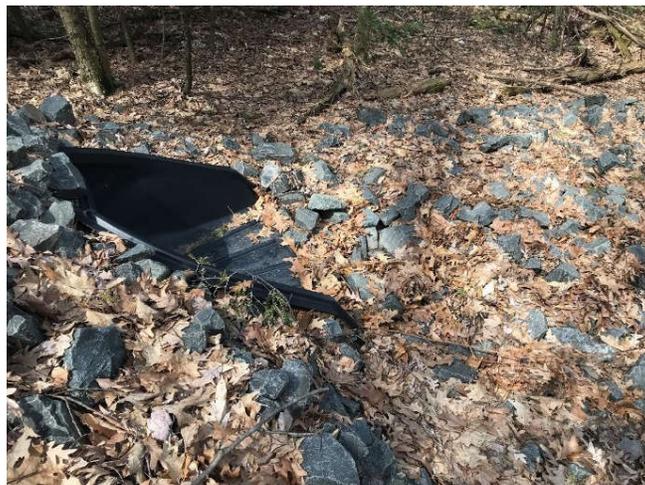
In good condition. Riprap is sufficient.

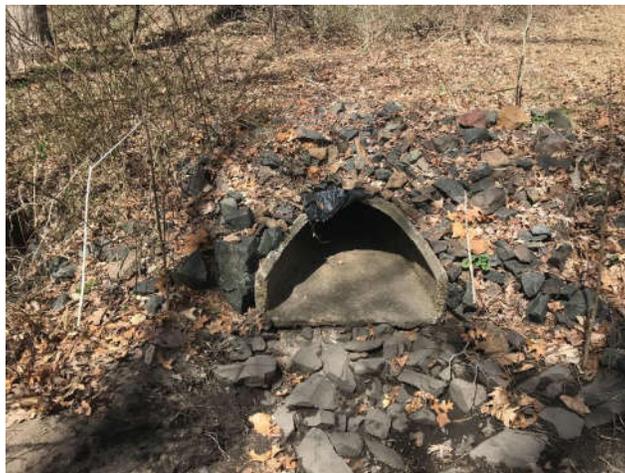
Pipe slightly broken at flare.

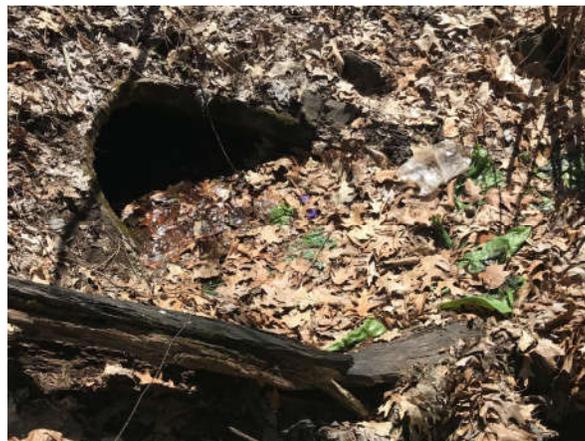
Outfall pipe is partially clogged by leaf litter. High volume of pet waste bags found at flared end.

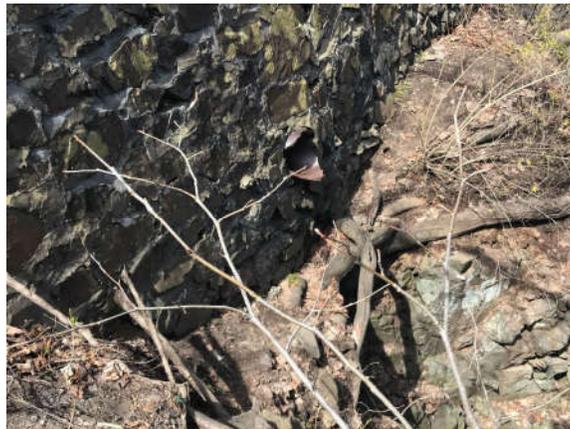
Outfall possibly made from clay. End of outfall is broken. Slight erosion on Hillside.  
Outfall comes directly out of bridge.

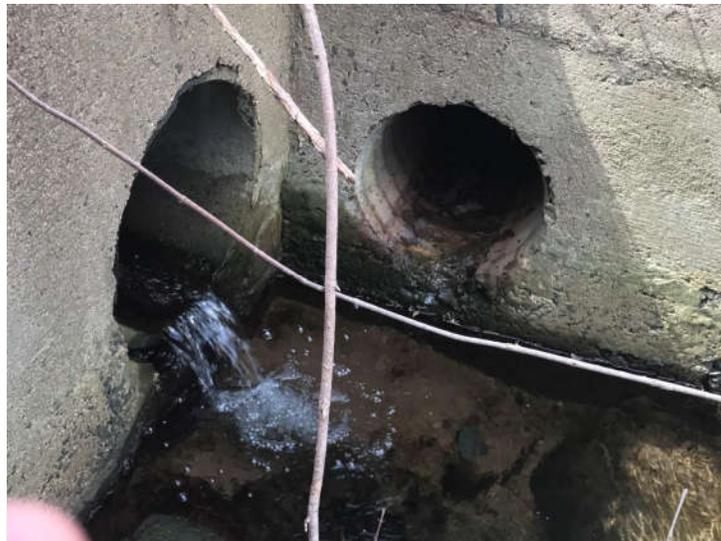
Outfall in good condition. Some leaf litter and branches throughout channel.

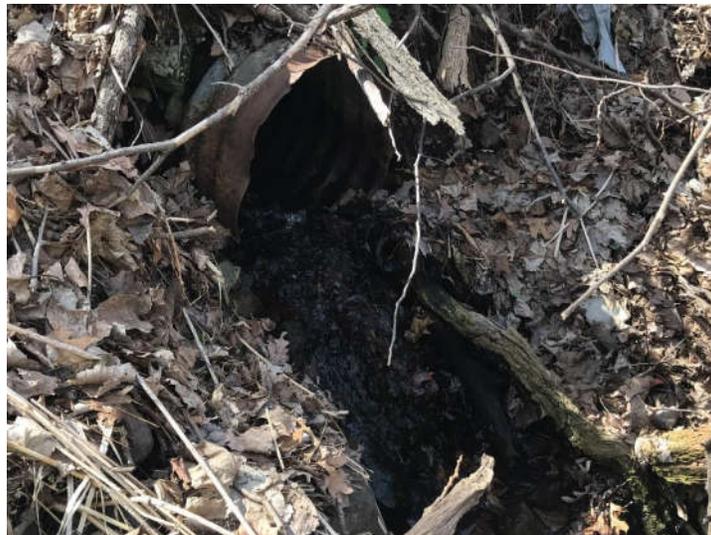
End of pipe is slightly corroded.

Catch basins Connected to this outfall and surrounding out falls come from a steeped area, possible ground water infiltrating outfall pipe.

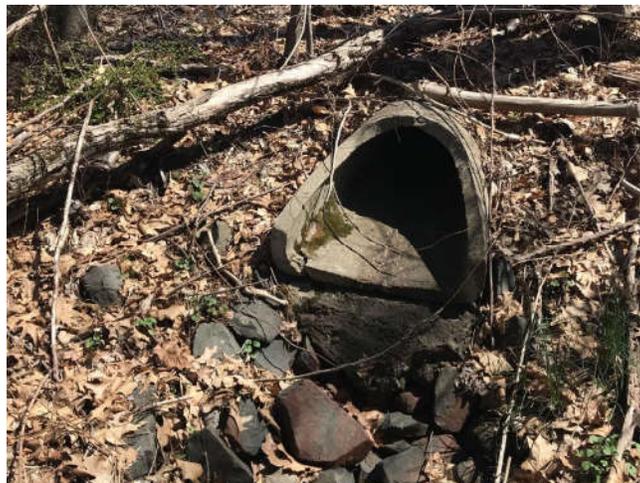
Good condition.

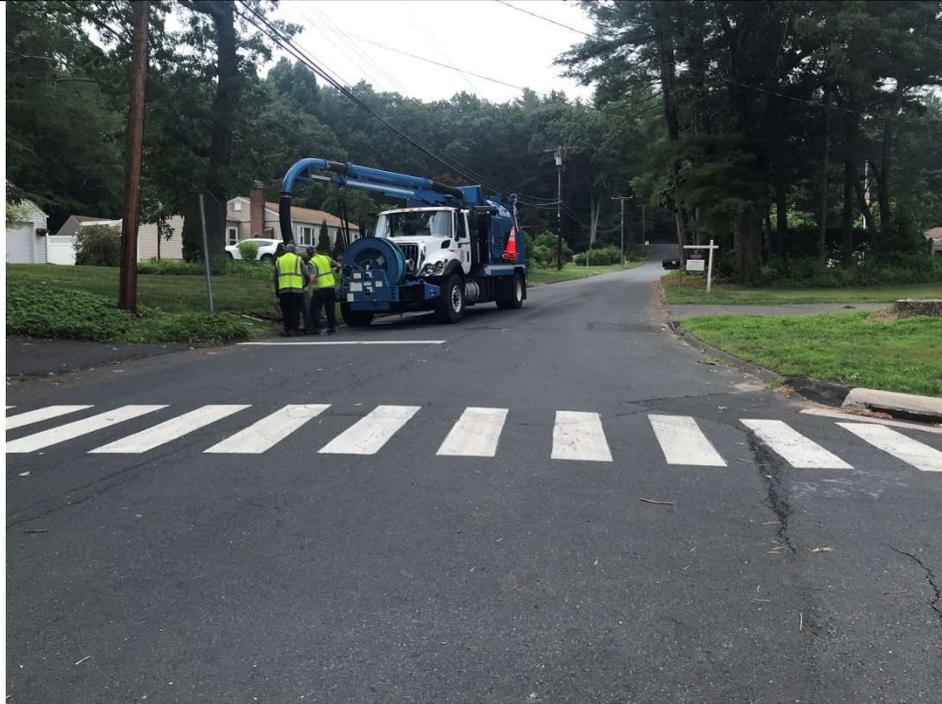
## Photograph #1

**Description:**  
*Town of Simsbury  
vacuuming out initial  
catch basin (facing  
north, towards 9  
Mountain View  
Drive).*

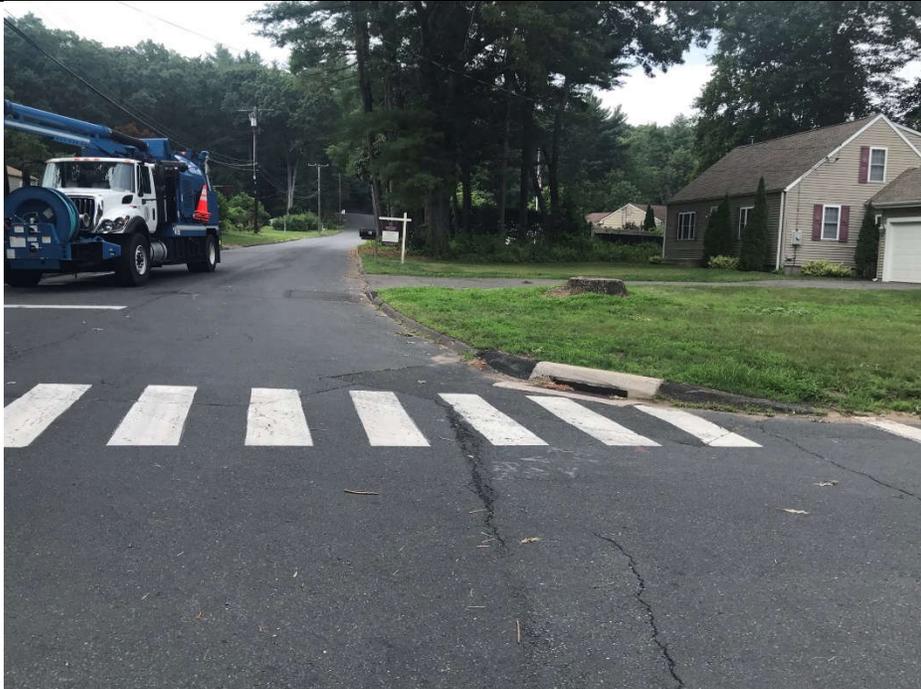
## Photograph #2

**Description:**  
*Second associated  
catch basin of  
water mixture flow.*

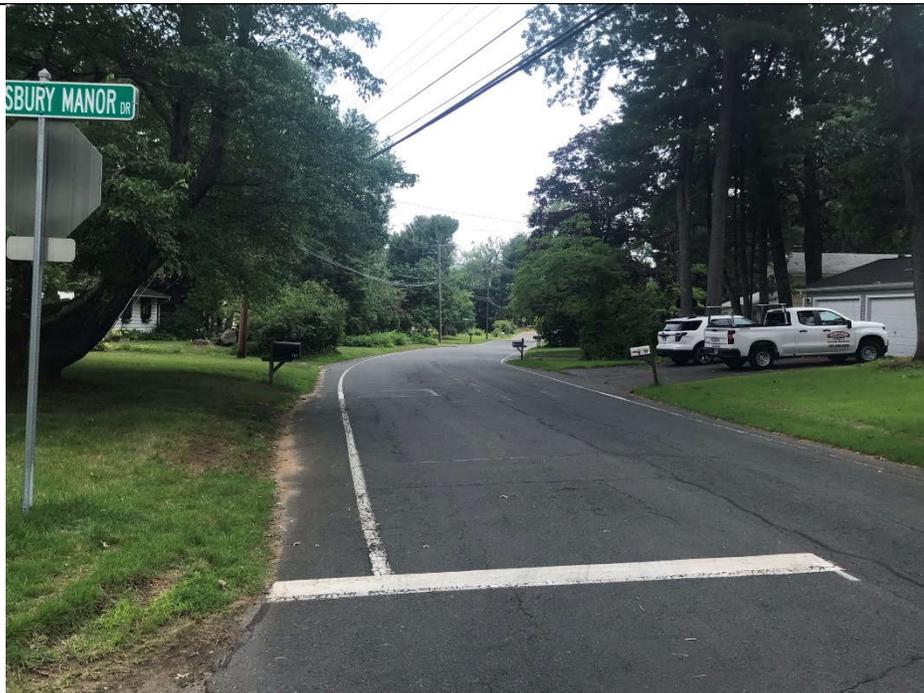
**Photograph #3**  
**Description:**  
*Facing south, showing direction of flow (towards Russell Brook, through the stormwater drainage system).*

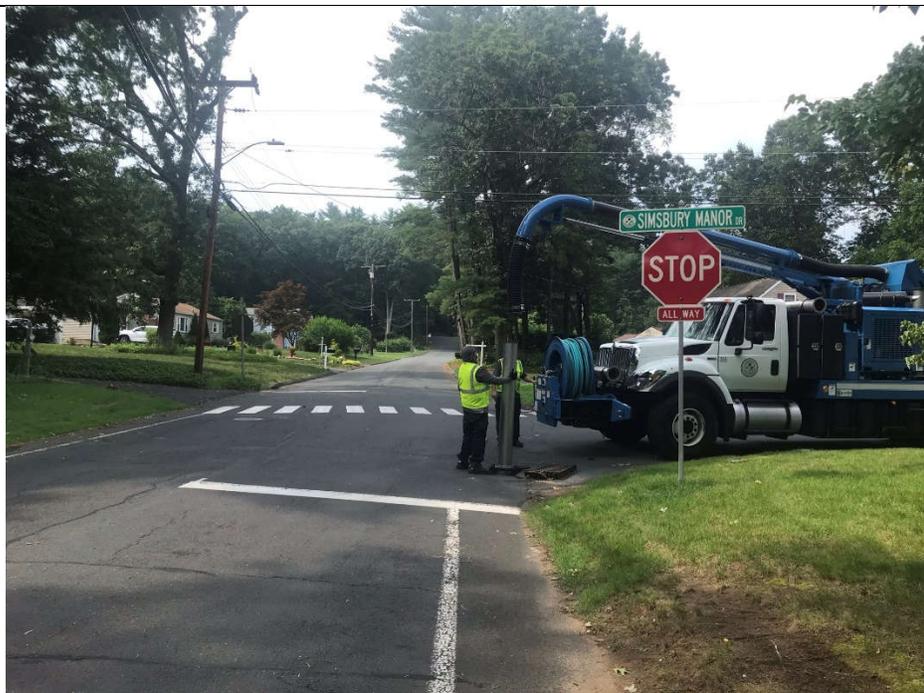
**Photograph #4**  
**Description:**  
*Third associated catch basin of water mixture flow.*
