BRIDGE NO.04548

68940 - SIMSBURY
CLIMAX ROAD
over
NOD BROOK

Routine Inspection

09/17/2015

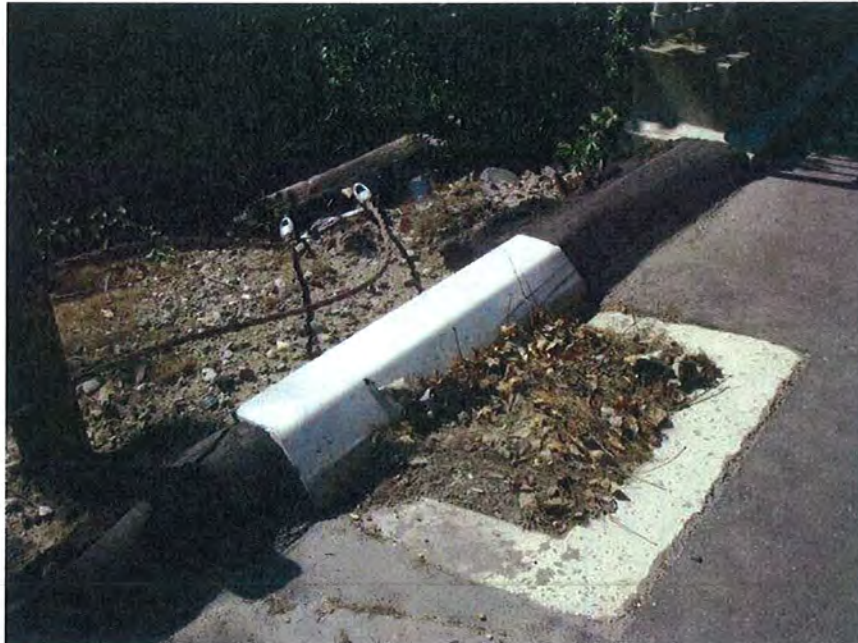
Photo Number: 5

Approach Pavement: 7 (1) Broken post at southeast adjacent to structure with cables lying on the ground.,
Newer Bituminous-

Approach Embankment: 8 Additionally there is (1) catch basin at east approach on south side adjacent to struture that is filled/ clogged with leaves, pine needles & debris.

Broken post with cables lying on ground at the southeast. Note clogged catch basin.

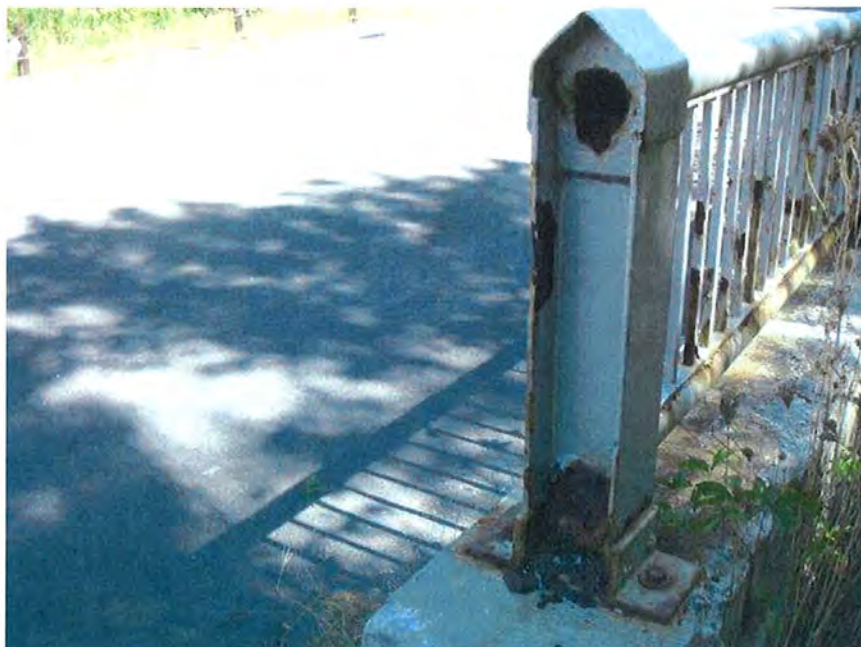
Photo Number: 6

West end section missing.

Random stanchions have collision damage with dents & scrape & minor bends of interior flanges.

Area of collision damage to south railing at west end with missing end section.

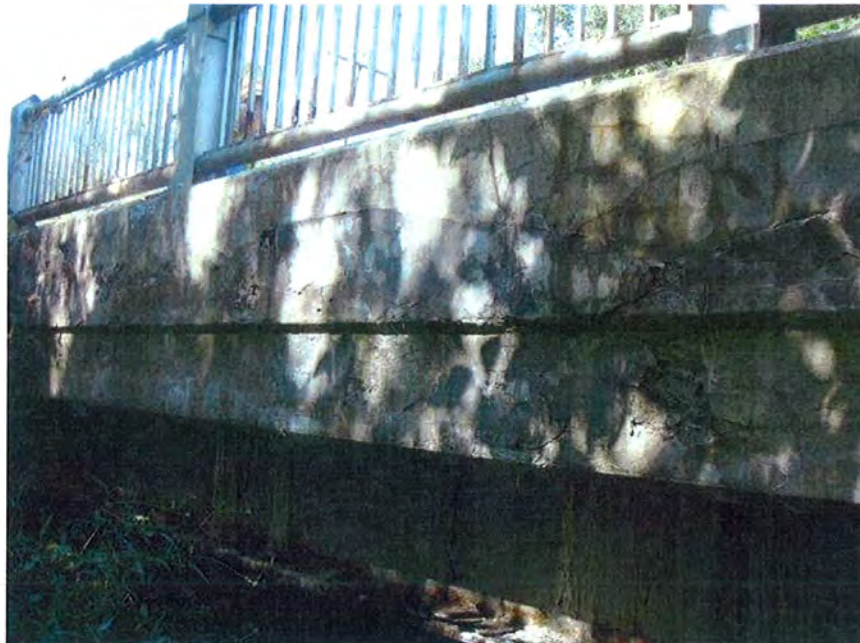
Photo Number: 11

Exterior face has several hollow patched areas up to 7' x 1' with hairline cracks and efflorescence.

Exterior face of south railbase exhibits large hollow patched areas with cracking and efflorescence.

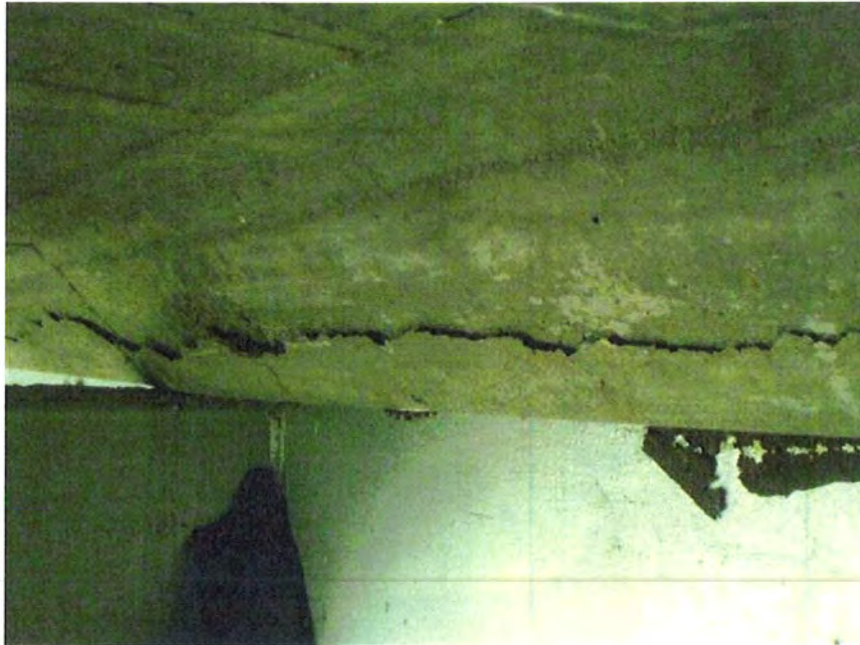
Photo Number: 13

(1) 8' x 6" hollow area/ potential spall along haunch of beam #2 adjacent to abutment #1.

Hollow area /potential spall in haunch over beam #2 in bay 2.

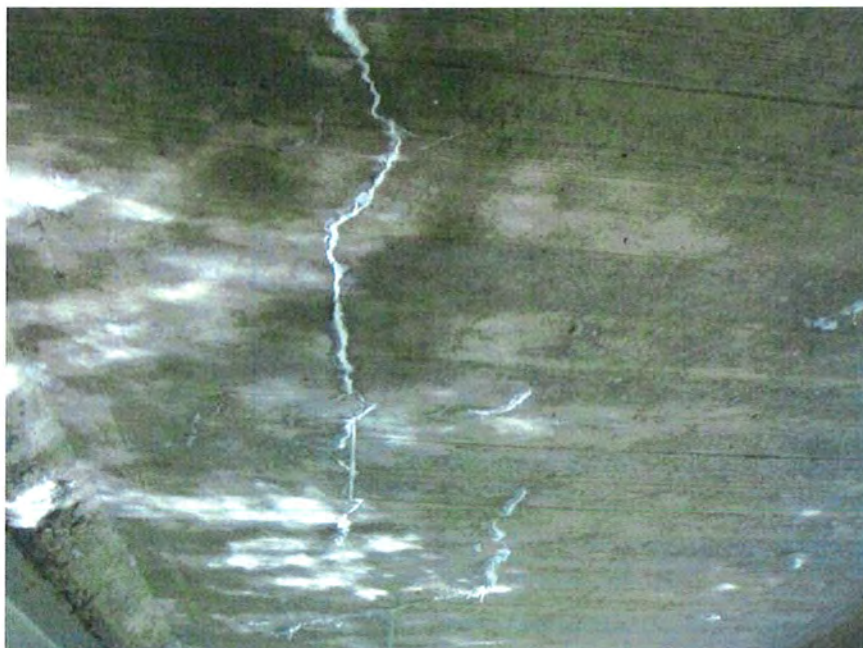
Photo Number: 14

Hairline cracks with efflorescence, especially in bay#4.

Bay 4 exhibits cracks with heavy efflorescence.

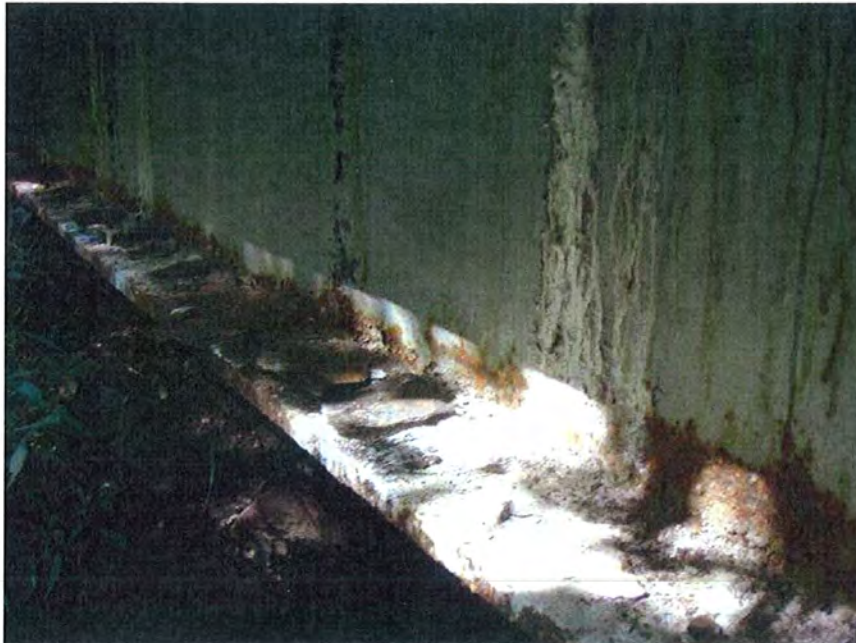
Photo Number: 15

Areas of heavy laminar rust with minimal section loss at top and bottom flanges on exterior face of the north & south fascia beam.

Beam 5 south side at top of bottom flange exhibits heavy laminar rust.

Verify minimum section loss by removing laminar rust and taking measurements next inspection. (lcc 10/6/15)

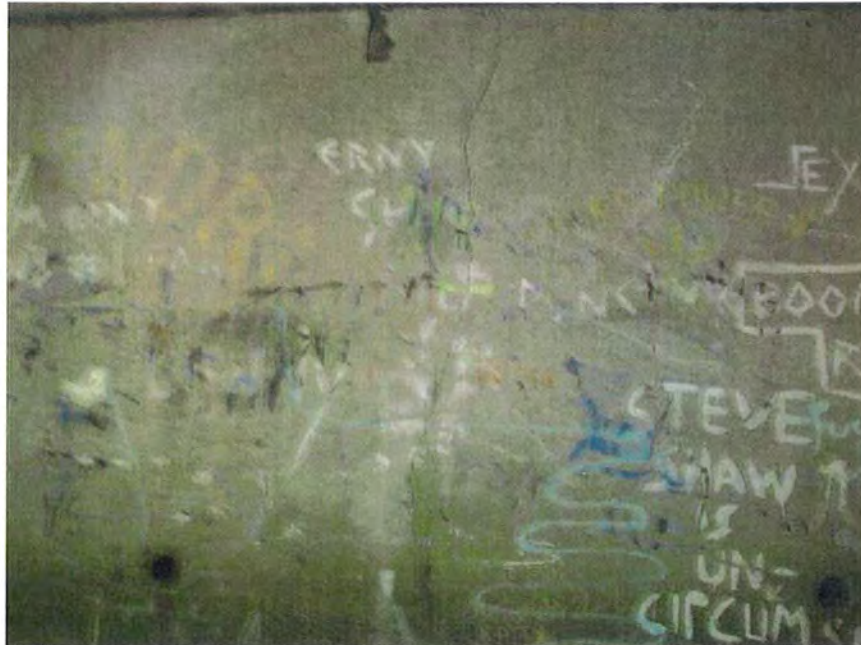
Photo Number: 11

Full height vertical crack open 1/8" with small surface spalls, at west end.

Full height vertical crack in abutment #2 adjacent to inlet.

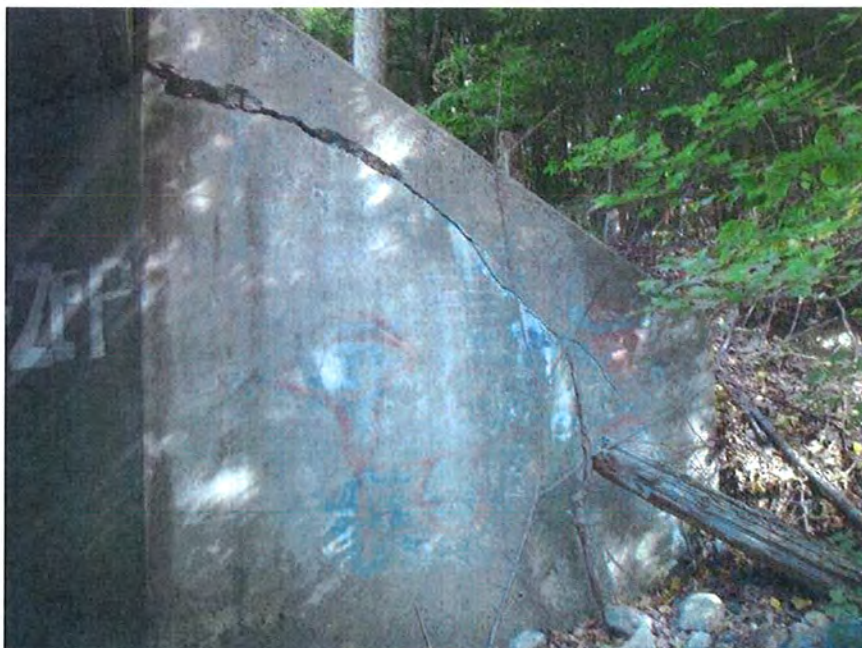
Photo Number: 12

(1) Diagonal crack, starting as hairline from base near free end extending upwards to structure opening up to 1.5" at top with 4" spalls along crack with exposed rebar adjacent to structure.

Open 1.5" at top, shifted 1" at paint mark. No change noted during 9/21/15 inspection.

Northeast wingwall exhibits open diagonal crack with adjacent spalls near structure.
