DAM SAFETY PROGRAM DAM INSPECTION REPORT FORM – FOR REGULATORY INSPECTION

Dam Name:	House Rest Pond Dam	Inspection Date(s):	1/20/2016
Alternate Dam Name(s):	N/A	CT Dam ID #:	12812
Location (Municipality):	Simsbury	Temperature / Weather:	Clear 25°
Registered?: Yes or No If yes, provide the 9 digit registration number found on the notification letter.	Yes	Pool Level: See Instructions	= Crest of spillway
Emergency Action Plan?: Yes or No If Yes, see instructions	No	Impoundment Use: use options listed in instructions	Recreation
Hydraulic and Hydrologic Analysis?: Yes or No If Yes, see instructions	No	Stability Analysis?: Yes or No If Yes, see instructions	No
Overall Condition: (refer to Appendix A located at the end of this form) Poor

Dam Name:	Stoddard Reservoir	Inspection Date(s):	1/20/2016
Alternate Dam Name(s):	N/A	CT Dam ID #:	12804
Location (Municipality):	Simsbury	Temperature / Weather:	30°, clear
Registered?: Yes or No If yes, provide the 9 digit registration number found on the notification letter.	Yes	Pool Level: See Instructions	Spillway + 1"
Emergency Action Plan?: Yes or No If Yes, see instructions	No	Impoundment Use: use options listed in instructions	Recreation
Hydraul

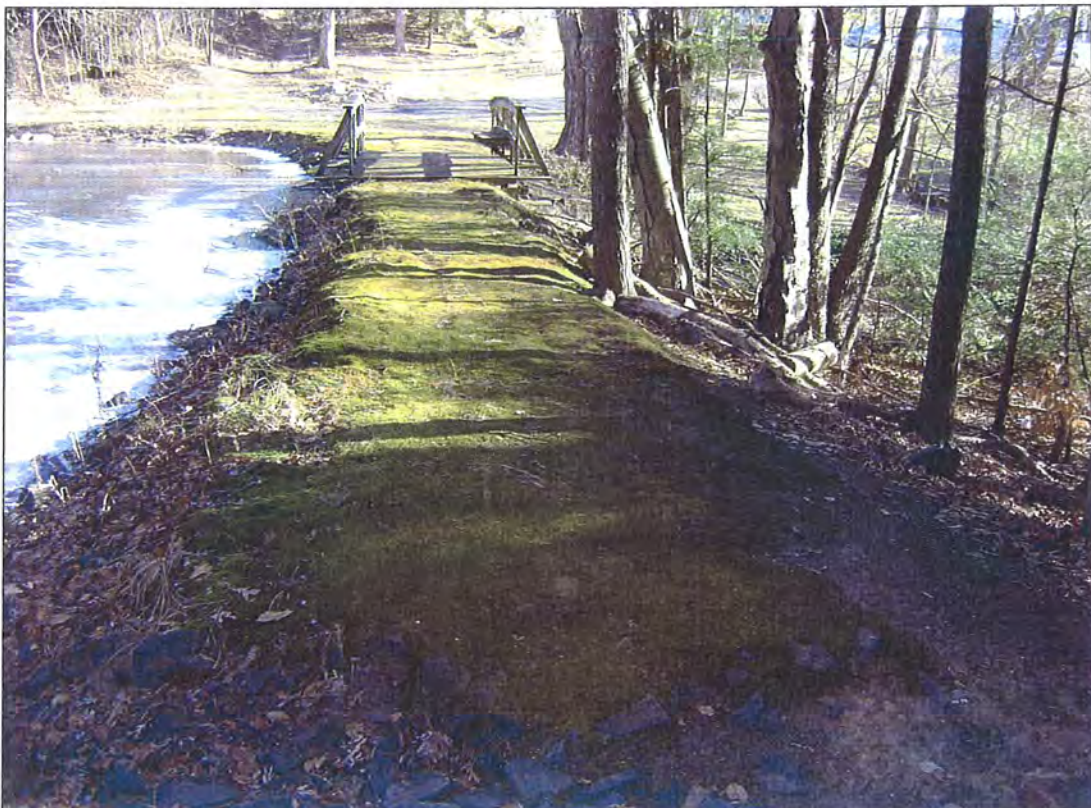
Other: Top of embankment is uneven. Large trees growing on downstream side of embankment.

Photo 1: Embankment from right abutment

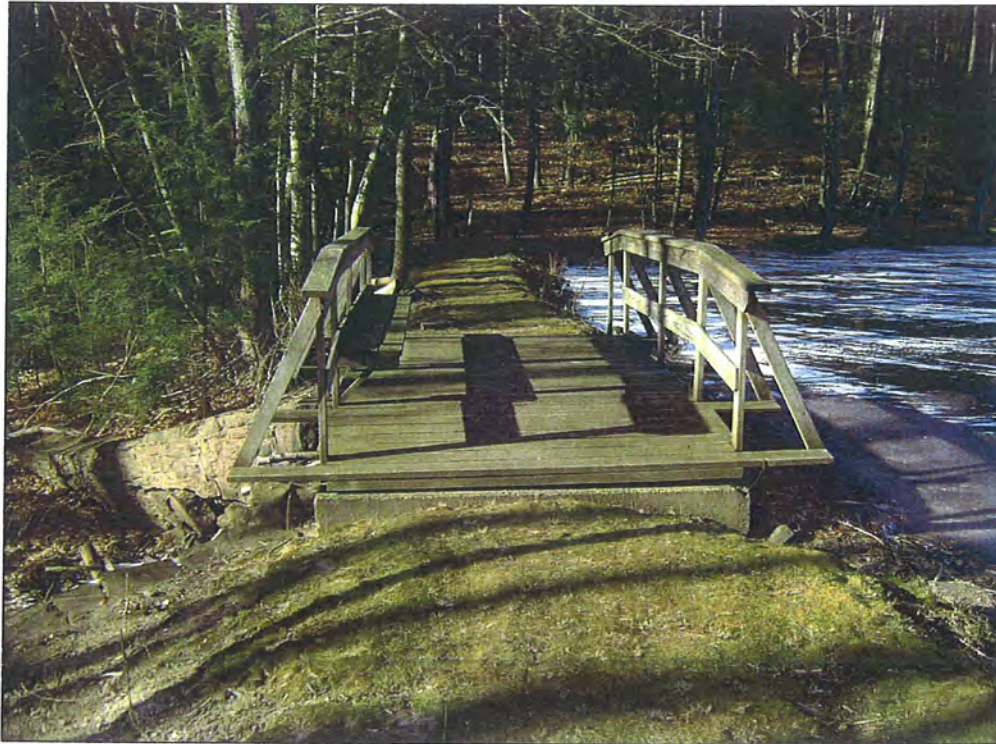
Photo 2: Footbridge over spillway

Settlement/Alignment/Movement: Some settlement - inadequate support for footbridge

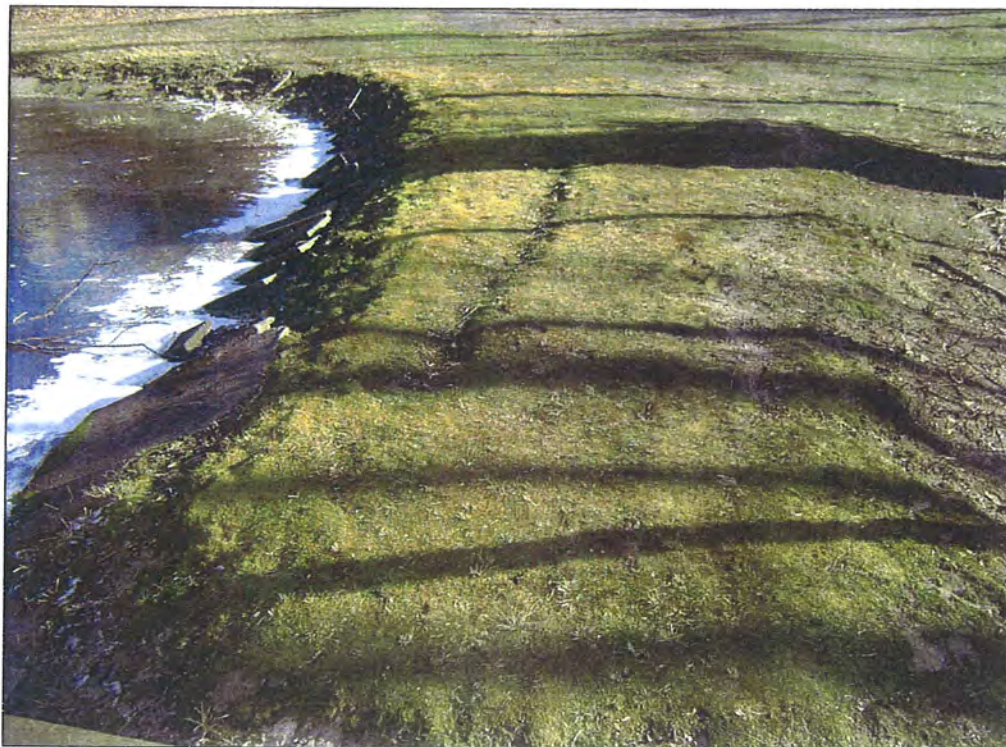
Photo 3: Left abutment, ruts on embankment, concrete paver protection

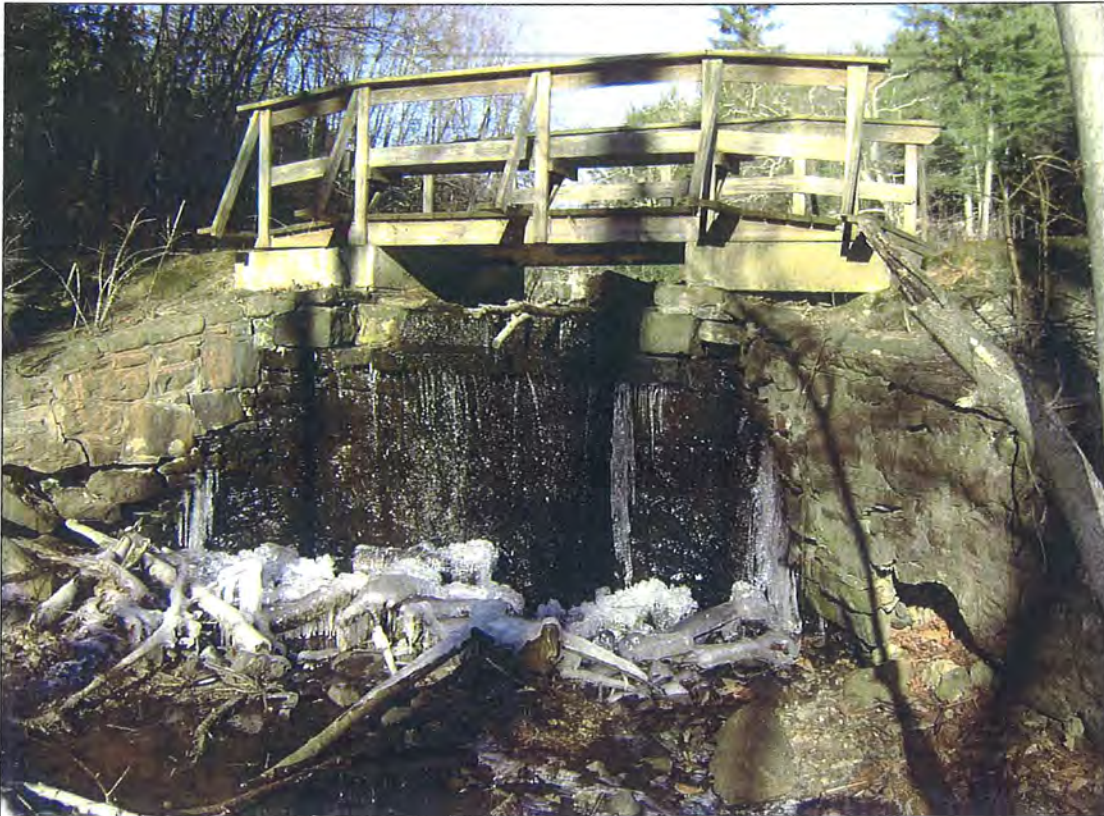
Stone Masonry: Loose and leaking

Seepage/Foundation Drainage: Leaking throughout

Other: Poor connection to wing walls leaves gaps to sides, wings walls nearly completely failed

Photo 4: Main spillway and wing walls

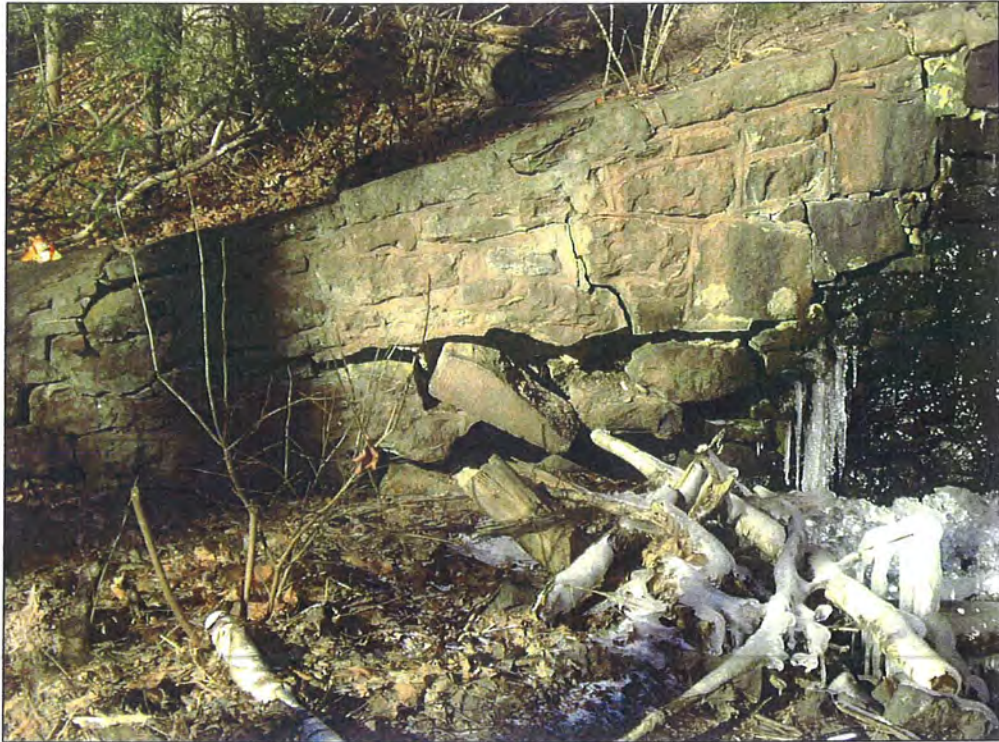
Photo 5: Right wing wall

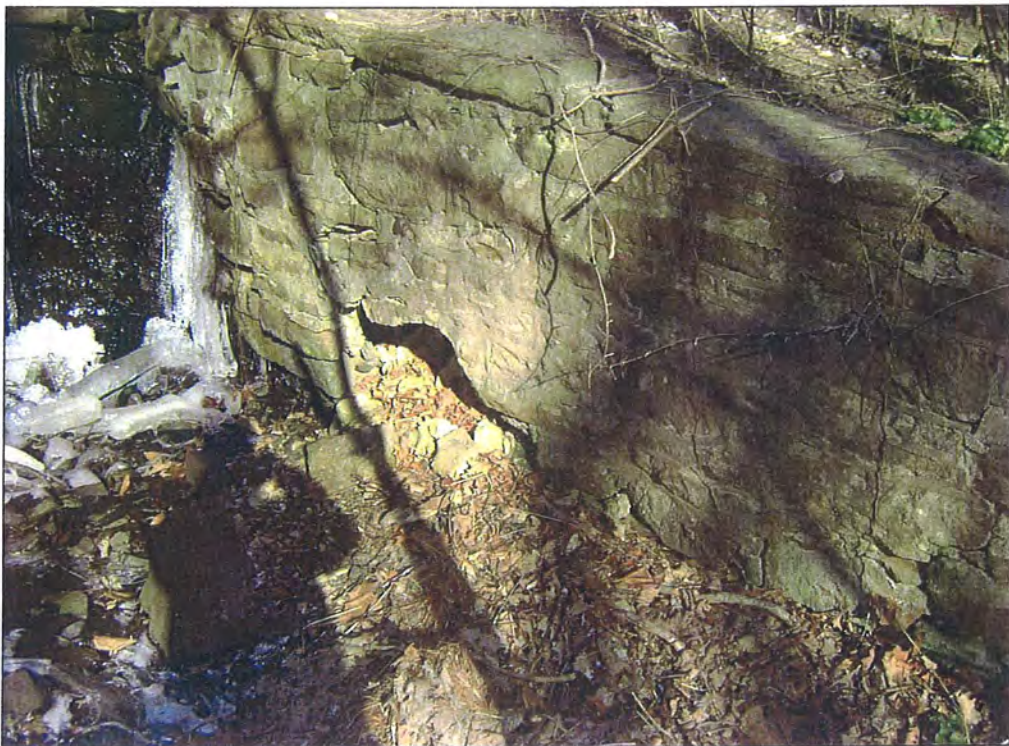
Photo 6: Left wing wall

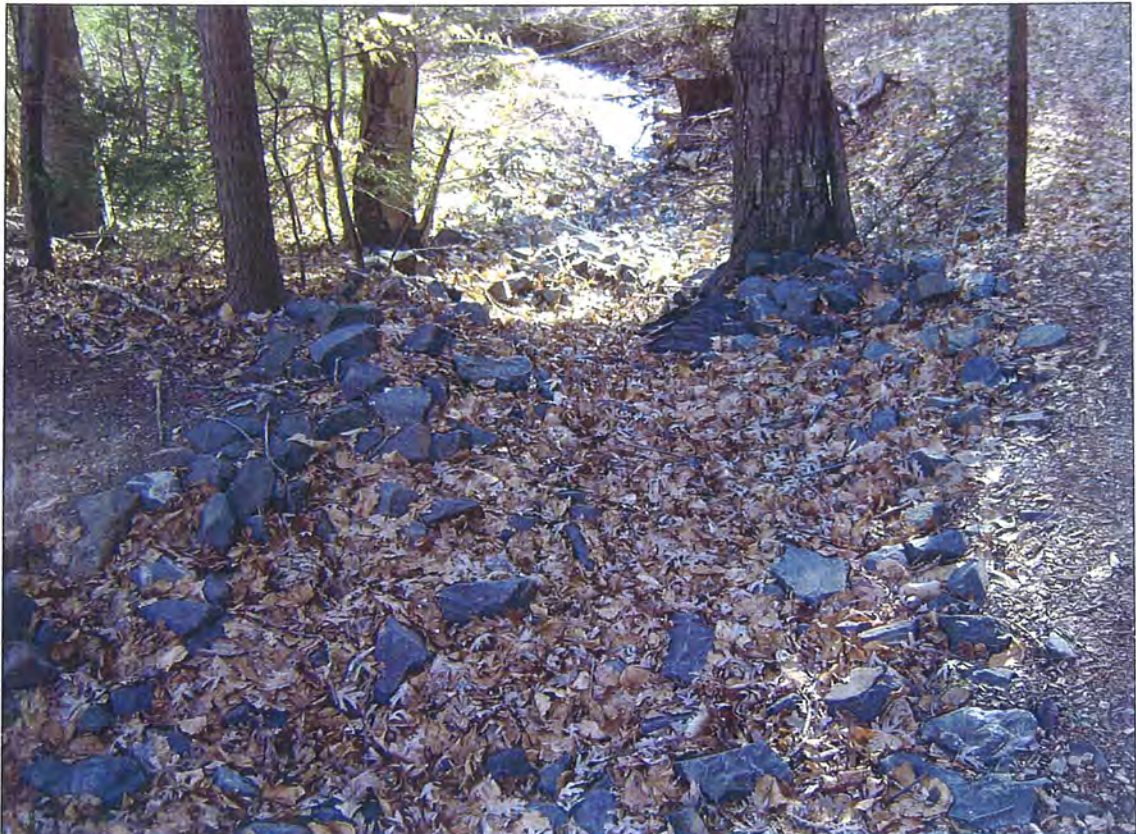
Other: Spillway did not show evidence of recent use.

Photo 7: Auxiliary spillway at right abutment

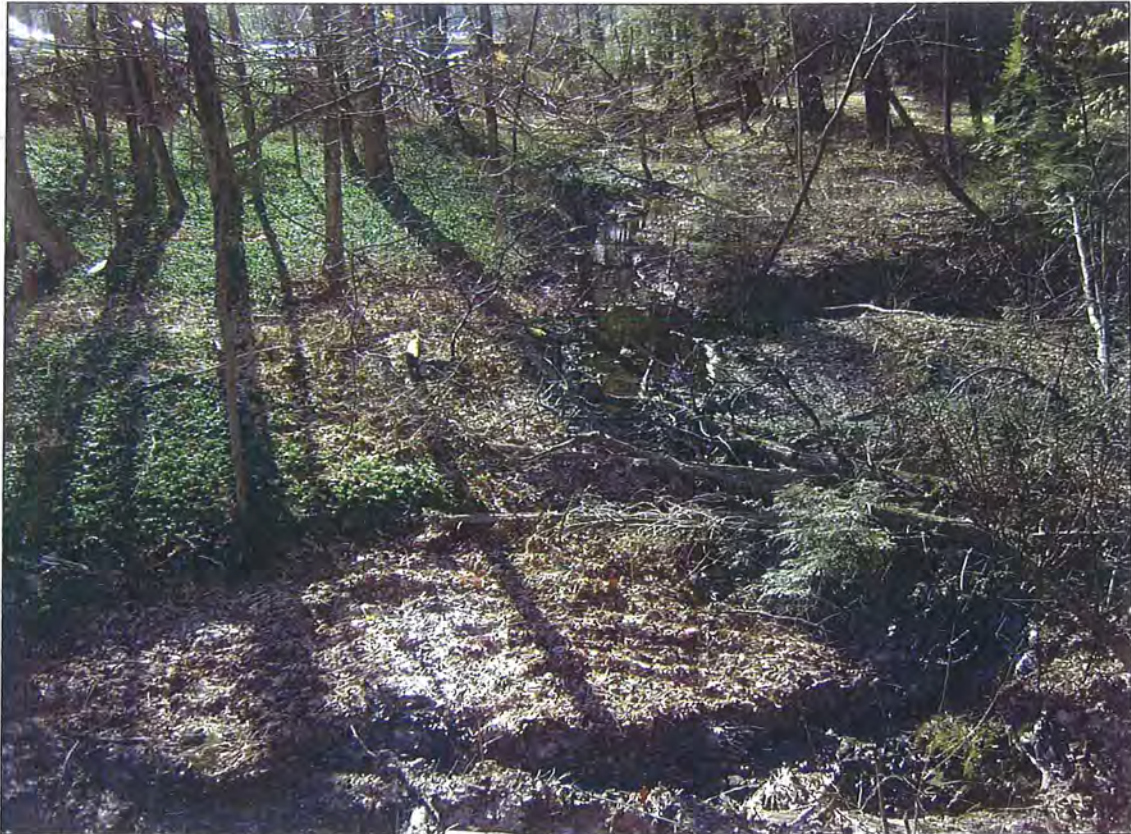
Other: Due to leakage of spillway stream flows continuously, has natural appearance

Photo 8: Looking downstream from dam

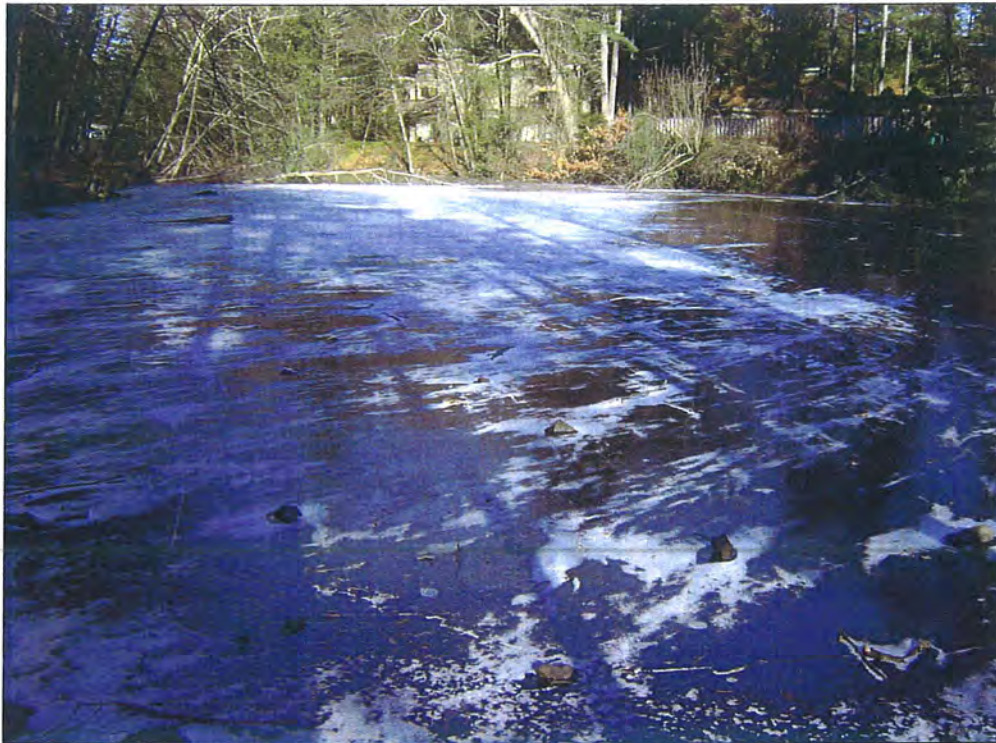
Photo 9: Overview of Pond

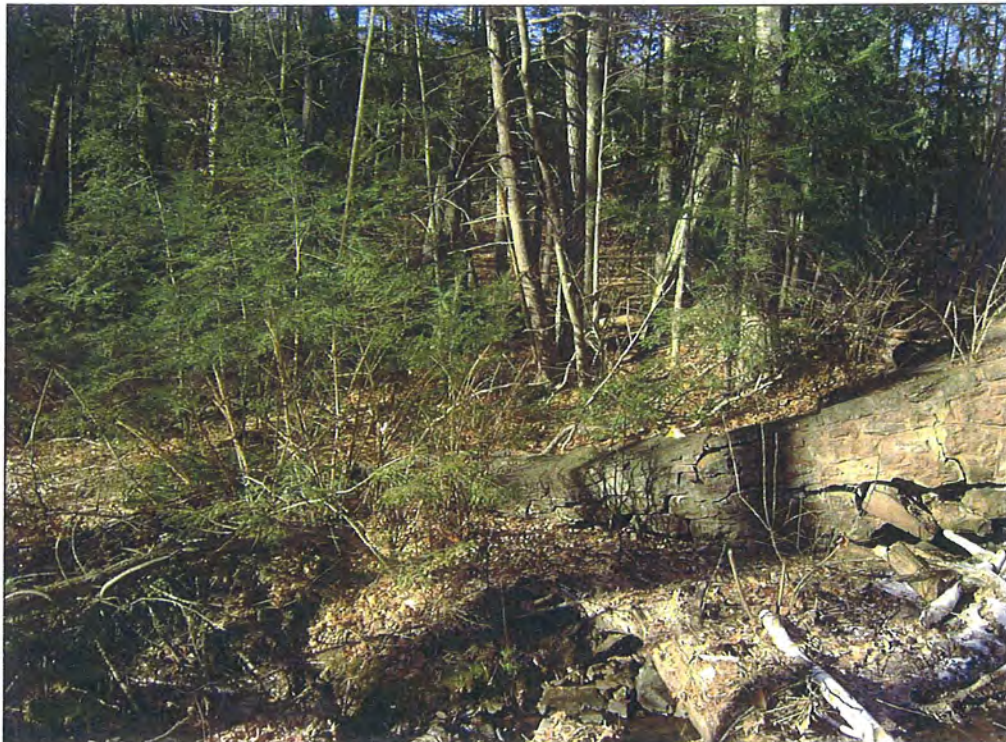
Photo 10: Vegetation on embankment

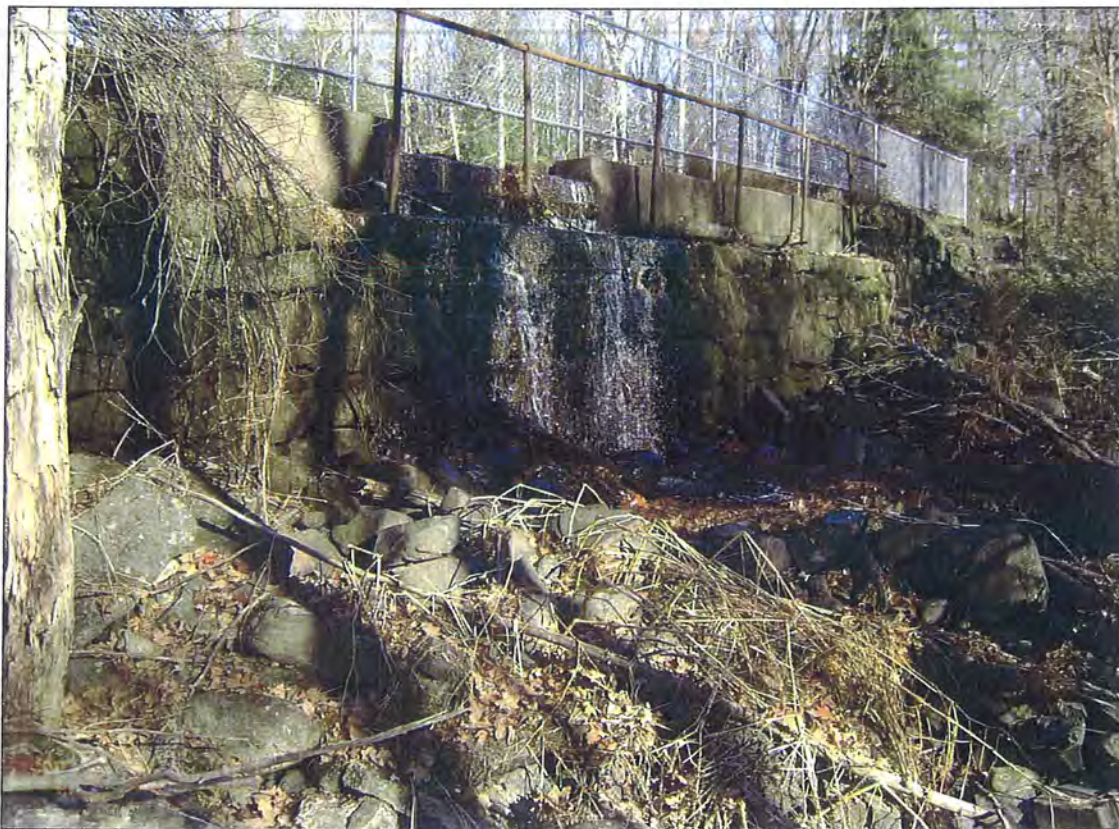
Photo 1: Main section of dam & spillway

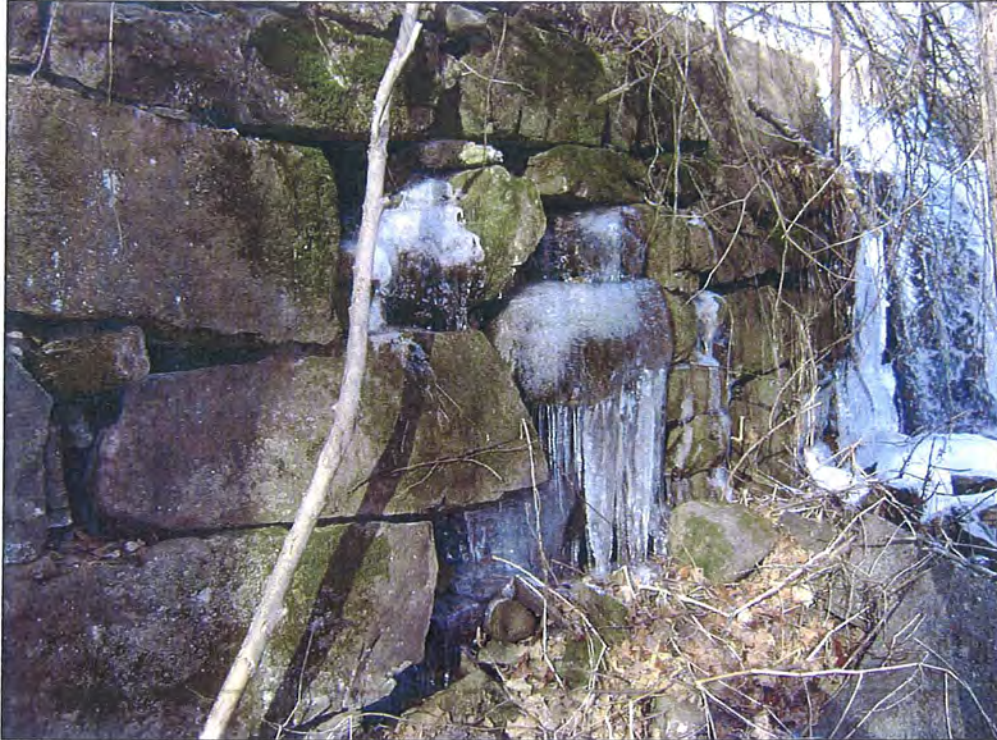
Stone Masonry: Fair - some leaks

Photo 2: Leak in rubble embankment

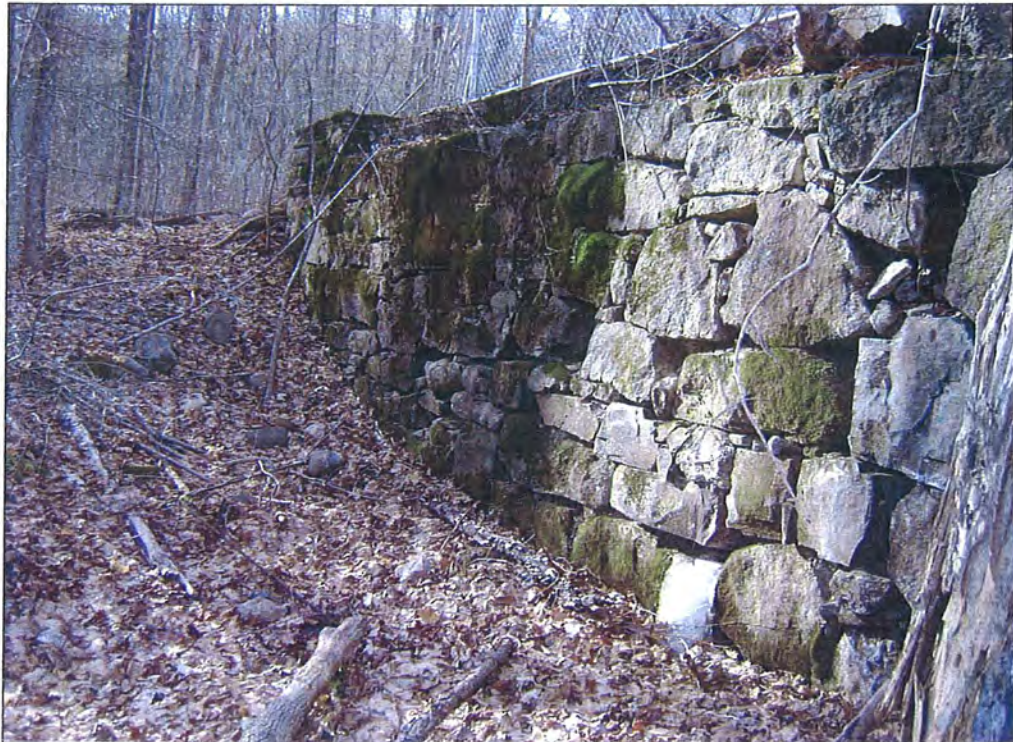
Photo 3: Looking to right abutment

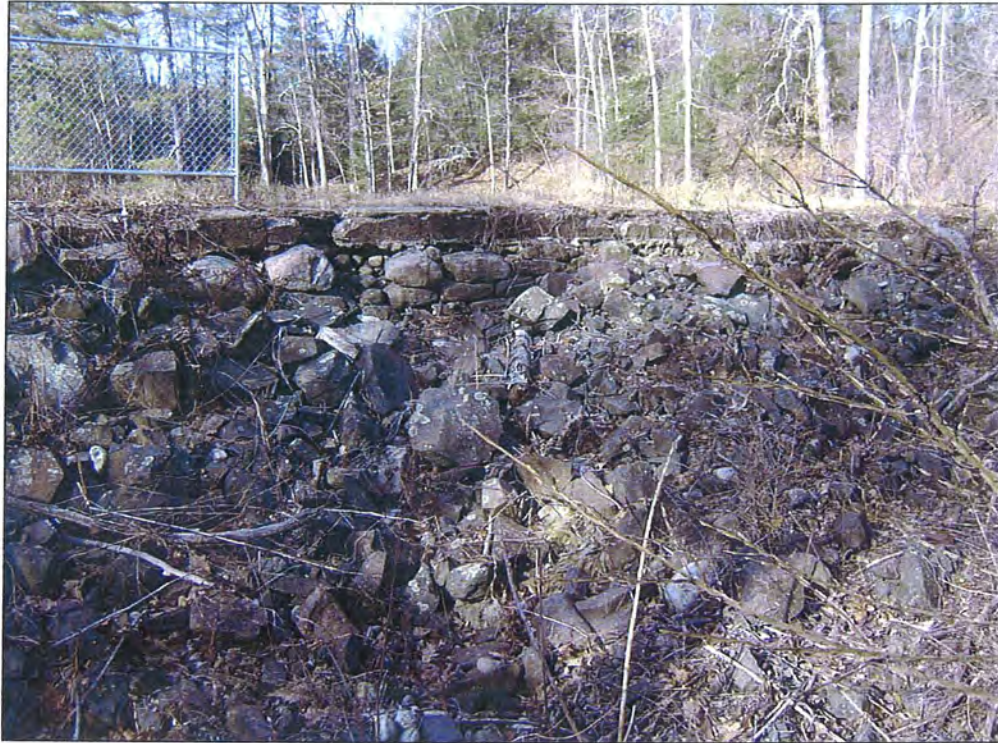
Riprap: New dumped riprap left of spillway. Appears that dam overtopped and repairs to downstream left embankment were required.

Photo 4: Left side of embankment, with dumped riprap repair

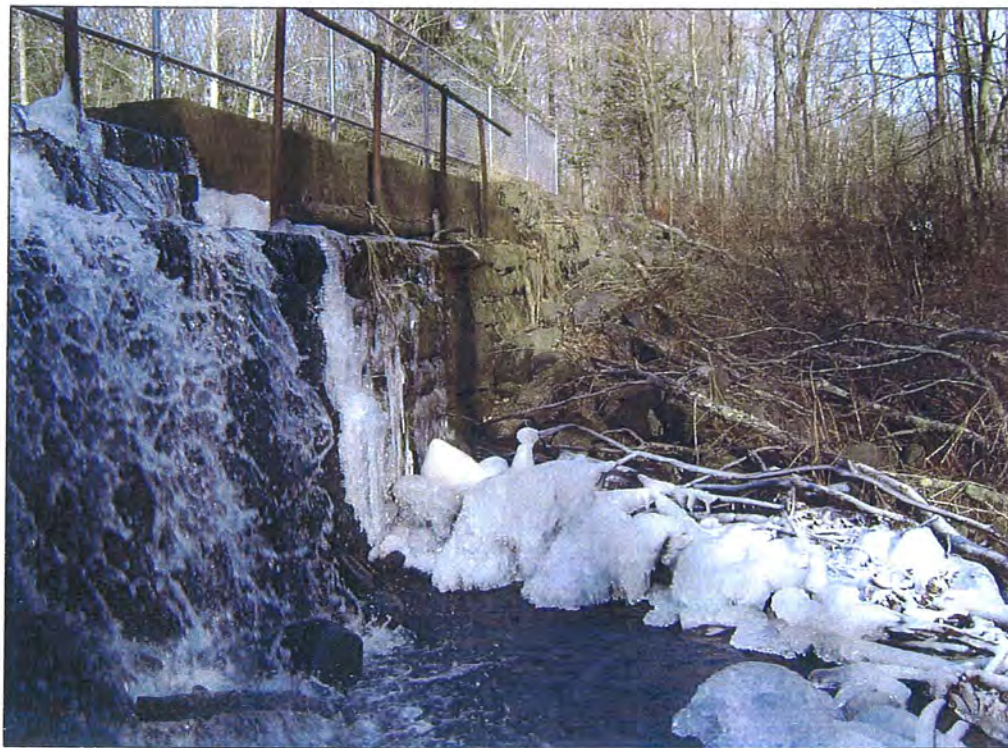
Photo 5: From spillway looking left

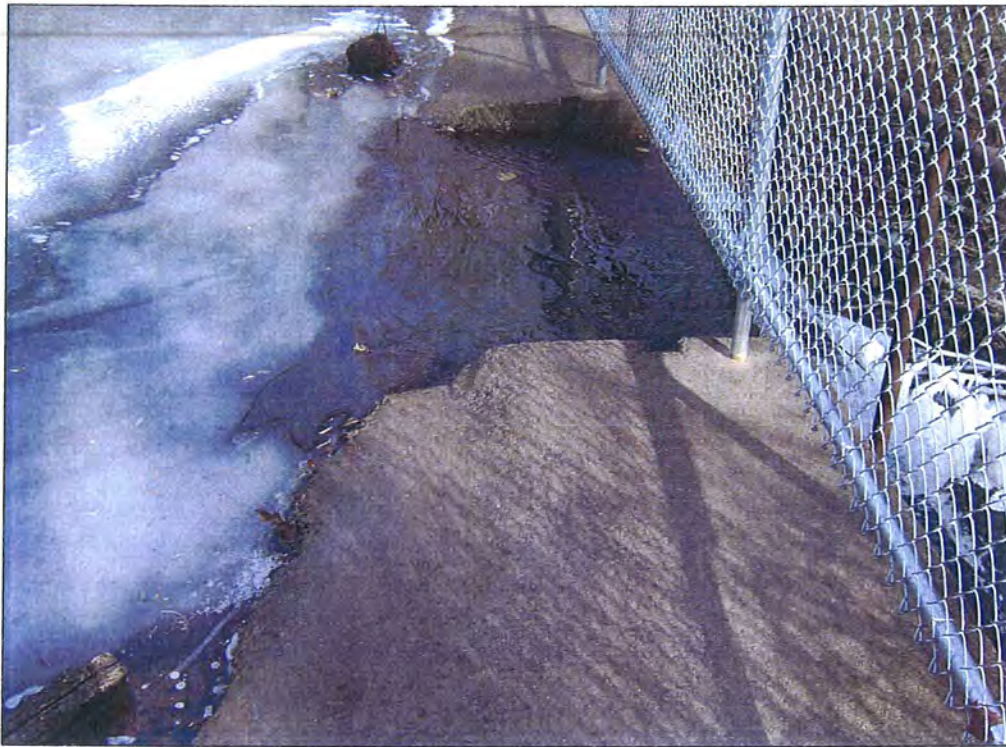
Other: Pipe and chain link fence cross spillway, possibly causing blockage if branches wash into spillway.

Photo 6: Spillway - cast into concrete cap

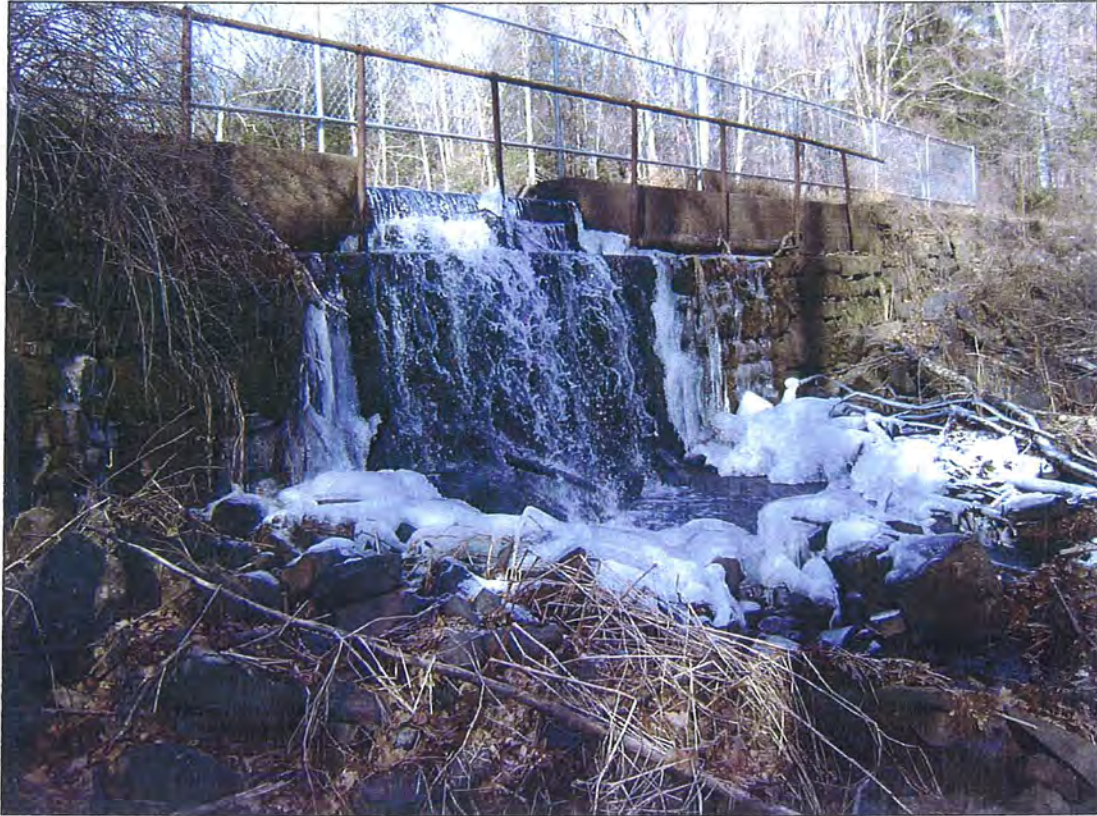
Photo 7: Spillway downstream area

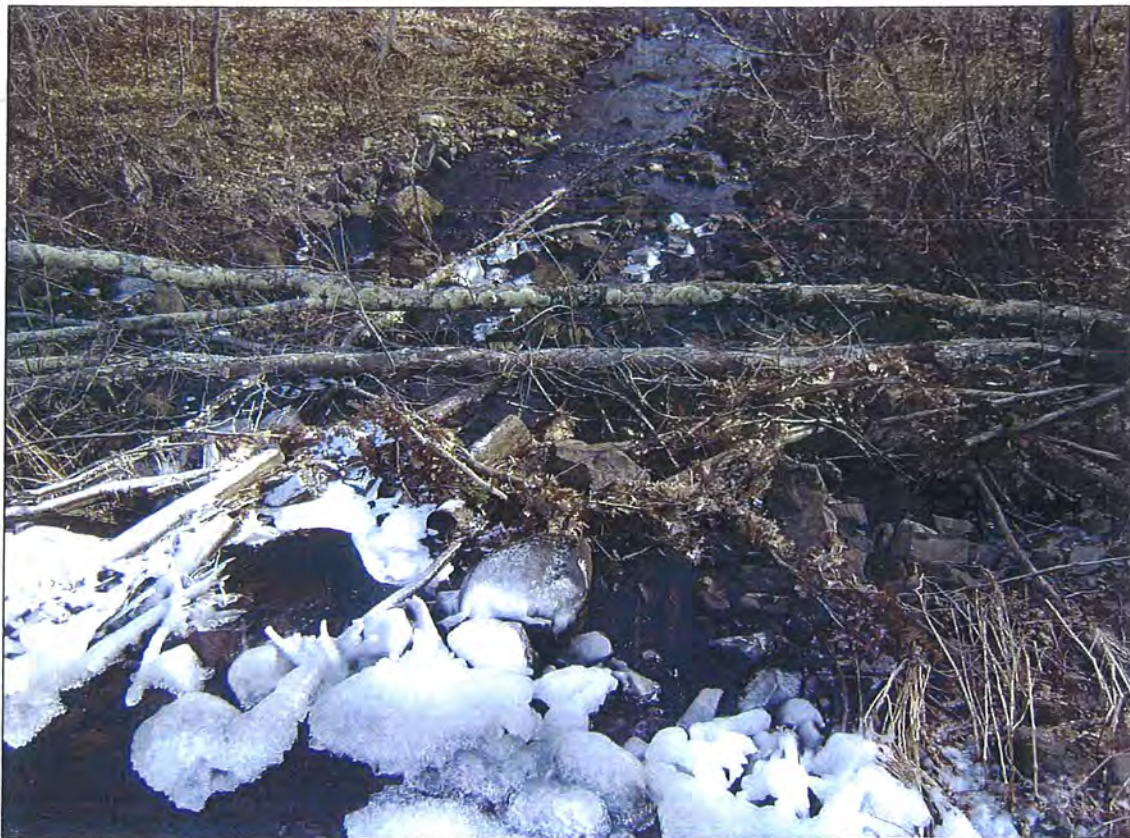
Photo 8: Debris in outlet channel just downstream of spillway

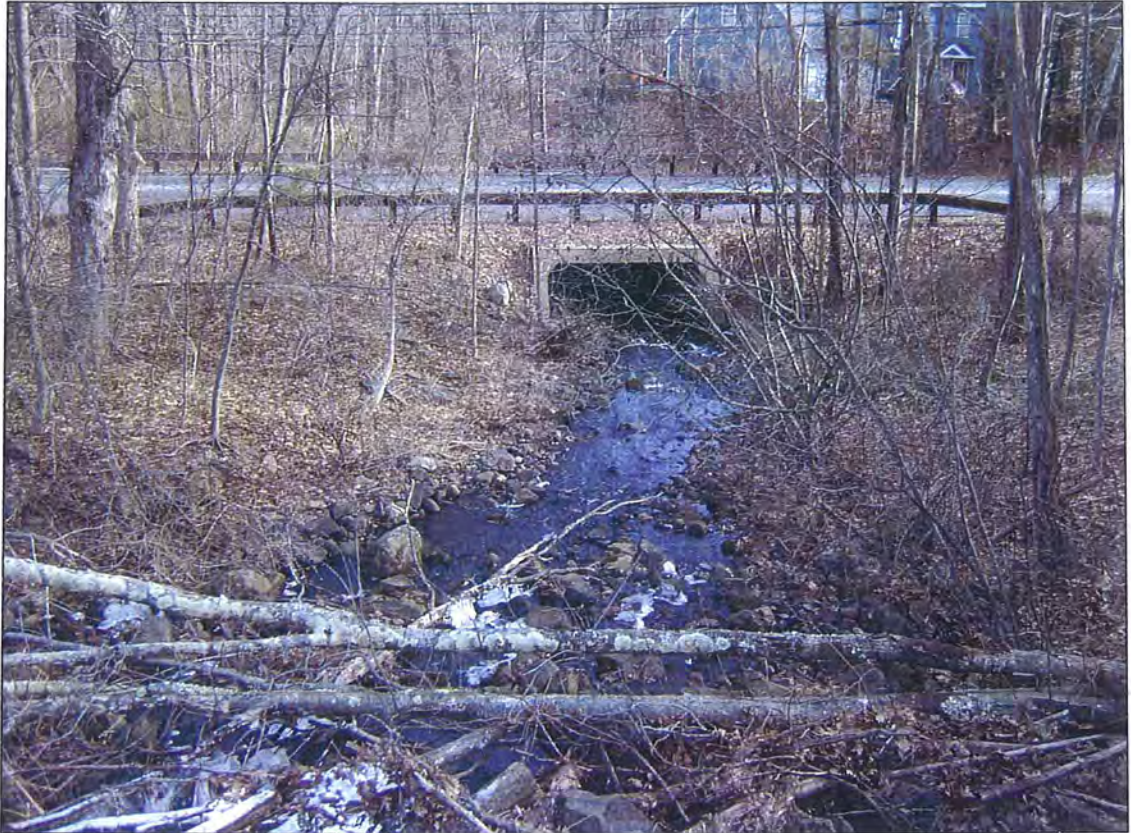
Photo 9: Outlet channel from dam to West Mountain Road culvert

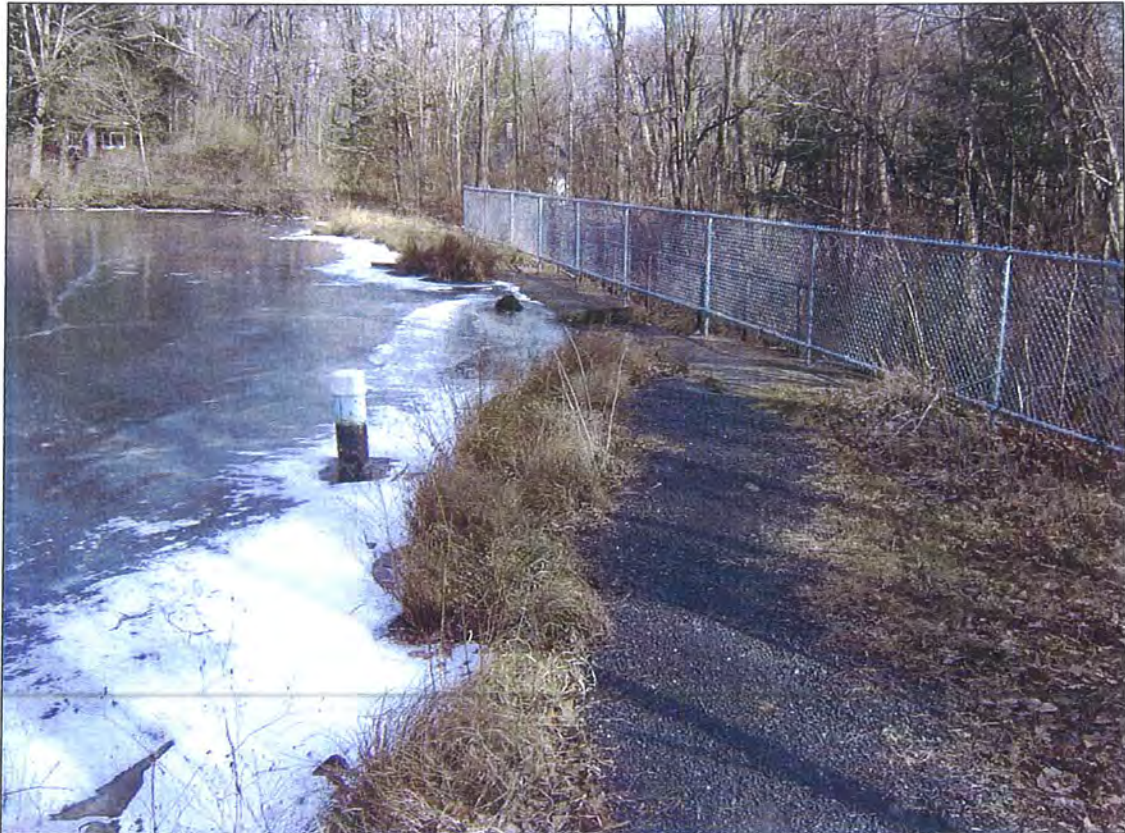
Photo 10: Access to valve on intake

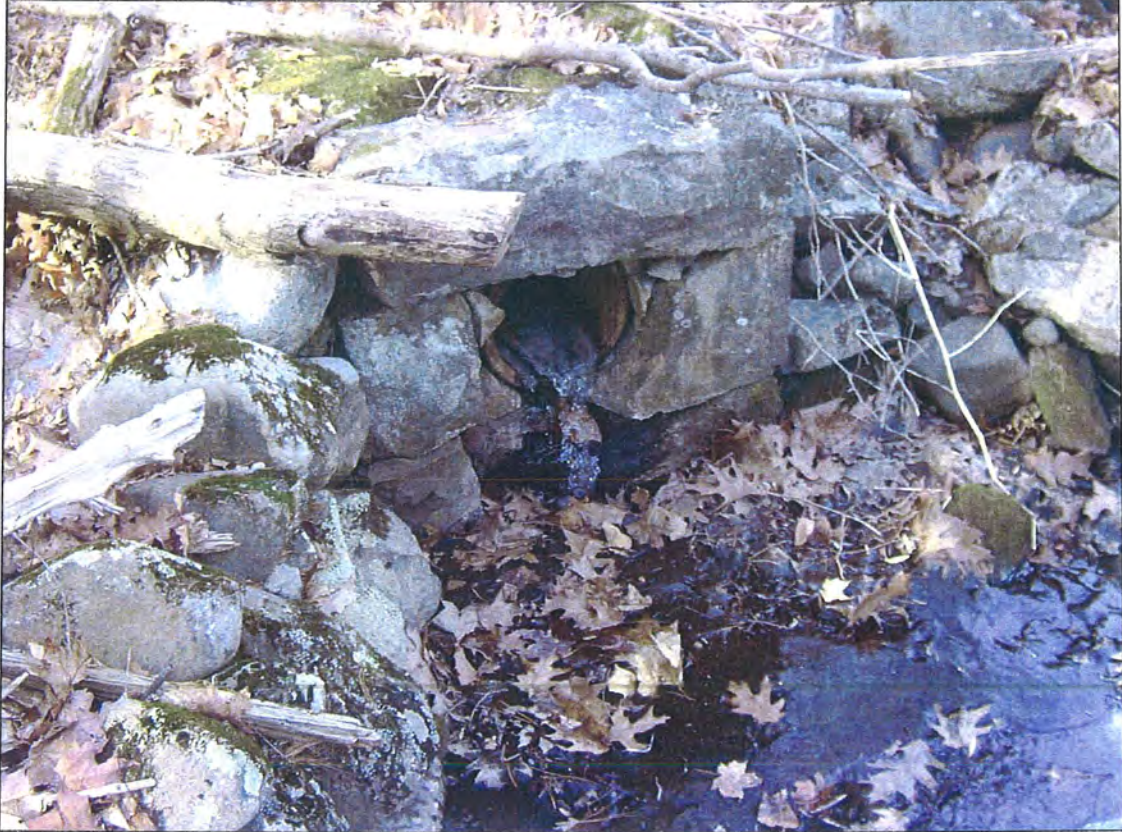
Other: Outlet pipe is at grade and likely not used for a significant time

Photo 11: Pipe Outlet with rubble masonry endwall

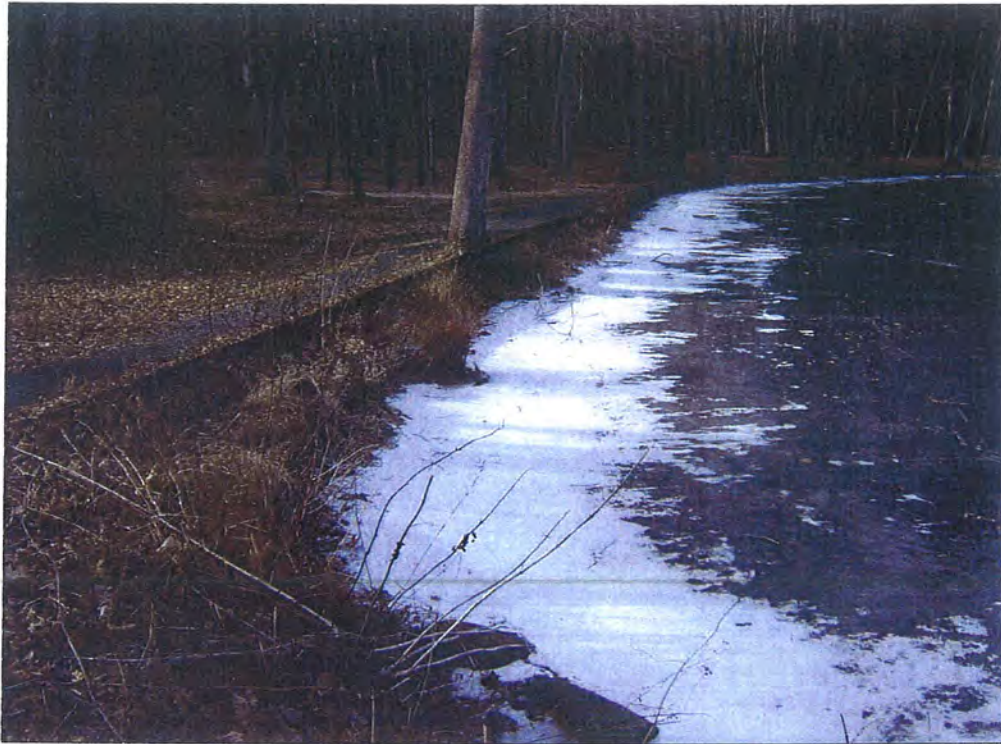
Photo 12: Walkway around right side

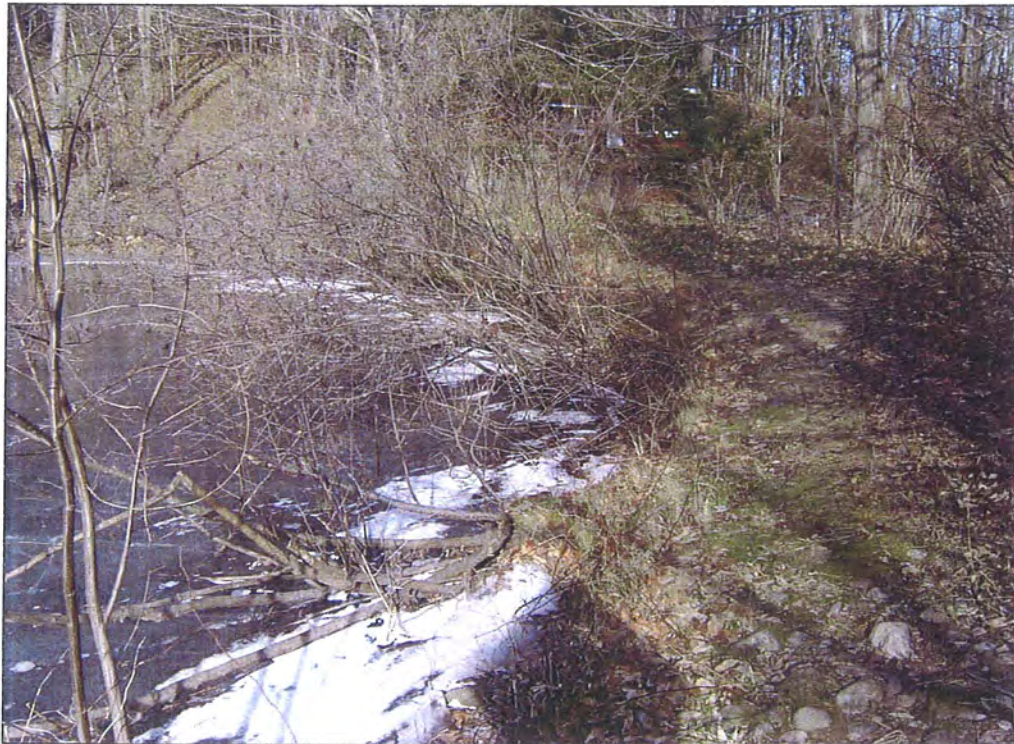
Photo 13: Low embankment to left

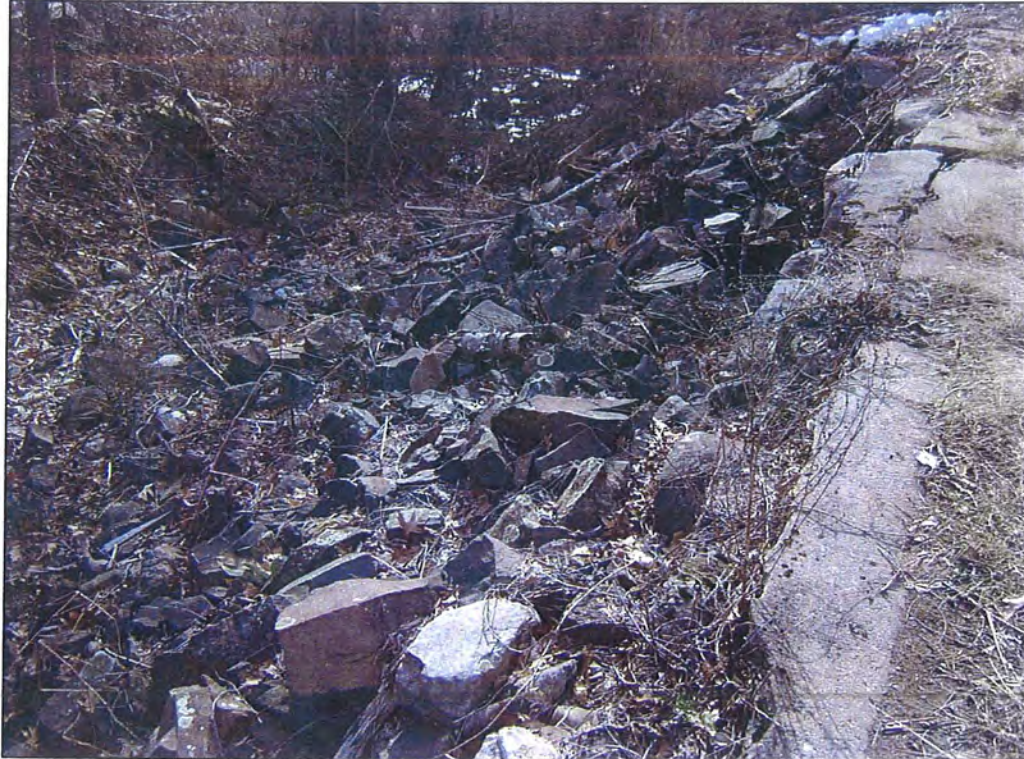
Photo 14: Riprap repair downstream left

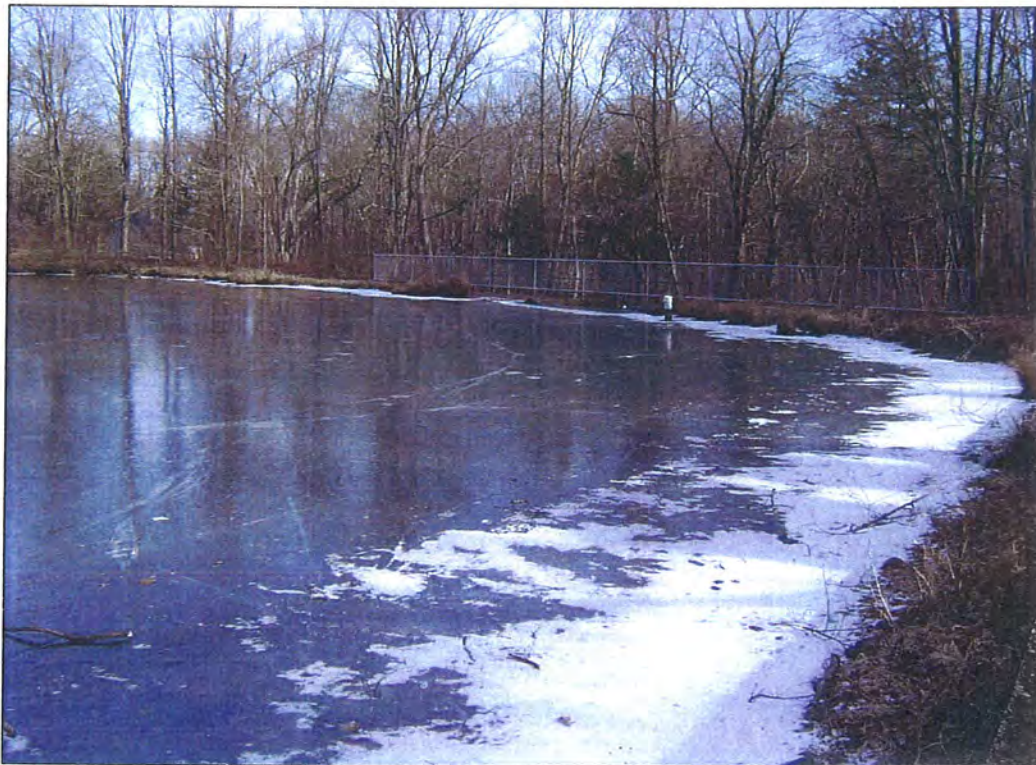
Photo 15: Upstream overview of dam

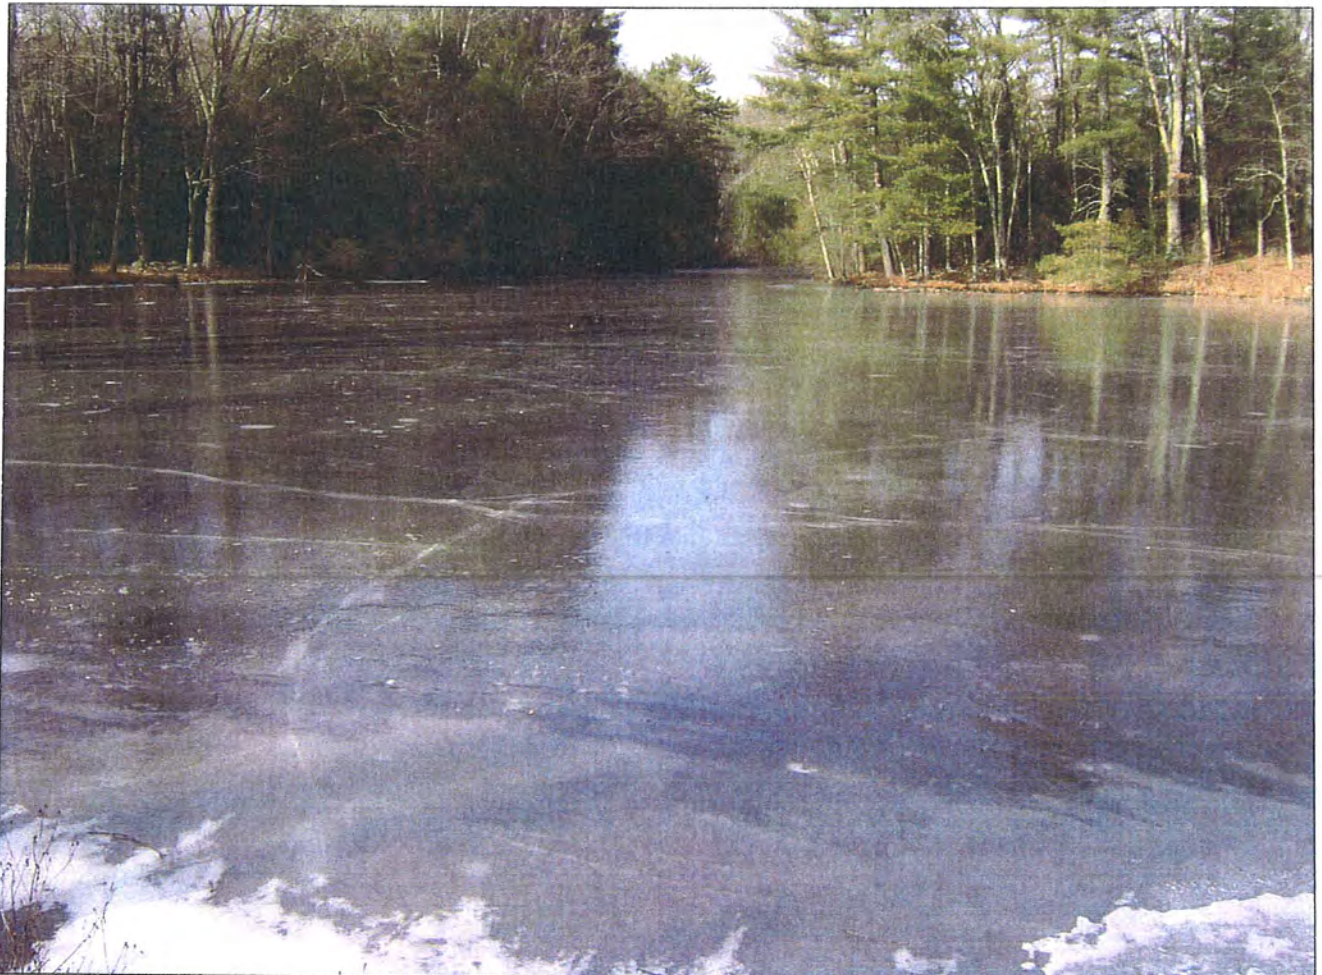
Photo 16: Reservoir overview
