# Town of Simsbury

#### **WATER POLLUTION CONTROL FACILITY PRIMARY CLARIFIER RESTORATION**

**TOWN OF SIMSBURY, CONNECTICUT**  
**PROFESSIONAL DESIGN SERVICES**  
**WATER POLLUTION CONTROL FACILITY**  
**PRIMARY CLARIFIER RESTORATION**

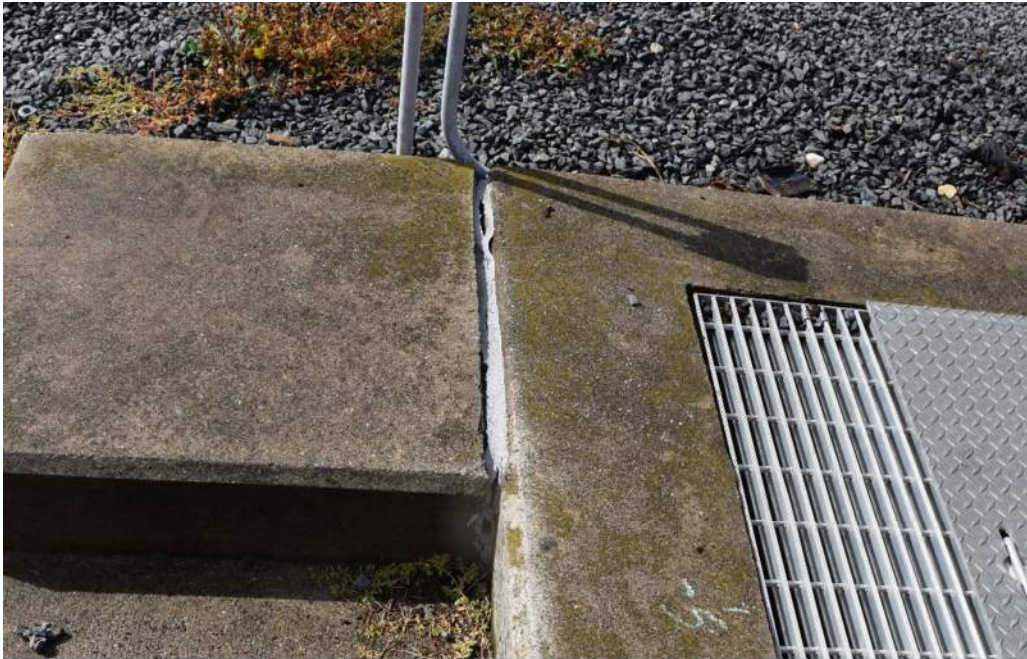
**Photo 2 – Cracked Joint Sealant**

View of cracked joint sealant between the clarifier and a concrete pad at the southwest corner of the clarifier.

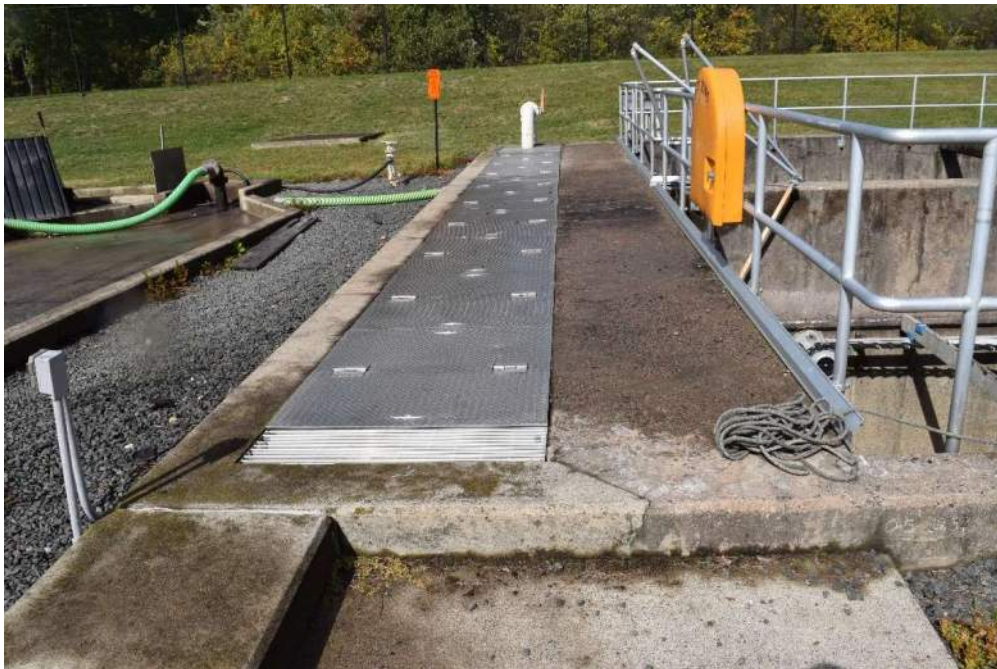
**Photo 3 – Clarifier Top Slab – West End (Looking North)**

View of the top of the top slab on the west end of the clarifier. Top of slab includes surface scaling with shallow patches and map cracks.

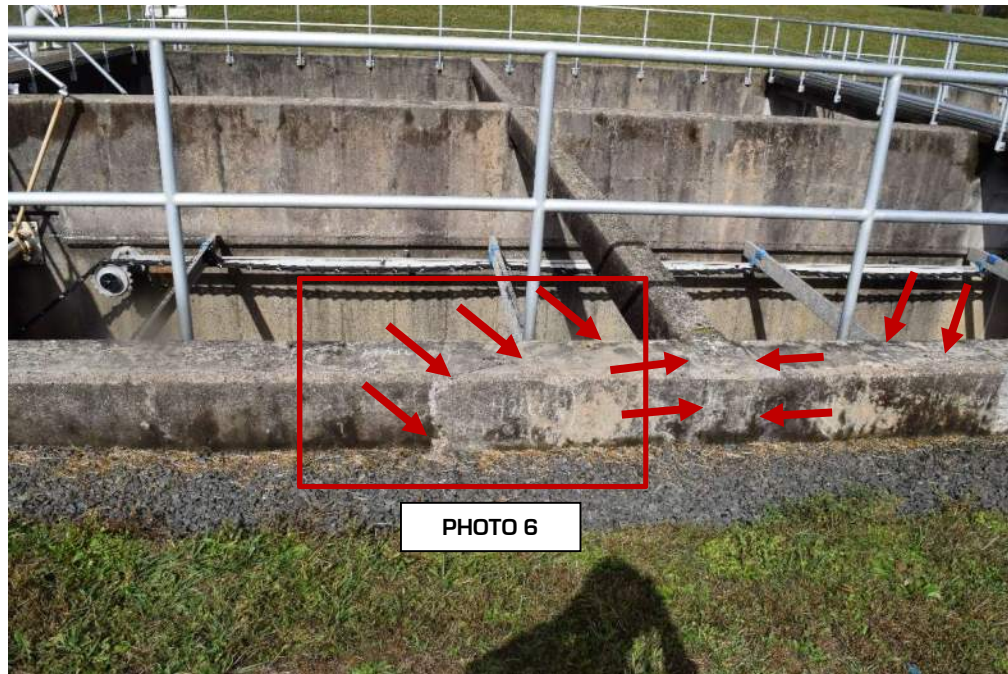
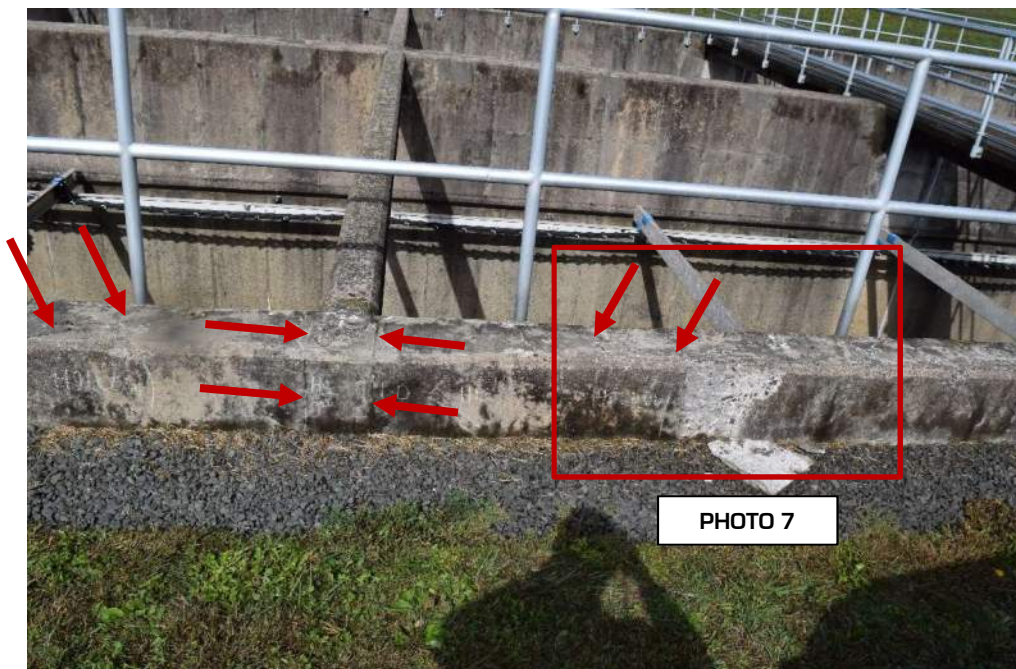
Significant shear failure was observed in the top of the south wall on each side of the west bracing strut connection. Additionally, visible punching shear failure occurred to the longitudinal wall at the bracing strut connection. Similar but less significant punching shear distress was also observed in the north longitudinal wall at the east and west bracing strut connections.

The shear failure of the south longitudinal wall at the west bracing strut is of significant concern. The west bracing strut is no longer effective and does not provide adequate bracing to the top of the westerly half of the south longitudinal wall.

**Photo 4 & 5 – South Wall of Basin No. 2 at West Bracing Strut (Looking North)**  
Shear cracks in the South Wall of Basin No. 2 on each side of the West Bracing Strut, and punching shear cracks along the perimeter of the Bracing Strut.

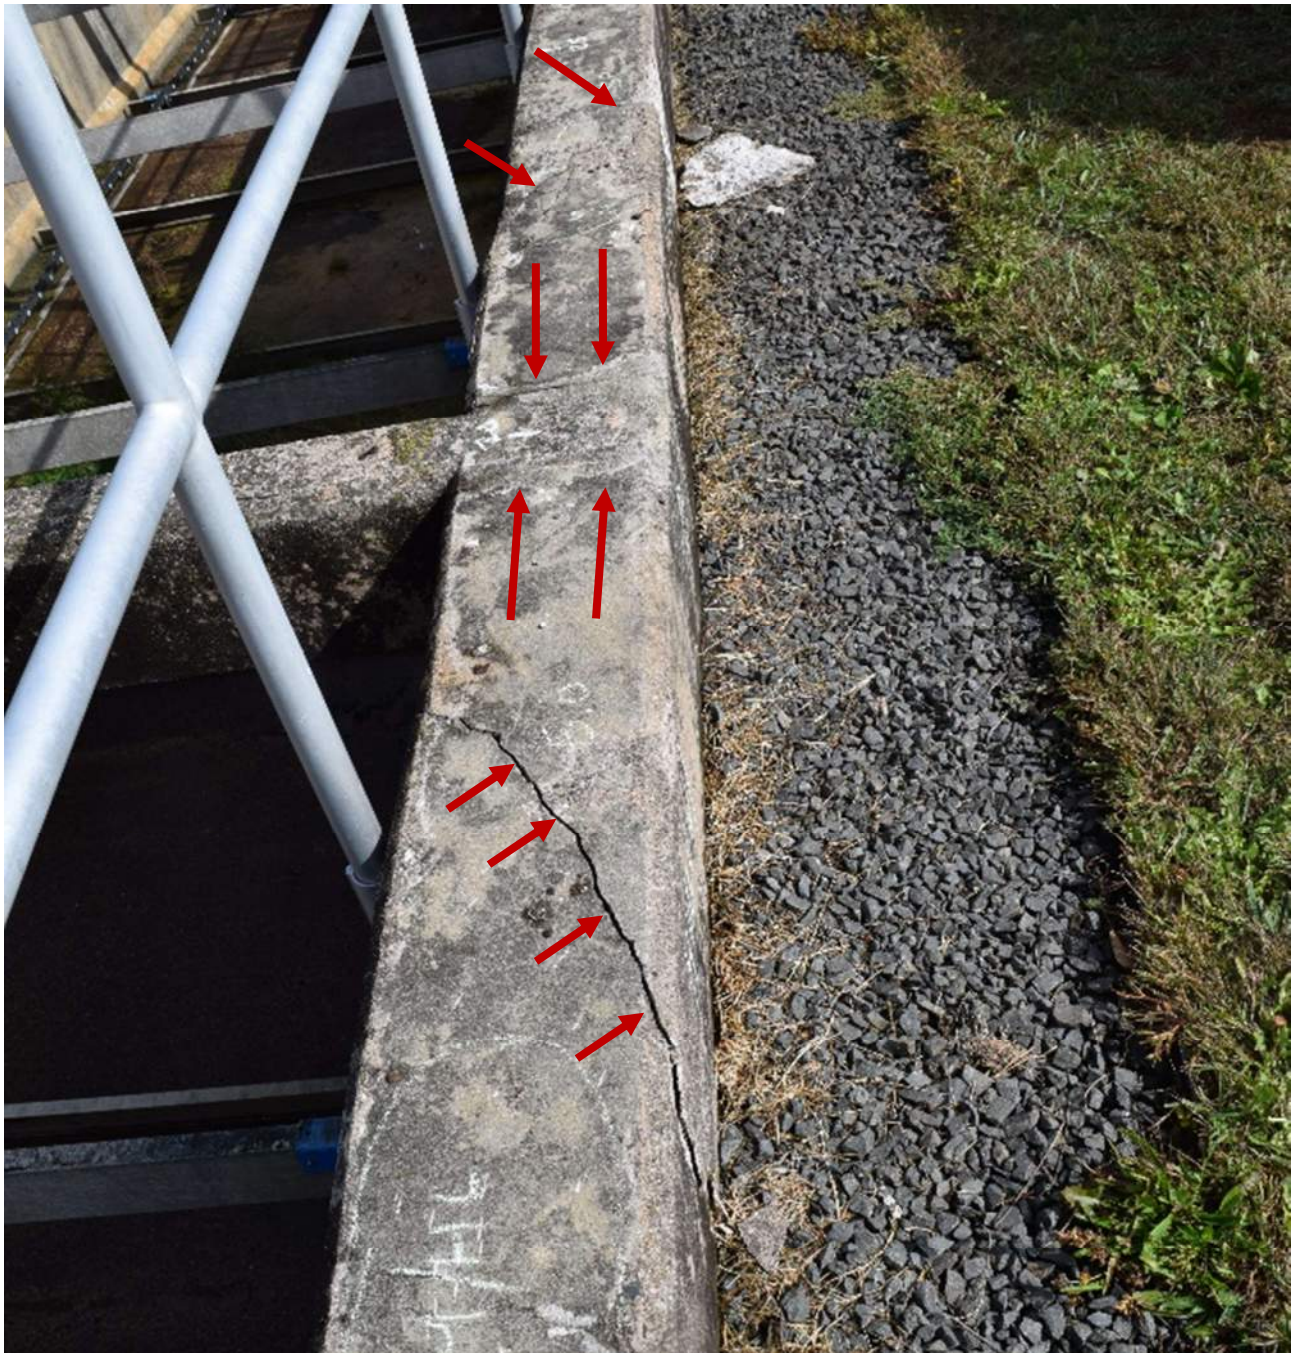
**Photo 6 – South Wall of Basin No. 2 at West Bracing Strut (Looking East)**

Shear cracks in the South Wall of Basin No. 2 on each side of the West Bracing Strut, and punching shear cracks along the perimeter of the Bracing Strut.

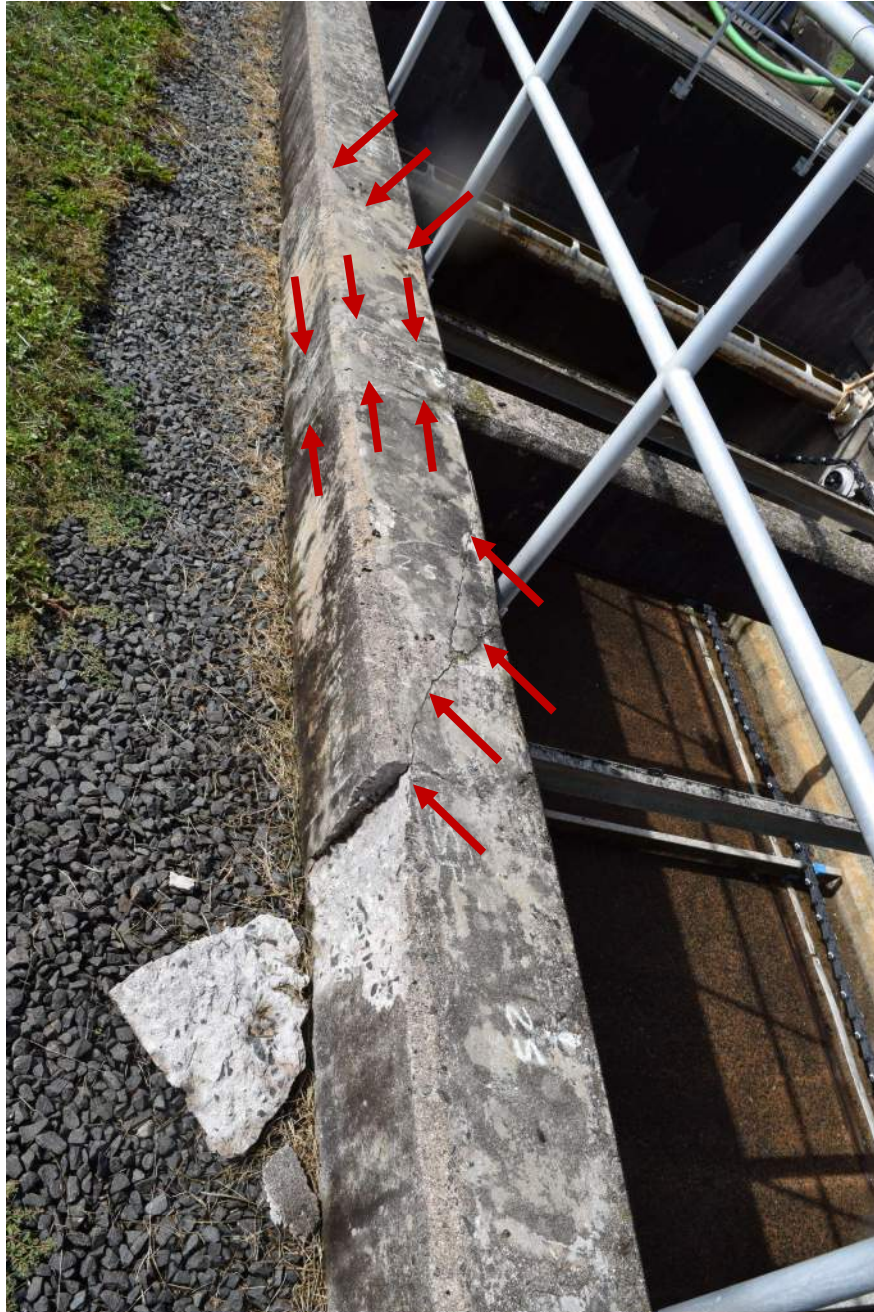
**Photo 7 – South Wall of Basin No. 2 at West Bracing Strut (Looking West)**  
Shear cracks in the South Wall of Basin No. 2 on each side of the West Bracing Strut, and punching shear cracks along the perimeter of the Bracing Strut.

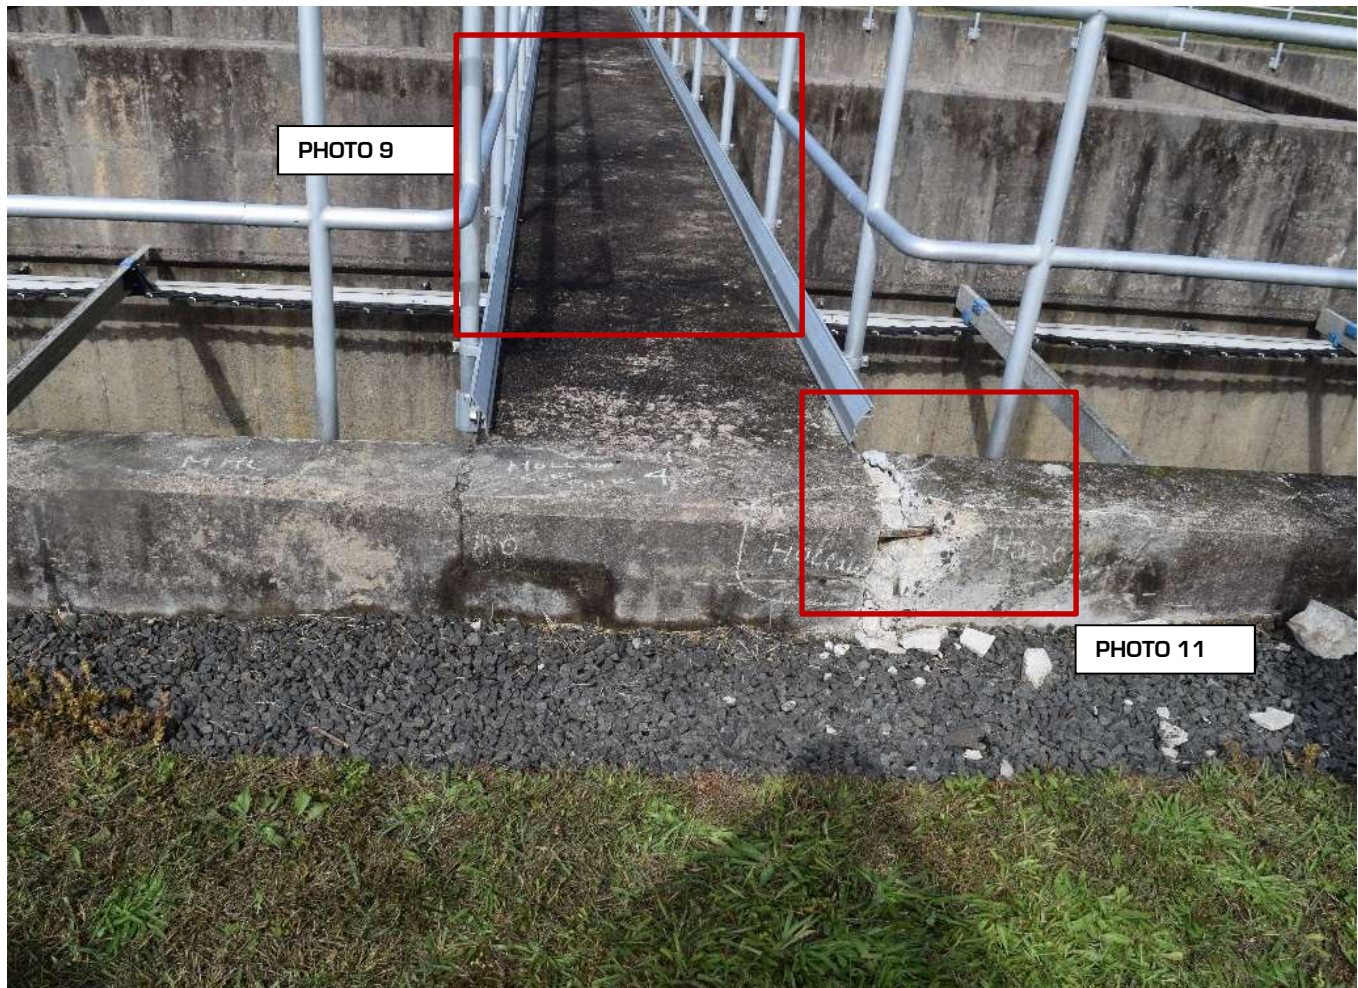
**Photo 8 – South Wall of Basin No. 2 at Center Bracing Strut/Catwalk (Looking North)**  
General view of the connection between the Center Bracing Strut/Catwalk and the South Wall of Basin No 2. Note cracked concrete patch on east side of the Catwalk at Expansion Joint.

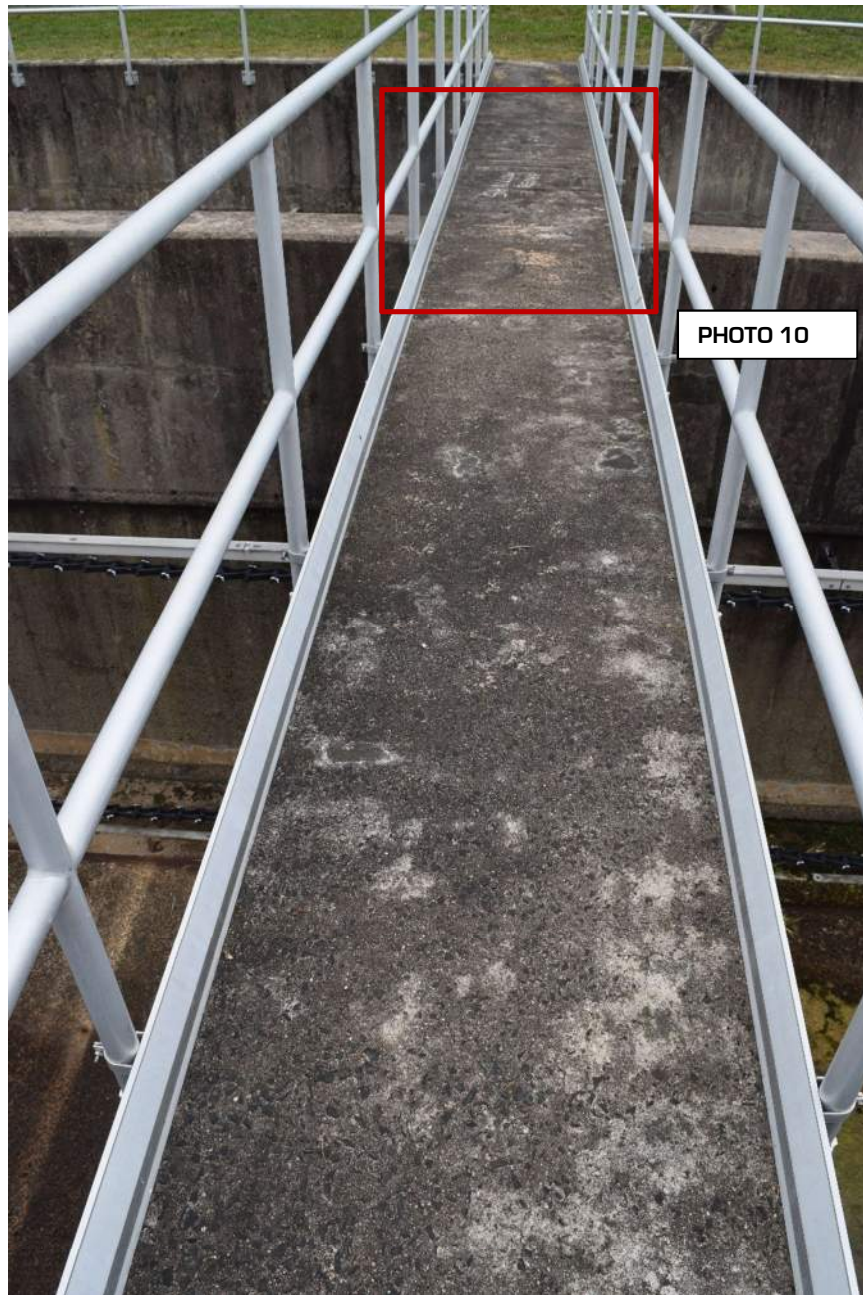
**Photo 9 – Center Bracing Strut/Catwalk (Looking North)**  
Areas of surface scaling on Catwalk.

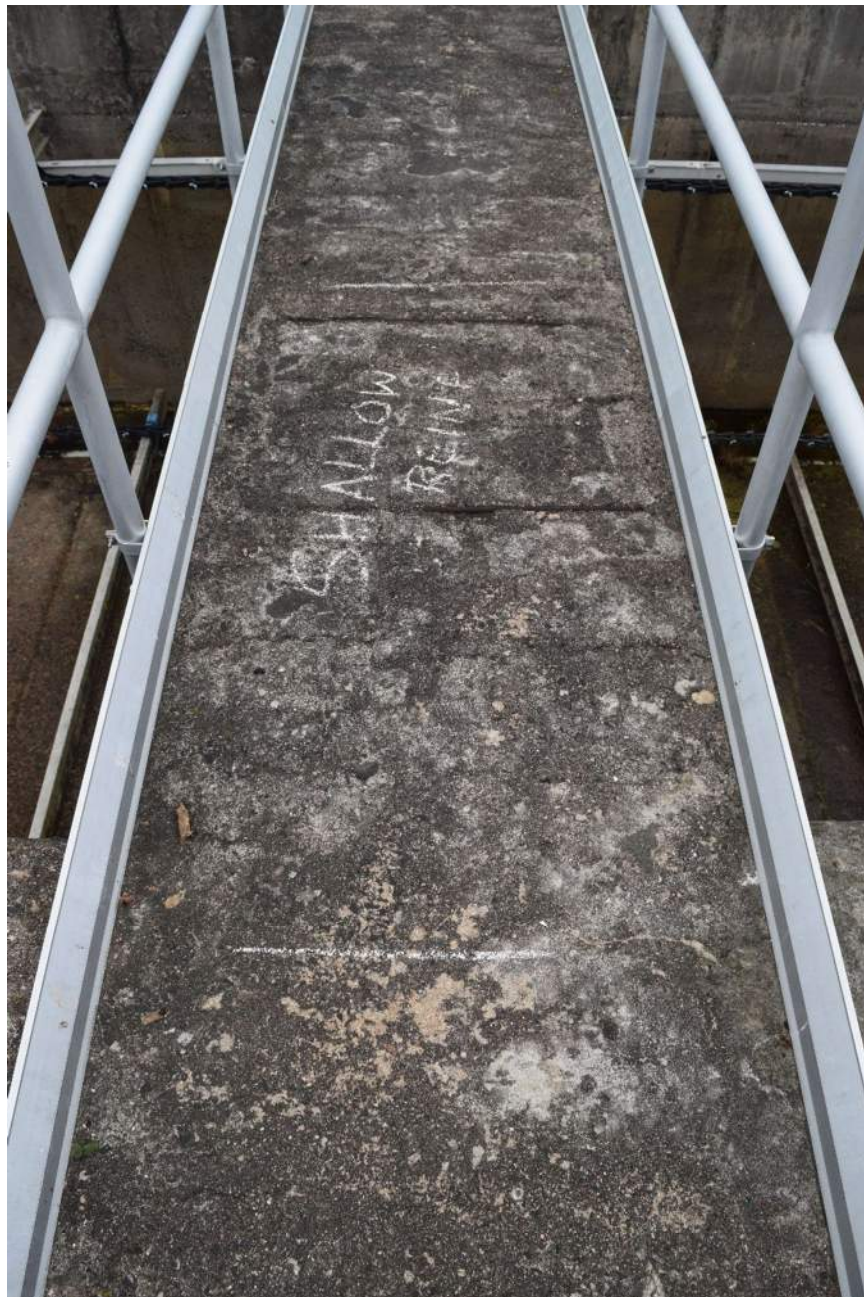
**Photo 10 – Center Bracing Strut/Catwalk (Looking North)**  
View of exposed shallow reinforcement at the top of the Center Bracing Strut/Catwalk.

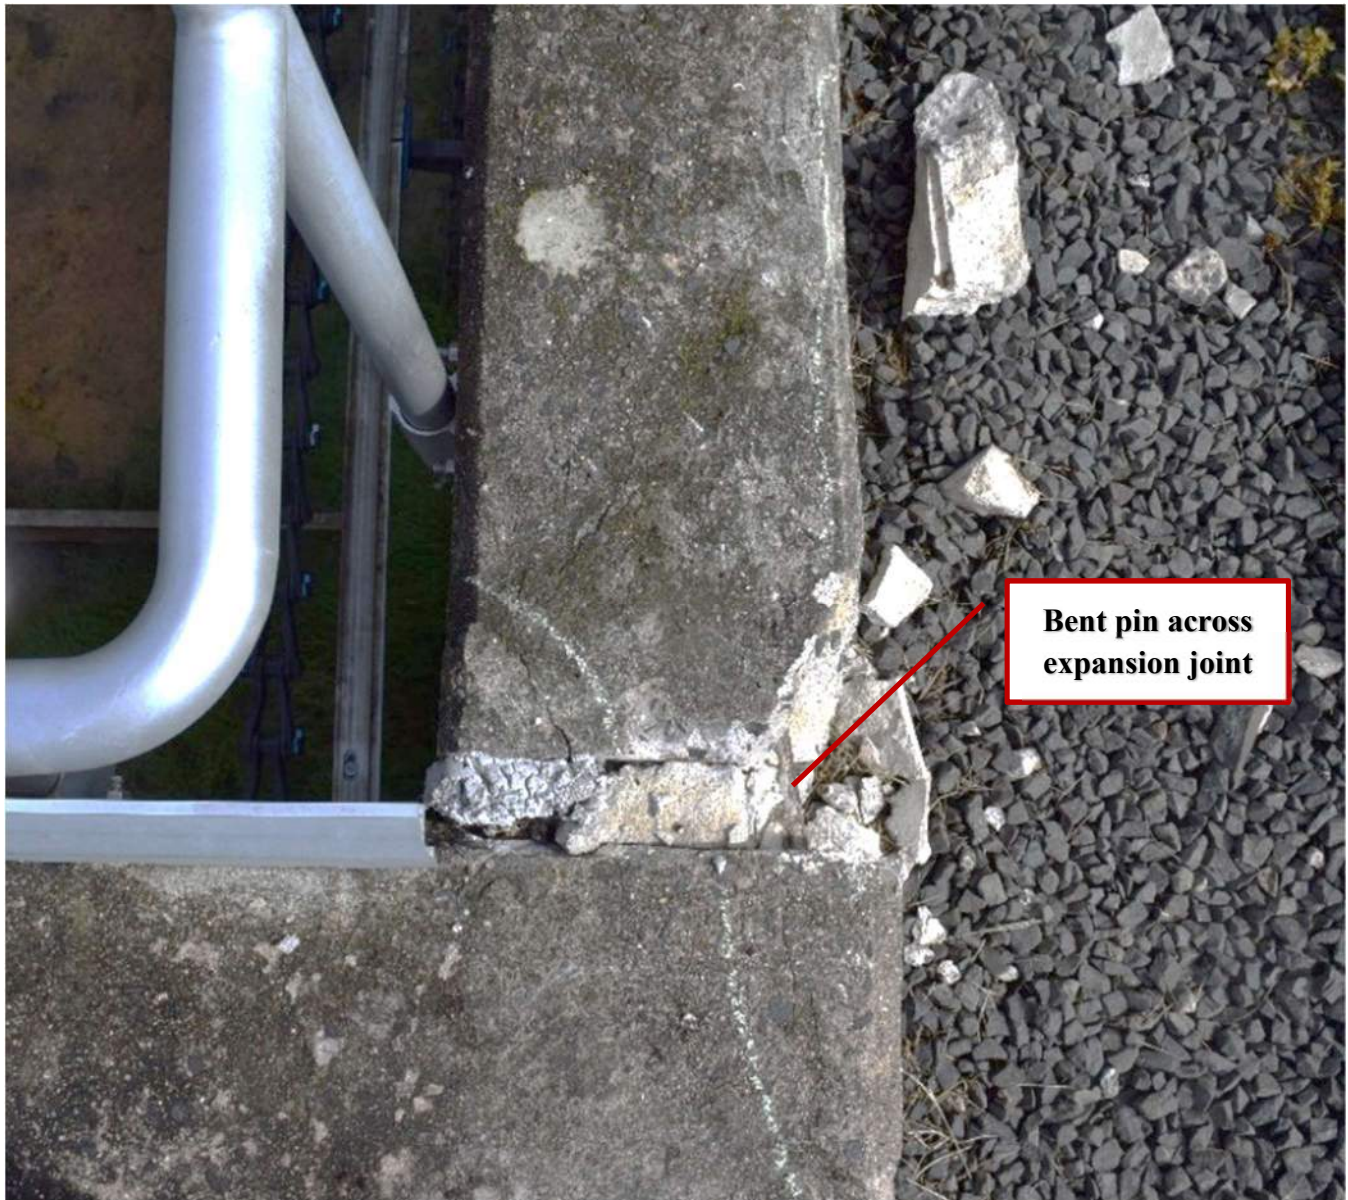
**Photo 11 – South Wall of Basin No. 2 at Expansion Joint**  
(East of Center West Bracing Strut/Catwalk)

The top of the south wall adjacent to the expansion joint included patching repairs which were completed in 2003. Spalling was observed around the patch, indicating active movement of the wall since the repairs were completed. The spalled concrete exposed a horizontal steel pin that is embedded into the original concrete on both sides of the expansion joint. The exposed steel pin was bent inward on the east side, indicating significant differential wall movement.

On the east side of the expansion joint, it appears that only bracing of the top of the wall was provided by a steel pin. On the south side, a pin was observed to be bent and the longer effective. On the north side, the concrete surrounding the presumed pin is hollow and does not provide adequate confinement of the pin.

Broken concrete patch, hollow areas of concrete, and bent pin at top of South Wall due to lateral displacement of the unbraced portion of South Wall on east side of Expansion Joint.

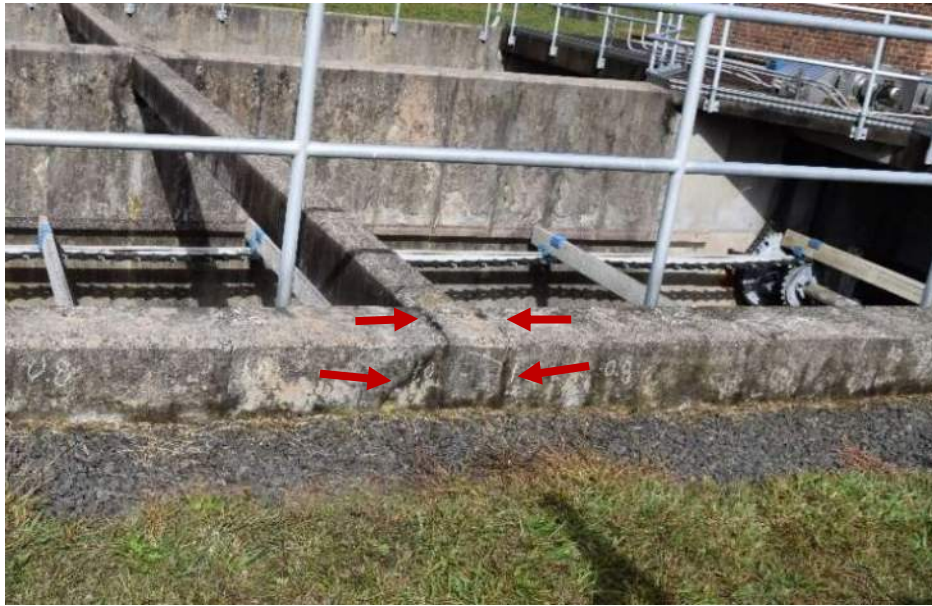
**Photo 12 – South Wall of Basin No. 2 at East Bracing Strut (Looking North)**  
Punching shear cracks along the perimeter of the Bracing Strut.

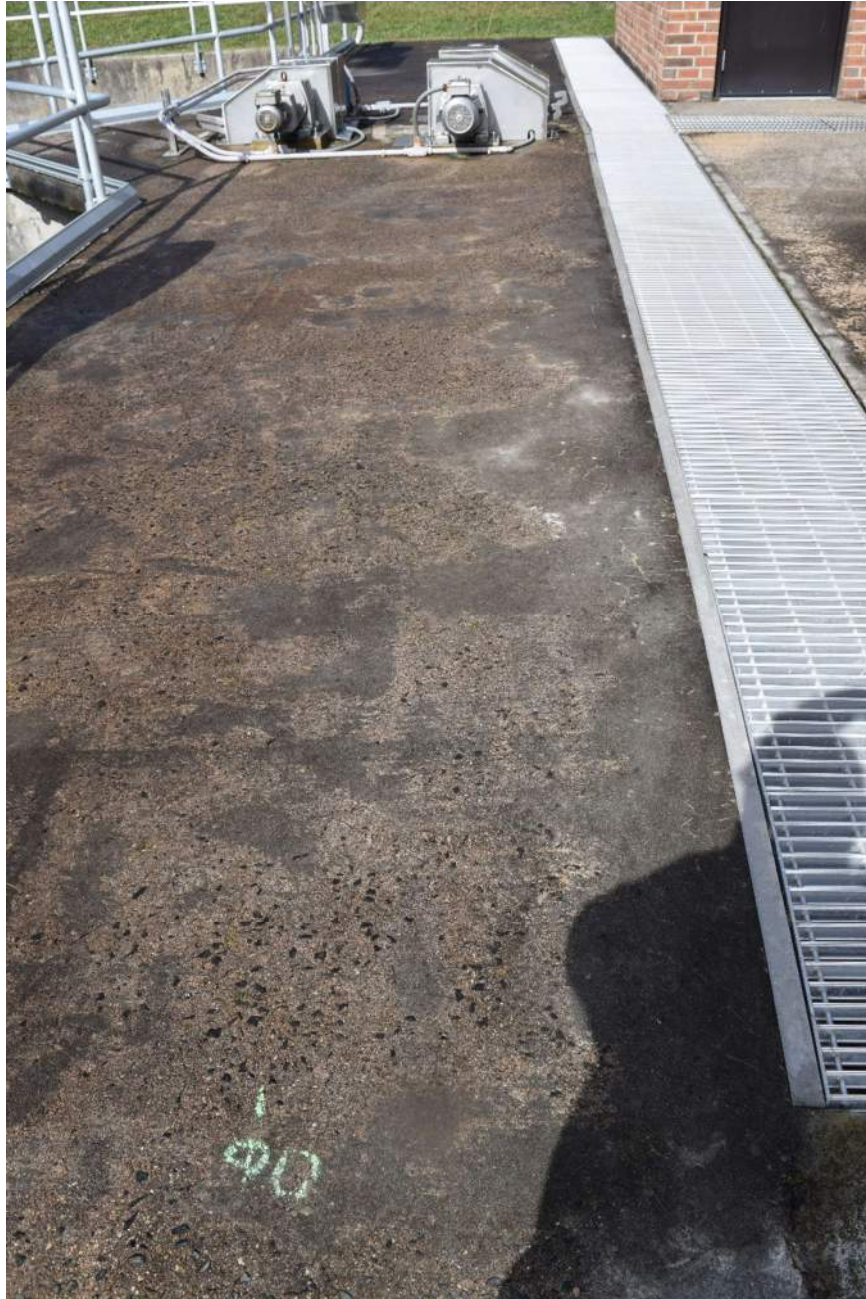
**Photo 14 – Clarifier Top Slab – East End (Looking North)**

Close-up view of the top slab at the east end of the clarifier. Top of slab includes surface scaling and areas of map cracks.

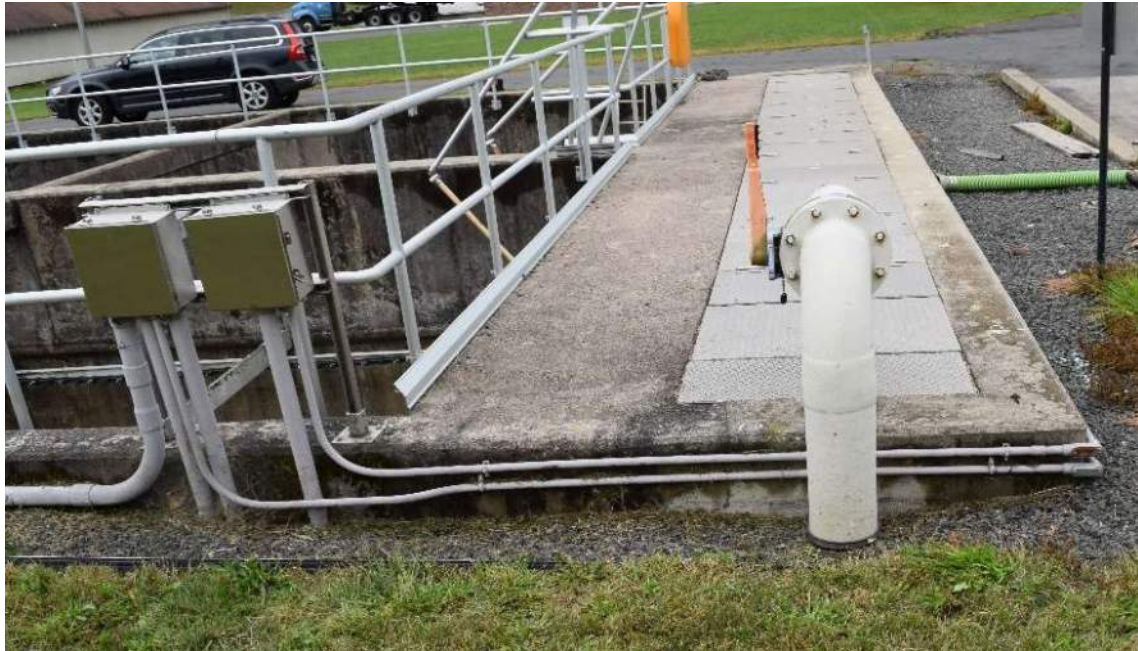
**Photo 15 – Clarifier Top Slab – West End (Looking South)**

View of the top of the top slab on the west side end of the clarifier. Top of slab includes surface scaling with shallow patches and map cracks.

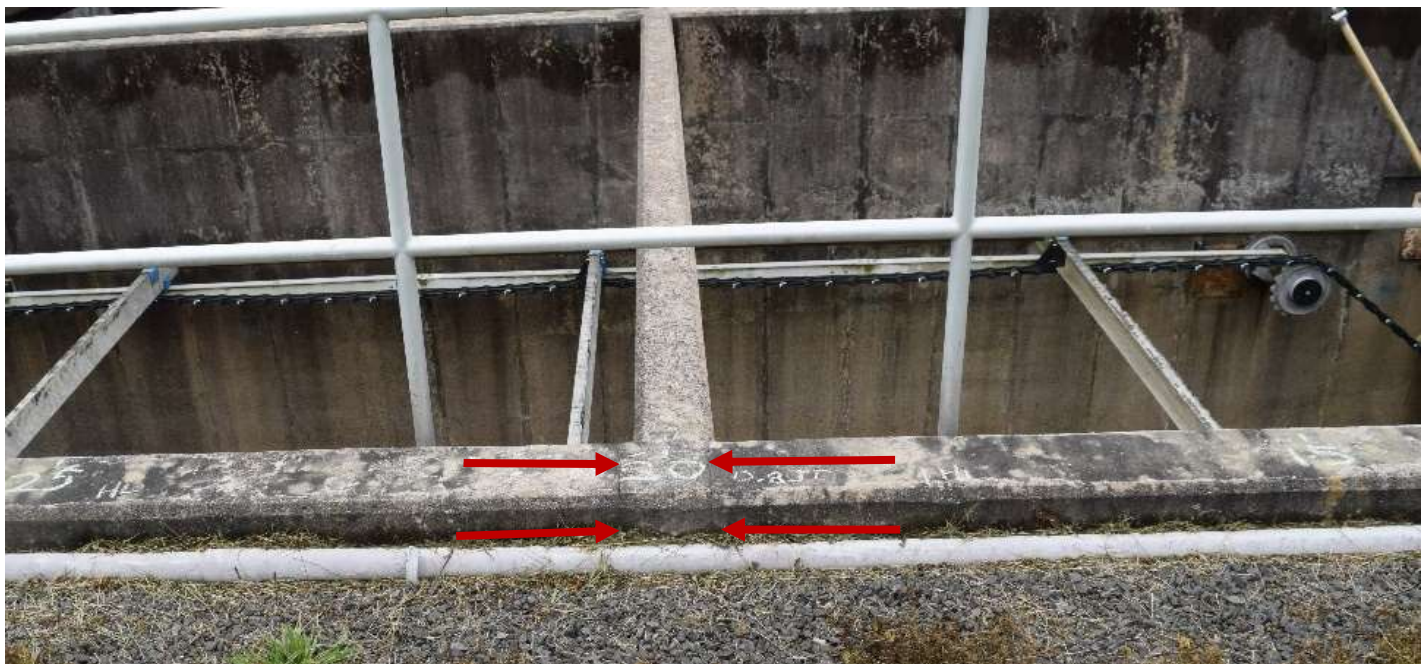
**Photo 16 – North Wall of Basin No. 1 at West Bracing Strut (Looking South)**

Punching shear cracks along the perimeter of the Bracing Strut.

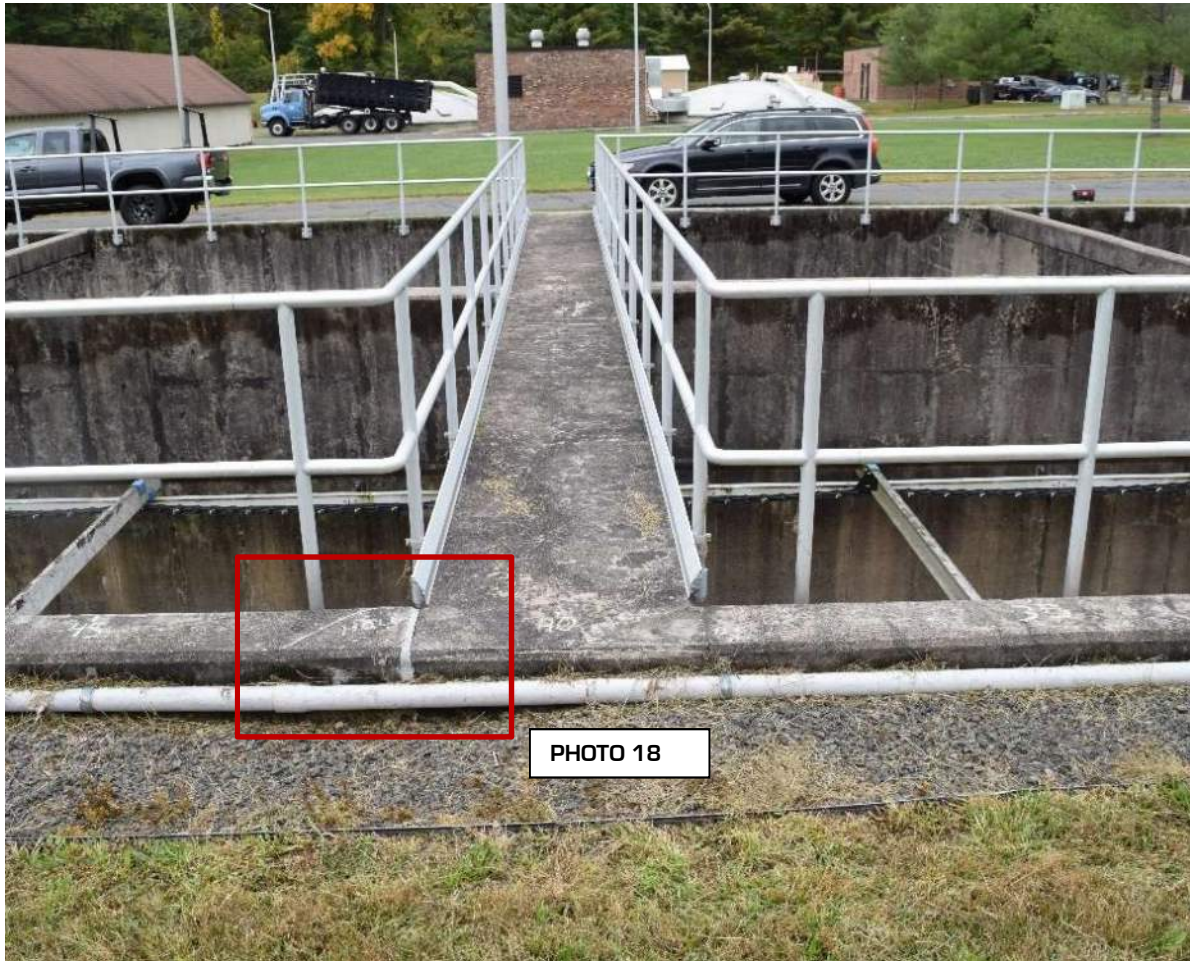
**Photo 17 – North Wall of Basin No. 1 at Center Bracing Strut/Catwalk (Looking South)**  
General view of the connection between the Center Bracing Strut/Catwalk and the North Wall of Basin No 1. Note hollow area of concrete on east side catwalk at Expansion Joint marked with chalk.

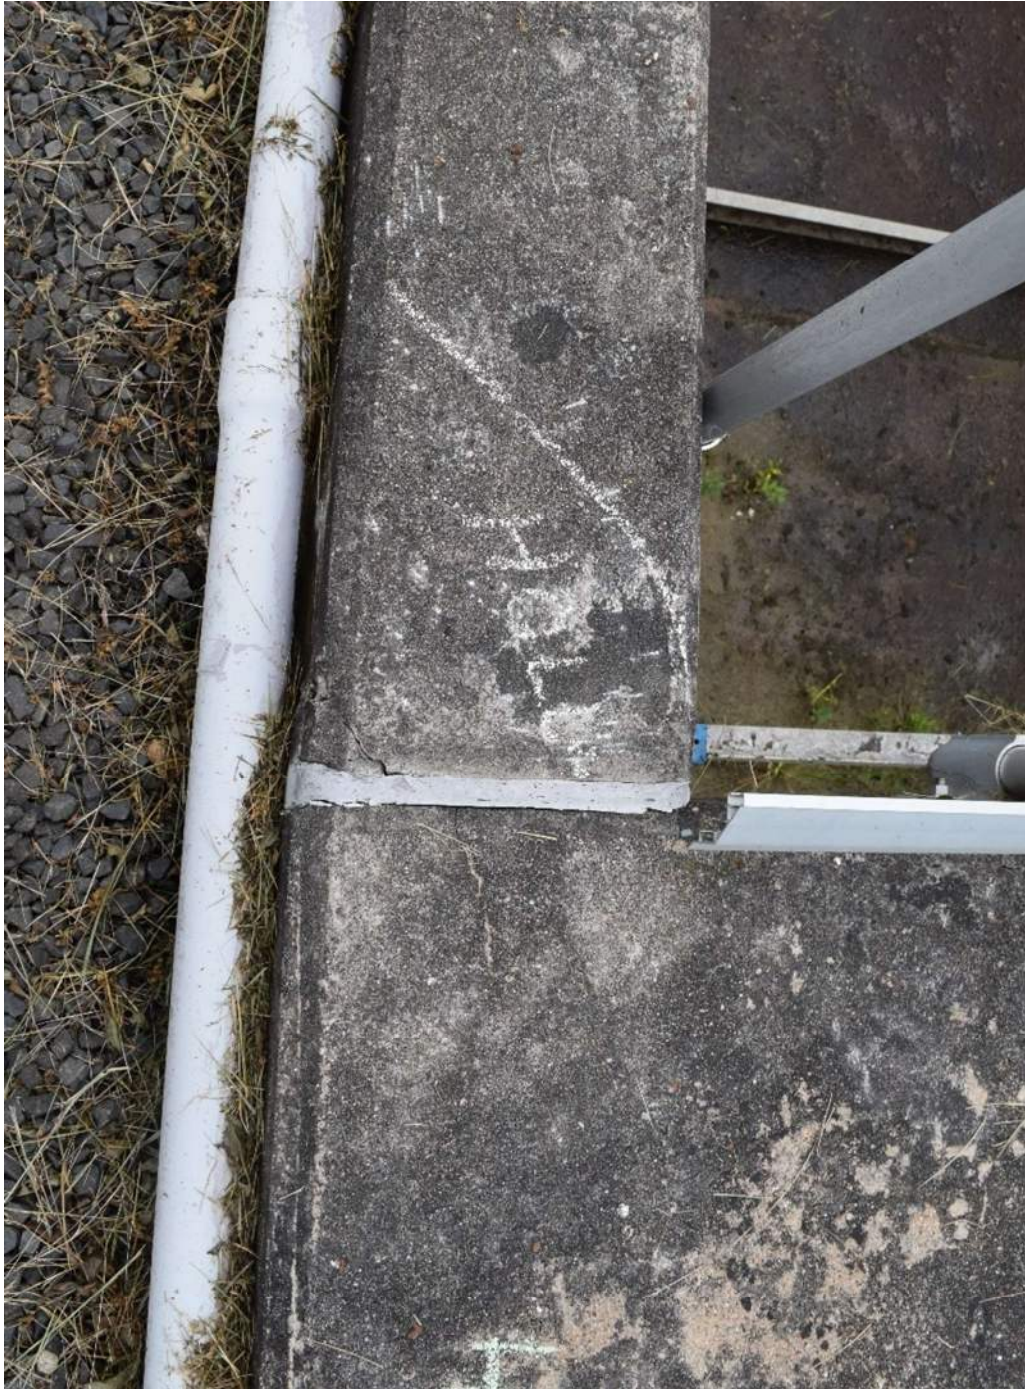
**Photo 18 – North Wall of Basin No. 1 at Expansion Joint**  
(East of Center West Bracing Strut/Catwalk)

Hollow area of concrete at top of North Wall due to lateral displacement of the unbraced portion of North Wall on east side of Expansion Joint.

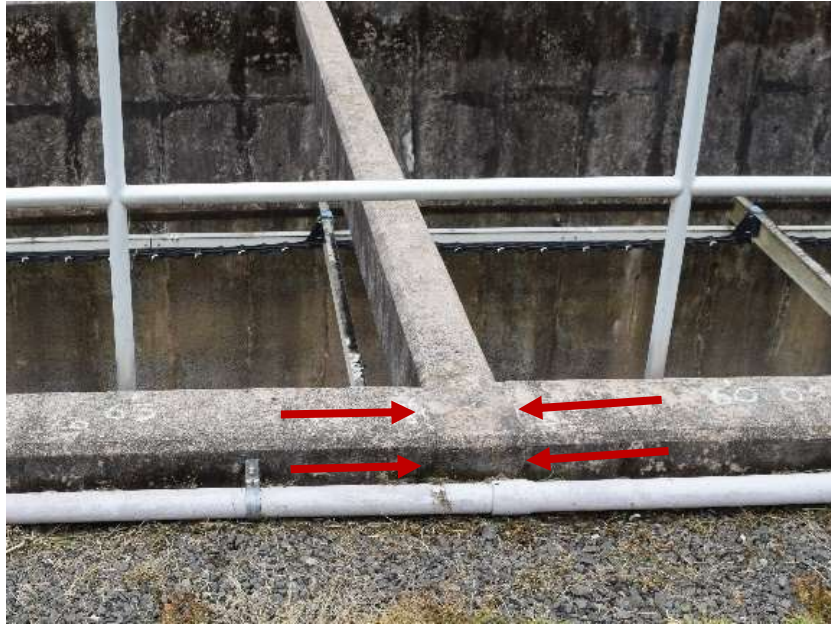
**Photo 19 – North Wall of Basin No. 1 at East Bracing Strut (Looking South)**  
Punching shear cracks along the perimeter of the Bracing Strut.

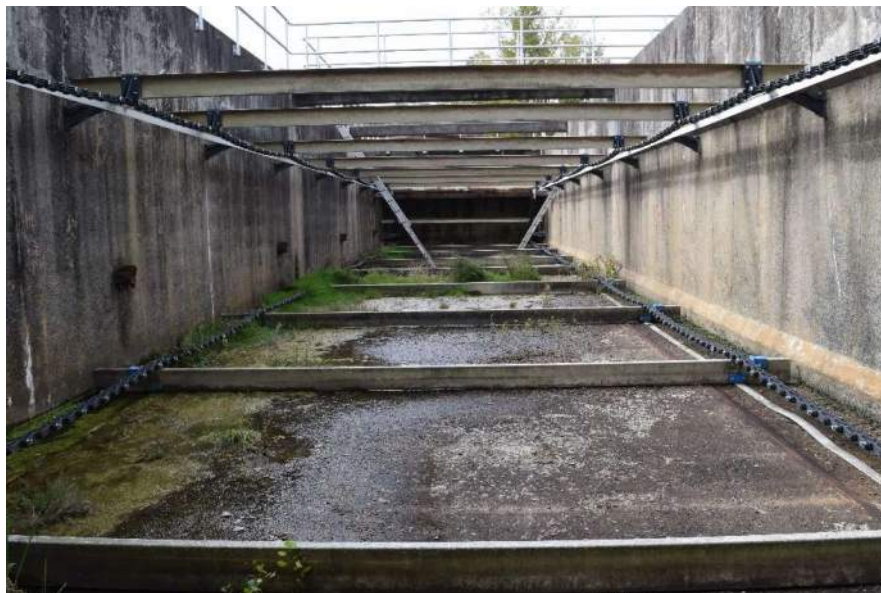
**Photo 22 – Clarifier Basin No. 2 Interior (Looking West)**

General view of the interior of Basin No. 2. Areas of heavy scaling and vegetation growth on concrete slab.

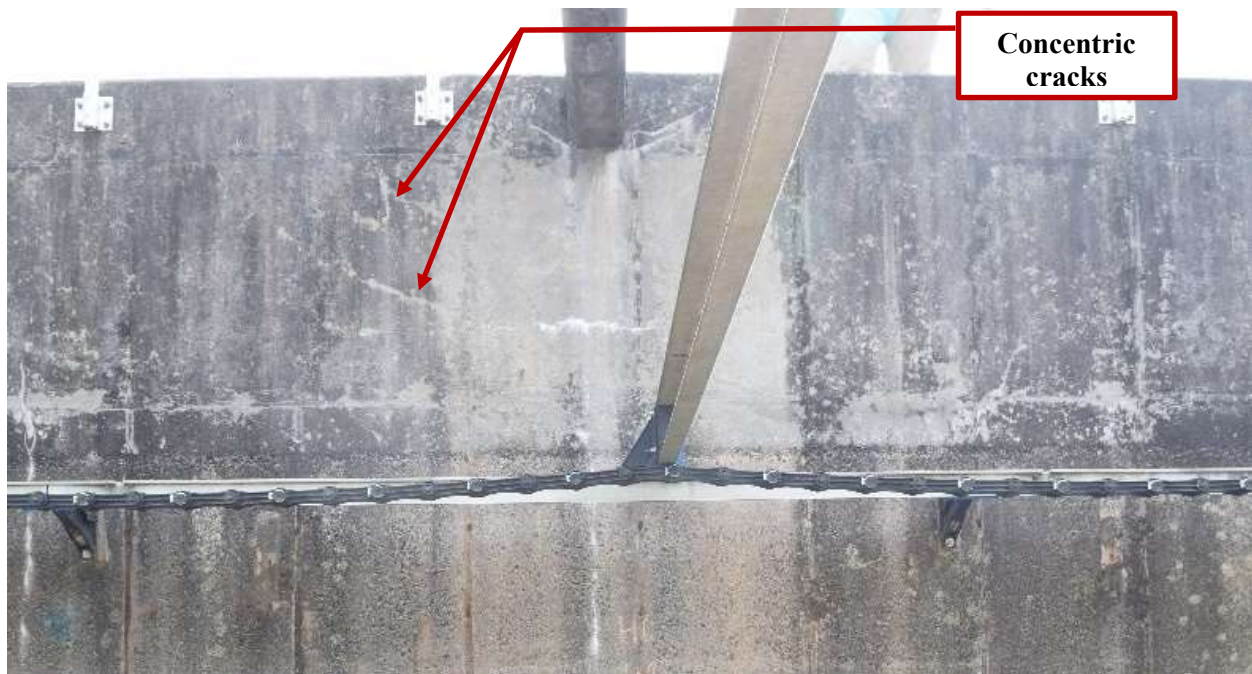
**Photo 23 – South Wall of Basin No. 2 at West Bracing Strut – (Looking South)**

South wall concentric cracking was visible around each bracing strut and indicates areas of high tensile stress in the concrete, likely caused by the differential displacement of the wall between the struts.

View of the connection of the West Bracing Strut to the South Wall of Basin No. 2. Concentric cracks are visible at the top of the wall surrounding the strut, indicating areas of high stress in the concrete at the top of the wall.

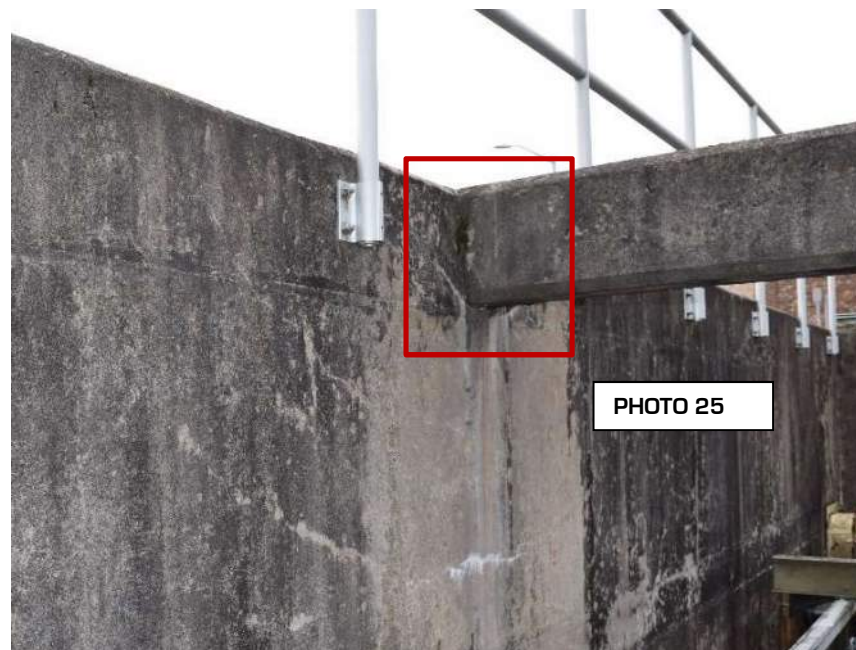
**Photo 24 – South Wall of Basin No. 2 at West Bracing Strut – (Looking West)**

View showing concentric cracking around the West Bracing Strut at the South Wall of Basin No. 2, and of punch-trough failure of the strut at the connection with the wall.

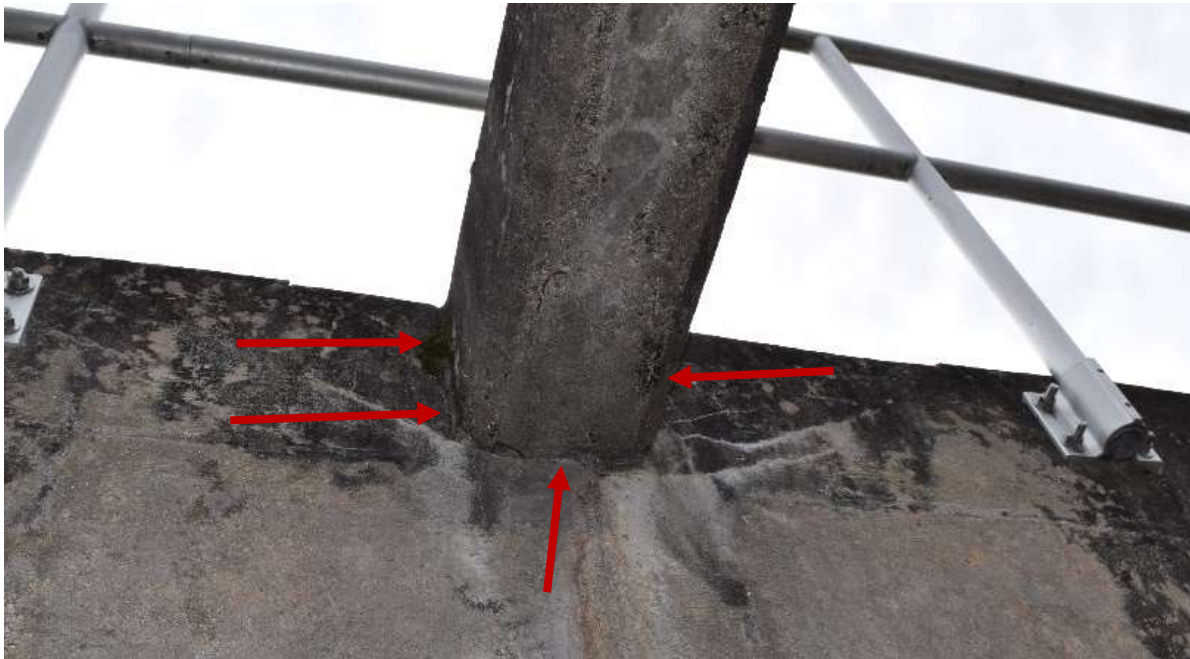
**Photo 25 – South Wall of Basin No. 2 at West Bracing Strut – (Looking South)**  
Punch-trough failure of the strut at the connection with the wall.

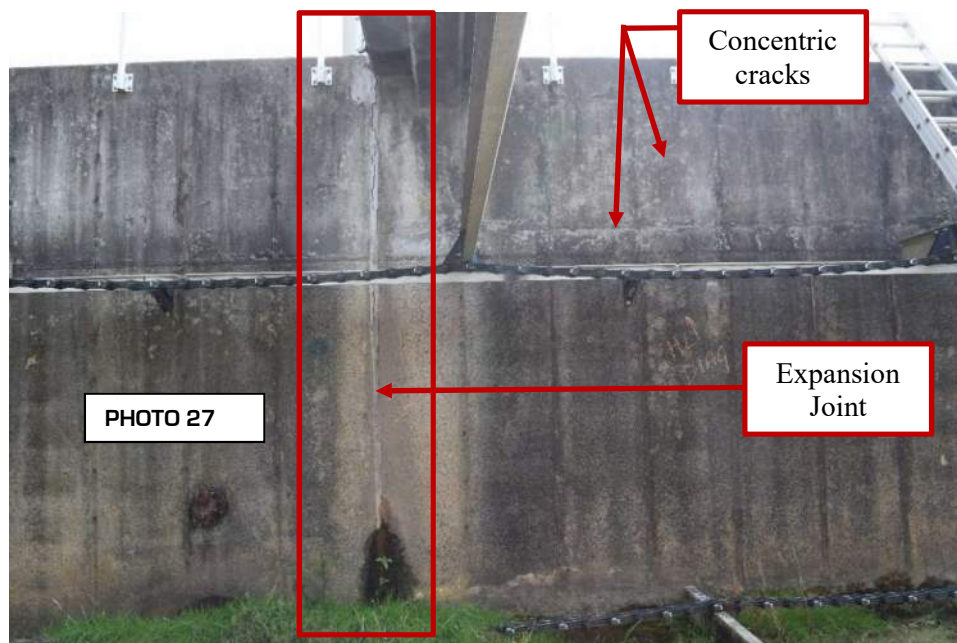
**Photo 26 – South Wall of Basin No. 2 at Center Bracing Strut/Catwalk – (Looking South)**  
Connection of the Center Bracing Strut/Catwalk to the South Wall of Basin No. 2. Concentric cracking is visible around the strut on the west side of the Expansion Joint, where the wall is restrained by the strut. On the east side of the Expansion Joint, the wall is unrestrained at the top, and has displaced inward approximately 1 inch.

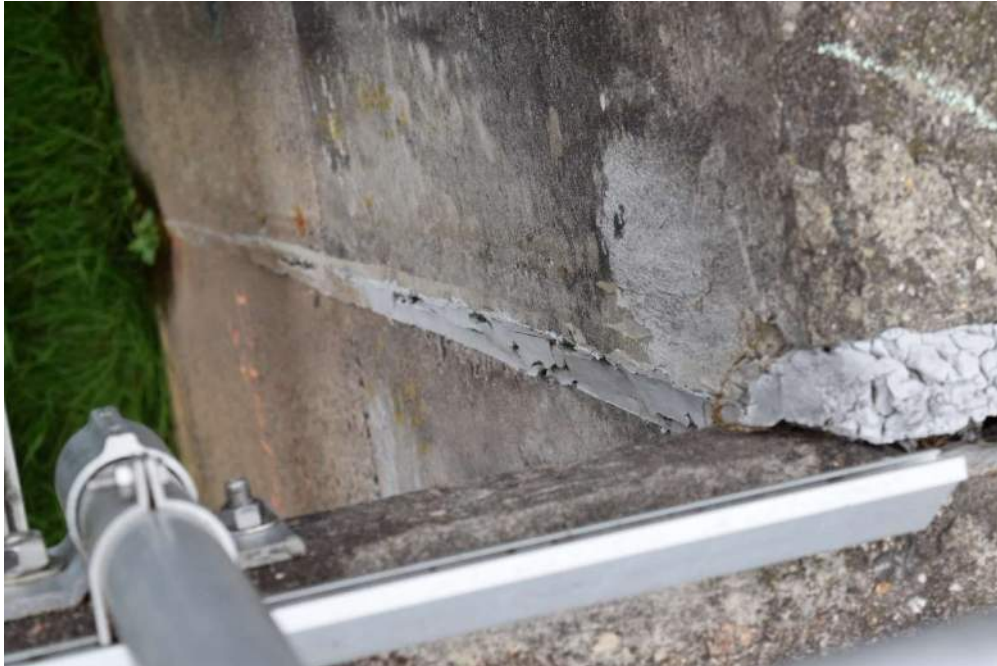
**Photo 27 – Expansion Joint at South Wall of Basin No. 2**

View of the Expansion Joint showing failed joint sealant and 1-inch lateral displacement of the unrestrained wall on the east side of the joint.
