# Town of Simsbury

#### **WATER POLLUTION CONTROL FACILITY PRIMARY CLARIFIER RESTORATION**

**TOWN OF SIMSBURY, CONNECTICUT**  
**PROFESSIONAL DESIGN SERVICES**  
**WATER POLLUTION CONTROL FACILITY**  
**PRIMARY CLARIFIER RESTORATION**

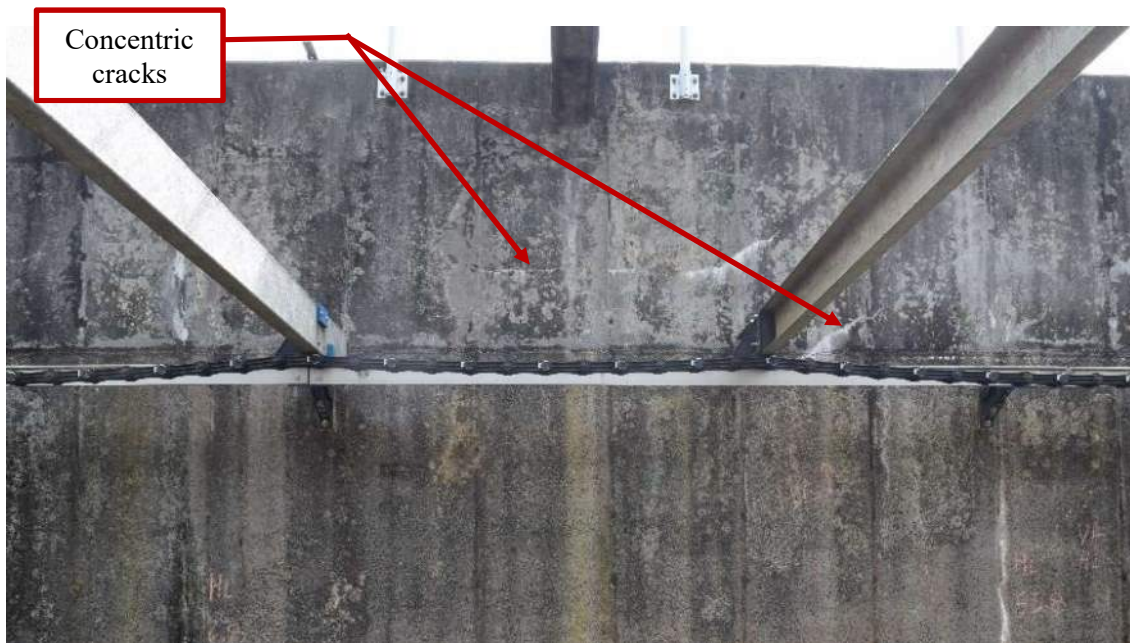
**Photo 28 – South Wall of Basin No. 2 at East Bracing Strut – (Looking South)**

View of the connection of the East Bracing Strut to the South Wall of Basin No. 2. Concentric cracks are visible at the top of the wall surrounding the strut, indicating areas of high stress in the concrete at the top of the wall.

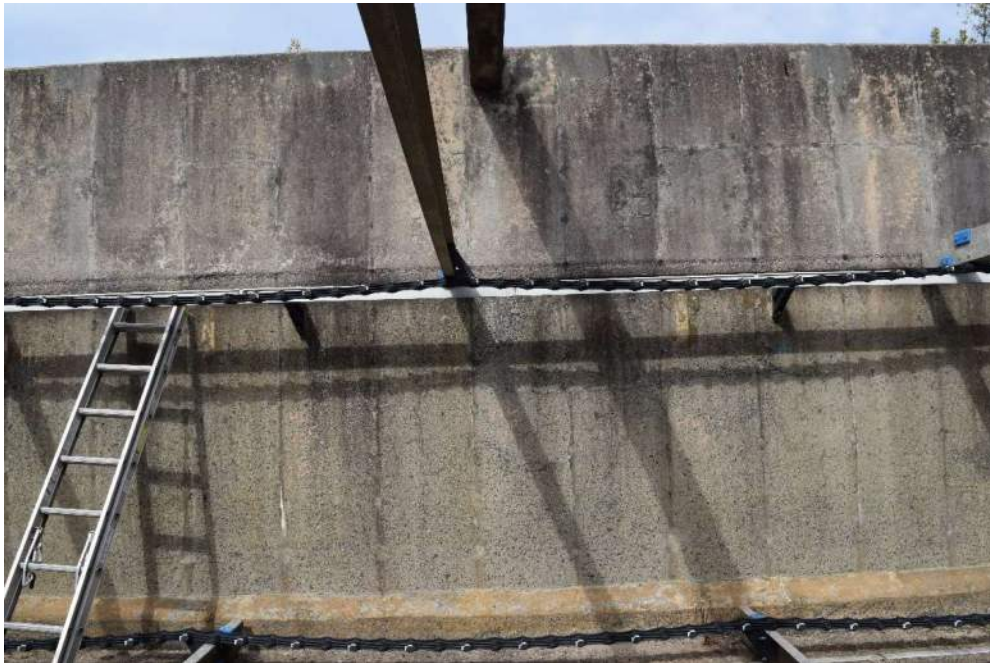
**Photo 29 – Center Wall of Basin No. 2 at West Bracing Strut – (Looking North)**  
General view of the connection between the West Strut and the Center Wall of Basin No. 2. Slight cracking was observed at the connection of the strut to the wall.

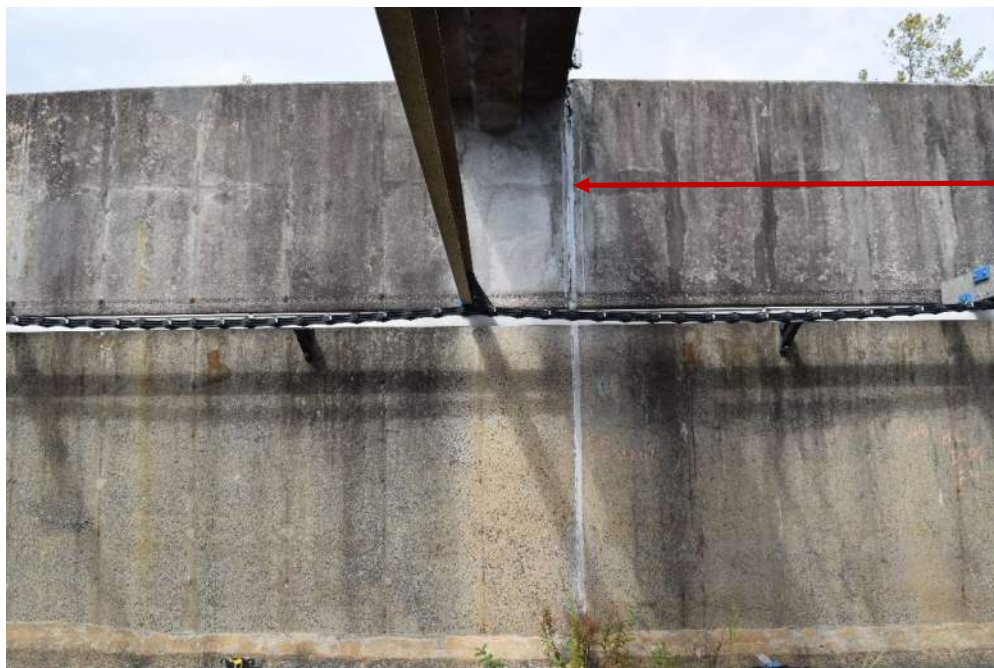
**Photo 30 – Center Wall of Basin No. 2 at Center Bracing Strut/Catwalk – (Looking North)**  
General view of the connection between the Center Strut and the Center Wall of Basin No. 2 showing failed Expansion Joint Sealer.

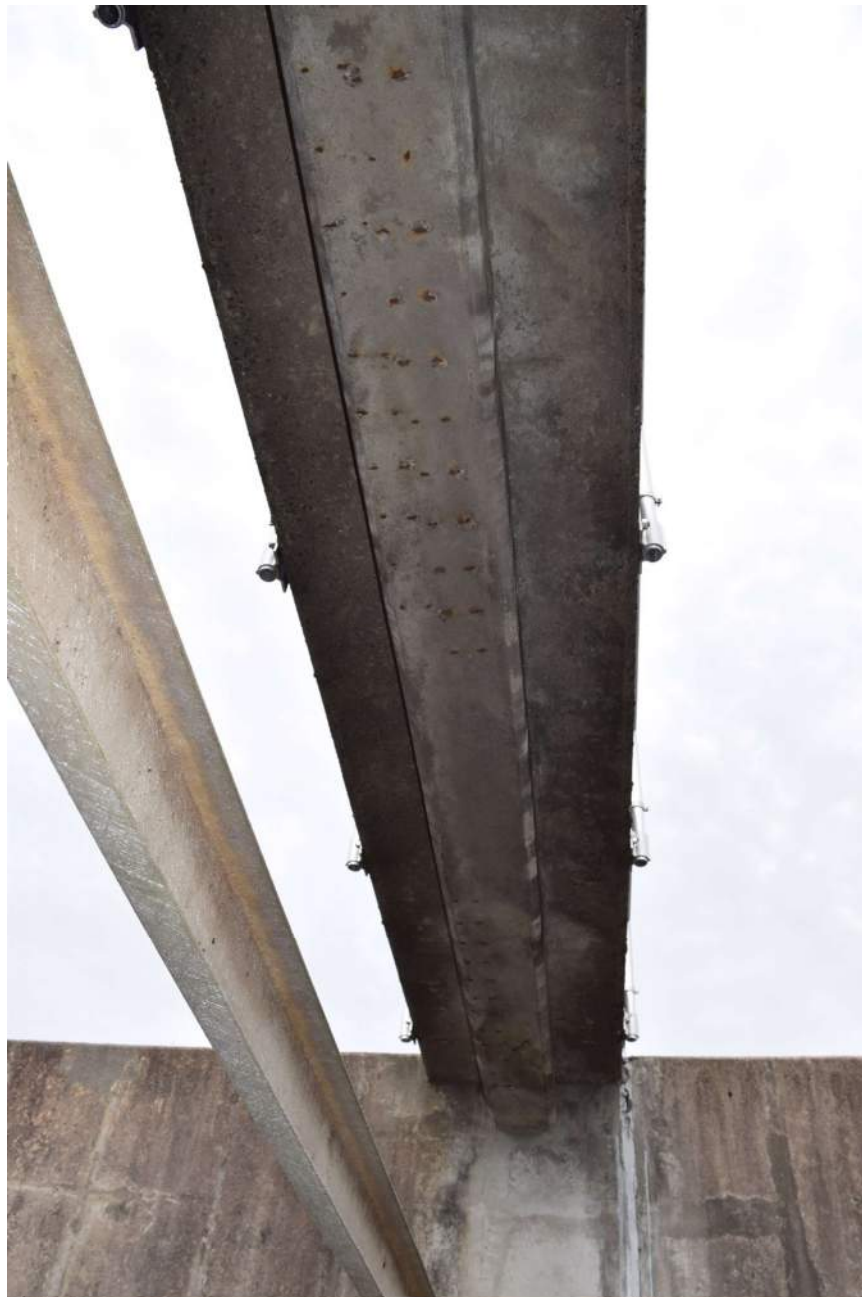
**Photo 31 – Underside of Center Strut/Catwalk – Basin No. 2 – (At connection with Center Wall)**  
View of exposed reinforcement on the underside of the Center Strut/Catwalk above Basin No. 2.

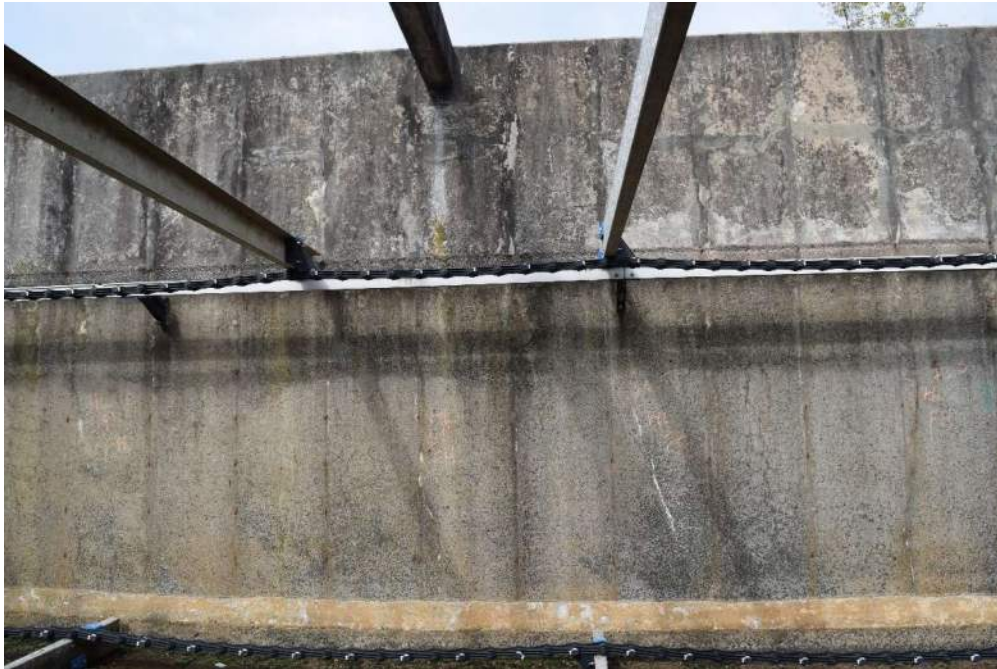
**Photo 32 – Center Wall of Basin No. 2 at East Bracing Strut – (Looking North)**  
General view of the connection between the East Strut and the Center Wall of Basin No. 2. Slight cracking was observed at the connection of the strut to the wall.

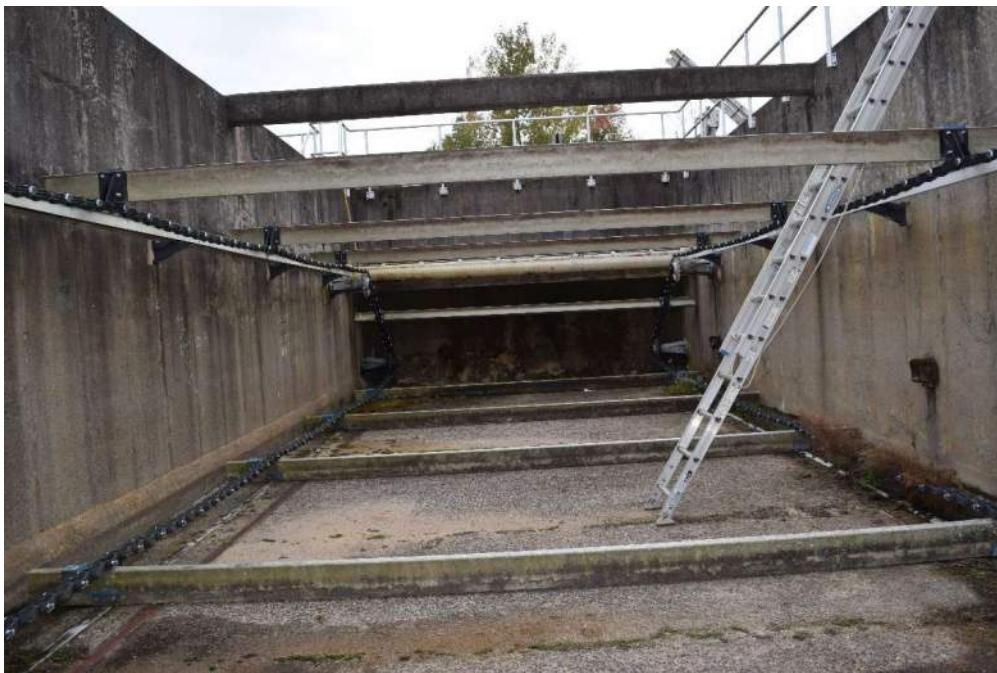
**Photo 33 – Clarifier Basin No. 1 Interior (Looking West)**  
General view of the interior of Basin No. 1. Areas of heavy surface scaling on concrete slab.

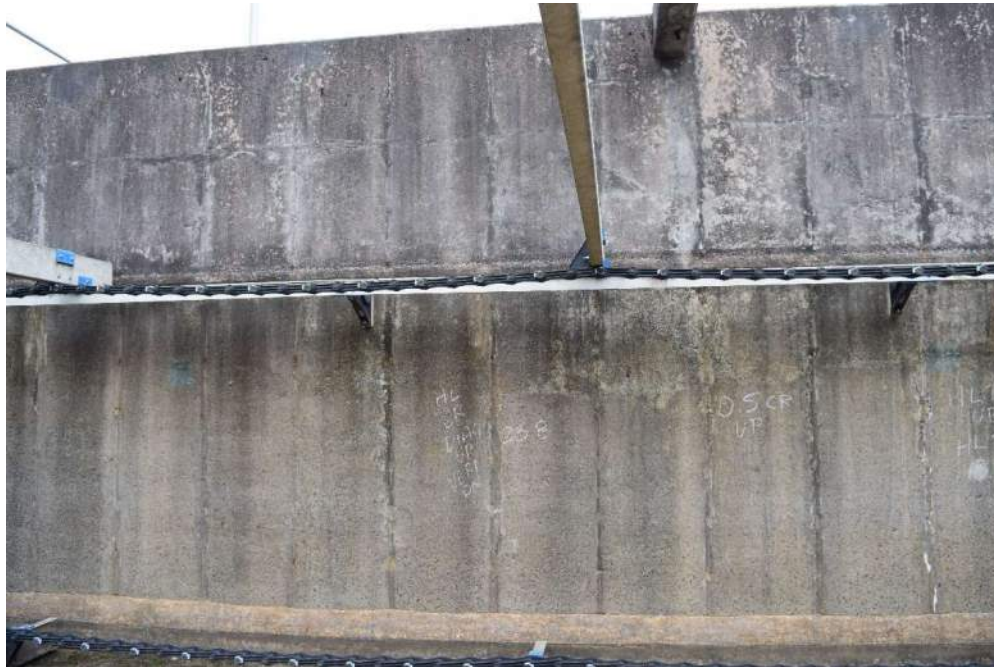
**Photo 34 – Center Wall of Basin No. 1 at West Bracing Strut – (Looking South)**  
General view of the connection between the West Strut and the Center Wall of Basin No. 1. Slight cracking was observed at the connection of the strut to the wall.

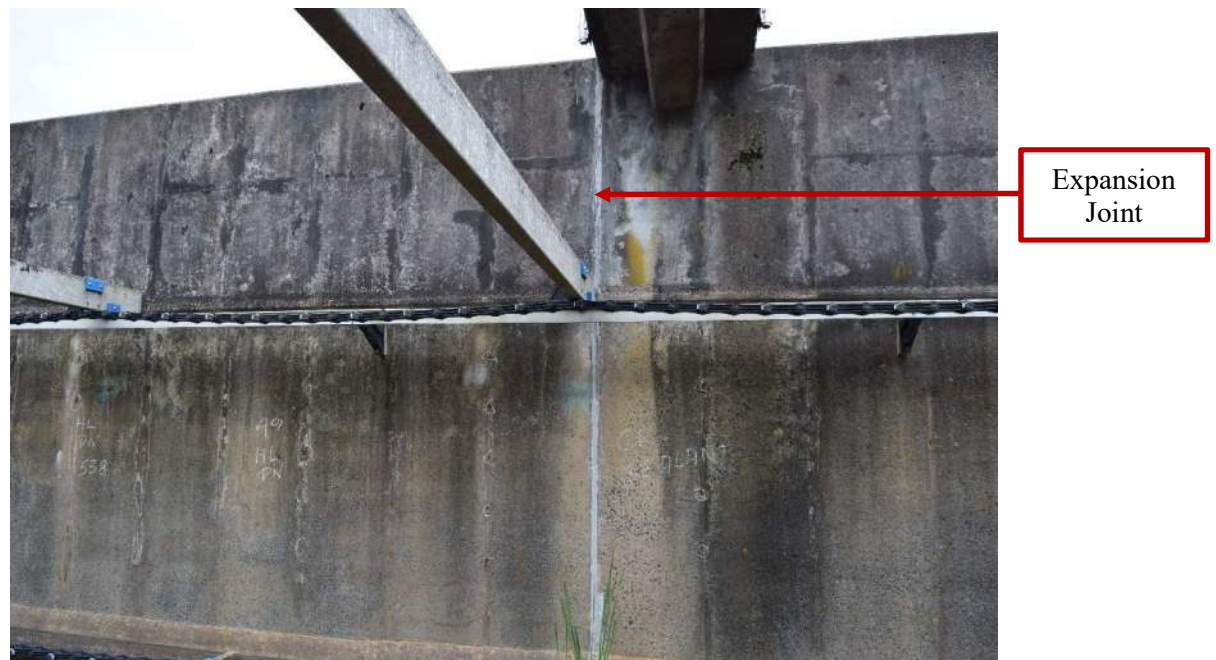
**Photo 35 – Center Wall of Basin No. 1 at Center Bracing Strut/Catwalk – (Looking South)**  
General view of the connection between the Center Strut and the Center Wall of Basin No. 2 showing failed Expansion Joint Sealer.

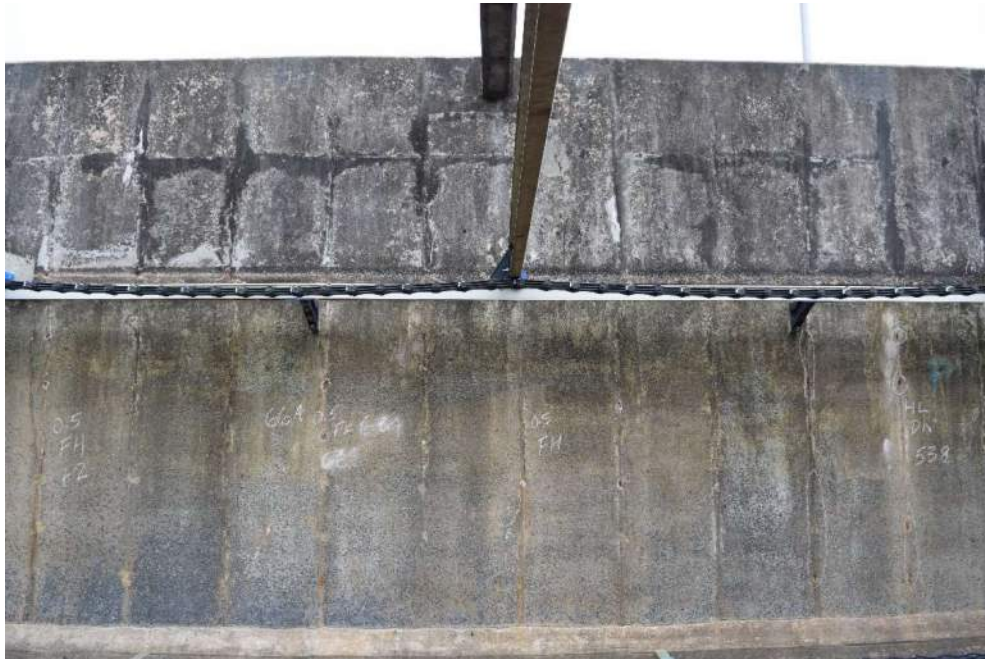
**Photo 36 – Center Wall of Basin No. 1 at East Bracing Strut – (Looking South)**  
General view of the connection between the East Strut and the Center Wall of Basin No. 1. Slight cracking was observed at the connection of the strut to the wall.

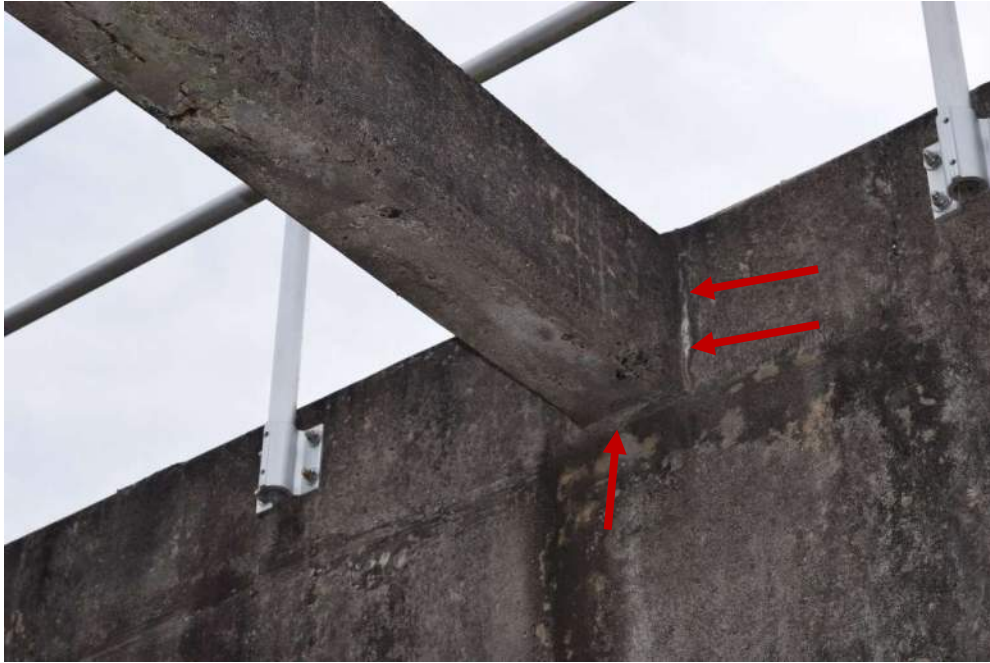
**Photo 38 – Connection of North Wall of Basin No. 1 to West Bracing Strut**  
Punching shear cracks along the perimeter of the bracing strut.

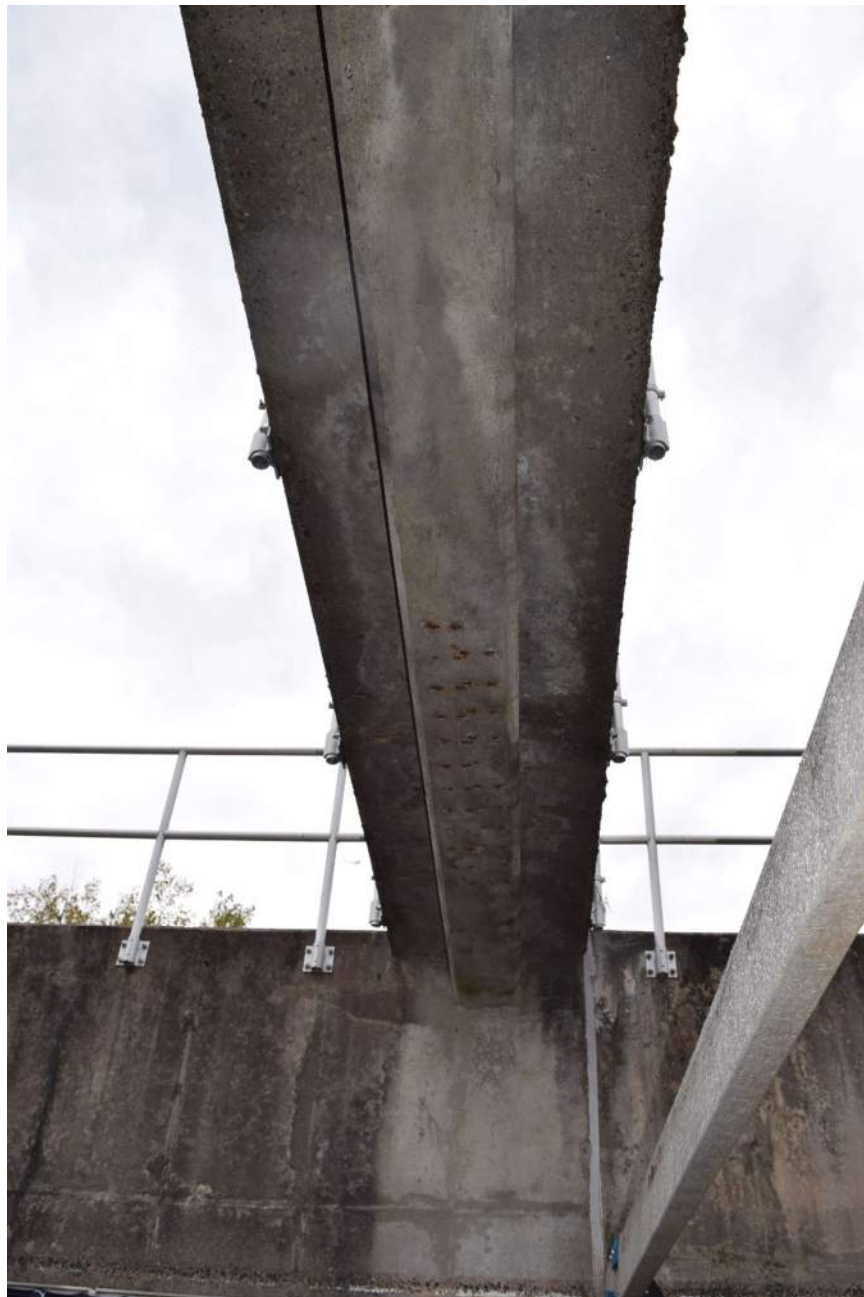
**Photo 40 – Underside of Center Strut/Catwalk – Basin No. 1 – (At connection with North Wall)**  
View of exposed reinforcement on the underside of the Center Strut/Catwalk above Basin No. 1.

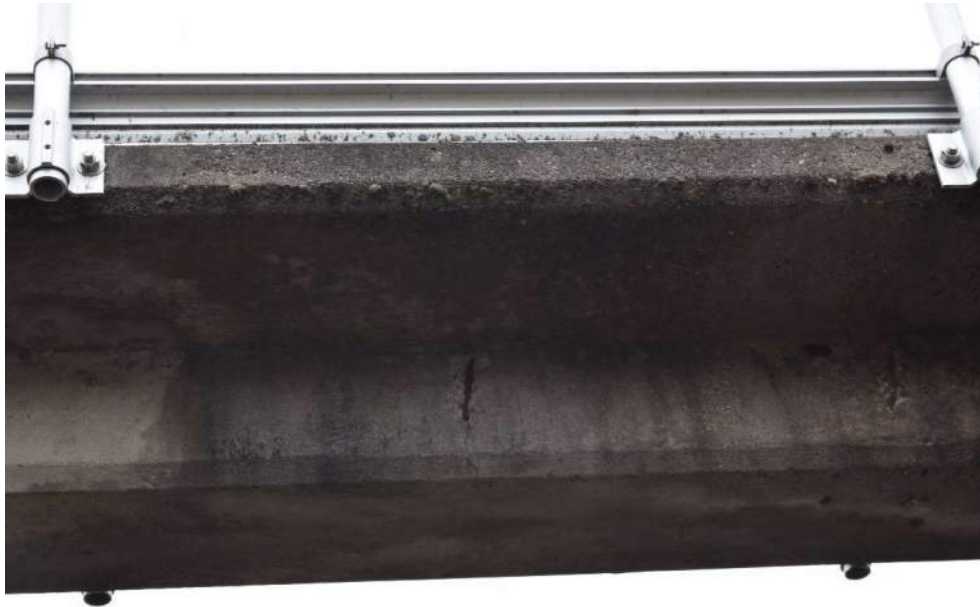
**Photo 41– Underside of Center Strut/Catwalk – Basin No. 1** (Looking East at Misdpan of Strut)  
Visible exposed reinforcement with concrete pop-out.

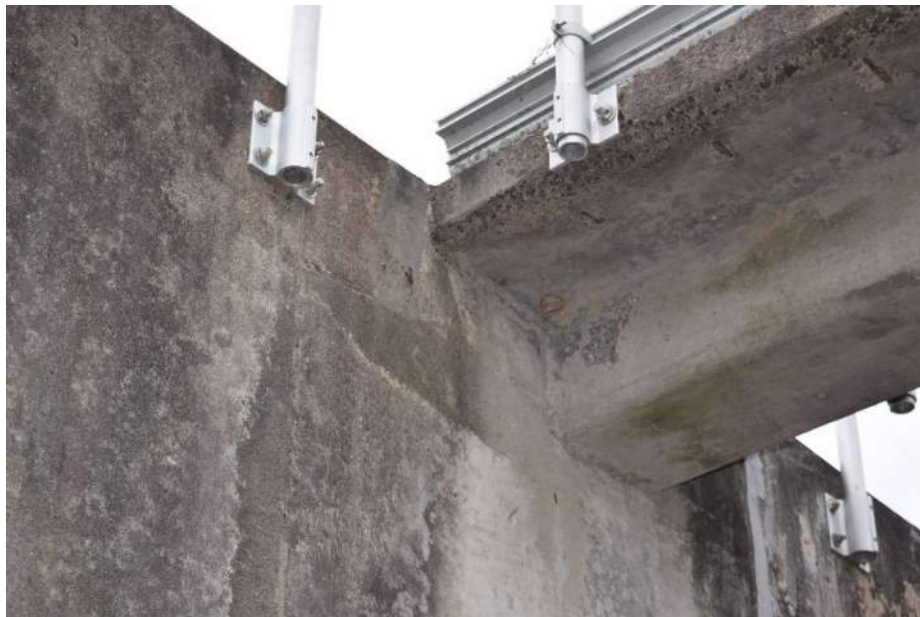
**Photo 42 – North Wall of Basin No. 1 at Center Bracing Strut/Catwalk**  
Connection of the Center Bracing Strut/Catwalk to the North Wall of Basin No. 1. Concentric hairline cracking is visible around the strut on the west side of the Expansion Joint, where the wall is restrained by the strut. On the east side of the Expansion Joint, the wall is unrestrained at the top, and has displaced inward approximately 9/16 inch.

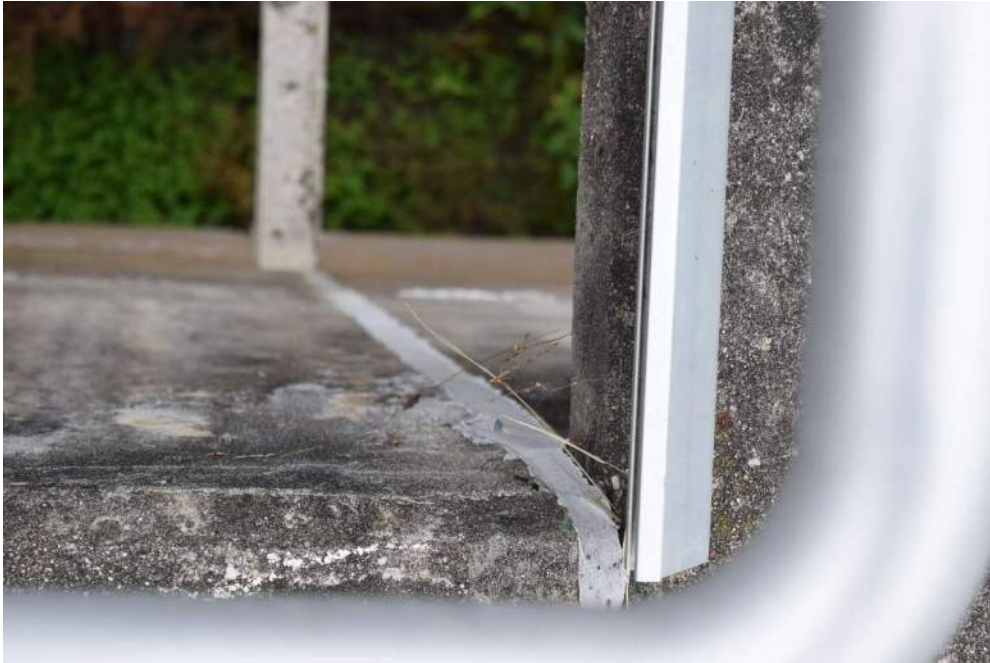
**Photo 43 – Expansion Joint at North Wall of Basin No. 1**

View of the Expansion Joint showing failed joint sealant and 9/16-inch lateral displacement of the unrestrained wall on the east side of the joint.

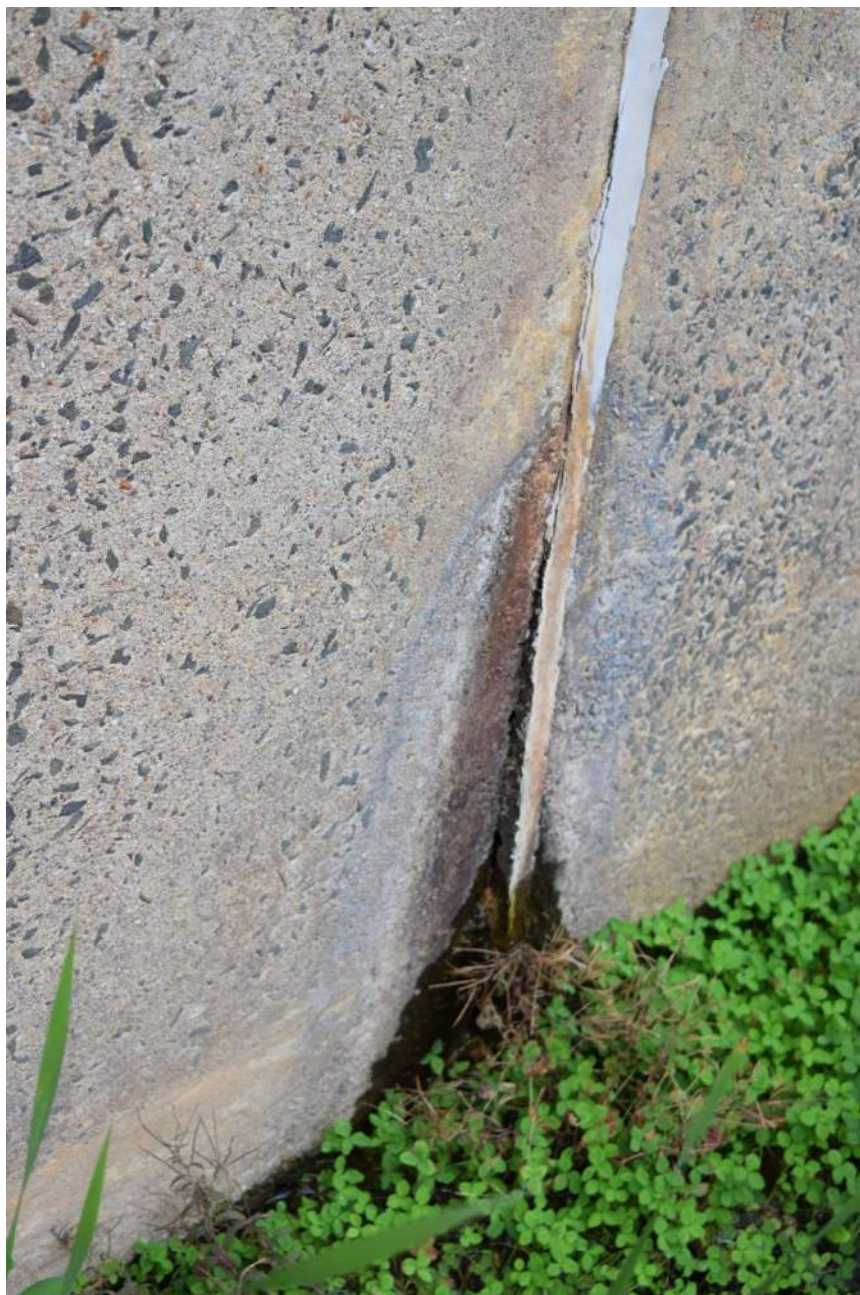
**Photo 44 – Expansion Joint at North Wall of Basin No. 1**

Failed Expansion Joint Sealant with active leakage at the base of the North Wall at Basin No. 1.

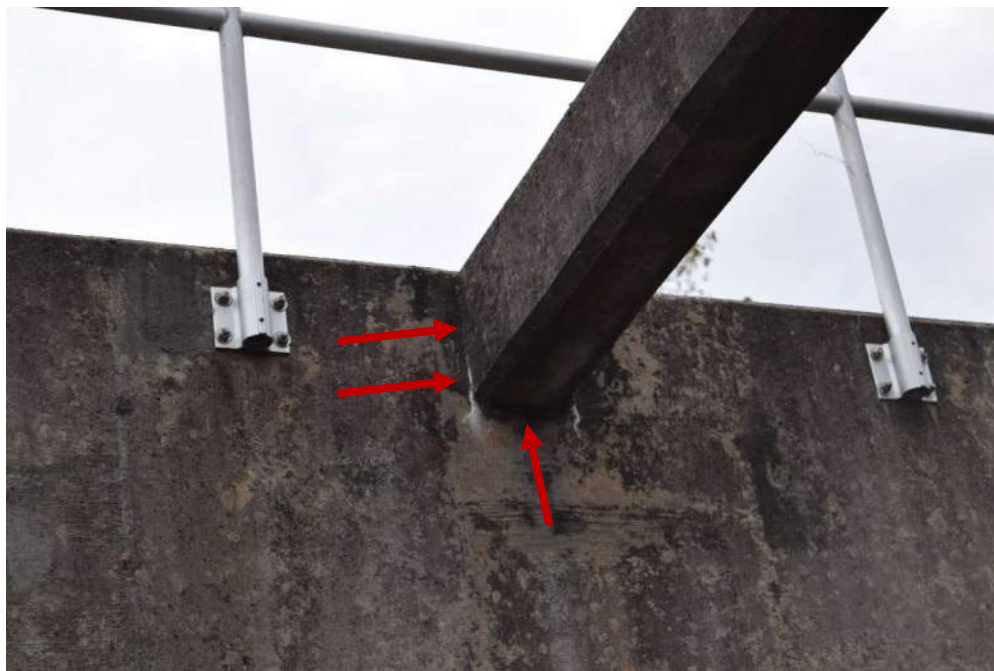
**Photo 46 – Connection of North Wall of Basin No. 1 to East Bracing Strut**  
Punching shear cracks along the perimeter of the bracing strut.
