**Handicap Accessibility Review  
ADA / CT 504 Assessment  
Eno Memorial Hall**

**For the  
Simsbury Senior Center**

Re: Eno Memorial Hall  
Handicap Accessibility Review - ADA / CT 504 Assessment

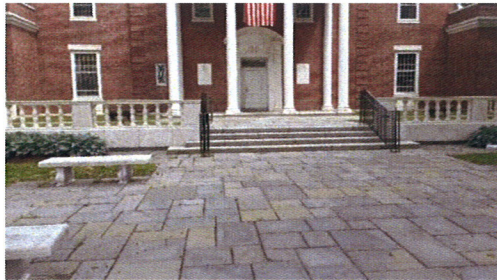
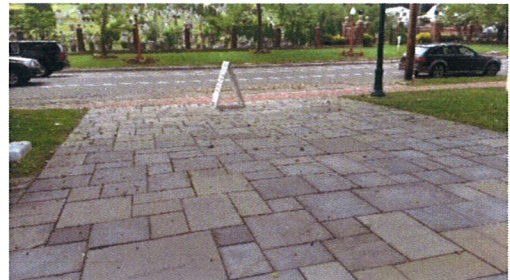
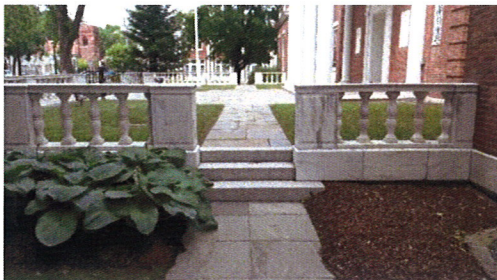
### FRONT DEDICATED ENTRANCE

- No handicap parking on street
- Stairs and path- no accessible route
- Path gradient exceeds allowable pitch
- Inadequate door clearance- front door

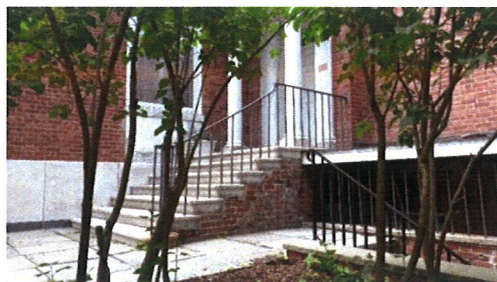
### MID-LEVEL ENTRANCE

- No accessible path
- Inadequate door clearance
- Non-compliant hardware

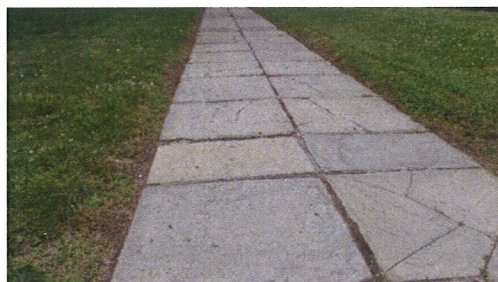
### SOUTH EAST ENTRANCE

- Non- compliant door hardware
- No accessible path
- Ground surface- not flat
- Surface irregularities exceed 1/2" in height
- No HL access

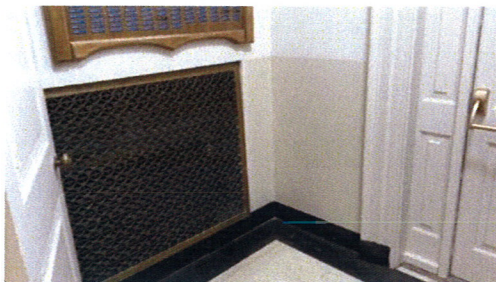
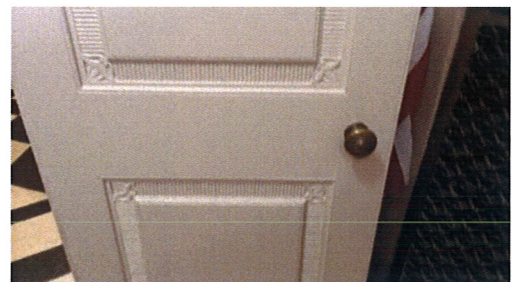
#105

- Non- compliant door opening- door leafs are too small
- Non- compliant depth of vestibule
- Non- compliant door hardware

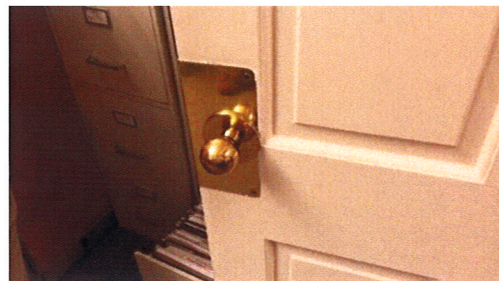
#112 & 113

- Non- compliant door hardware- closet
- Non- compliant thermostat height

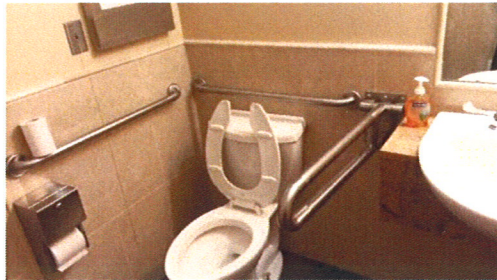
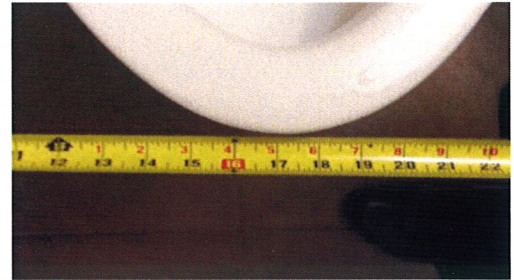
#109 & 110

- Non- compliant braille marking height
- Non- compliant door hardware
- Non- compliant grab-bar
- Non- compliant sink (sink to close)
- Non- compliant toilet (toilet too close to wall)

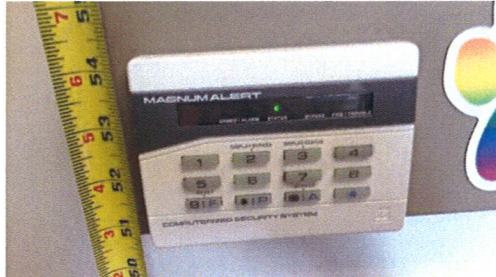
#108

- Non-compliant thermostat, light controls and security system height
- Non-compliant door hardware

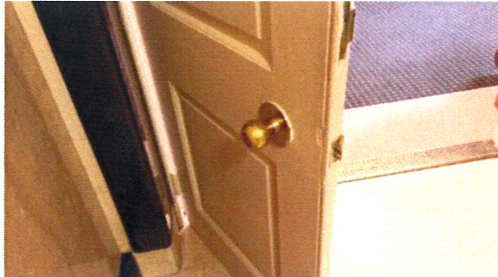
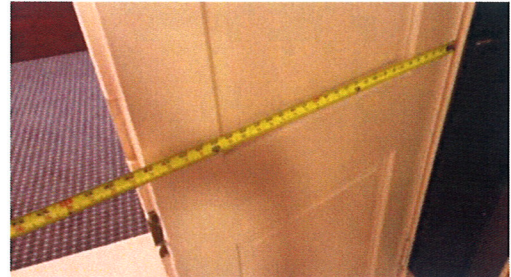
#107

- Non- compliant door hardware
- Inadequate door leaf width
- Non- compliant thermostat height

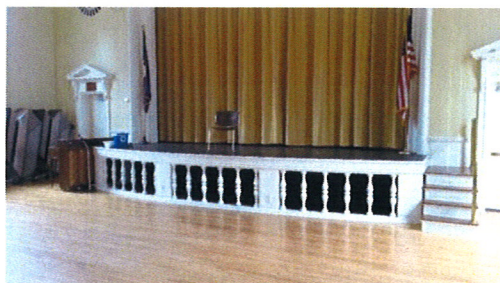
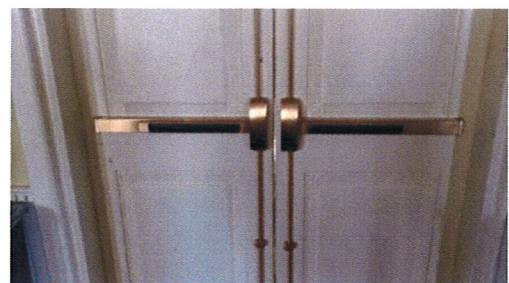
#2 & 101

- Inadequate door leaf width (entrance doors to auditorium)
- Non- compliant thermostat height
- No accessible access to stage
- No accessible egress from rear of auditorium
- Non- compliant fire alarm height
- Non- compliant lighting controls
- Space needs acoustic device

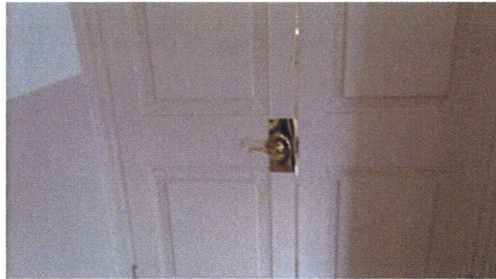
**#12**

- Inadequate door leaf width
- Non- compliant door hardware
- Non- compliant fire alarm height

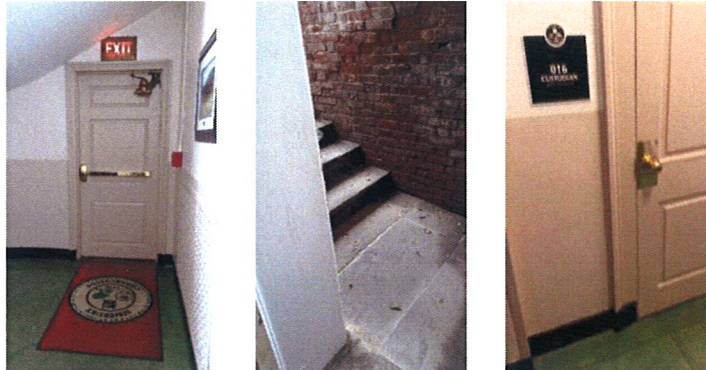
#22

- Inadequate door leaf width
- Non- compliant door hardware
- Non- compliant door hardware for custodian
- Inadequate fire alarm height
- No accessible egress

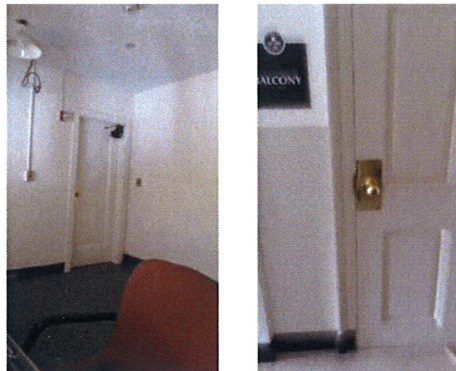
#203

- Non- accessible
- Control room- Inadequate door and non- compliant door hardware

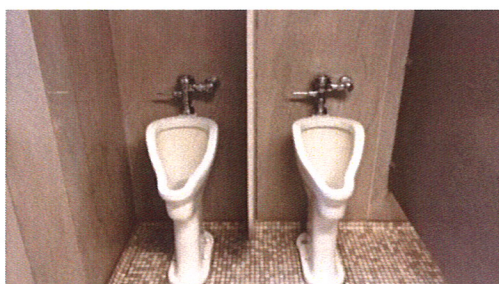
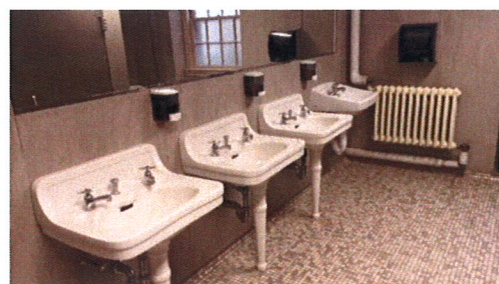
#005

- Non- compliant urinal- clearance and height
- Non- compliant mirror- height and angle
- Inadequate thermostat height
- Inadequate accessories height (towels)
- Inadequate storage cabinet height

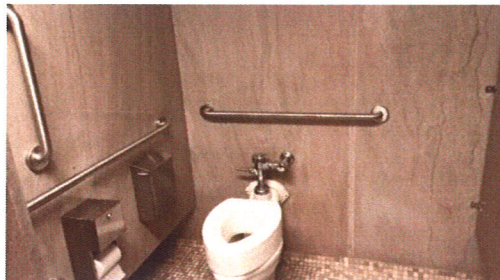
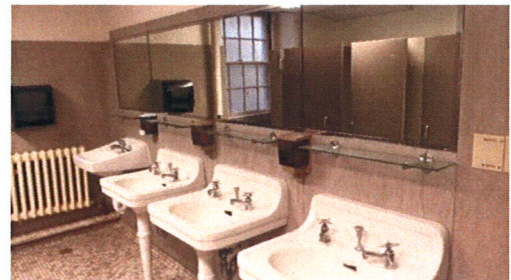
#008

- Non- compliant mirror
- Inadequate accessories height (towels)
- Inadequate storage cabinet height

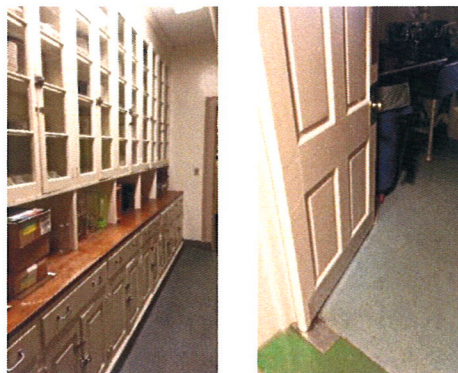
#012

- Inadequate storage cabinet (percentage of shelves out of reach exceeds the allowable limit)

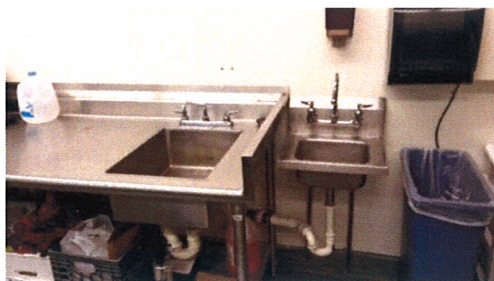
#011

- No HC work station
- Non- compliant electrical panel height
- Stove non- accessible
- Non- compliant hood controls
- Hand wash and dish wash sink non- accessible

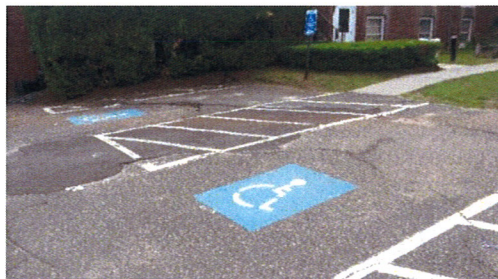
## PARKING

- HC parking spaces gradient exceeds the allowable percentage
- pavement torn up
- Accessible pathway surface irregularities exceed 1/2" in height
