Town of Simsbury, Connecticut Sidewalk and Curb Ramp Assessment

FINAL DRAFT

Prepared By:
BETA Group, Inc.
1010 Wethersfield Avenue
Suite 305
Hartford, CT 06114

September 2019

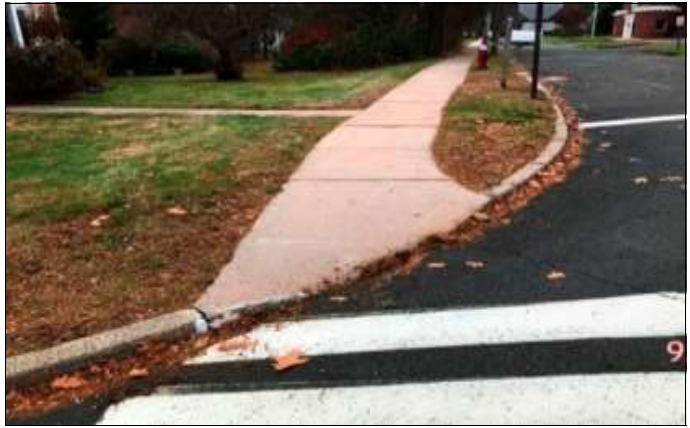
Ramp ID:	95-2
Street:	CHURCH STREET
Intersecting Street:	ELM STREET
Ramp Material:	Concrete
Det. Warning Panel:	No
Panel Damage:	No
Obstructions:	No
Obstruction Type:	None
Condition:	Good
Ramp Pass:	No

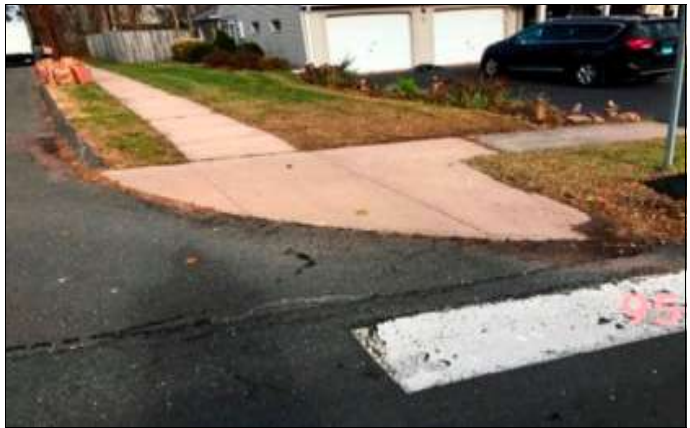
Ramp ID:	95-3
Street:	CHURCH STREET
Intersecting Street:	ELM STREET
Ramp Material:	Concrete
Det. Warning Panel:	No
Panel Damage:	No
Obstructions:	No
Obstruction Type:	None
Condition:	Good
Ramp Pass:	No

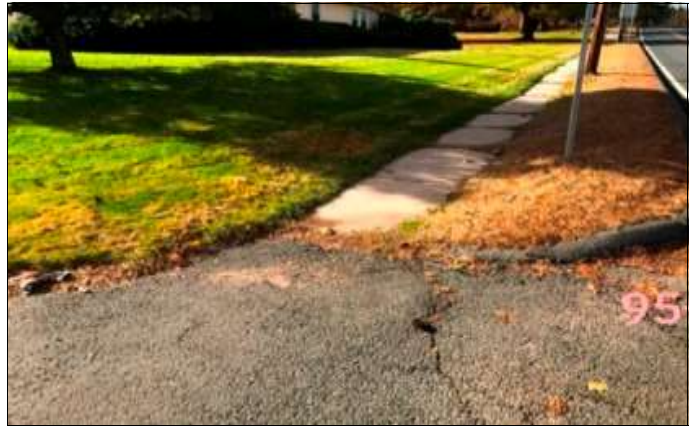
Ramp ID:	37-1
Street:	CRESTWOOD ROAD
Intersecting Street:	BUTTONWOOD DRIVE
Ramp Material:	Asphalt
Det. Warning Panel:	No
Panel Damage:	No
Obstructions:	No
Obstruction Type:	None
Condition:	Good
Ramp Pass:	No

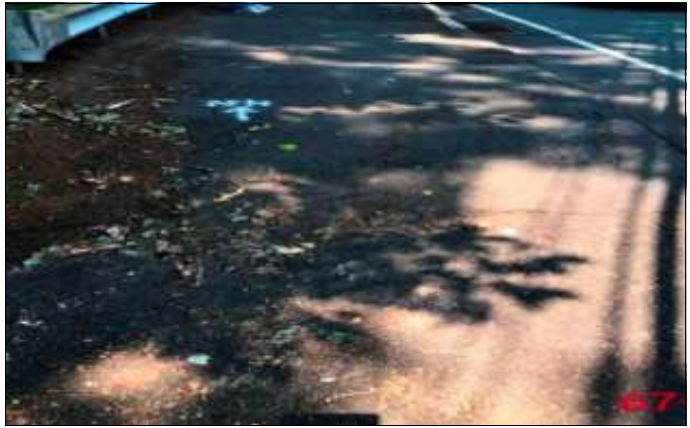
Ramp ID:	67-3
Street:	DRAKE HILL ROAD
Intersecting Street:	IRON HORSE BOULEVARD
Ramp Material:	Asphalt
Det. Warning Panel:	No
Panel Damage:	No
Obstructions:	No
Obstruction Type:	None
Condition:	Good
Ramp Pass:	No

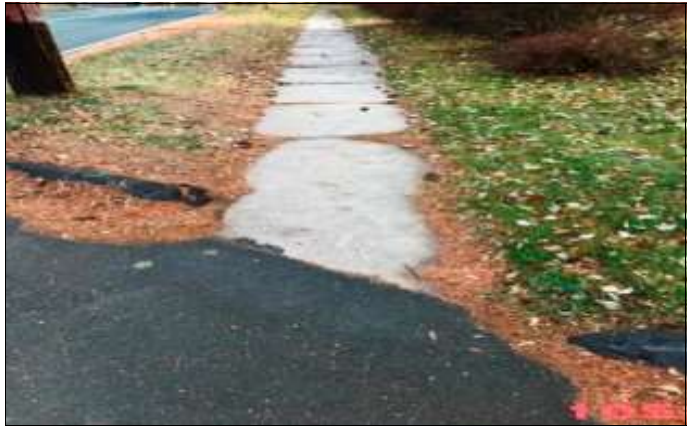
Ramp ID:	111-1
Street:	ELM STREET
Intersecting Street:	DRIVEWAY #55
Ramp Material:	Concrete
Det. Warning Panel:	No
Panel Damage:	No
Obstructions:	No
Obstruction Type:	None
Condition:	Good
Ramp Pass:	No

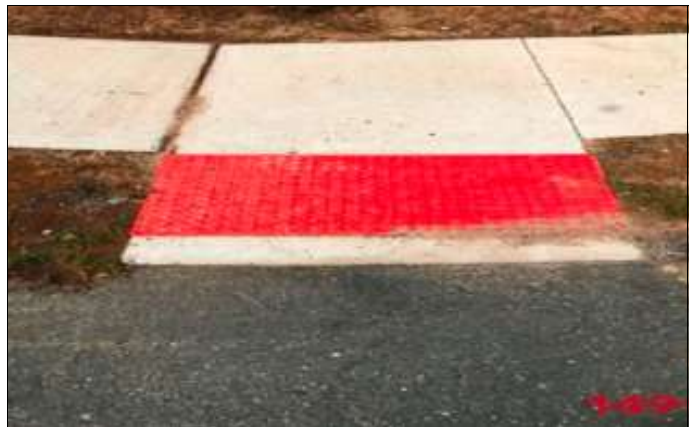
Ramp ID:	149-5
Street:	FARMS VILLAGE ROAD
Intersecting Street:	BUSHY HILL ROAD
Ramp Material:	Concrete
Det. Warning Panel:	Yes
Panel Damage:	No
Obstructions:	No
Obstruction Type:	None
Condition:	Good
Ramp Pass:	Yes

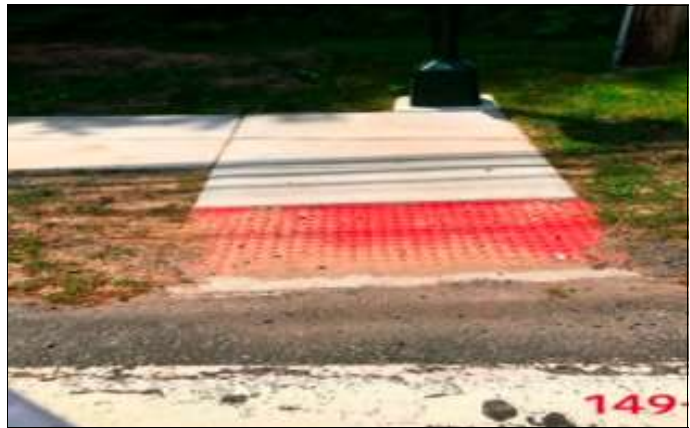
Ramp ID:	F-1
Street:	FARMS VILLAGE ROAD
Intersecting Street:	SIMSBURY HIGH SCHOOL
Ramp Material:	Concrete
Det. Warning Panel:	No
Panel Damage:	No
Obstructions:	Yes
Obstruction Type:	Vegetation
Condition:	Good
Ramp Pass:	No

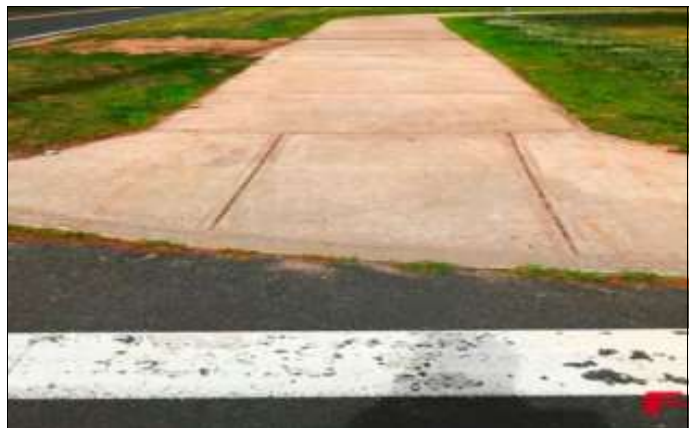
Ramp ID:	F-2
Street:	FARMS VILLAGE ROAD
Intersecting Street:	SIMSBURY HIGH SCHOOL
Ramp Material:	Asphalt
Det. Warning Panel:	No
Panel Damage:	No
Obstructions:	No
Obstruction Type:	None
Condition:	Poor
Ramp Pass:	No

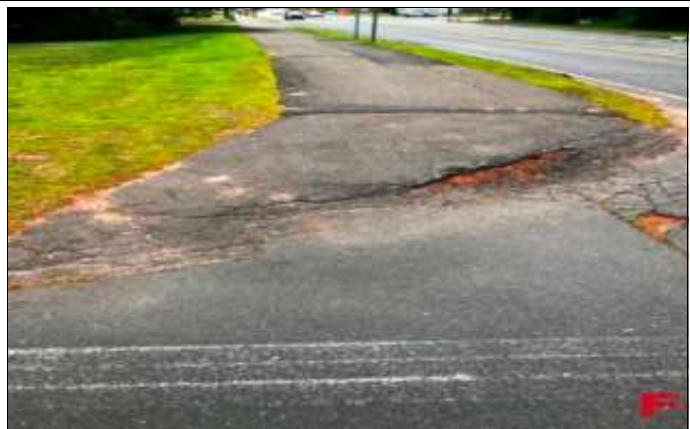
Ramp ID:	G-1
Street:	FARMS VILLAGE ROAD
Intersecting Street:	SIMSBURY HIGH SCHOOL
Ramp Material:	Asphalt
Det. Warning Panel:	No
Panel Damage:	No
Obstructions:	Yes
Obstruction Type:	Vegetation
Condition:	Fair
Ramp Pass:	No

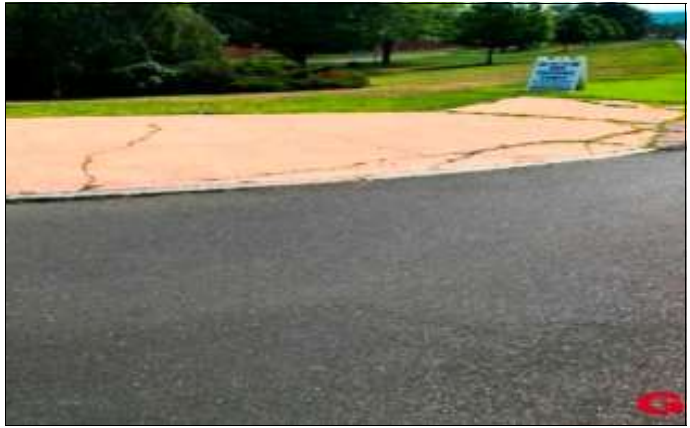
Ramp ID:	12-1
Street:	FIRETOWN ROAD
Intersecting Street:	SQUADRON LINE ROAD
Ramp Material:	Asphalt
Det. Warning Panel:	No
Panel Damage:	No
Obstructions:	No
Obstruction Type:	None
Condition:	Good
Ramp Pass:	No

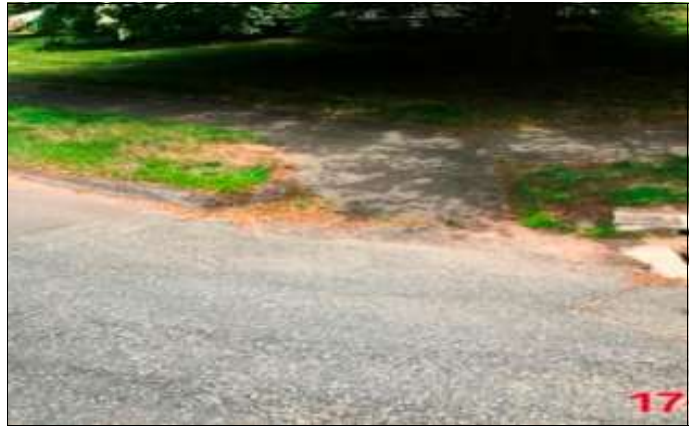
Ramp ID:	17-2
Street:	FIRETOWN ROAD
Intersecting Street:	CHRISWELL DRIVE
Ramp Material:	Asphalt
Det. Warning Panel:	No
Panel Damage:	No
Obstructions:	No
Obstruction Type:	None
Condition:	Poor
Ramp Pass:	No

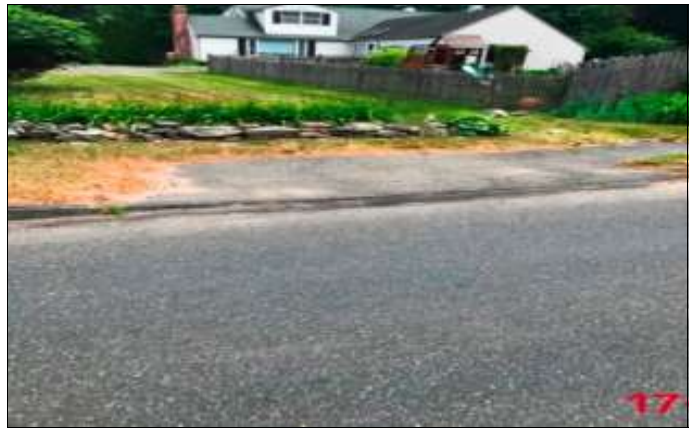
Ramp ID:	18-1
Street:	FIRETOWN ROAD
Intersecting Street:	OWENS BROOK BOULEVARD
Ramp Material:	Asphalt
Det. Warning Panel:	No
Panel Damage:	No
Obstructions:	No
Obstruction Type:	None
Condition:	Good
Ramp Pass:	No

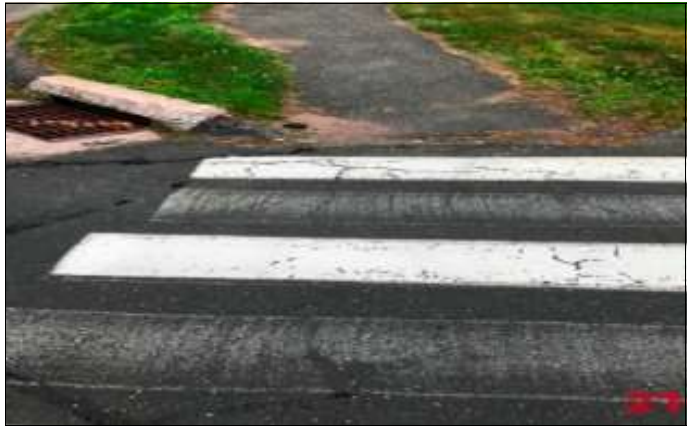
Ramp ID:	21-2
Street:	FIRETOWN ROAD
Intersecting Street:	SIMSCROFT PLACE
Ramp Material:	Asphalt
Det. Warning Panel:	No
Panel Damage:	No
Obstructions:	No
Obstruction Type:	None
Condition:	Good
Ramp Pass:	No

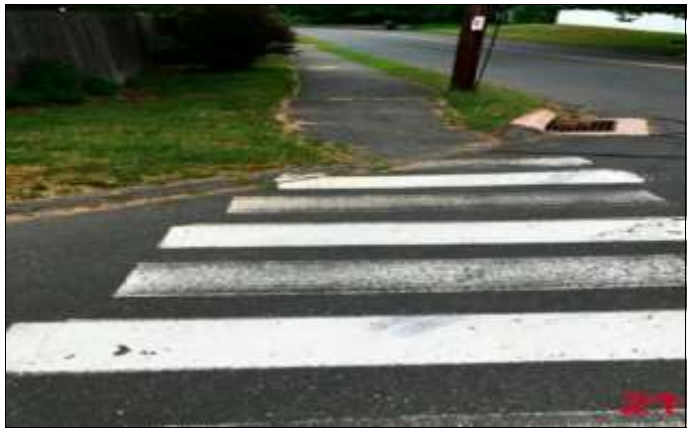
Ramp ID:	24-1
Street:	FIRETOWN ROAD
Intersecting Street:	HENRY JAMES MIDDLE SCHOOL
Ramp Material:	Asphalt
Det. Warning Panel:	No
Panel Damage:	No
Obstructions:	No
Obstruction Type:	None
Condition:	Good
Ramp Pass:	No

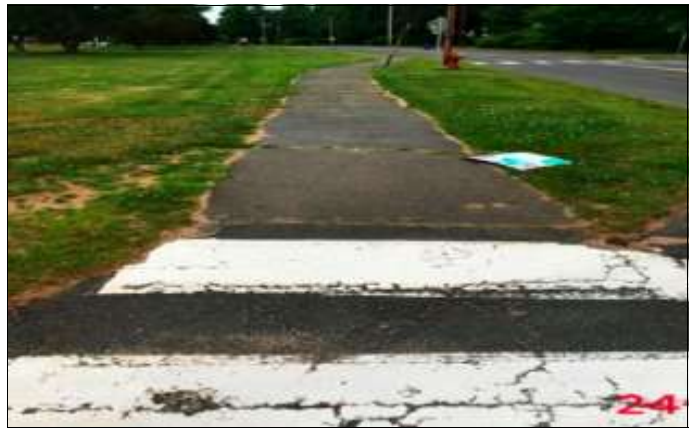
Ramp ID:	24-4
Street:	FIRETOWN ROAD
Intersecting Street:	HENRY JAMES MIDDLE SCHOOL
Ramp Material:	Asphalt
Det. Warning Panel:	No
Panel Damage:	No
Obstructions:	No
Obstruction Type:	None
Condition:	Fair
Ramp Pass:	No

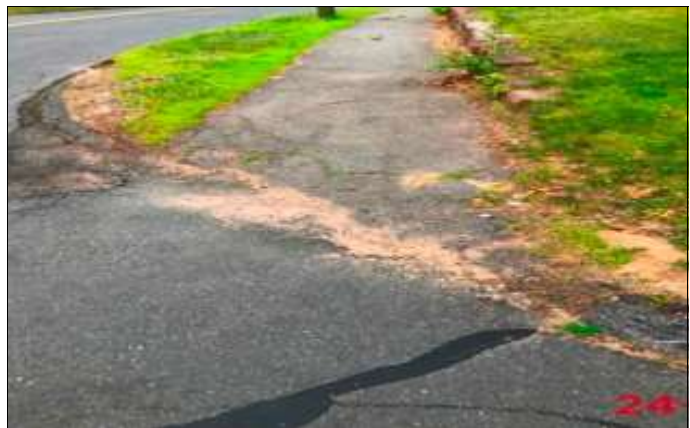
Ramp ID:	25-1
Street:	FIRETOWN ROAD
Intersecting Street:	SEMINARY ROAD
Ramp Material:	Asphalt
Det. Warning Panel:	No
Panel Damage:	No
Obstructions:	No
Obstruction Type:	None
Condition:	Good
Ramp Pass:	No

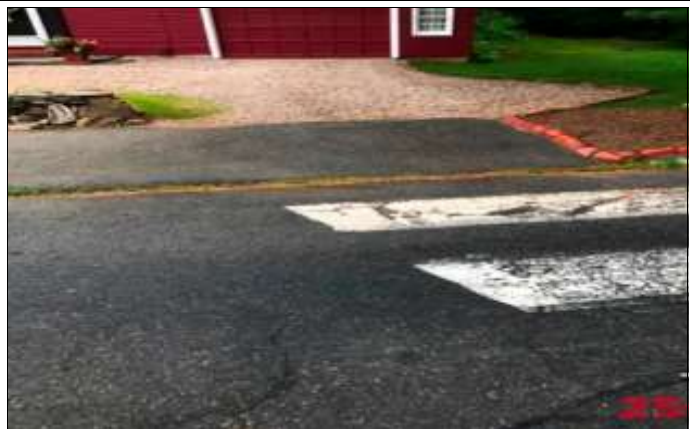
Ramp ID:	25-2
Street:	FIRETOWN ROAD
Intersecting Street:	SEMINARY ROAD
Ramp Material:	Asphalt
Det. Warning Panel:	No
Panel Damage:	No
Obstructions:	No
Obstruction Type:	None
Condition:	Fair
Ramp Pass:	No

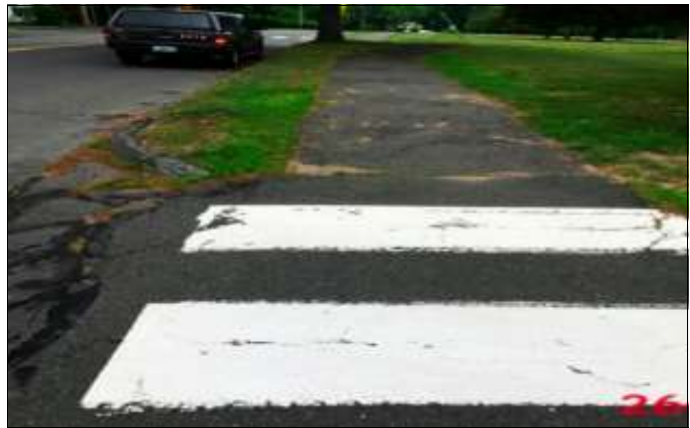
Ramp ID:	26-2
Street:	FIRETOWN ROAD
Intersecting Street:	OAKWOOD ROAD
Ramp Material:	Asphalt
Det. Warning Panel:	No
Panel Damage:	No
Obstructions:	No
Obstruction Type:	None
Condition:	Fair
Ramp Pass:	No

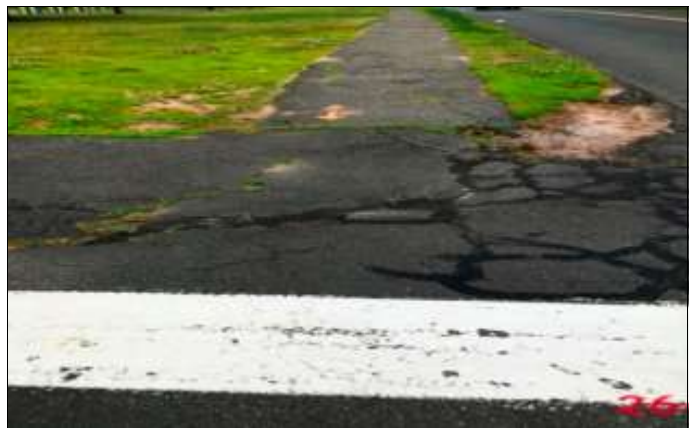
Ramp ID:	C-1
Street:	FIRETOWN ROAD
Intersecting Street:	DRIVEWAY #228
Ramp Material:	Asphalt
Det. Warning Panel:	No
Panel Damage:	No
Obstructions:	Yes
Obstruction Type:	Curbing
Condition:	Good
Ramp Pass:	No

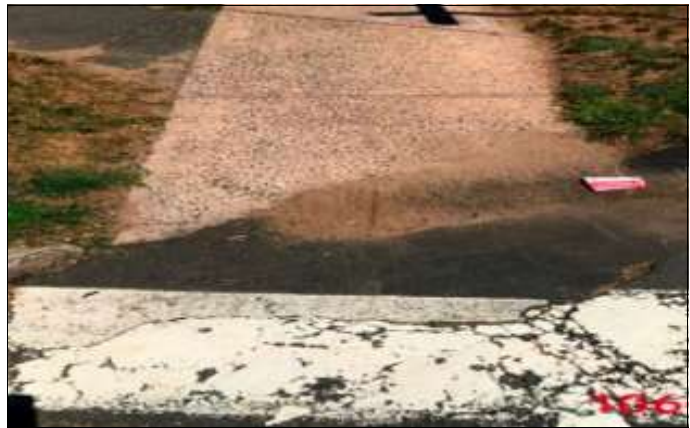
Ramp ID:	106-2
Street:	HOPMEADOW STREET
Intersecting Street:	MASSACO STREET
Ramp Material:	Concrete
Det. Warning Panel:	No
Panel Damage:	No
Obstructions:	Yes
Obstruction Type:	None
Condition:	Fair
Ramp Pass:	No

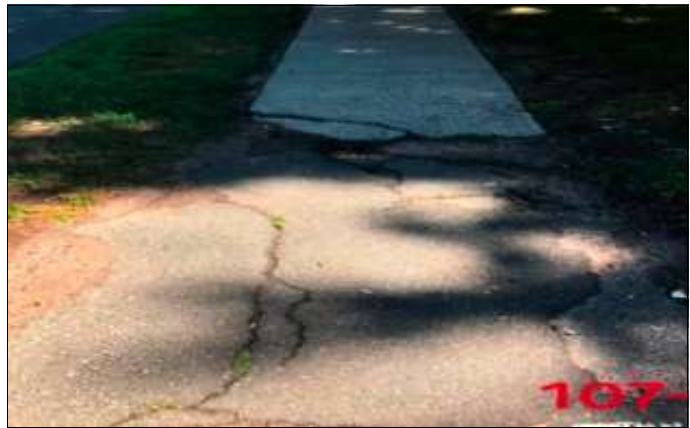
Ramp ID:	107-2
Street:	HOPMEADOW STREET
Intersecting Street:	PENT ROAD
Ramp Material:	Asphalt
Det. Warning Panel:	No
Panel Damage:	No
Obstructions:	Yes
Obstruction Type:	Curbing
Condition:	Good
Ramp Pass:	No

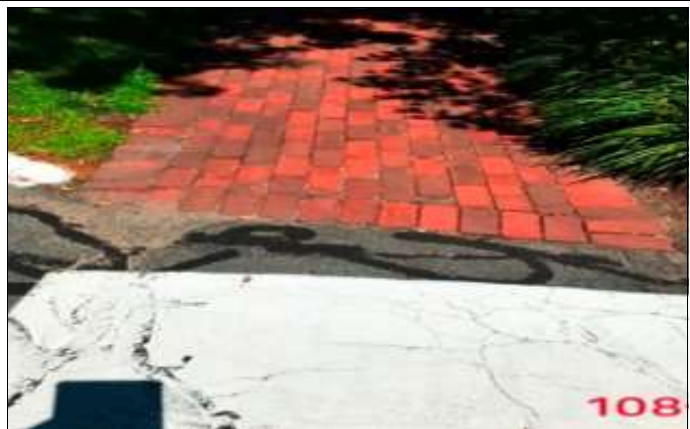
Ramp ID:	108-2
Street:	HOPMEADOW STREET
Intersecting Street:	PRIVATE STREET
Ramp Material:	Brick
Det. Warning Panel:	No
Panel Damage:	No
Obstructions:	No
Obstruction Type:	None
Condition:	Good
Ramp Pass:	No

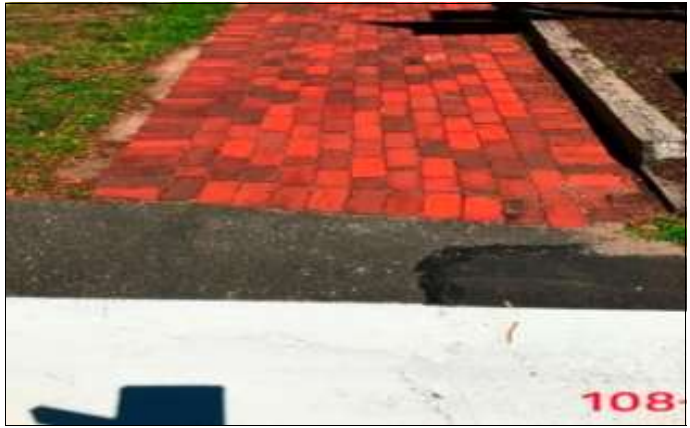
Ramp ID:	108-4
Street:	HOPMEADOW STREET
Intersecting Street:	PRIVATE STREET
Ramp Material:	Brick
Det. Warning Panel:	No
Panel Damage:	No
Obstructions:	No
Obstruction Type:	None
Condition:	Good
Ramp Pass:	No

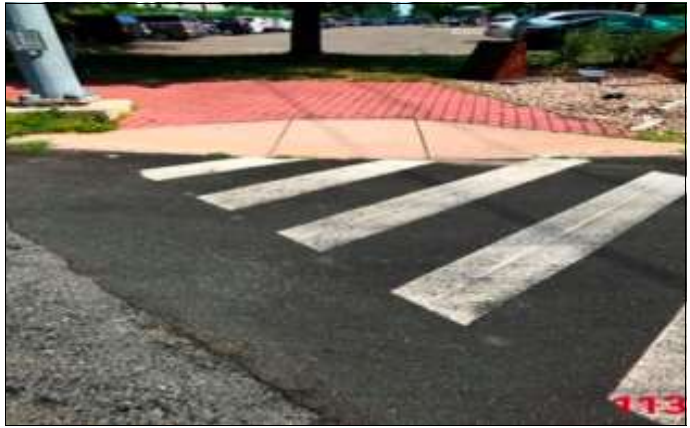
Ramp ID:	113-2
Street:	HOPMEADOW STREET
Intersecting Street:	WINSLOW PLACE
Ramp Material:	Concrete
Det. Warning Panel:	No
Panel Damage:	No
Obstructions:	Yes
Obstruction Type:	Vegetation
Condition:	Fair
Ramp Pass:	No

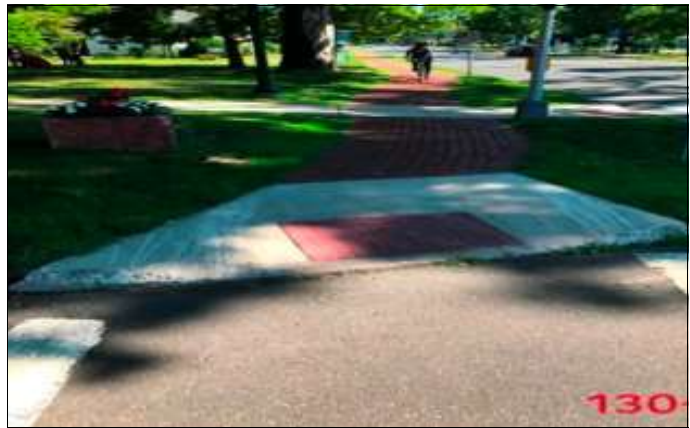
Ramp ID:	130-3
Street:	HOPMEADOW STREET
Intersecting Street:	PLANK HILL ROAD
Ramp Material:	Concrete
Det. Warning Panel:	Yes
Panel Damage:	No
Obstructions:	No
Obstruction Type:	None
Condition:	Good
Ramp Pass:	No

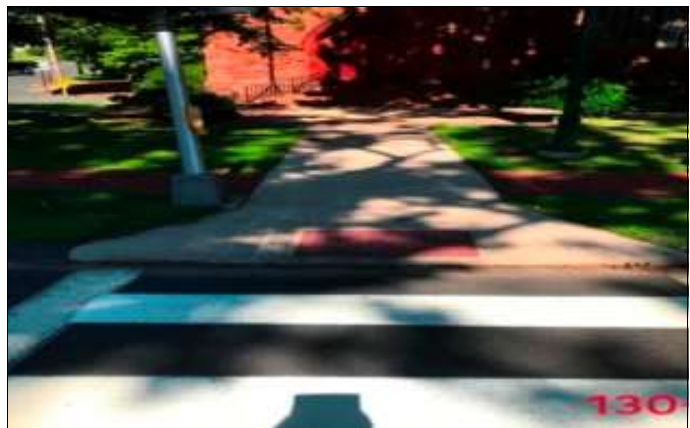
Ramp ID:	130-4
Street:	HOPMEADOW STREET
Intersecting Street:	PLANK HILL ROAD
Ramp Material:	Concrete
Det. Warning Panel:	No
Panel Damage:	No
Obstructions:	Yes
Obstruction Type:	Vegetation
Condition:	Fair
Ramp Pass:	No

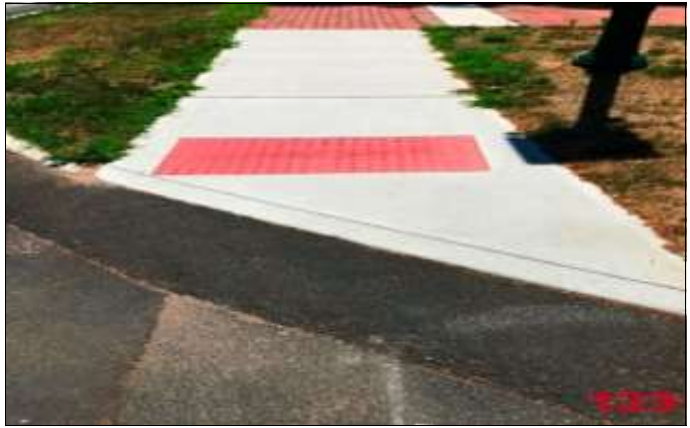
Ramp ID:	133-3
Street:	HOPMEADOW STREET
Intersecting Street:	EAGLEWOOD LANE
Ramp Material:	Concrete
Det. Warning Panel:	Yes
Panel Damage:	No
Obstructions:	No
Obstruction Type:	None
Condition:	Good
Ramp Pass:	Yes

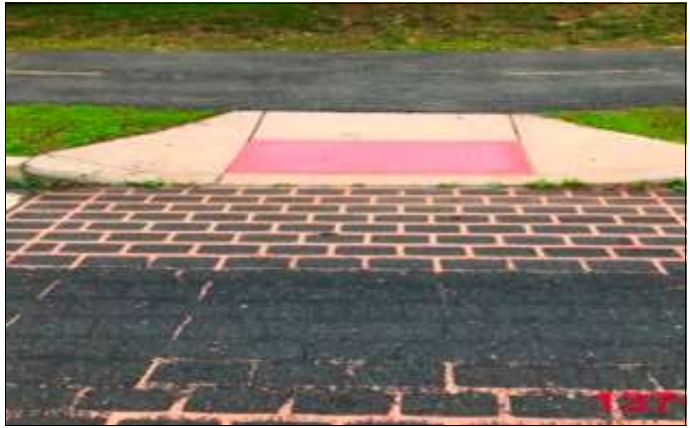
Ramp ID:	36-1
Street:	HOPMEADOW STREET
Intersecting Street:	WOODLAND STREET
Ramp Material:	Asphalt
Det. Warning Panel:	No
Panel Damage:	No
Obstructions:	Yes
Obstruction Type:	Vegetation
Condition:	Fair
Ramp Pass:	No

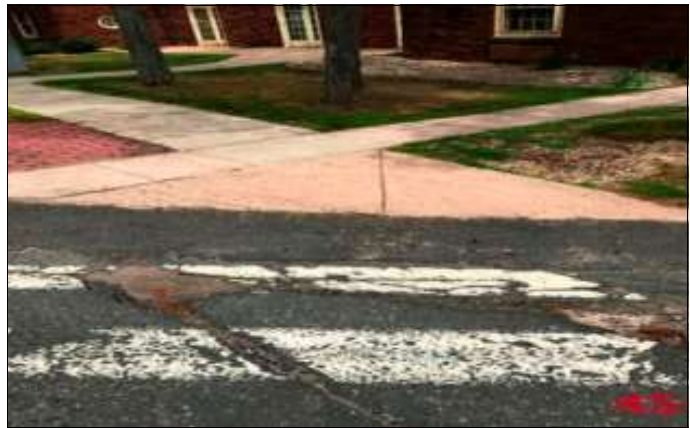
Ramp ID:	45-3
Street:	HOPMEADOW STREET
Intersecting Street:	WOODLAND PLACE
Ramp Material:	Concrete
Det. Warning Panel:	No
Panel Damage:	No
Obstructions:	No
Obstruction Type:	None
Condition:	Good
Ramp Pass:	No

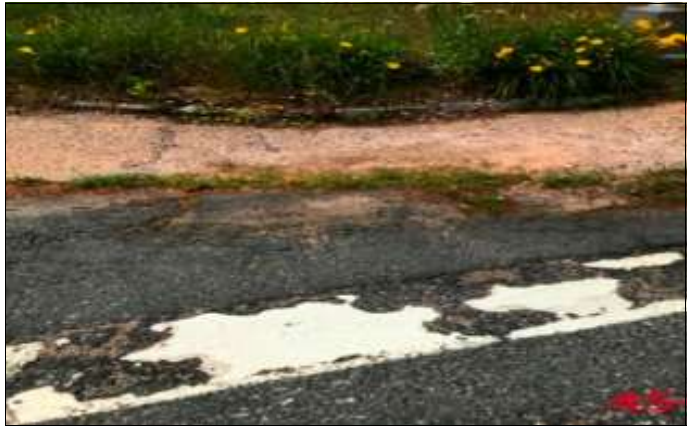
Ramp ID:	56-1
Street:	HOPMEADOW STREET
Intersecting Street:	DRAKE HILL ROAD
Ramp Material:	Concrete
Det. Warning Panel:	Yes
Panel Damage:	No
Obstructions:	No
Obstruction Type:	None
Condition:	Good
Ramp Pass:	Yes

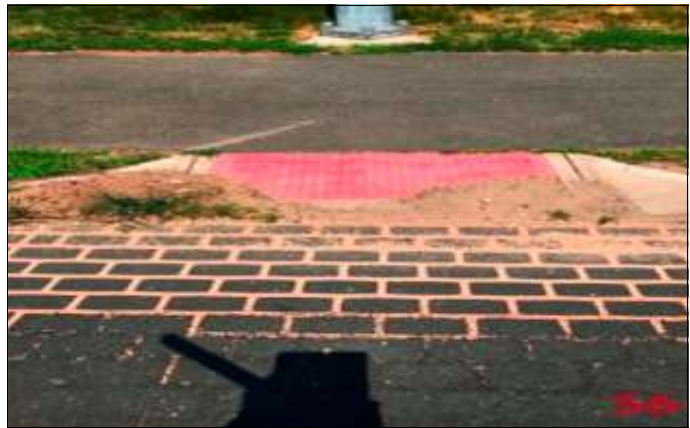
Ramp ID:	63-1
Street:	HOPMEADOW STREET
Intersecting Street:	MALL WAY
Ramp Material:	Concrete
Det. Warning Panel:	Yes
Panel Damage:	No
Obstructions:	No
Obstruction Type:	None
Condition:	Good
Ramp Pass:	No

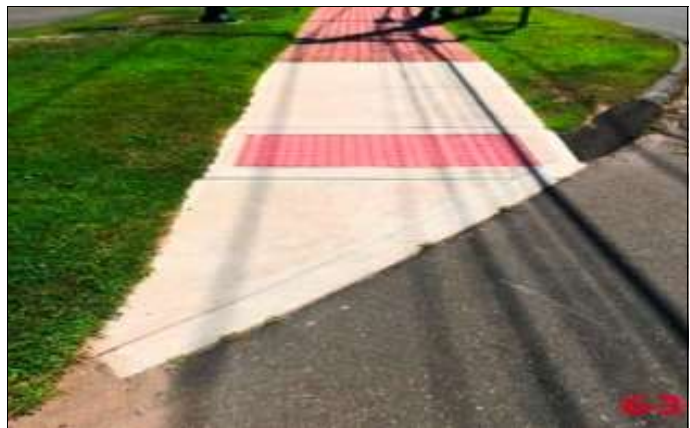
Ramp ID:	63-2
Street:	HOPMEADOW STREET
Intersecting Street:	MALL WAY
Ramp Material:	Concrete
Det. Warning Panel:	Yes
Panel Damage:	No
Obstructions:	No
Obstruction Type:	None
Condition:	Good
Ramp Pass:	No

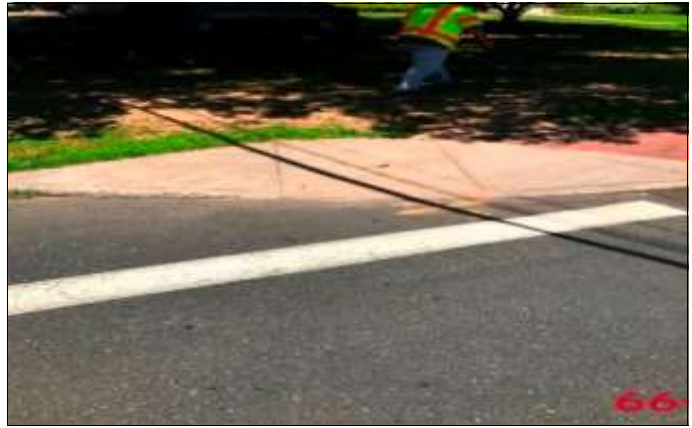
Ramp ID:	66-3
Street:	HOPMEADOW STREET
Intersecting Street:	LIBRARY LANE
Ramp Material:	Concrete
Det. Warning Panel:	Yes
Panel Damage:	No
Obstructions:	No
Obstruction Type:	None
Condition:	Good
Ramp Pass:	Yes

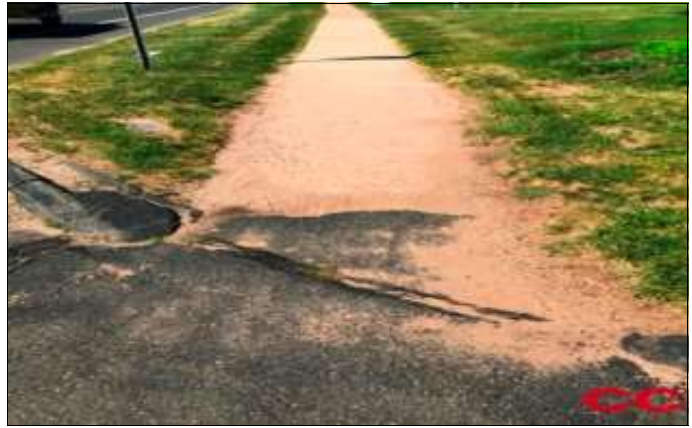
Ramp ID:	CC-2
Street:	HOPMEADOW STREET
Intersecting Street:	DRIVEWAY #981
Ramp Material:	Asphalt
Det. Warning Panel:	No
Panel Damage:	No
Obstructions:	Yes
Obstruction Type:	Vegetation
Condition:	Poor
Ramp Pass:	No

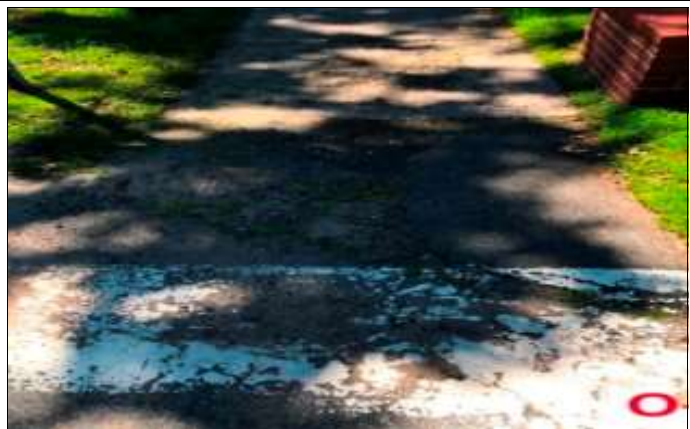
Ramp ID:	O-3
Street:	HOPMEADOW STREET
Intersecting Street:	DRIVEWAY #932
Ramp Material:	Asphalt
Det. Warning Panel:	No
Panel Damage:	No
Obstructions:	No
Obstruction Type:	None
Condition:	Good
Ramp Pass:	No

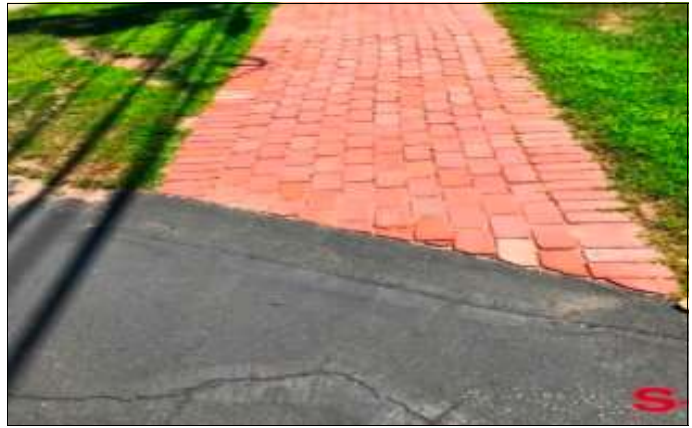
Ramp ID:	T-1
Street:	HOPMEADOW STREET
Intersecting Street:	DRIVEWAY #869
Ramp Material:	Brick
Det. Warning Panel:	No
Panel Damage:	No
Obstructions:	No
Obstruction Type:	None
Condition:	Good
Ramp Pass:	No

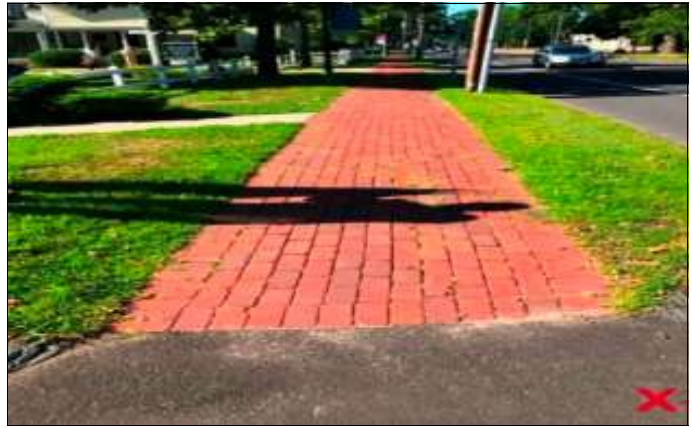
Ramp ID:	X-3
Street:	HOPMEADOW STREET
Intersecting Street:	DRIVEWAY #809
Ramp Material:	Brick
Det. Warning Panel:	No
Panel Damage:	No
Obstructions:	No
Obstruction Type:	None
Condition:	Good
Ramp Pass:	No

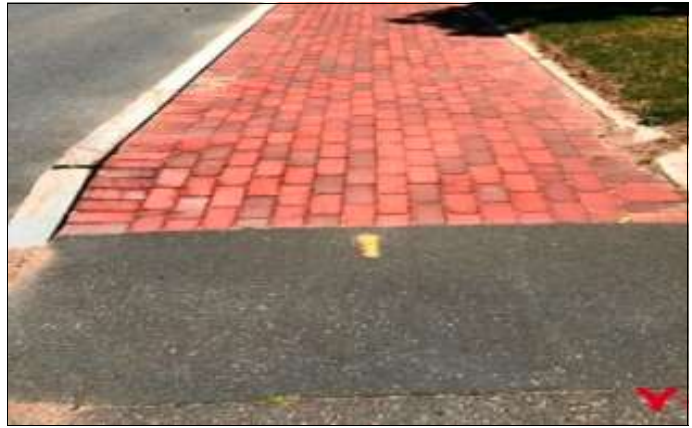
Ramp ID:	Y-3
Street:	HOPMEADOW STREET
Intersecting Street:	DRIVEWAY #760
Ramp Material:	Brick
Det. Warning Panel:	No
Panel Damage:	No
Obstructions:	No
Obstruction Type:	None
Condition:	Good
Ramp Pass:	No

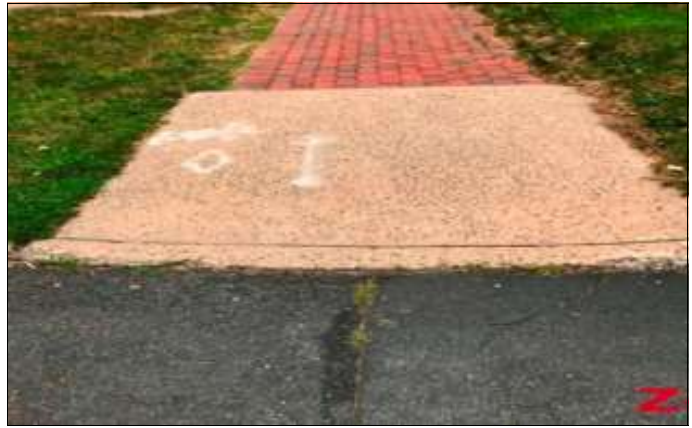
Ramp ID:	Z-3
Street:	HOPMEADOW STREET
Intersecting Street:	DRIVEWAY #731
Ramp Material:	Brick
Det. Warning Panel:	No
Panel Damage:	No
Obstructions:	No
Obstruction Type:	None
Condition:	Good
Ramp Pass:	No

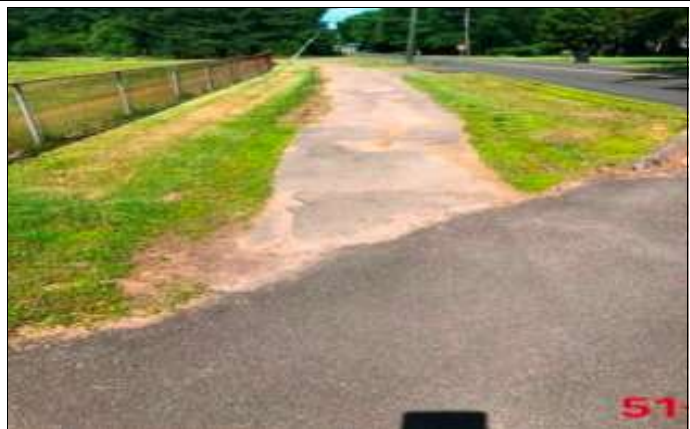
Ramp ID:	B-1
Street:	HOSKINS ROAD
Intersecting Street:	DRIVEWAY #96
Ramp Material:	Asphalt
Det. Warning Panel:	No
Panel Damage:	No
Obstructions:	No
Obstruction Type:	None
Condition:	Good
Ramp Pass:	No

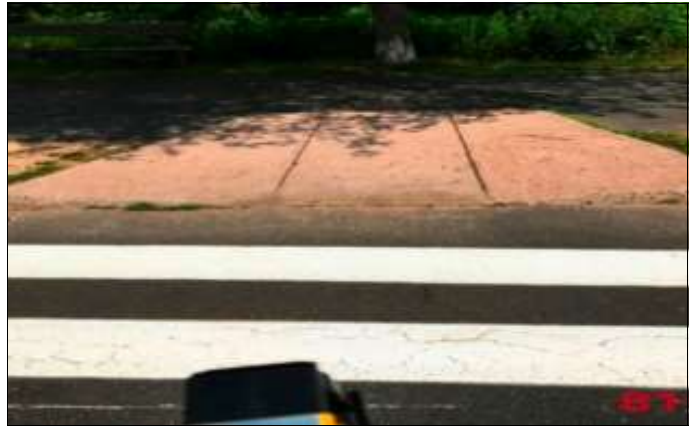
Ramp ID:	HH-1
Street:	IRON HORSE BOULEVARD
Intersecting Street:	DRIVEWAY #22
Ramp Material:	Asphalt
Det. Warning Panel:	No
Panel Damage:	No
Obstructions:	No
Obstruction Type:	None
Condition:	Good
Ramp Pass:	No

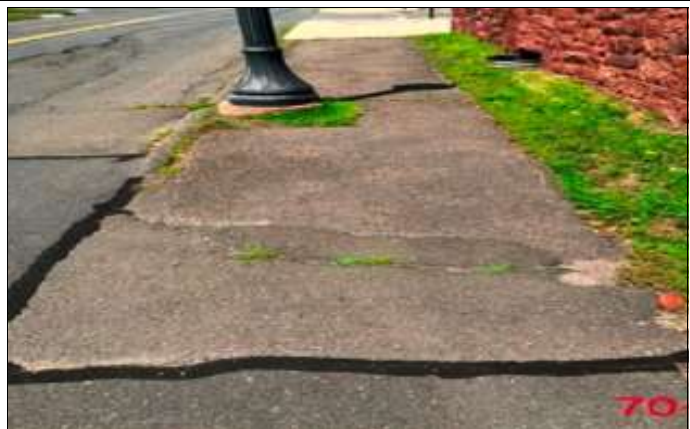
Ramp ID:	A-1
Street:	KILBOURN ROAD
Intersecting Street:	KILBOURN FARMS
Ramp Material:	Asphalt
Det. Warning Panel:	Yes
Panel Damage:	No
Obstructions:	No
Obstruction Type:	None
Condition:	Good
Ramp Pass:	No

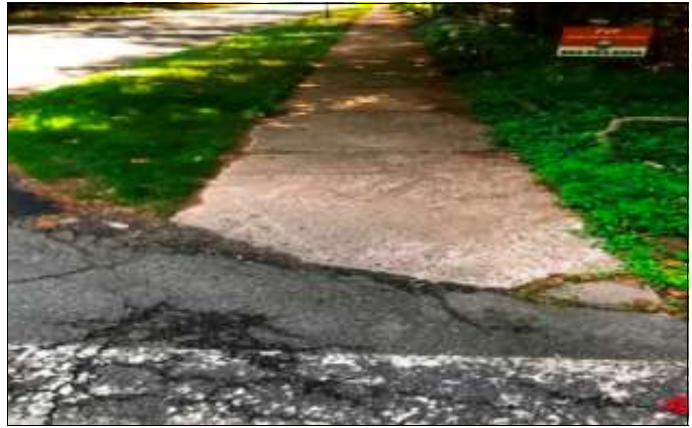
Ramp ID:	4-2
Street:	LATIMER LANE
Intersecting Street:	SPRUCE LANE
Ramp Material:	Asphalt
Det. Warning Panel:	No
Panel Damage:	No
Obstructions:	No
Obstruction Type:	None
Condition:	Good
Ramp Pass:	No

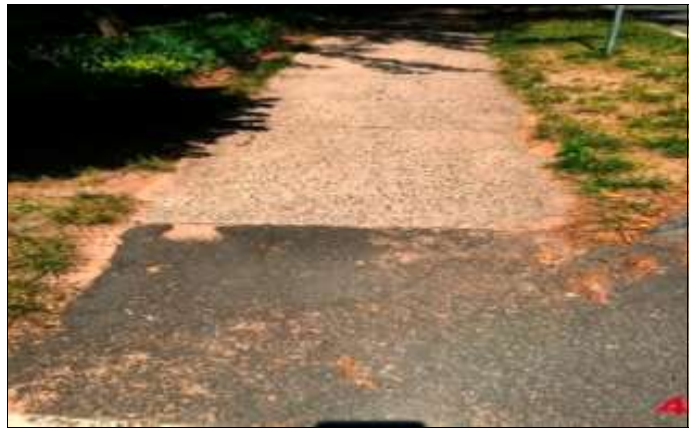
Ramp ID:	5-1
Street:	LATIMER LANE
Intersecting Street:	HARRIET LANE
Ramp Material:	Concrete
Det. Warning Panel:	No
Panel Damage:	No
Obstructions:	No
Obstruction Type:	None
Condition:	Good
Ramp Pass:	No

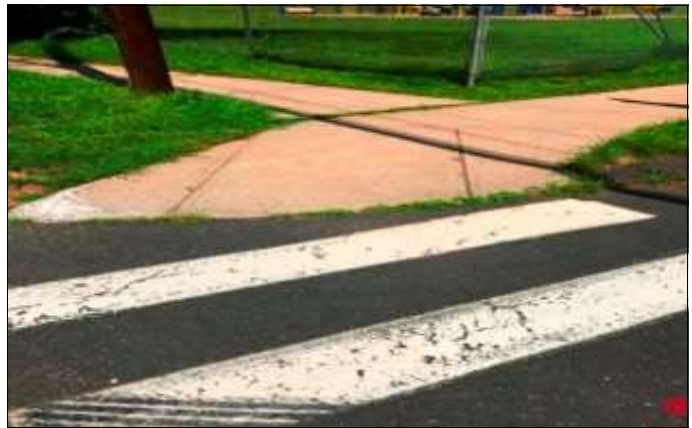
Ramp ID:	100-1
Street:	MAIN STREET
Intersecting Street:	RED HILL ROAD
Ramp Material:	Concrete
Det. Warning Panel:	No
Panel Damage:	No
Obstructions:	No
Obstruction Type:	None
Condition:	Good
Ramp Pass:	No

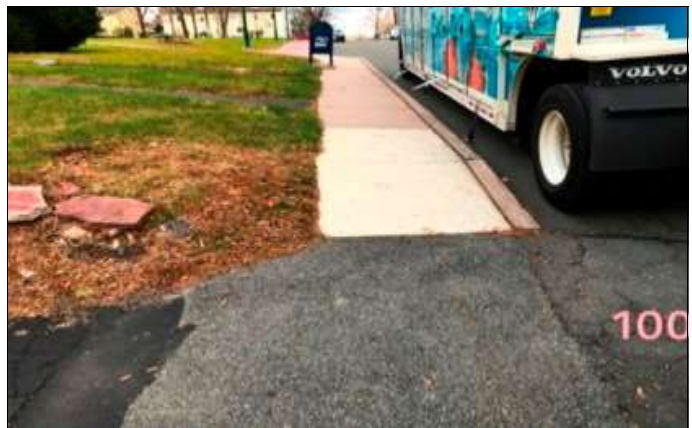
Ramp ID:	101-1
Street:	MAIN STREET
Intersecting Street:	RED HILL ROAD
Ramp Material:	Concrete
Det. Warning Panel:	No
Panel Damage:	No
Obstructions:	No
Obstruction Type:	None
Condition:	Fair
Ramp Pass:	No
