SIMSBURY BOARD OF SELECTMEN **Special Meeting – February 8, 2021 – 5:00 p.m.**

CONDITIONS ASSESSMENT & MASTER PLAN STATUS UPDATE

SUMMARY PRESENTATION FOR BOS
2.8.2021

ENO MEMORIAL HALL

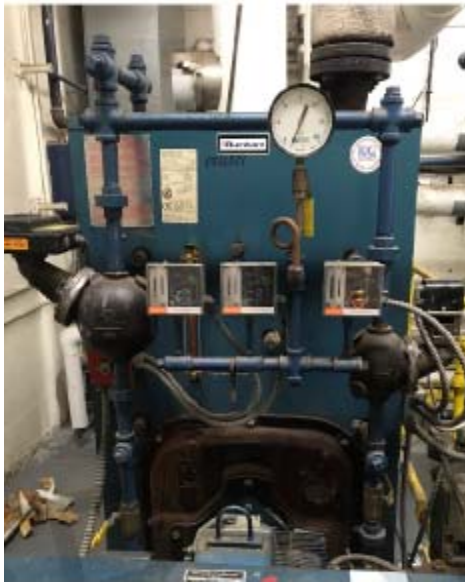
Ranking Procedure Example

Steam Fired Boiler

Heating Plant (Boilers, pumps, etc.) Rating: 3
Boiler Plan is approaching the end of useful life
85% efficient

The building is served by three (3) cast iron sectional steam boilers as manufactured by Burnham. These boilers are fitted with natural gas fired burners as manufactured by PowerFlame. Each boiler is rated for a net capacity of 703 MBH. The boilers were installed in 1998 and are in fair condition approaching the end of their useful life.

Recommended CIP timeframe 5-10 years

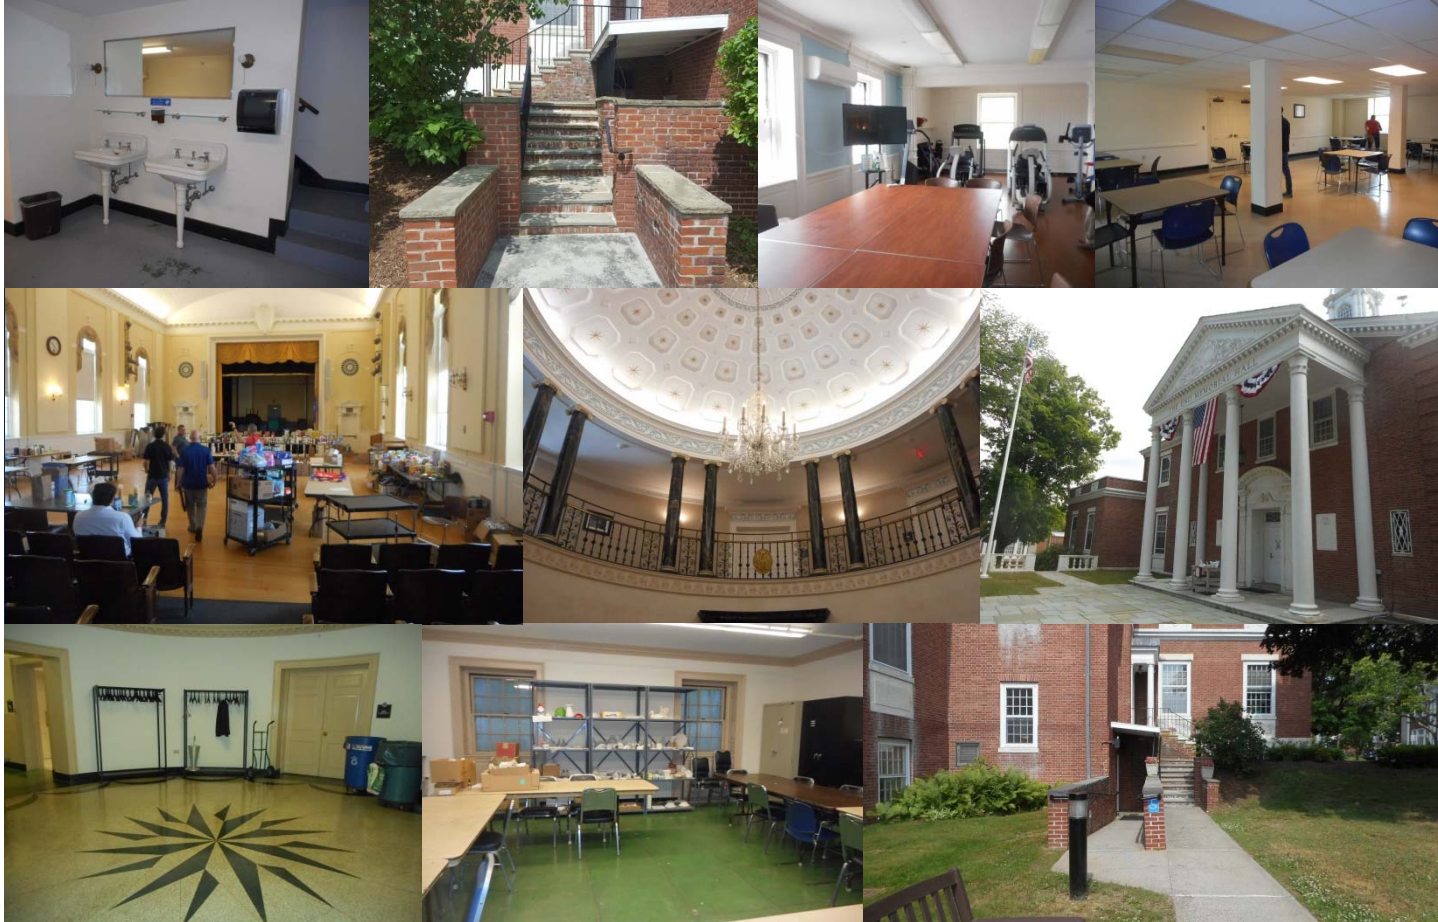
"FIRST BEST USE"

- Eno Memorial Hall is not well suited to Senior Center and Social Services functions.
 - No covered drop-off for buses and Accessible vans.
 - One accessible entrance.
 - Program space on multiple floors.
 - Restrooms are not well suited to needs of Seniors.
 - Poor observability of program spaces from staff locations.
 - Auditorium space is underutilized.
 - Insufficient food storage (refrigerated and non-refrigerated)
 - Acoustics
 - Outdated cooling/heating control
 - Parking/site grade

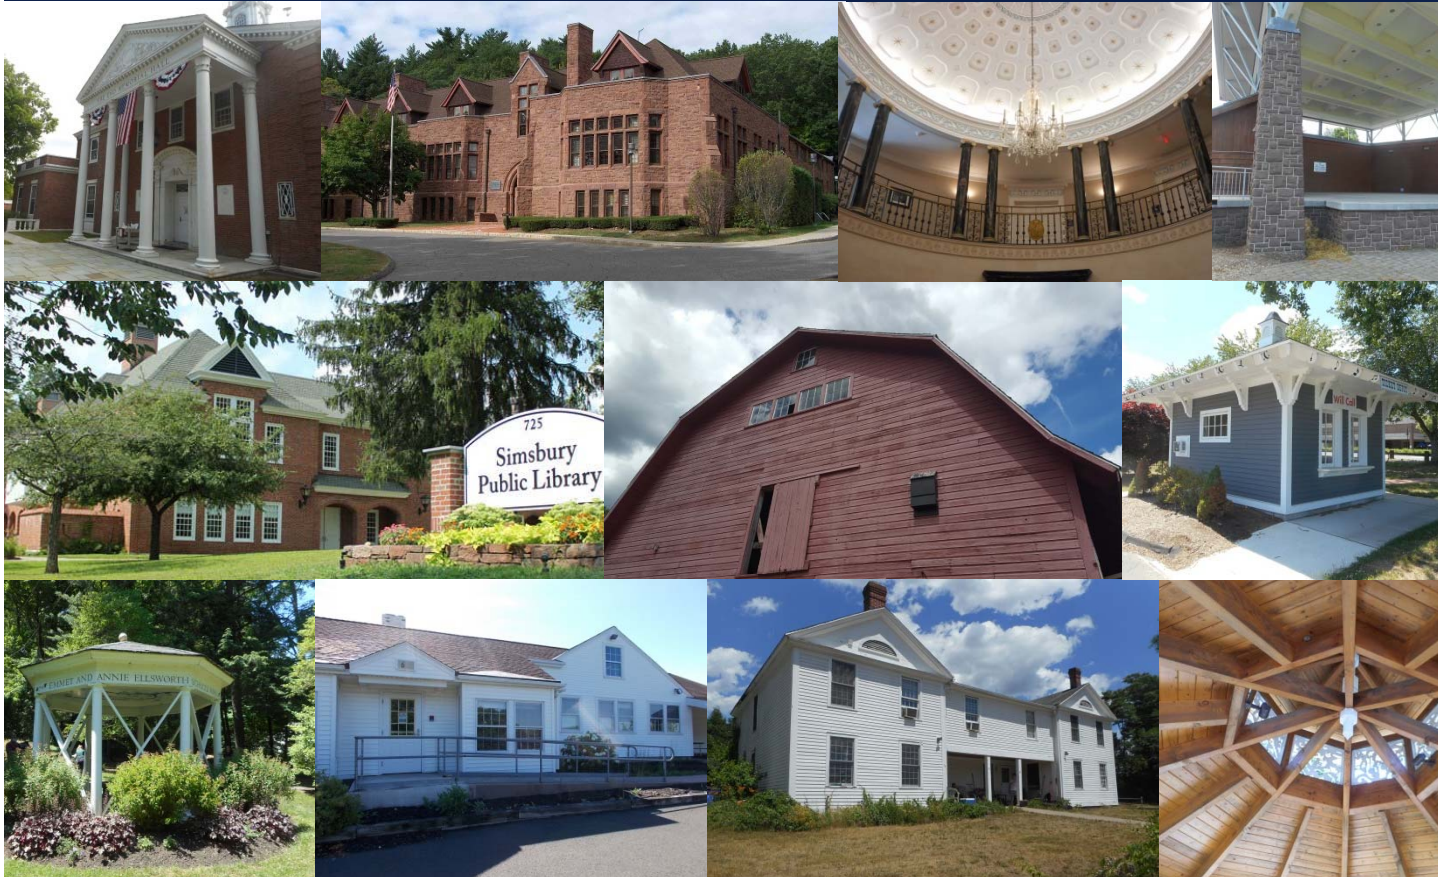
Summary of Findings

- The Town's Buildings overall are well maintained, with some noted life-cycle upgrades coming due within the 10-year study window
- Site repairs and improvements resulting from normal wear and tear were observed at all 18 sites
- HVAC and Lighting end of life upgrades were observed at many buildings
- Site ADA improvements were noted at several primary facilities

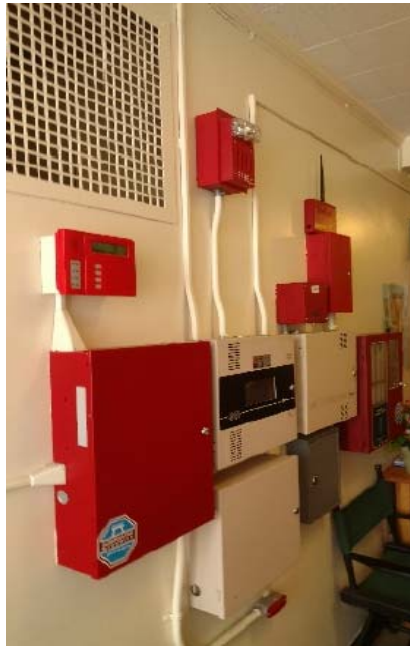
CIP Identification Example

Fire Alarm Control Panels

Fire Alarm System Rating: 3
Fire alarm upgraded in 2006 but the entire system was not installed new.

. . . system that has many backboxes left behind used as raceways . . . pull stations are older . . . The presence of an auditorium . . . would require a voice capable occupant notification system to be provided for the auditorium as a minimum.

Recommended CIP timeframe 3-5 years

CIP Hard Cost Estimate:	\$54,024
CIP Soft Cost estimate:	\$9,454
CIP Total estimate:	\$63,478

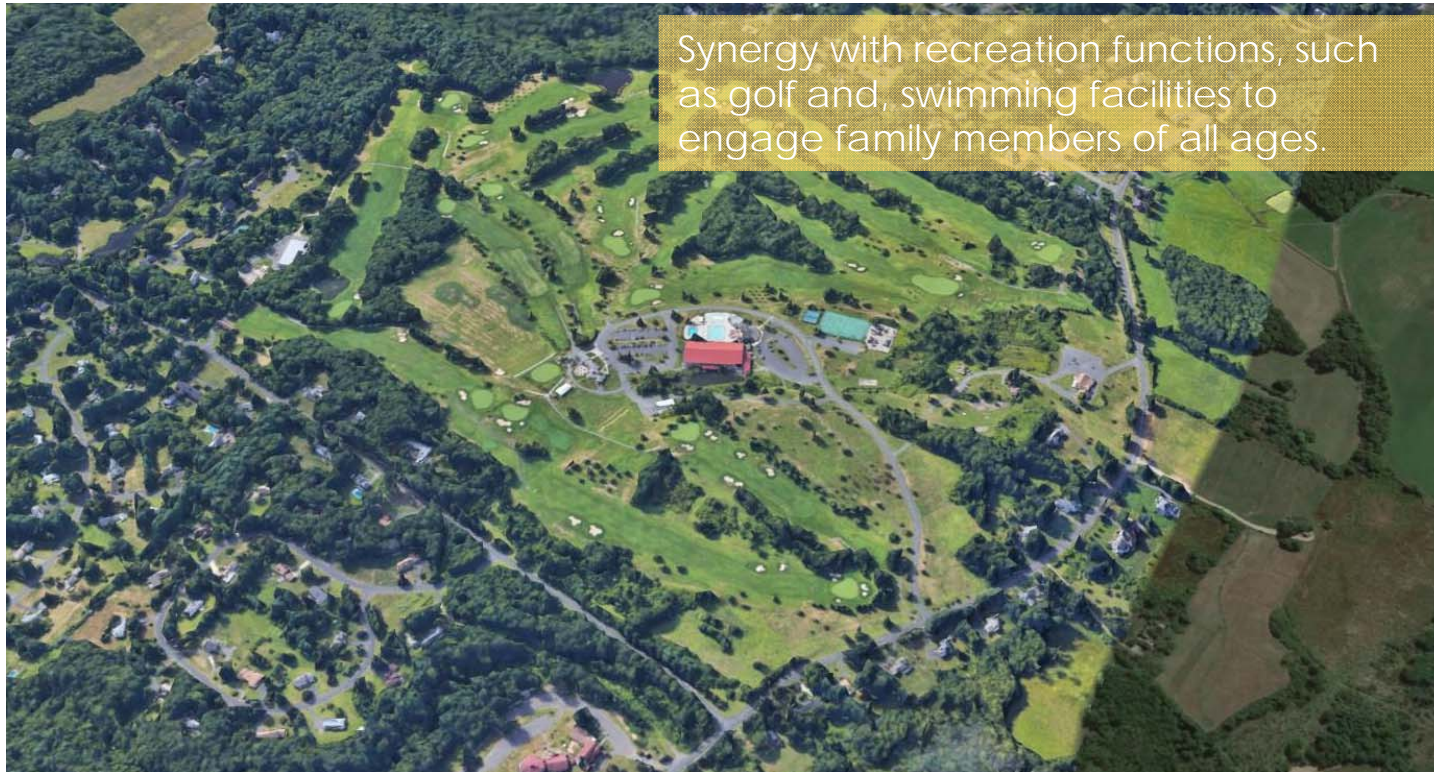
Aerial Image

Synergy with recreation functions, such as golf and, swimming facilities to engage family members of all ages.

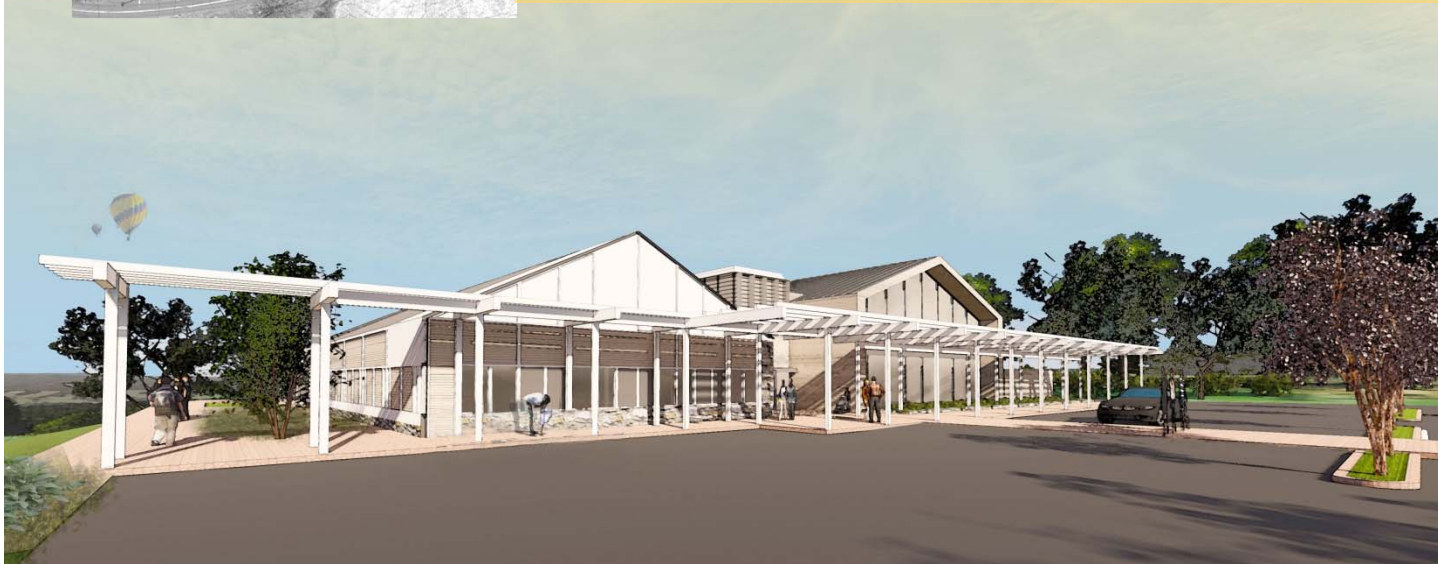
View to North

Parks and Recreation program space for after school and evening use

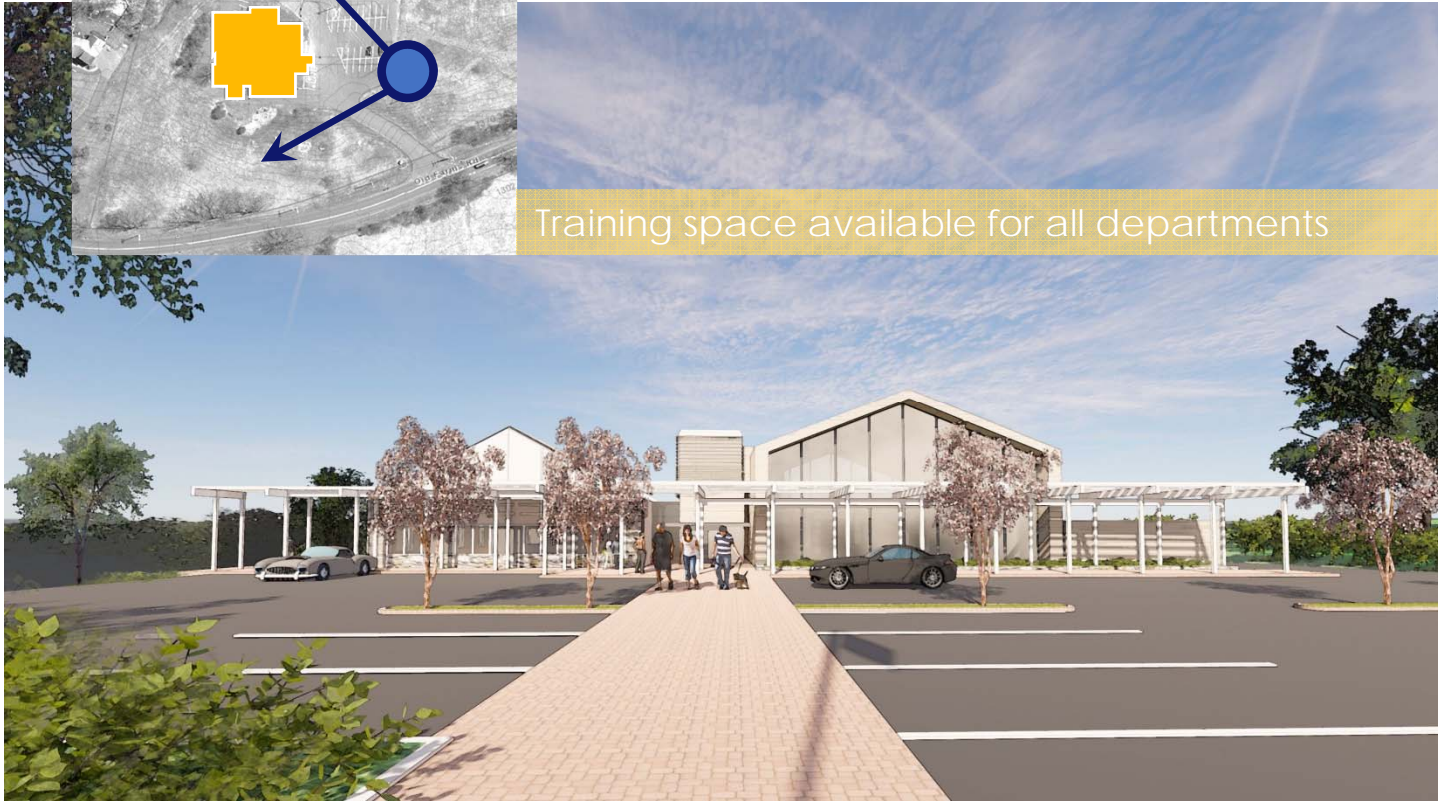
View to North

Training space available for all departments
