Appendix B:

Test Sites

Test Site #1: Post Office Redevelopment

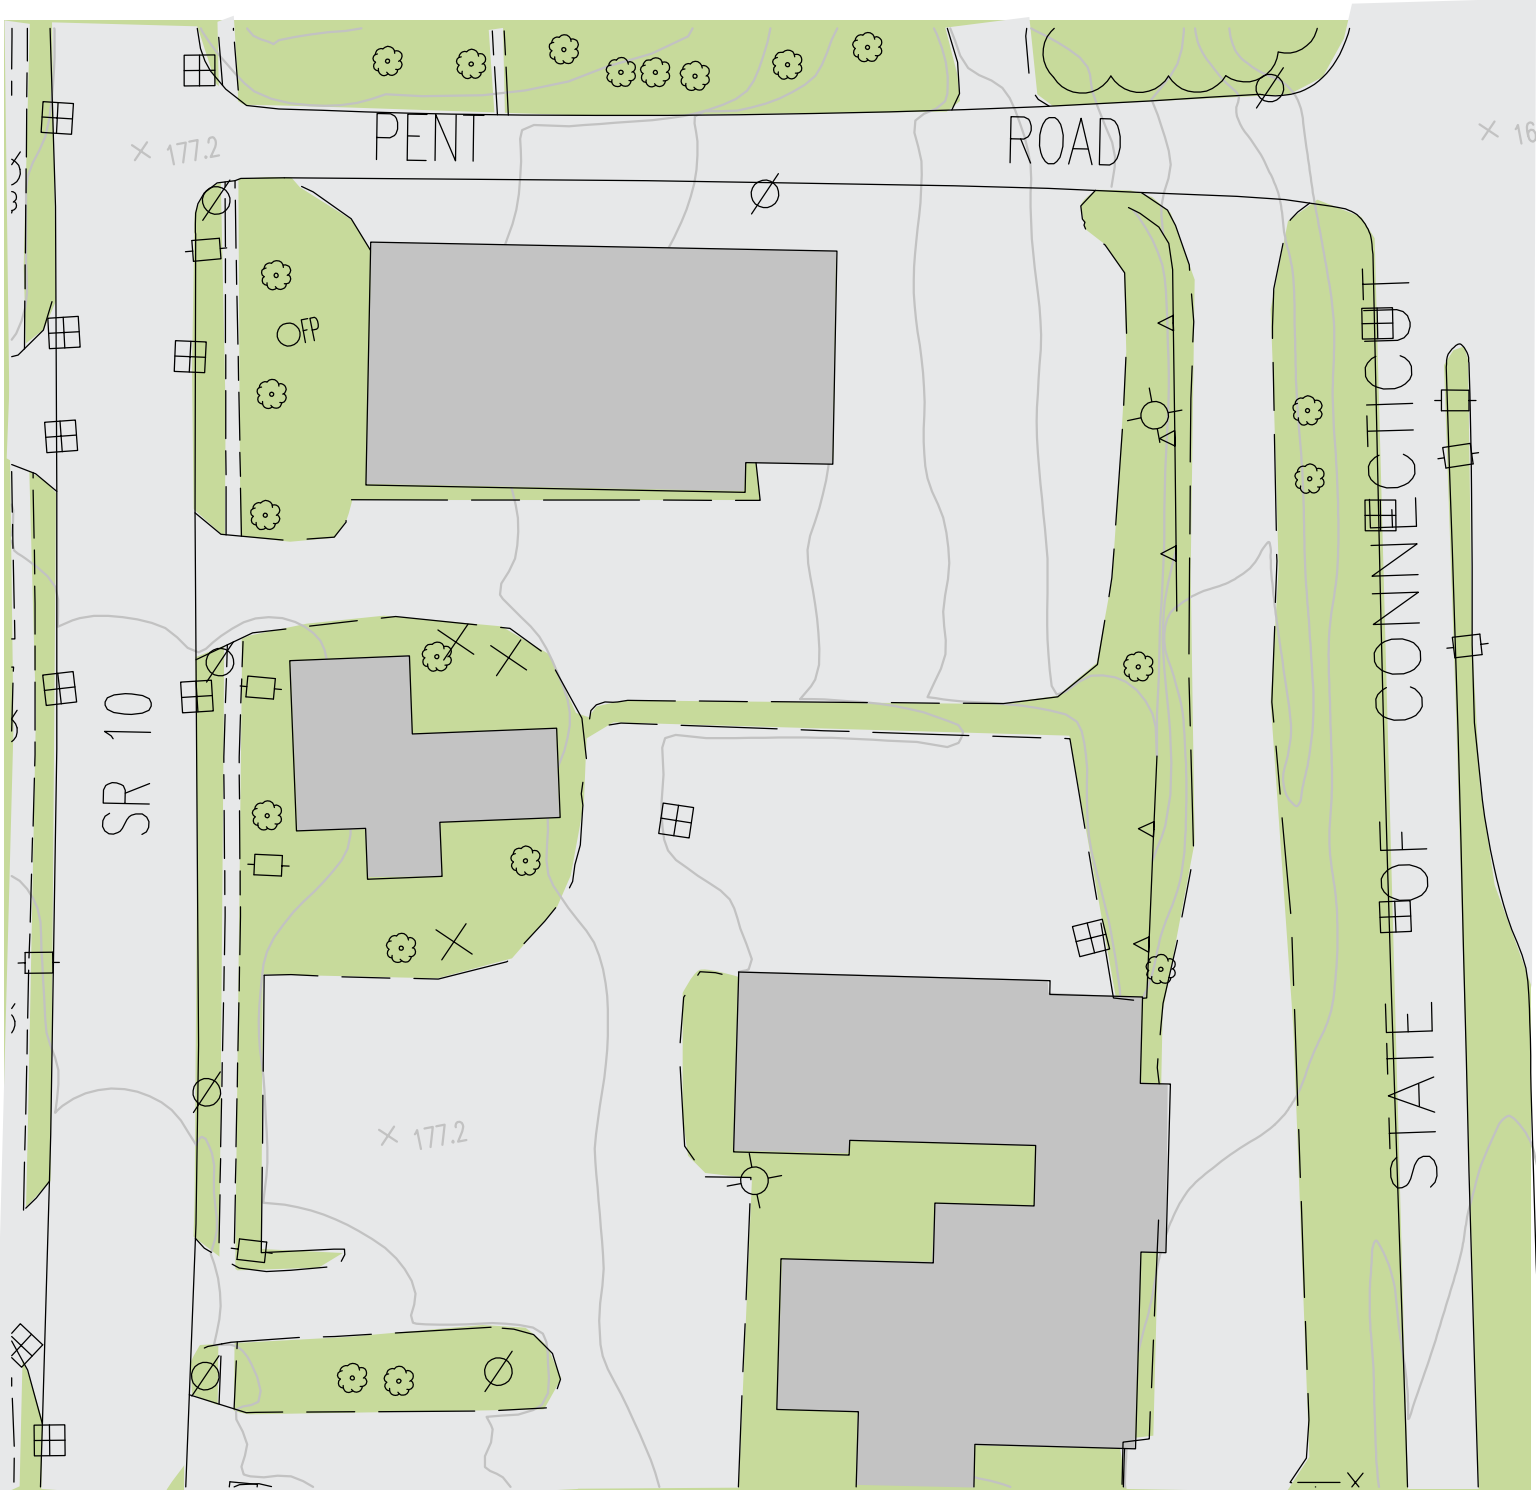
Existing Conditions

<u>Value</u>	<u>%</u>
Pre-Development		
Total Area (sf)	68,000	
Impervious Area (sf)	53,135	78.1%

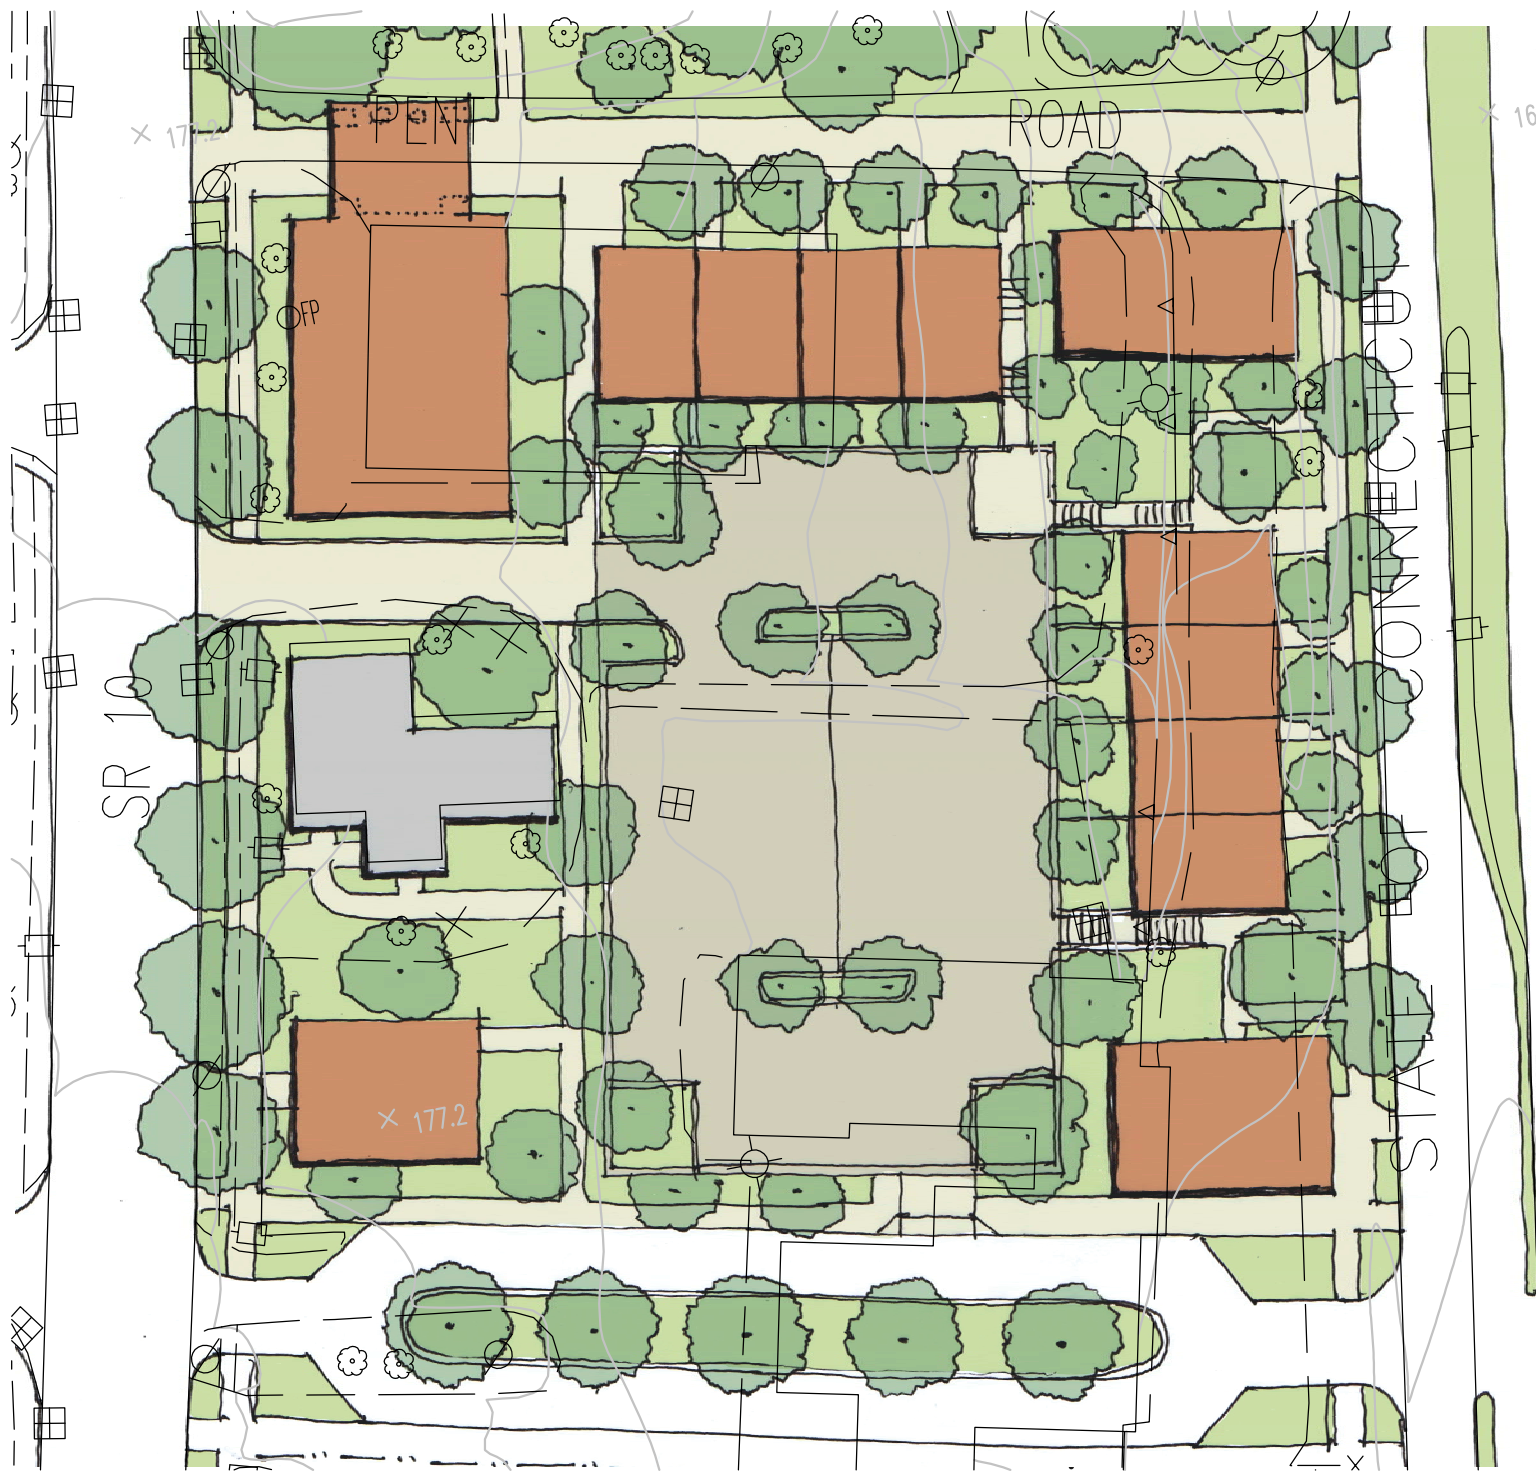
Post-Development Conditions

Value	%	Notes
Pre-Development			
Total Area (sf)	68,000		
Impervious Area (sf)	53,135	78.1%	
Post-Development			
Total Area	68,000		
Impervious Area (sf)	52,880	77.8%	
Redevelopment credit	50%		Existing Impervious Area > 50%
Location-based credit	30%		Simsbury Center composite value

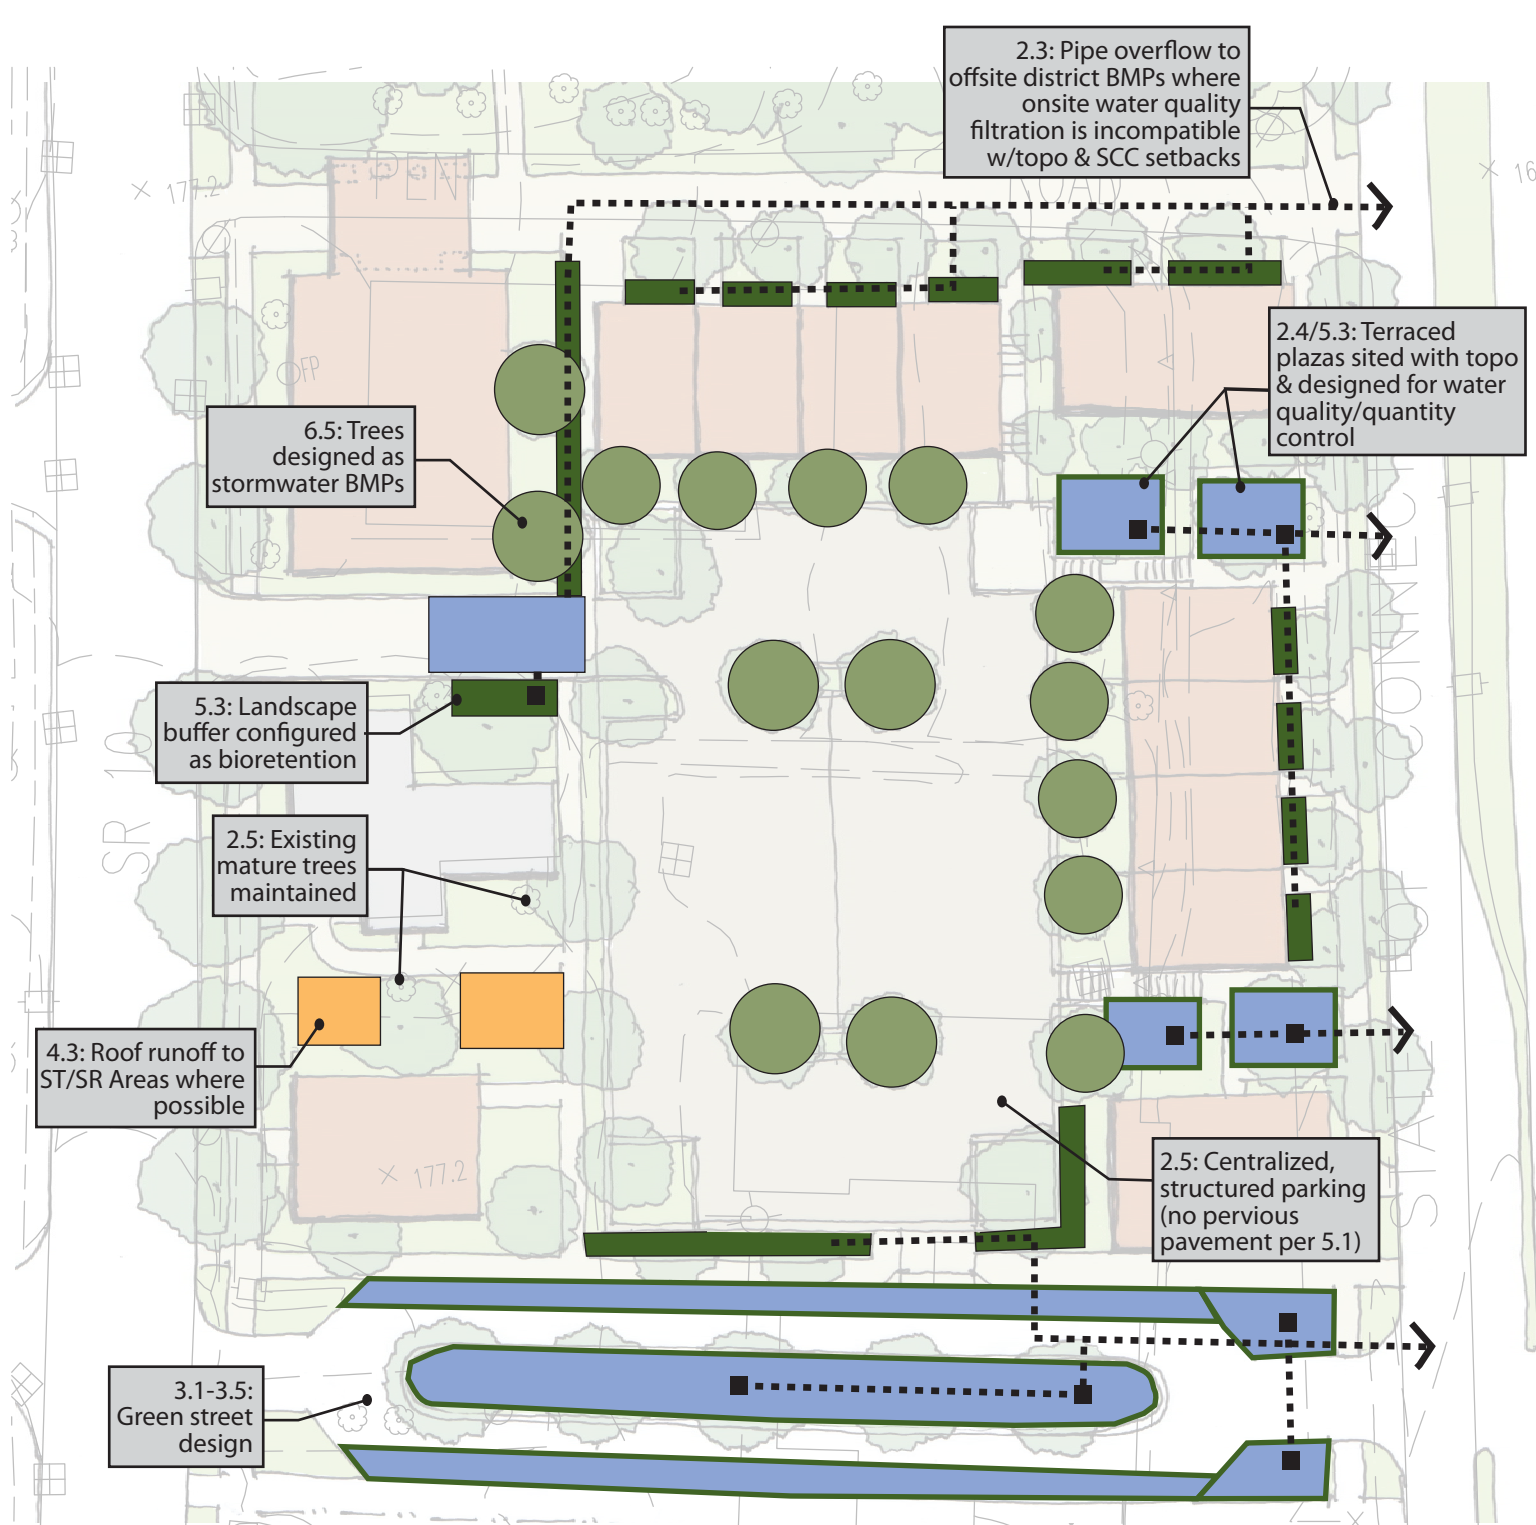
Post-Development Conditions

- Recharge
- Water Quality
- Recharge & Water Quality
- SR/ST Areas
- Tree Credit
- Underground Pipe
