# *Ethel Walker Woods Master Plan Report*

**Additional Subject Parcels:  
Stratton Brook Open Space  
Town Forest Park**

January 2015

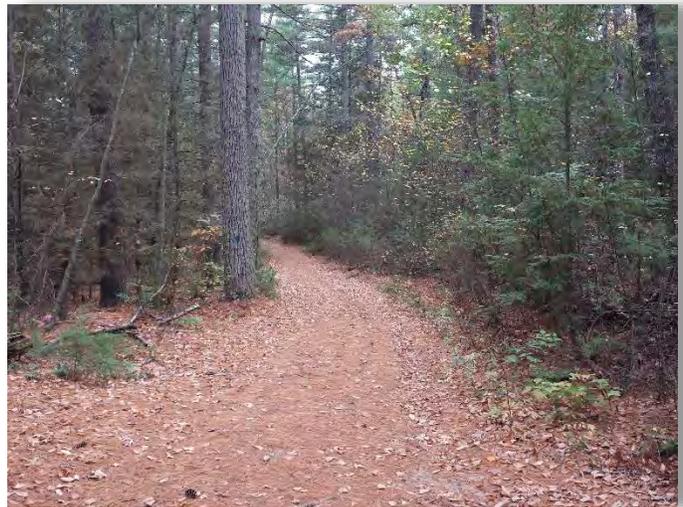
**Typical Trail Condition**

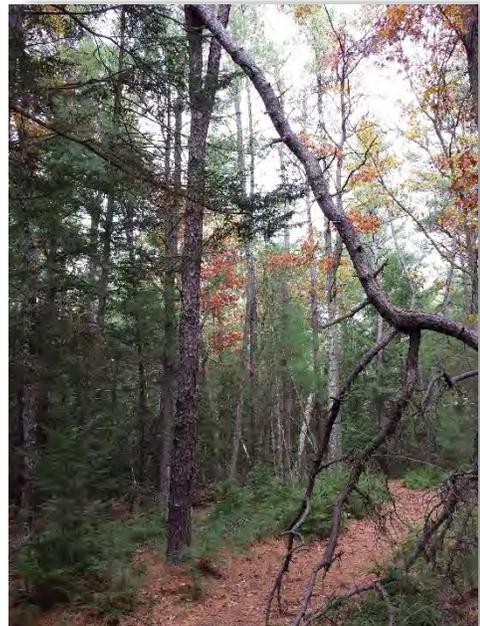
There were very few safety concerns identified within the subject parcels. Most notably, there are a number of damaged trees with overhanging branches that are commonly termed "widow makers" due to their potential to injure trail users by falling on them. These hazardous trees and/or tree limbs are noted on Figure 3. It should be a priority for the town to remove the identified trees. These locations include:

- Two on Orange Trail Segment B
- One on Blue Trail North just east of the Wegner Meadow Trail
- One on Yellow Trail near the intersection with Blue Trail South
- One on Blue Trail North near the Green Trail intersection

**Hazard Tree – Orange Trail**

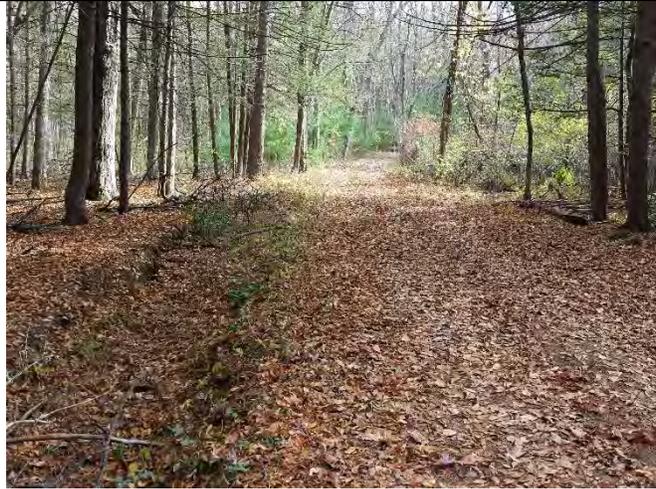
## Blue Trail North

**Existing Conditions:** 15-foot-wide gravel and compact sand road. Primary access trail/road into property and to existing EWS wellfield. Trail is in good, stable condition with some vehicle ruts and wet low-lying areas.

Trail should be considered for modifications to comply with universal trail accessibility guidelines – see Section 13.0.

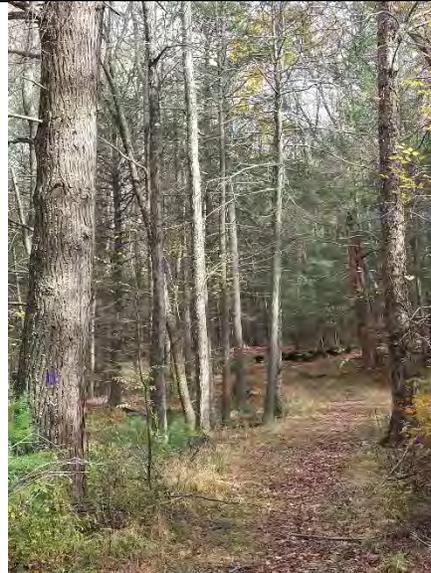
## Purple Trail

**Existing Conditions:** 8-foot-wide trail that is in fair condition. Southern section is uneven, rutted terrain apparently from vehicle use. Intermittent drainage crossing needs improvements.

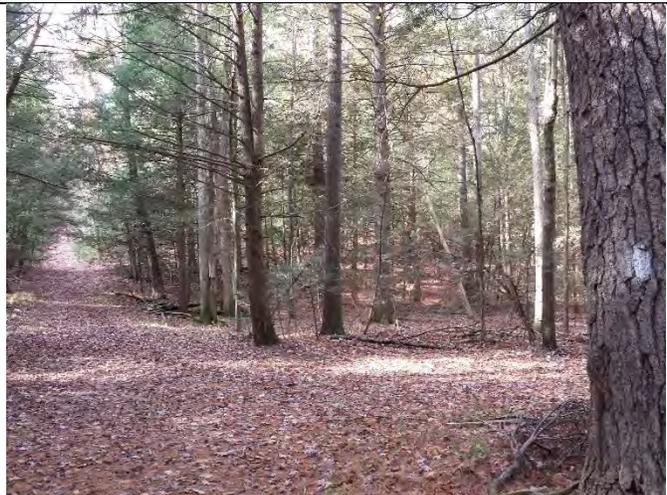
## White Trail

**Existing Conditions:** 8-foot-wide trail that is in fair condition. Trail has steep sections on both east and west ends that have developed rills, gullies, and loose soil due to erosion.

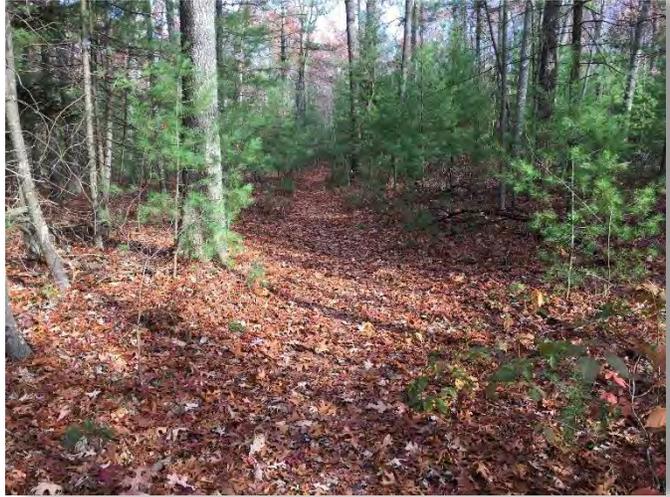
The Stratton Brook Open Space parcel has a few unmarked trail spurs off the main Green Trail, which runs east-west connecting the intersection of Bushy Hill Road and Stratton Brook Road to the Ethel Walker Woods parcel. One feature accessed from the trail spurs is the open field area, which provides a unique area for bird watching. There is the potential to connect to the Farmington River Trail parking area at the corner of Stratton Brook Road and Town Forest Road. This would provide an off-road linkage to the adjacent Farmington River Trail. A bridge crossing would be necessary to complete this connection.

**Unmarked Trail – Stratton Brook Parcel**

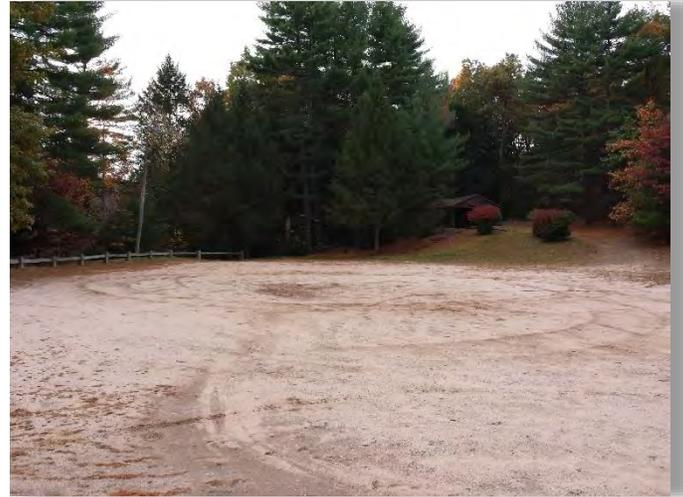
The Ethel Walker parcel is accessible from select locations. The primary site access is from the south side of Town Forest Road from the adjacent Town Forest Park. The south side of the park has a dirt parking area, picnic pavilions, open lawn area, a basketball court, and trailhead map for the Ethel Walker Woods parcel. Across the road to the north is the Town Forest Park swimming area and additional parking. There is additional pull-off parking to the west of the park off Town Forest Road near the Little League baseball field. None of the parking areas are paved or striped making identification of the total number of spaces difficult.

**Town Forest Park South Parking Lot**

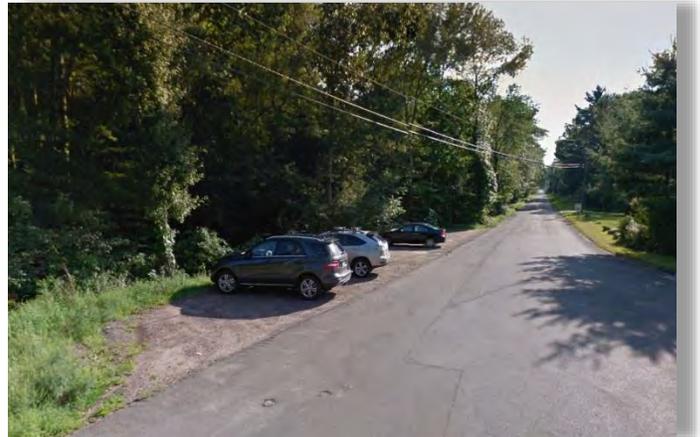
The town also owns a developed parcel adjacent to the Stratton Brook Open Space that could provide future trail connections, parking options, and connectivity to other town and state amenities. This parcel is located at the corner of Stratton Brook Road and Town Forest Road. Currently, there is space for pull-off parking of approximately seven to eight cars. The parking area is currently used for access to the Farmington River Trail but, with trail expansion including a crossing of Stratton Brook, this parking lot could provide access to the Open Space parcel as well. This potential future connection would allow access to the Farmington River Trail, Stratton Brook Open Space, Ethel Walker Woods, Stratton Brook State Park, and Town Forest Park. The challenges to making this connection include crossing Stratton Brook, navigating wet areas along the brook within the Stratton Brook Open Space, and blazing a section for the trail across a state-owned parcel of land.

**Farmington River Trail Parking – Stratton Brook Road  
and Town Forest Road**

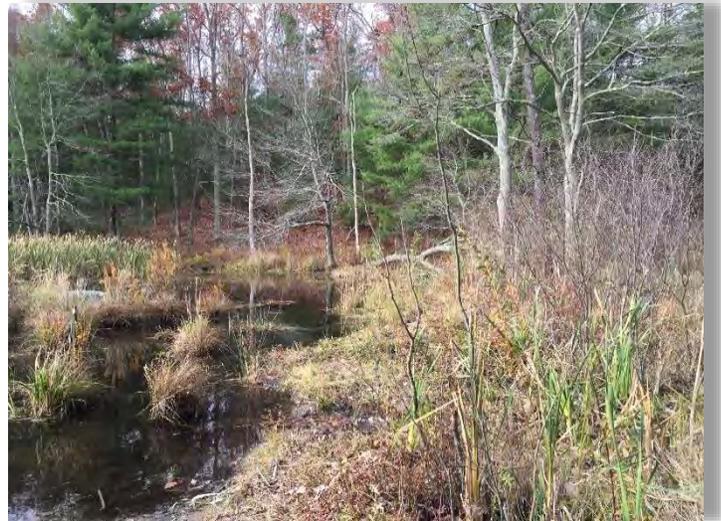
The largest and most significant wetland system on site is Stratton Brook and its tributaries along the western boundary of the site. Stratton Brook has two distinct flow regimes. A portion of the brook is impounded by a former beaver dam. Flow is quiescent here with moderate-sized expanses of open water. The beaver dam has formed an impoundment upstream resulting in the formation of scrub-shrub and emergent marsh wetland habitats. The water is shallow and warm since there is little canopy to provide shade. Although there are no published fishery surveys for this reach of Stratton Brook, it is clearly a warm-water fishery supporting species such as sunfish, grass pickerel, white sucker, brown bullhead, perch, and bass.

**Former Beaver Dam Area with Scrub-Shrub Wetlands**

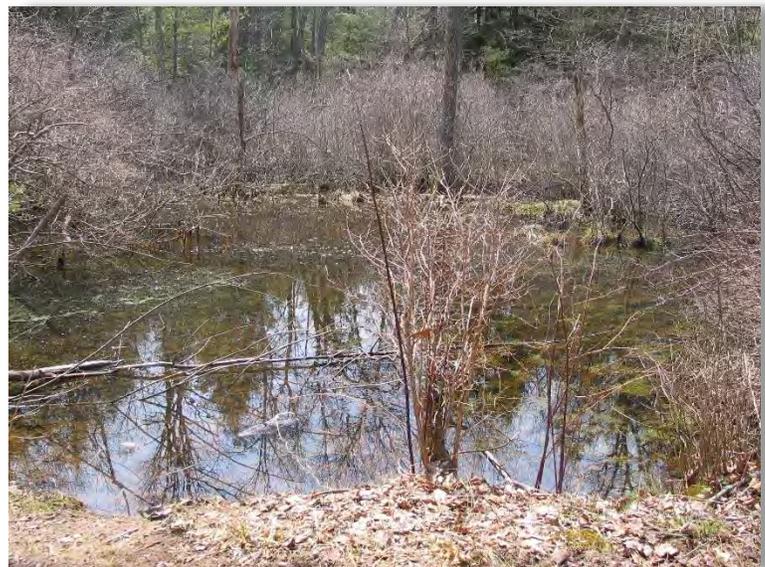
Vernal Pool 7

VP-7 is located in the northern portion of the site and is located adjacent to Blue Trail North. The pool abuts the trail, which acts as a berm. This pool system has two distinct wetland communities associated with it. The northern part of the pool is a scrub-shrub/emergent marsh habitat while the southern part is a shrubby/hemlock forested habitat. Both of these habitats provide high quality amphibian breeding habitat. The scrub-shrub/emergent marsh pool habitat is dominated by shiny winterberry, common winterberry, silky dogwood, buttonbush, and speckled alder. The herbaceous

plants include jewelweed, lesser bur-reed, fringed sedge, water smartweed, and sensitive fern. The forested pool habitat is dominated by eastern hemlock with a moderate density of common winterberry growing within it. Typical species that have been observed within this pool include spotted salamanders, wood frogs, red-spotted newts, green frogs, spring peepers, and odonates.

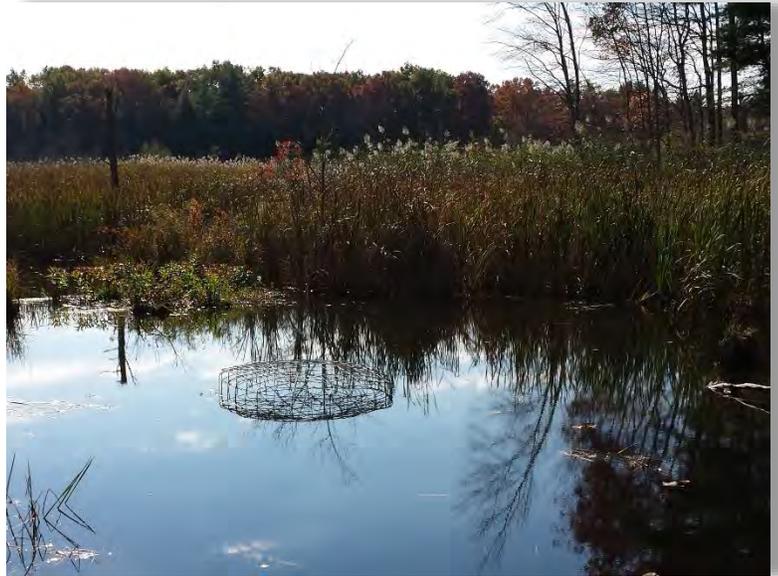
Located just off the Blue Trail within Stratton Brook is a drainage structure installed to allow for continuous movement of water and deter beavers from trying to dam the river. Considered a Best Management Practice for beaver control, the installed device consists of a flexible drainage pipe surrounded in a wire cage. The pipe is installed through the existing beaver dam allowing water to pass through. The cage prevents beavers from being able to clog and dam the inlet and outlet of the pipe. The cage is typically staked to the pond floor with rebar. The continuous flowing water baffles the beaver and, after repeated unsuccessful attempts to stop the flow, the beaver will typically move out of the area.

Beaver Baffle Wire Cage at Inlet

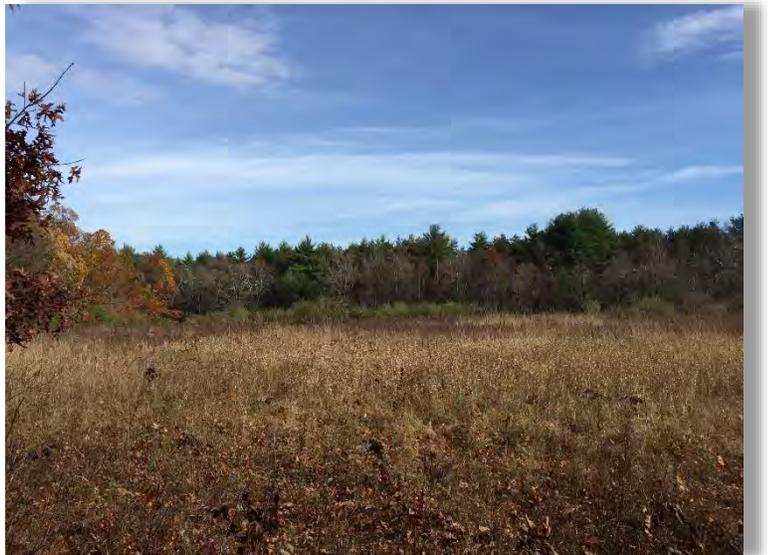
The Stratton Brook open space meadow has not been mowed over the past 5 years as evidenced by the colonization of the meadow by old field plant species. This meadow is classified as an old field with early pioneer plant species dominating the plant community. Goldenrods, grasses, blackberry, common milkweed, Queen Anne's lace, and a variety of other native herbaceous plants are present. Autumn olive, a nonnative invasive shrub, is present in low numbers. The meadow provides a great viewshed for a variety of passerine bird species during both the summer and migratory seasons of the year. Insects are plentiful within this meadow. In order to maintain this meadow's natural character and habitat, an annual mowing management program will be required.

Open Space Meadow

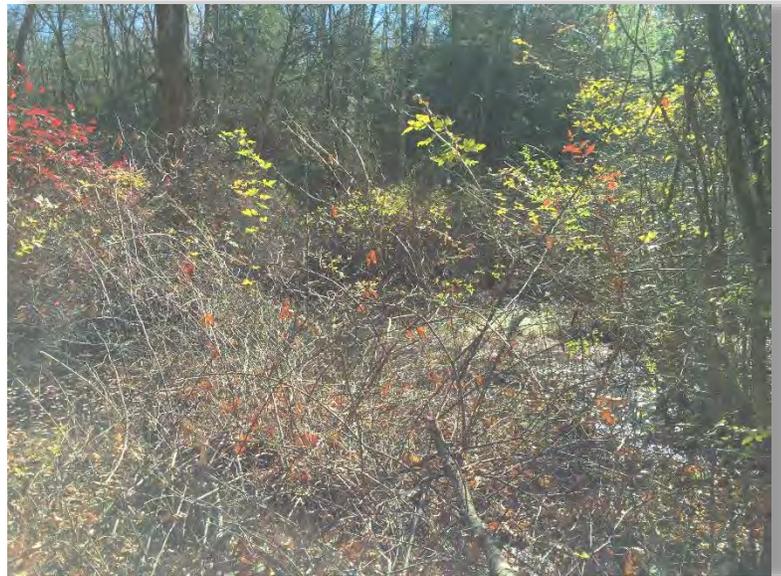
**Multiflora Rose and Japanese Barberry Within VP-7 Wetland**

The forested wetland located near VP-7 is becoming colonized by multiflora rose and Japanese barberry. These species are growing adjacent to the trail and can become a safety hazard to trail users. These plants are also diminishing the aesthetic quality of the wetlands and lowering biodiversity.

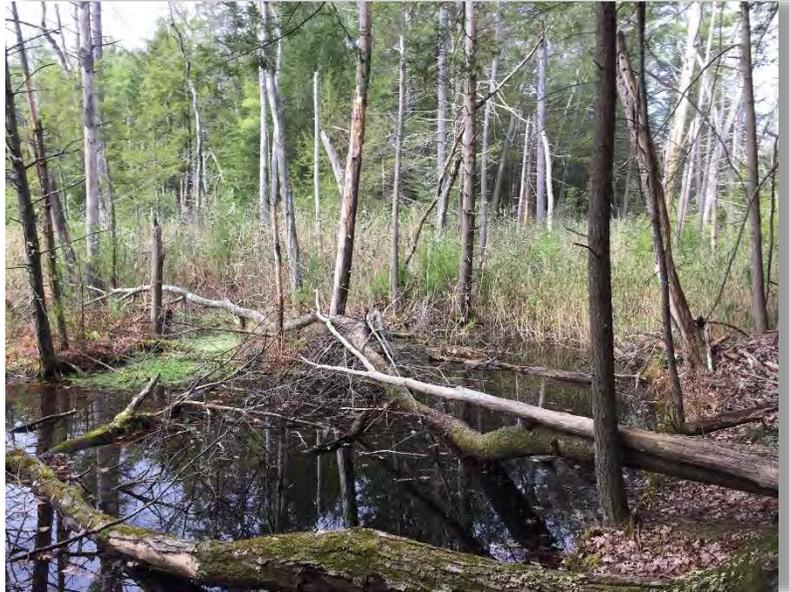
The Stratton Brook Wetland system is heavily infested with common reed. Common reed is an aggressive emergent wetland plant that can outcompete most herbaceous and woody vegetation. The plant forms a dense monoculture community. Common reed can reach heights in excess of 12 feet, which can cause shading that can suffocate the native wetland plants. The resulting dominance of these species typically results in depressing biodiversity (fauna and flora species) within a wetland, often impedes vistas of wetlands, and lowers aesthetic value.

Stratton Brook Wetland System

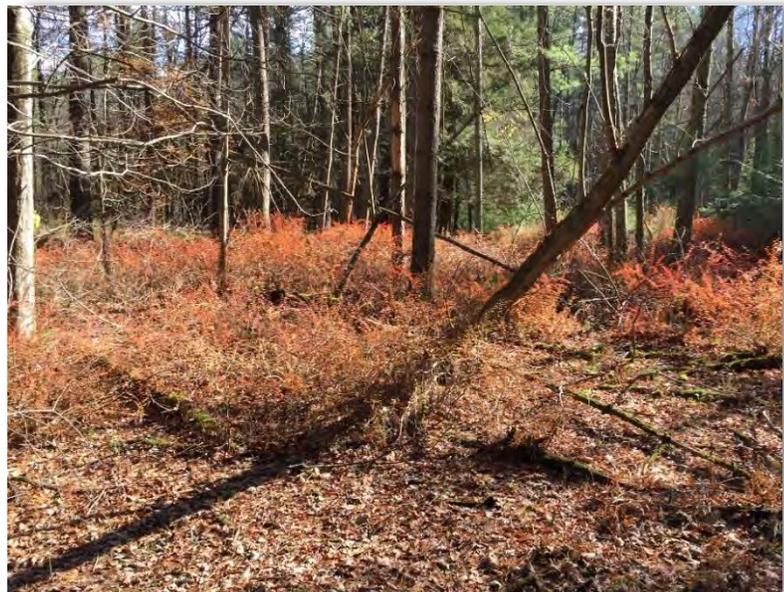
As stated previously, invasive vegetation occurs in relatively low densities on this property; however, there are some areas that have invasive species intermixed within the forested understory. Japanese barberry and multiflora rose are the dominant invasive species found within these forested understories. Japanese barberry is known to provide habitat for a variety of small mammals including field mice and has been known to harbor the carrier of Lyme disease, infected ticks. In fact, the Connecticut Agriculture and Experiment Station (CAES) estimates that eliminating stands of Japanese barberry from forested areas can reduce the number of Lyme disease-infected ticks on a given property by 80 percent. Preventing the further migration and/or spread of these invasive shrubs to other areas on site would decrease the potential for public health issues.

Japanese Barberry Infestation

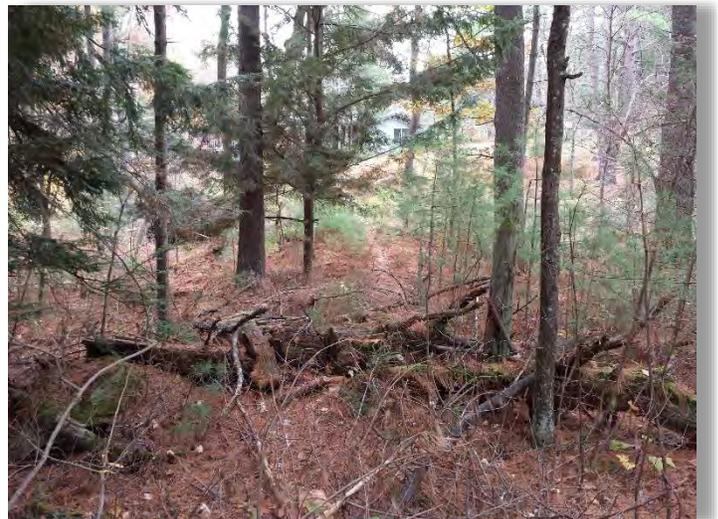
Trail closures should be done by placing brush, branches, logs, and boulders perpendicularly across the trail. Boulders, if used, should be buried by half their height to keep them in place. The soil surface of the closed trail should also be scarified to encourage seedling germination and pioneer plants to become established. If immediate vegetative cover of the closed trail is necessary, a professional should be consulted for appropriate species and implementation strategies.

**Trail Closure with Vegetative Debris**

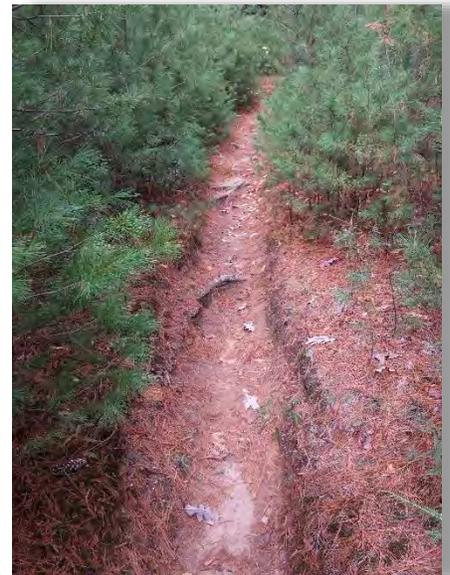
With any system of trails comprised of compacted soil, there is an inherent risk of damage and erosion occurring over time. This risk is increased tremendously if the trails also traverse slopes above 5% in grade. The subject parcels have earthen trails, grades over 5%, fairly heavy use and, in many areas, a sandy soil that can be eroded easily. Due to these factors, established trail building and maintenance strategies should be used to mitigate the risk of damage, trail closures, and increased maintenance.

Example of Trail Erosion

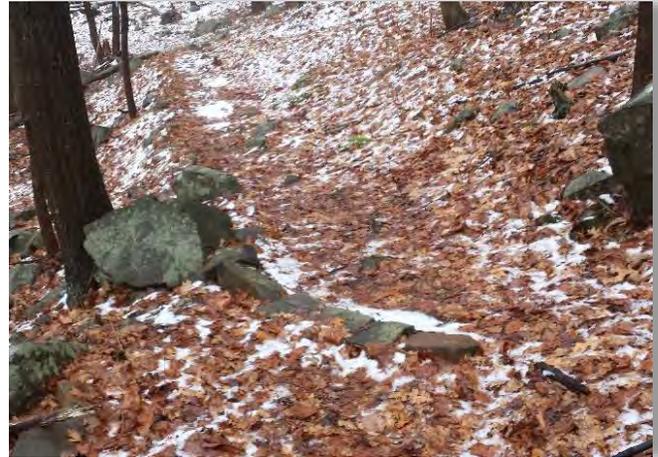
Whenever possible, trails should traverse parallel to slopes. If this is not possible for sections over 100 feet in length, the use of water bars should be considered. Water bars are typically constructed of logs or large rocks. If rocks are used, they must be large enough for three-quarters of their mass to be buried so they do not overturn from use or runoff. The use of water bars is a common practice to slow the movement of runoff and direct it off trails. Water bars can also help users traverse steep trail sections by acting as steps and providing a flat landing. It should be noted that water bars can impede some trail activities such as cross-country skiing and require periodic maintenance to remove built-up debris on the upslope side of the bar.

Example of Boulder Water Bar

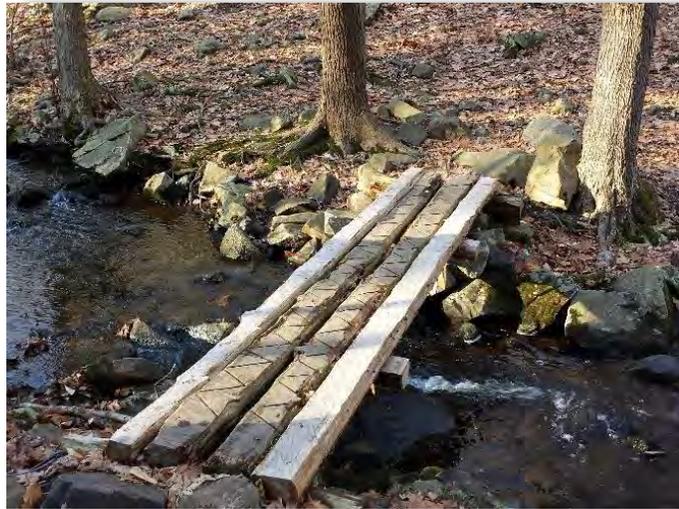
Boardwalk structures should be used in areas where bridges are not appropriate. Boardwalk structures can be simpler than bridges due to shorter distances being spanned and less severe drop-offs. Boardwalks are particularly useful in areas of wetlands where disturbance and fill should be minimized. Construction of boardwalks on designated universally accessible trails should keep gaps in deck boards or logs to no more than 1 inch and ramped transitions between trail and structure surface with no greater than a 2-inch difference in grade between the surfaces.

Example of Log Boardwalk Crossing

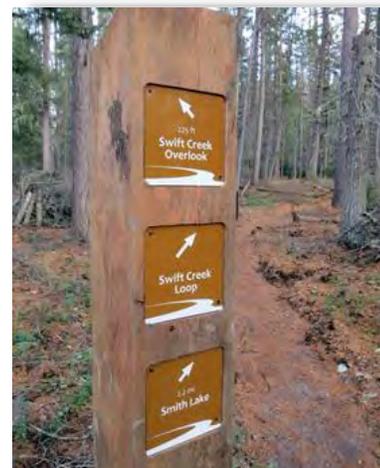
Wayfinding signs should typically be a single wood post with engraved colored lettering or small posted directional signage and trail identification.

Examples of Wayfinding Signage

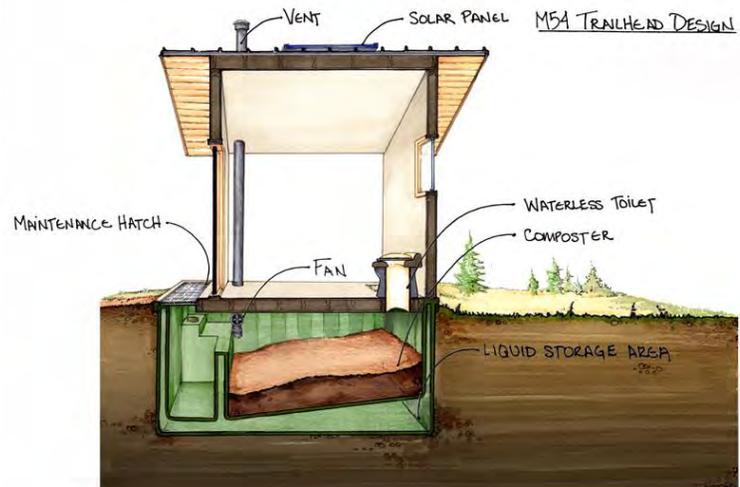
Composting restroom facilities offer a third alternative to providing conventional restrooms. Composting facilities have become a green way of providing restroom amenities. The composting units typically require the installation of a belowgrade composting chamber and an abovegrade toilet and building unit with an air venting system. Access to the belowgrade composting chamber is essential. Having a sloping topography from front to back of the facility is usually beneficial because it allows for personal access to the toilet on the upper level and access to the composting chamber at the lower level without it being buried. These facilities can be considered waterless and do not necessarily have to provide sinks. Maintenance is required including periodic removal of the compost and weekly cleaning of the facility. Maintenance of the composting chamber can be done by the manufacturer or an outside company. The costs associated with the installation and maintenance of this facility would be moderate to high. Comfort for this facility would be considered moderate. Aesthetics can typically be customized from low to high.

Example of Composting Toilet Design

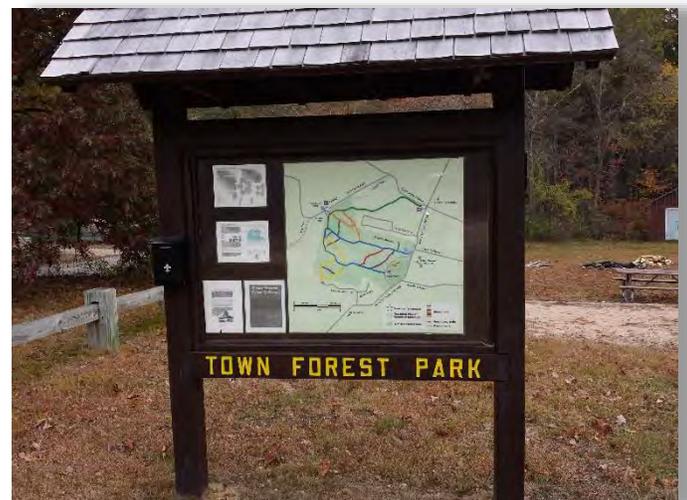
Example of Existing Kiosk

The text above demonstrates the importance of presenting information to arriving trail users so that they know they are at the right location, can orient themselves, and inform themselves of the trail conditions and uses. The kiosk should be located in a highly visible area, and parcel signage should be consolidated as much as possible within one sign structure. Trailhead kiosks for the subject parcels should be consistent in their construction and information they present. The kiosks should clearly present the following information:

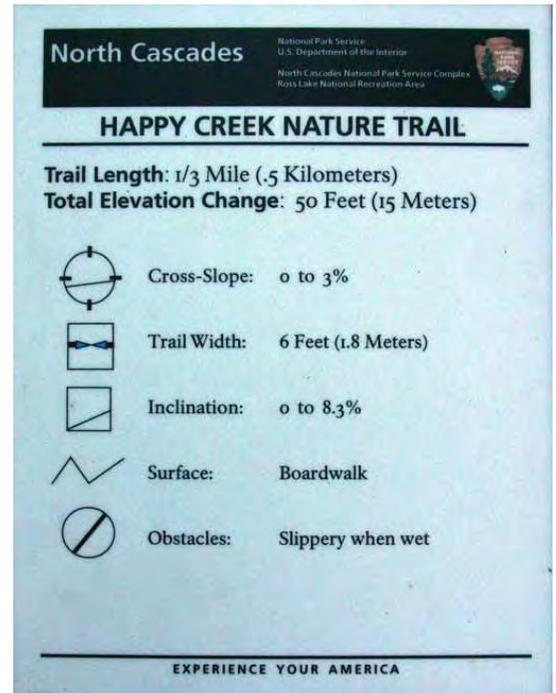
Where more extensive trail information is provided (e.g., an aerial map of the trail and related facilities), the location of specific trail features and obstacles that do not comply with the technical provisions of the accessibility guidelines should be identified, and a profile of the trail grade should be included.

Example of Accessible Trail Signage

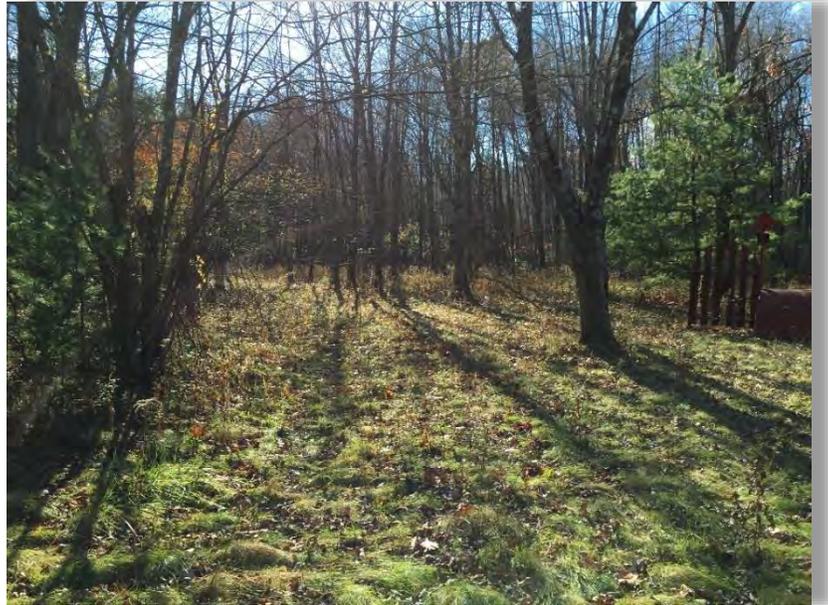
Wegner Meadow, located along the northeastern portion of the Ethel Walker Woods site, formerly served as a meadow and horse jumping area for the EWS. Over the past 10 to 15 years, the meadow has begun to transition into an early successional forested environment with shrubs and tree saplings becoming more dominant. In addition, the lack of maintenance has allowed invasive plant species such as autumn olive, multiflora rose, Japanese barberry, and Oriental bittersweet to become prevalent within the meadow. Early successional native trees and shrubs found within the meadow include white pine, white ash, red maple, black cherry, quaking aspen, grey stemmed dogwood, and silky dogwood. Herbaceous plants are predominantly grasses with goldenrods becoming more dominant.

Existing Conditions Wegner Meadow

Maintenance within the meadow should include the removal and management of the invasive plant species listed above. The following maintenance of this management area shall include:

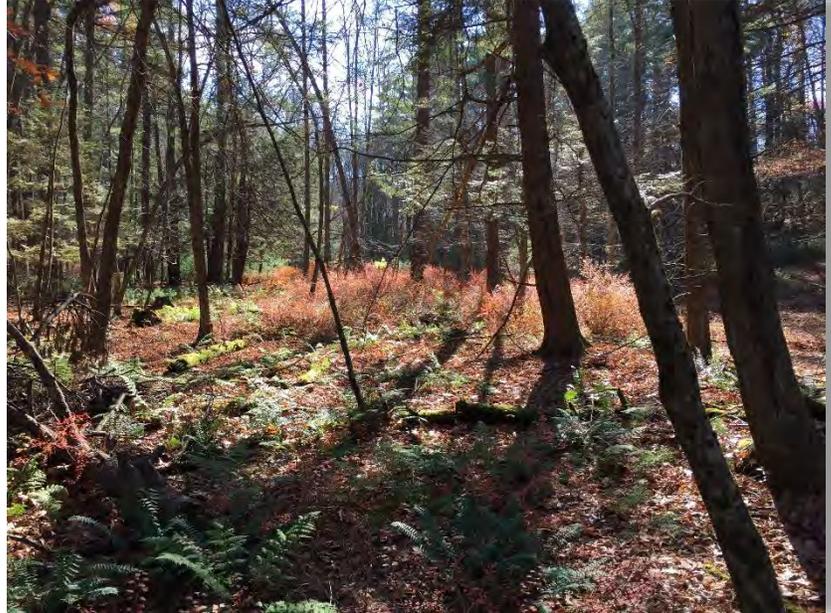
**Invasive Species Management Area #3**

Invasive species management area #3 is located near Yellow Trail along the southern portion of the site. Japanese barberry and multiflora rose are beginning to colonize the understory of the wetlands and uplands within this section of the site. Dense colonies of Japanese barberry may be managed through a variety of control methods including mechanical removal, controlled burning, and/or herbicide. The method is often dictated by the time of year in which the management is being implemented and may include a combination of the methods mentioned above.

If winter management is desired, the town may elect to implement a control burn on the Japanese barberry. Prior to any burning, the town should consult with the local Fire Department and determine whether a burn permit is required. In addition, it is advantageous to mow and/or cut the Japanese barberry shrubs down to the crown. Following cutting, a backpack propane heat torch can be used to burn the crown of the plant. In spring, if resprouting is observed, then the use of a foliar herbicide such as Garlon 4 and/or Habitat can be implemented to finalize the control of the barberry.

Summer management would include the use of a foliar herbicide to be applied to the actively growing portions of the shrub. The foliar herbicide must be applied after periods of heavy sap flow, typically between the months of June and August to be most effective. Repeat treatments may be required.

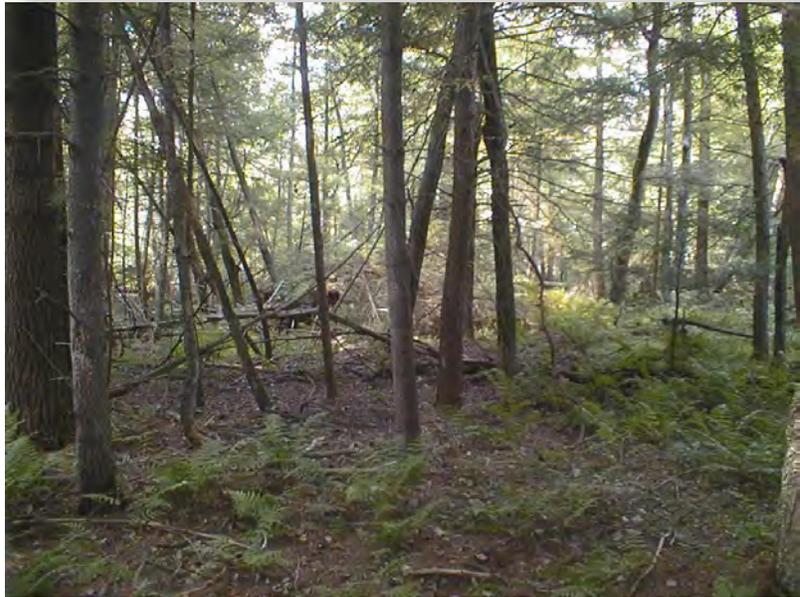
**Invasive Species Management Area #4**

The fourth management area is located within a mixwood forested system and is centrally located on the site. This area is located within a trough/valley setting with large white pine, eastern hemlock, and red pine trees present. The understory consists of ferns that are intermixed within Japanese barberry shrubs. Given the density of ferns, the preferred control method for these areas would be to apply a bark herbicide to the barberry during the winter months followed by an early summer foliar spray to retreat sprouts. This treatment method will reduce the nonselective killing of the ferns that are intermixed amongst the barberry. The following maintenance of this management area shall include:

- Year 1: Herbicide treatment of Japanese barberry during winter months. Use a bark application of Garlon 4 mixed with vegetable oil. Any herbicide use should be completed by a licensed pesticide applicator. Revisit the site during late spring and treat any resprouting with Habitat and/or Polaris.
- Year 2: Monitor management area and retreat actively growing crowns.

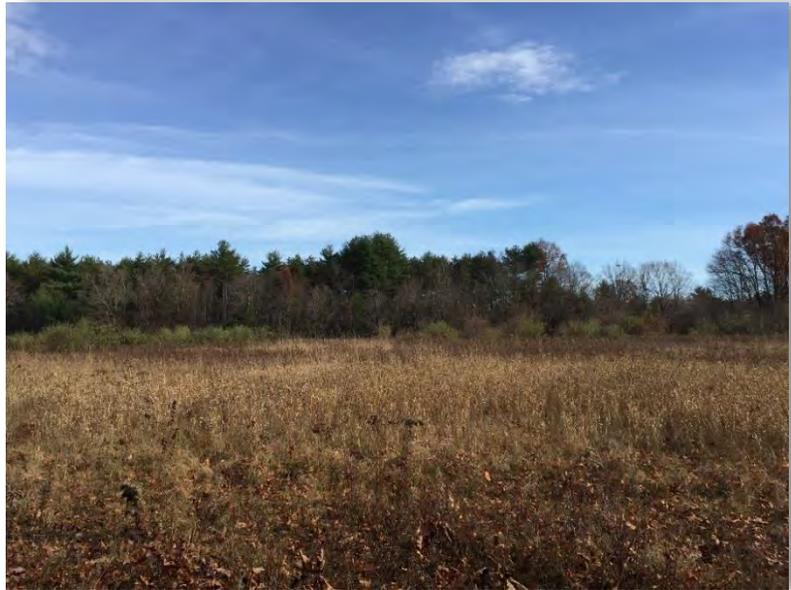
**Stratton Brook Open Space Meadow**

The Stratton Brook open space meadow has not been mowed over the past 5 years as evidenced by the colonization of the meadow by goldenrods and autumn olive. This meadow can be restored to provide valuable grassland bird habitat as well as hay. The recommended management approach includes the mechanical removal of the autumn olive shrubs (branches and roots) using a small excavator. The remaining meadow should be tilled under and then reseeded with a meadow seed mix/hayfield seed mix. The town should query local farmers to determine whether a hay lease can be established to allow the field to be under an active mowing plan. Any mowing (i.e., haying) must be completed after mid August when meadow bird species no longer have any ongoing breeding within the meadow. The following maintenance of this management area shall include:

- Year 1: Removal of autumn olive and other shrubs by small excavator. This shall include the removal of all branches, crowns, and roots. Following removal of shrubs, till under existing herbaceous vegetation and prepare the site for reseeding using a meadow mix/hayfield seed mix. This seeding should be completed during the spring months (April/May). Mow field during September.
- Year 2: Monitor for invasive shrubs and herbaceous vegetation. Complete annual mowing after mid August and continue this mowing schedule on an annual basis.

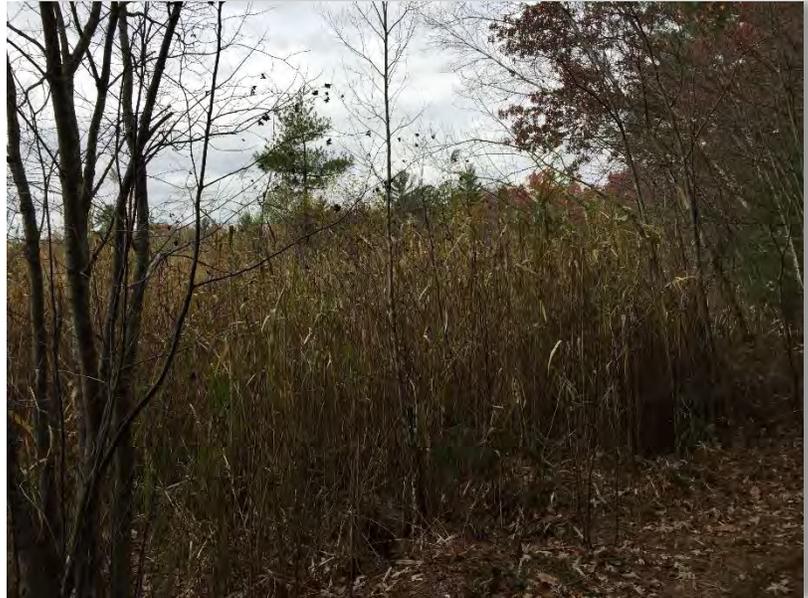
The Stratton Brook wetland system is an important resource within the Ethel Walker Woods site; however, over the past 10 to 15 years, common reed (*Phragmites australis*) has aggressively colonized a majority of the wetland system. The common reed has intermixed with the forested wetland, scrub-shrub wetlands, and emergent wetlands along this corridor. Its spread and colonization continues to reduce the biodiversity of this important wetland system. Managing the vast colonization of this specie within the Stratton Brook wetland system may be a difficult task. *Phragmites* is most effectively managed using herbicides, specifically Habitat and/or Polaris.

Wall of *Phragmites* Along Blue Trail

However, these herbicides are nonselective and will kill other native vegetation that may be in close proximity to the *Phragmites*' rhizome system. Therefore, the management of the *Phragmites* must be carefully planned and requires specialized equipment and expertise to complete the management of these plants. A Marshmaster-type apparatus will be required to treat and manage this species. MMI recommends that the town implement management of this species on a small scale. The goal for managing the *Phragmites* is to provide some primary viewing locations of the Stratton Brook wetland system and help increase biodiversity. If the small-scale management area is successful, the town may wish to expand its management to a broader scale within the corridor. The following management of the Stratton Brook wetland system shall include:

- Year 1: Herbicide application to be completed during August/September when *Phragmites* has formed its tassels. Apply herbicide Habitat and/or Polaris to actively growing vegetation. Herbicide will need to be applied using a Marshmaster unit. After the first hard frost, the treated *Phragmites* should be cut and the cut stems left in place to decompose.
- Year 2: During May and June, retreat actively growing *Phragmites* with herbicide.
- Year 3: Continue to retreat actively growing *Phragmites*. Additional treatments may be required, and expansion of the managed area must be evaluated.

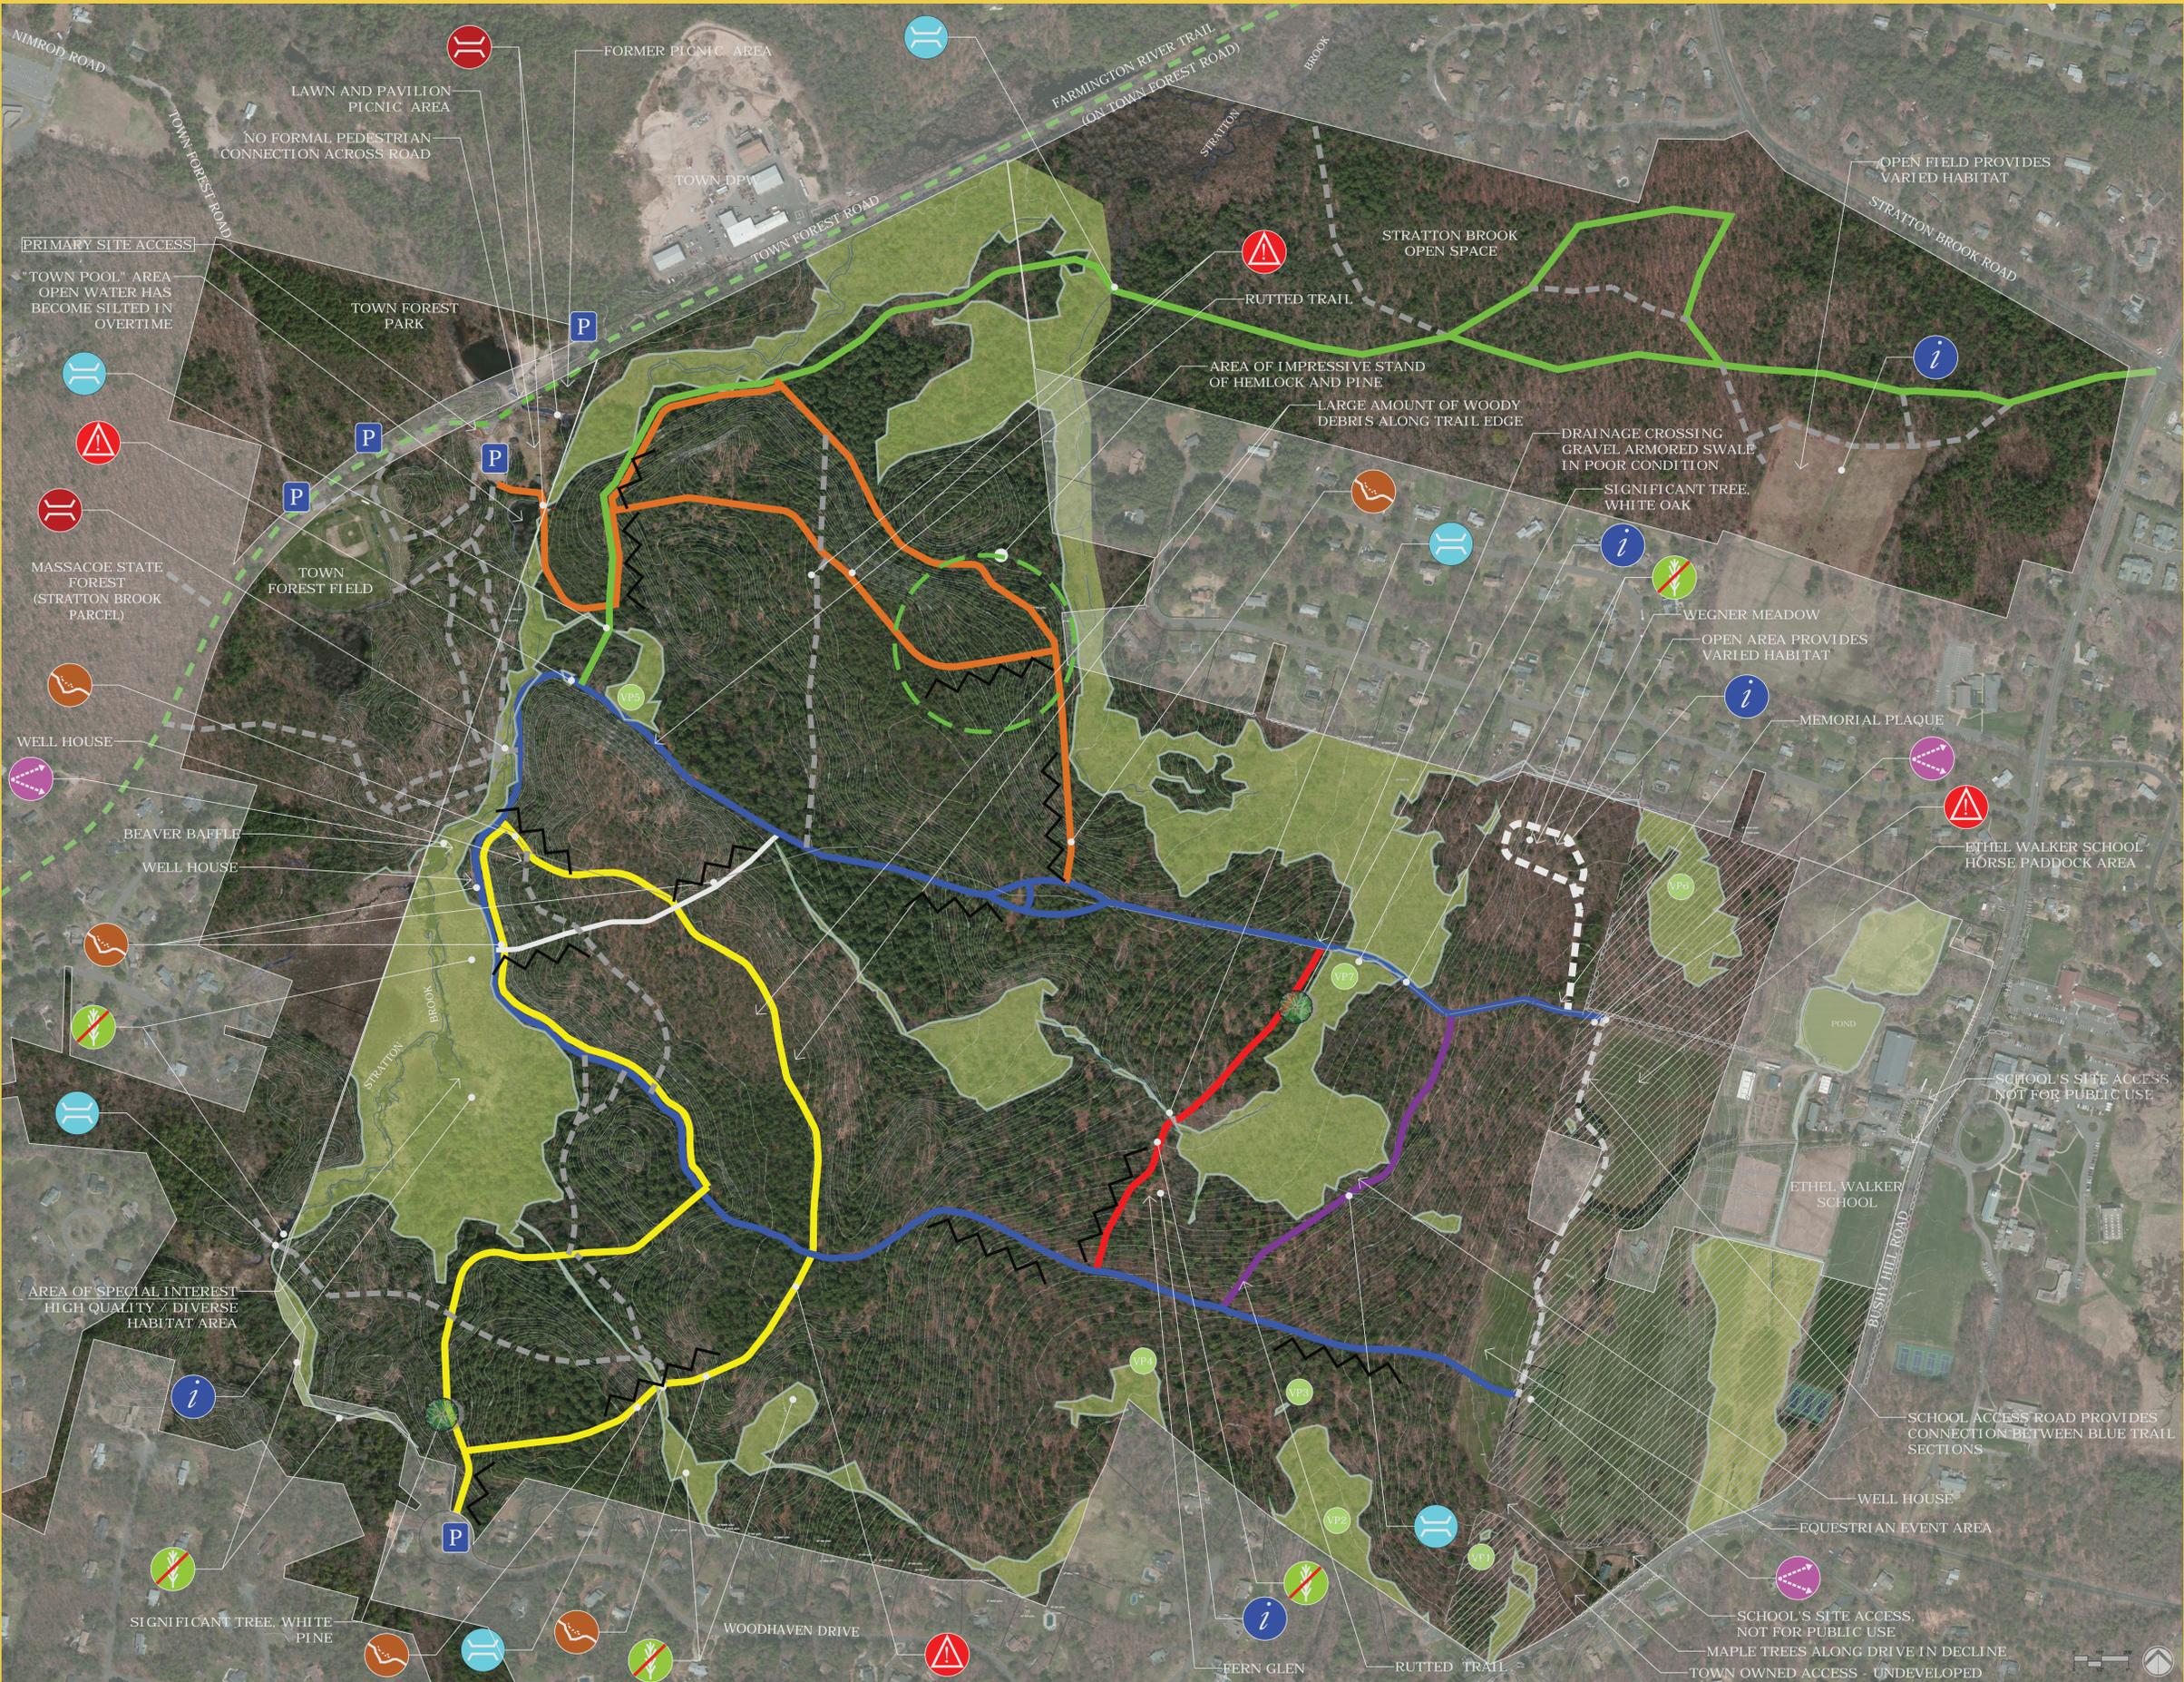
Figure 2

Prior to completing its field investigations, MMI developed a trail field evaluation form to help assess the safety, quality, and function of each of the trails located on the parcel. A sample of a completed evaluation form is appended to this report for reference. In addition to mapping the existing trail networks within the Ethel Walker parcel, MMI's team extended its trail mapping to the adjacent Stratton Brook Open Space and Town Forest Park. The trail networks are illustrated in Figure 2.

Existing Trail Map

The Orange Trail has two potential locations for closure and rerouting due to steep slopes over 5% and the associated erosion issues. These locations are on the east end of Orange Trail Segment B and the south end of Orange Trail Segment C as shown on Figure 2.
