**Freshwater Mussel Survey in the Farmington River for  
Proposed Bank Stabilization in Simsbury, Connecticut**

**WMC Consulting Engineers**

September 2014

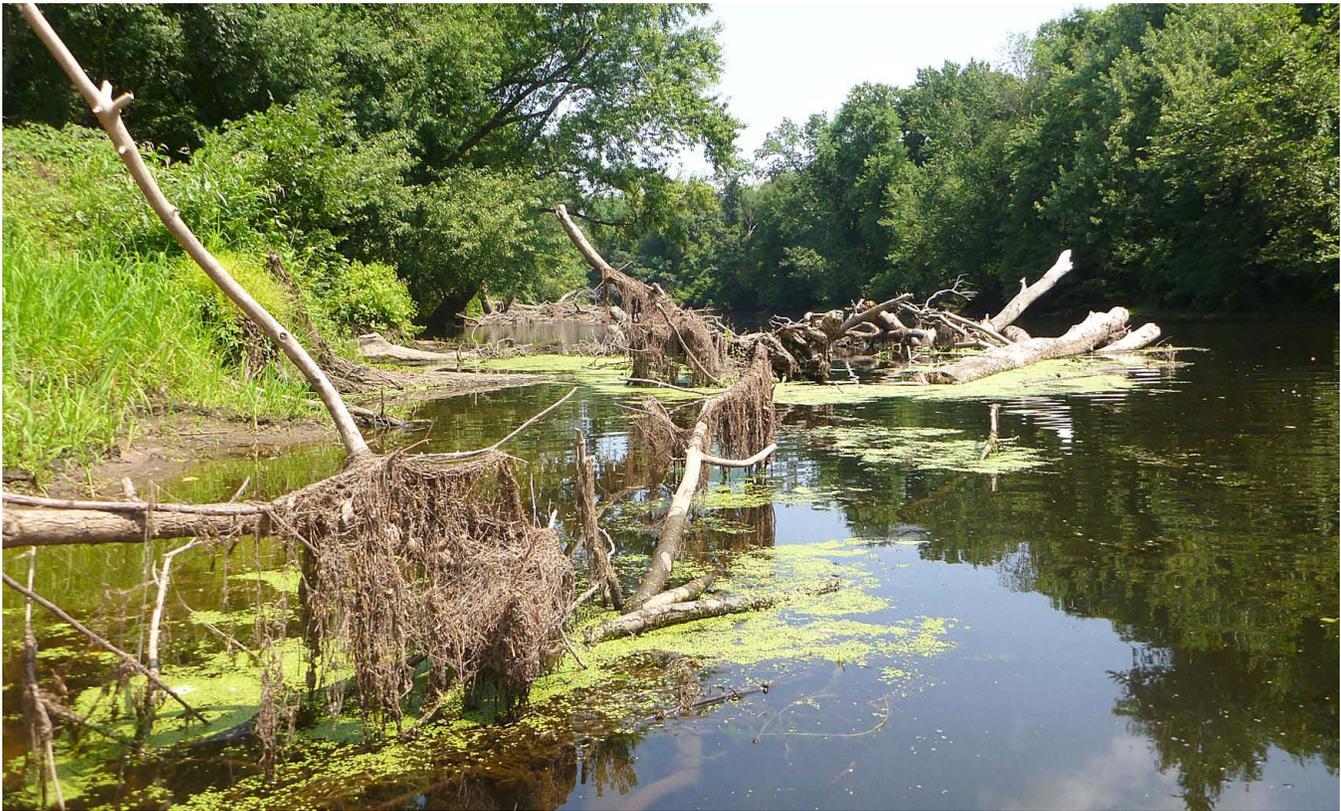
Part of the mussel survey area in the Farmington River, where bank stabilization is proposed.

Within the project area, prevalent habitat conditions included silt substrate, large amounts of woody debris, and patches of dense aquatic vegetation. Sand, gravel, and cobble increased away from the riverbank, and the center of the channel was mostly sand. The potential relocation site had less silt and woody debris, higher amounts of gravel, slightly stronger flows, and overall provided better mussel habitat than the project area.
