Memorandum: Brush Clearing for FBI Investigation – Iron Horse Boulevard

Simsbury Meadows
Iron Horse Boulevard
Simsbury, Connecticut

Photographic Log and General Description of Existing Vegetation

Project Assignment:
 Document existing conditions prior to vegetation clearing.

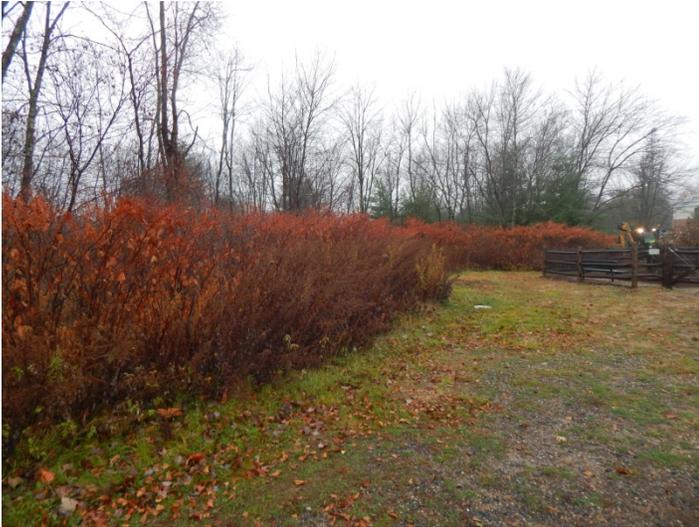
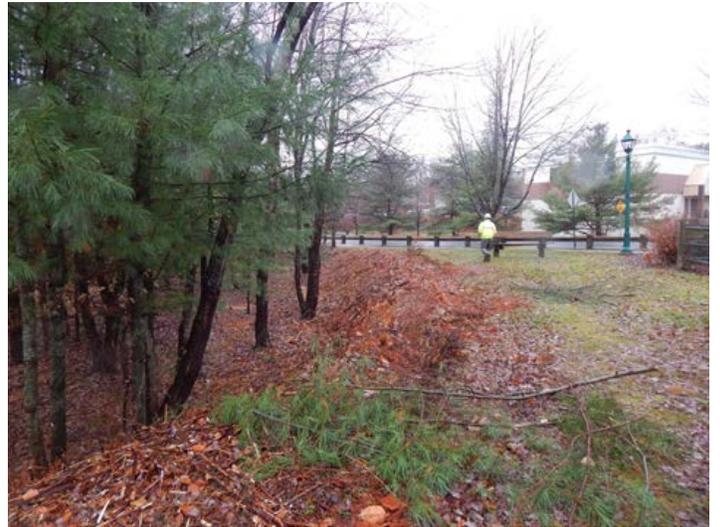
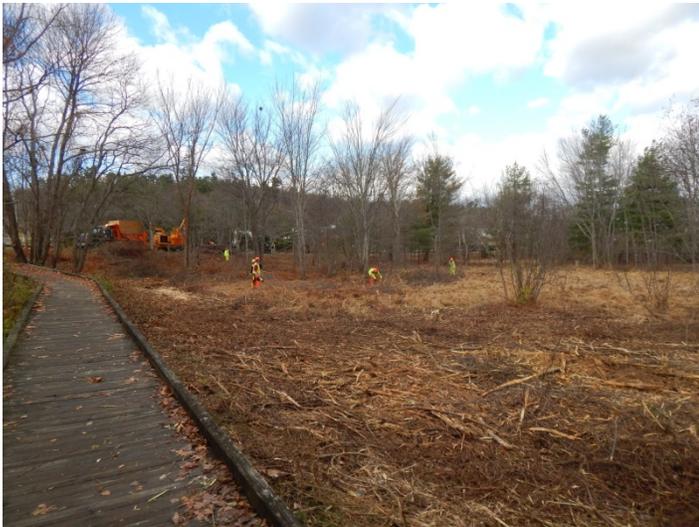
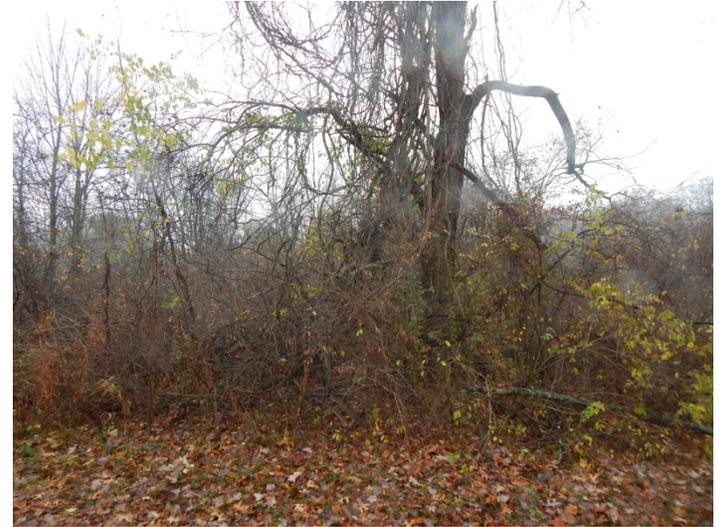
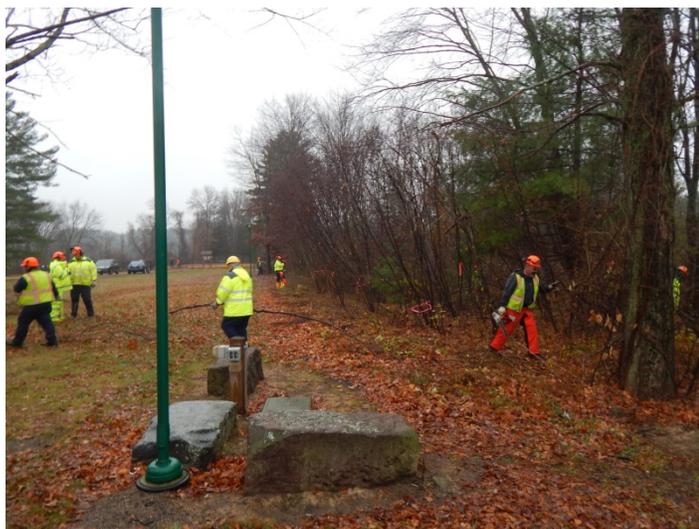
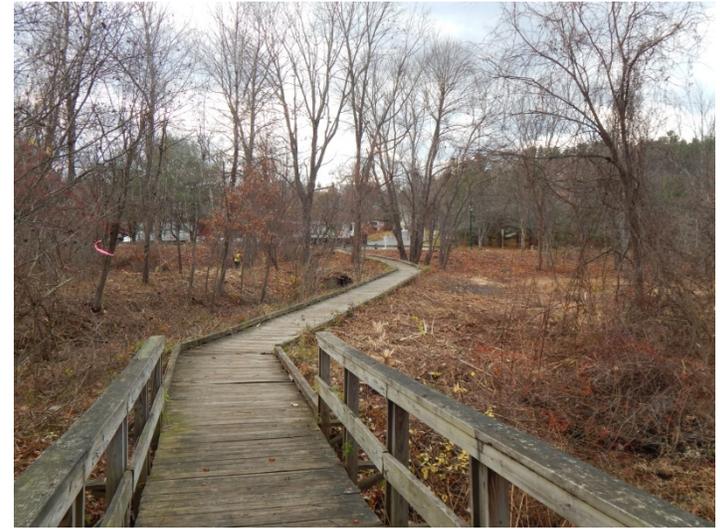
We worked to balance the needs of the environment with the necessity to conduct a thorough investigation into the murder that occurred in this area over a year ago. I have included a number of photos to help document the work that was completed and I have attached the report from Roger Gibson. I am available to answer any questions you may have on this work.

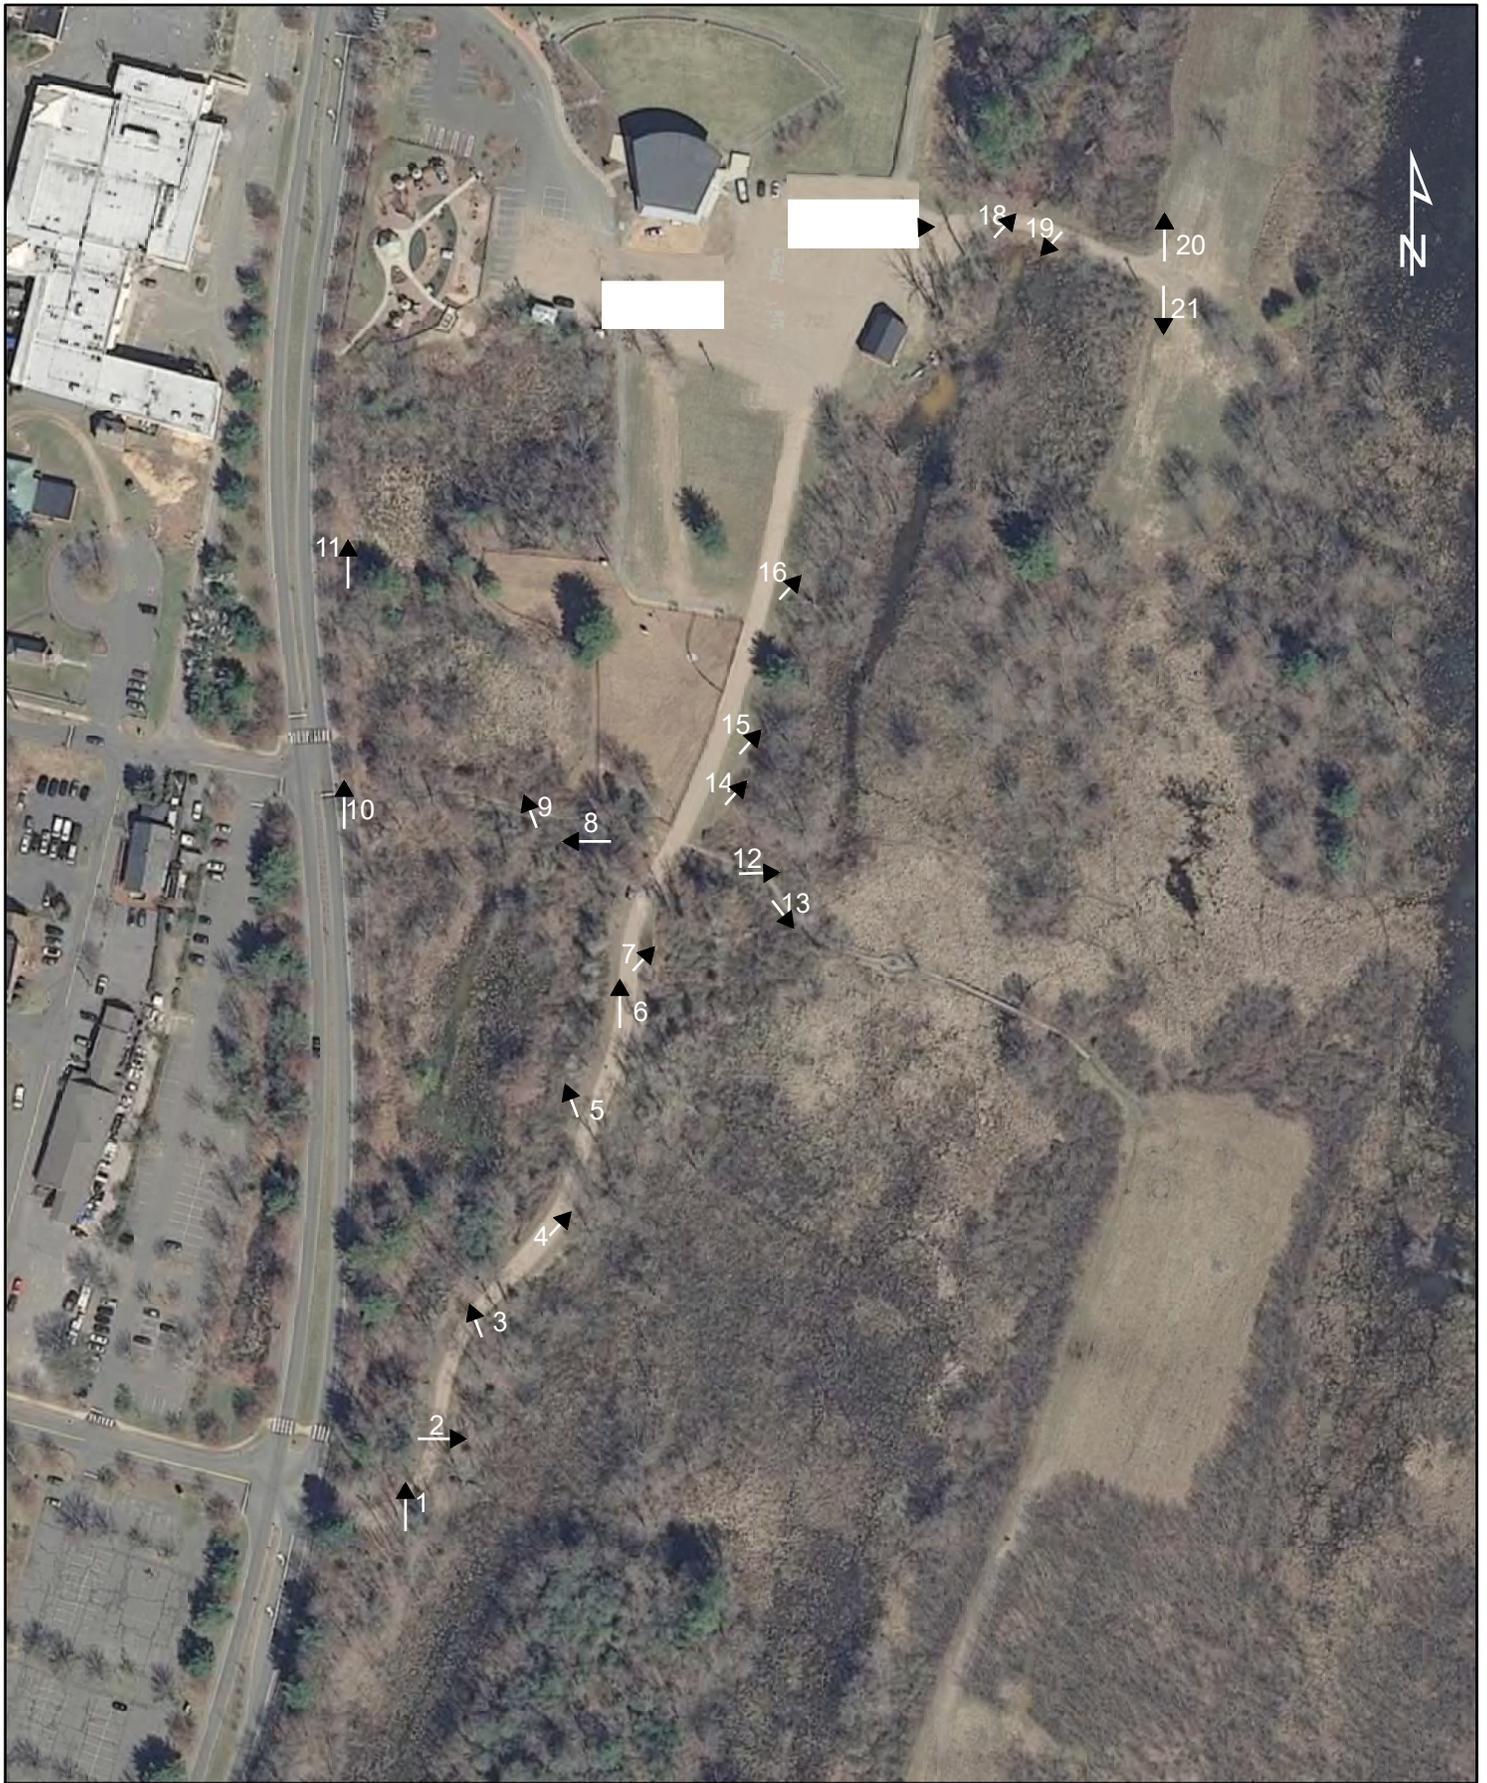
The following pages include an aerial of the site indicating the study area with the numbered observation areas photographed and accompanies the included photographic log.

↑ 1 Photographic # and direction

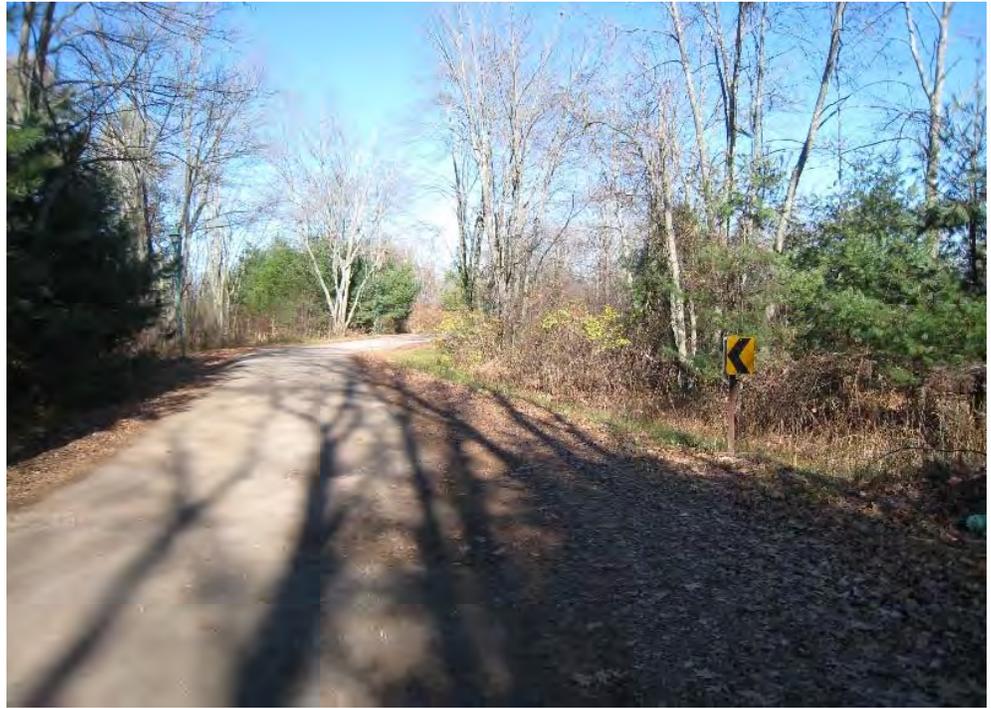
Photo No. 1 **Date:** 11/19/2015

Direction of Photo Taken:
 North

Description:
 Area bordering wetland on both sides, East and West, consisted of the evergreen white pine, *Pinus strobus* and other miscellaneous trees. Invasive vegetation was found to have dominated much of the area that was previously filled along the park's roadway. This included honeysuckle, multiflora rose, autumn olive, oriental bittersweet and japanese knotweed.

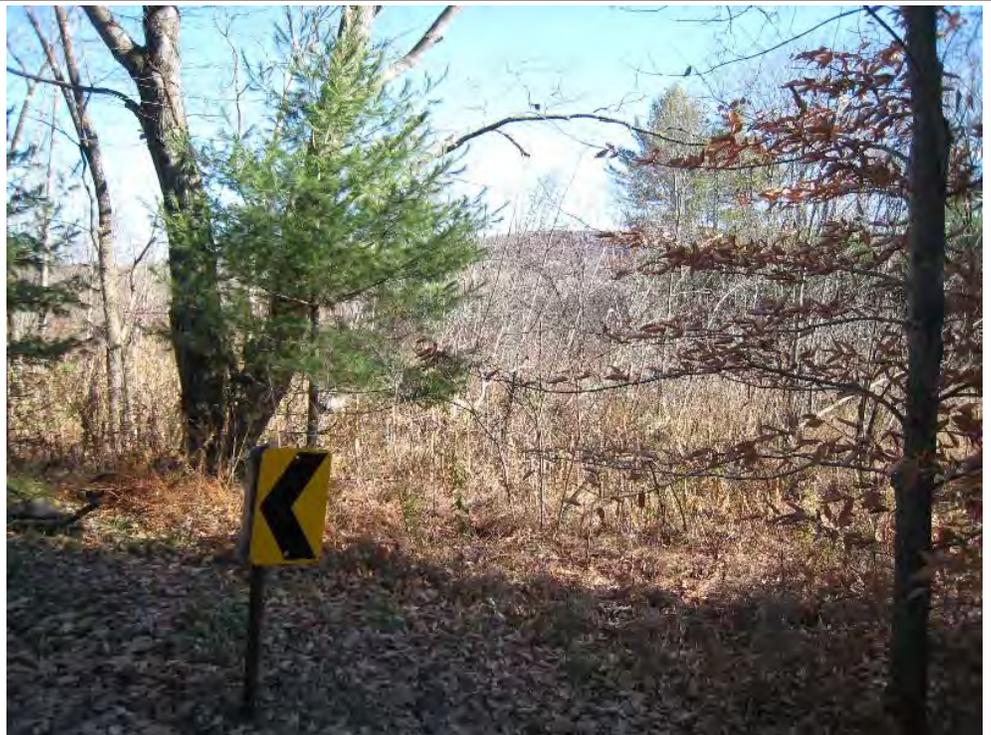
Photo No. 2 **Date:** 11/19/2015

Direction of Photo Taken:
 East

Description:
 Upland fill area bordering cattail swamp. View from park road, see aerial for location and direction.

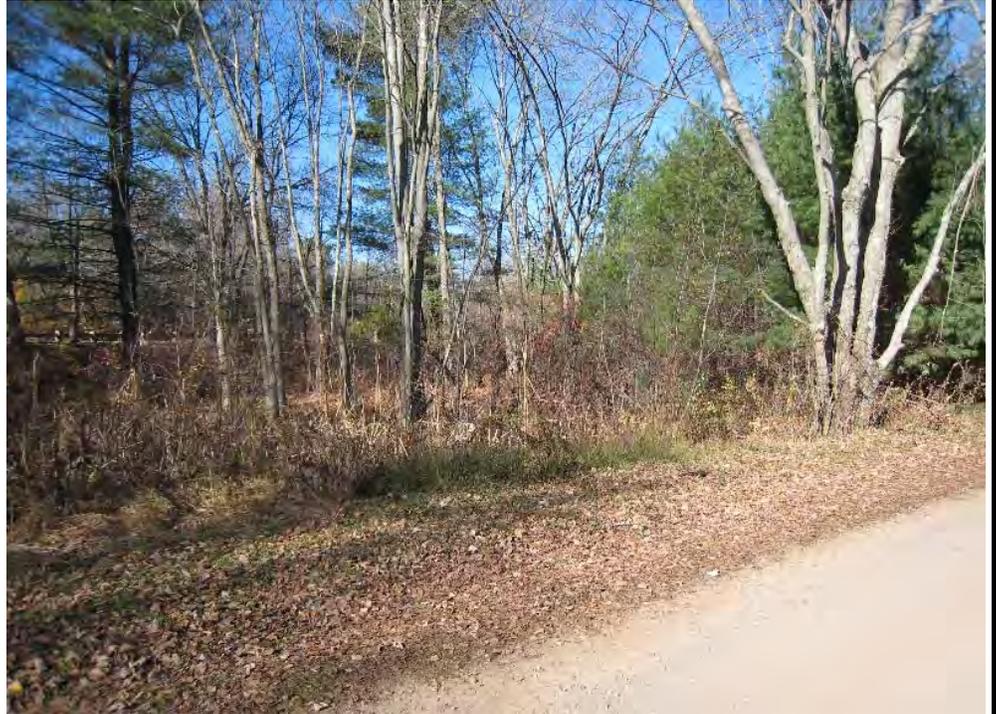
Photo No. **Date:**
 3 11/19/2015

Direction of Photo Taken:
 Northwest

Description:
 View on the other side of the park road with cattail shown in wetland area.

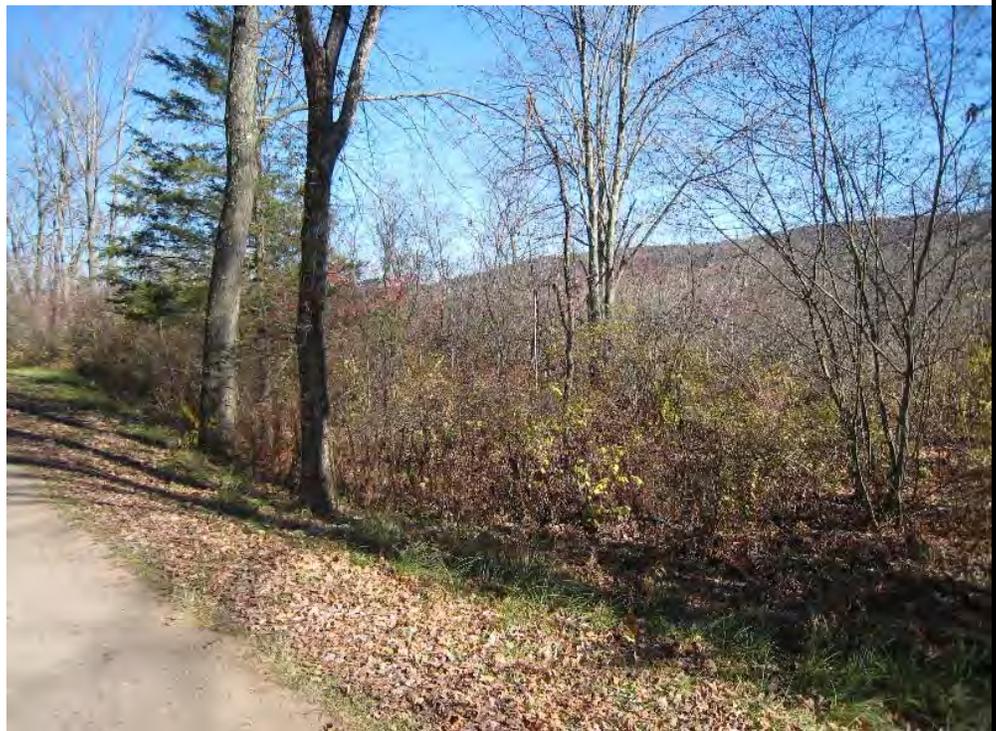
Photo No. **Date:**
 4 11/19/2015

Direction of Photo Taken:
 Northeast

Description:
 Winterberry (*Ilex verticillata*) and Alder (*Alnus serrulata*) were found as shrubs of ecological importance in this area along with several invasive species.

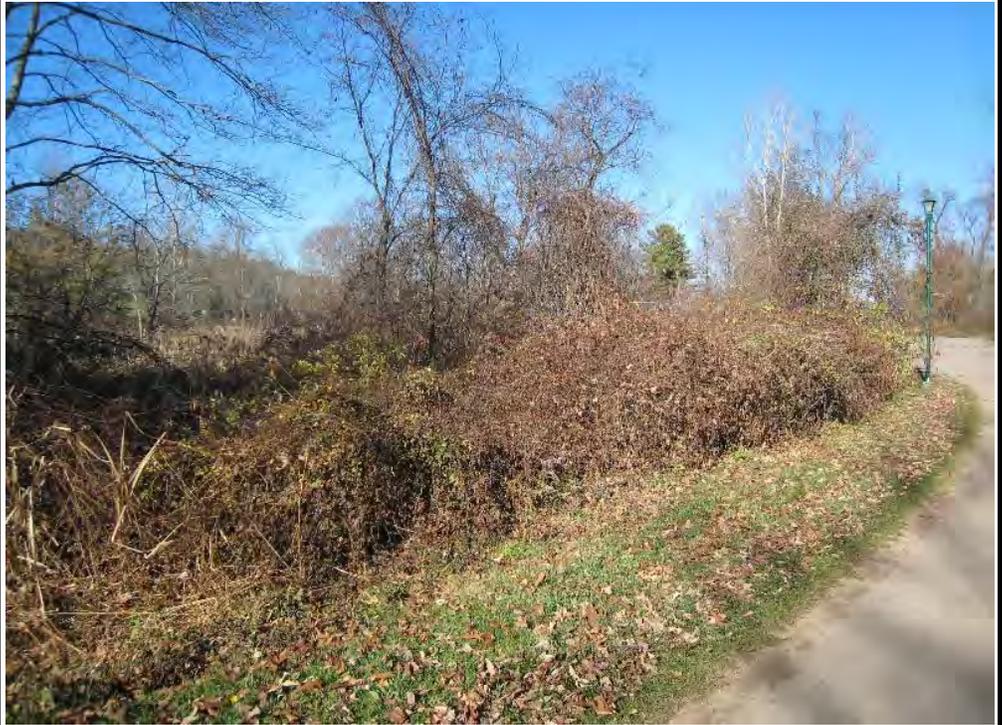
Photo No. **Date:**
 5 11/19/2015

Direction of Photo Taken:
 Northwest

Description:
 Upland fill area along road indicated no known vegetation of ecological importance other than dense groundcover for small mammals. Cattail swamp shown behind filled area.

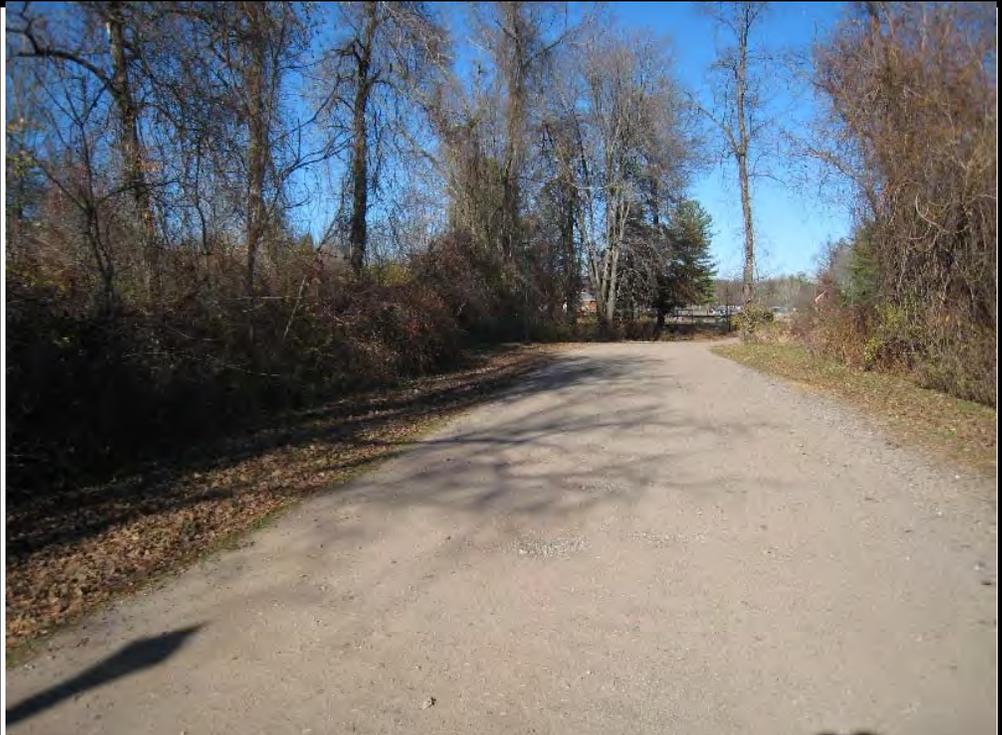
Photo No. **Date:**
 6 11/19/2015

Direction of Photo Taken:
 North

Description:
 View North towards Helen's Way boardwalk.

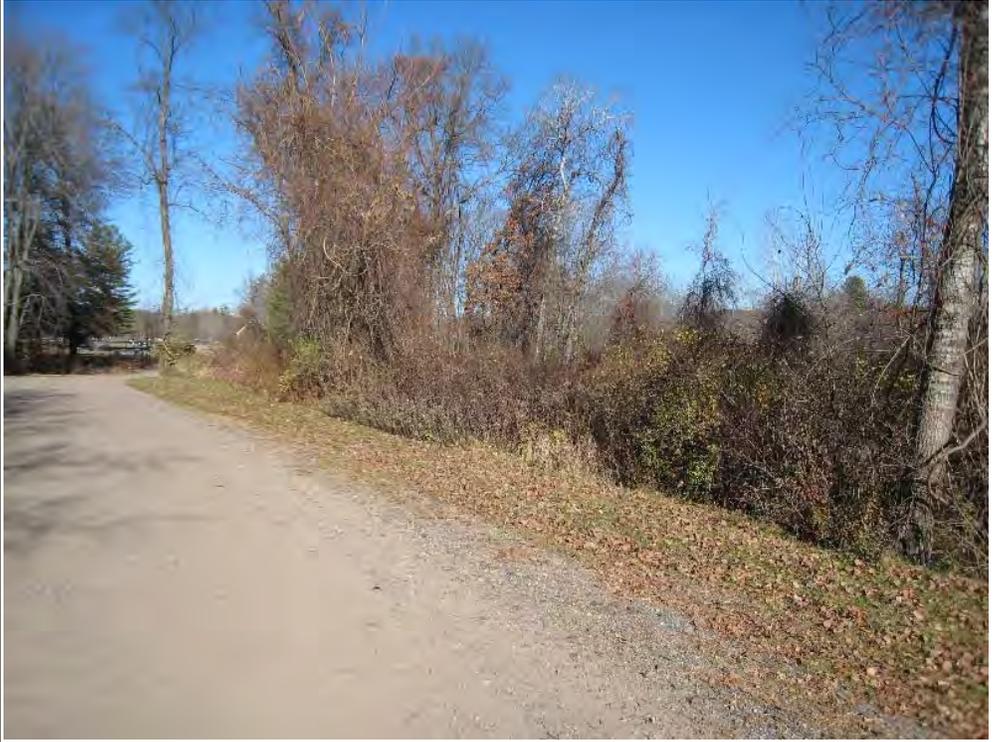
Photo No. 7
Date: 11/19/2015

Direction of Photo Taken:
 Northeast

Description:
 View Northeast towards boardwalk. Vegetation in vicinity included ecologically important alder, *Alnus serrulata*, along with invasive species such as oriental bittersweet and multiflora rose.

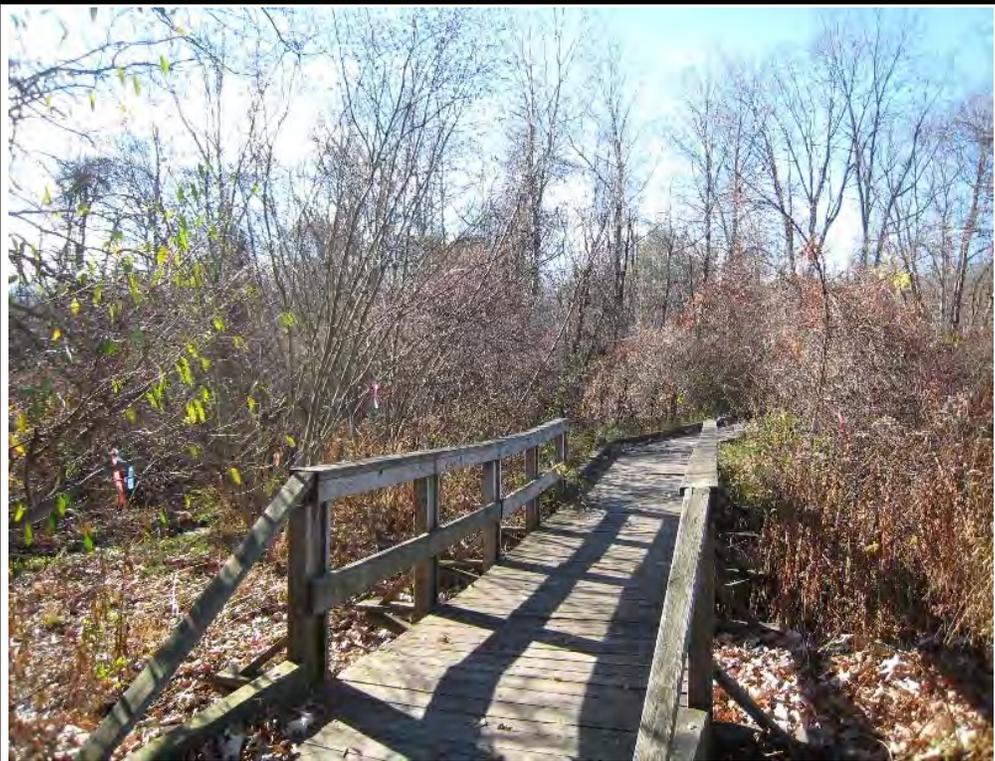
Photo No. 8
Date: 11/19/2015

Direction of Photo Taken:
 East

Description:
 Helen's Way boardwalk crossing wetland. Wetland flags shown in blue and red completed recently by Soil Science and Environmental Services, Inc. The dominant vegetation includes red maple (*Acer rubrum*), willow (*Salix sp.*), hazel alder (*Alnus serrulata*), highbush blueberry (*Vaccinium corymbosum*), and dogwood (*Cornus sp.*).

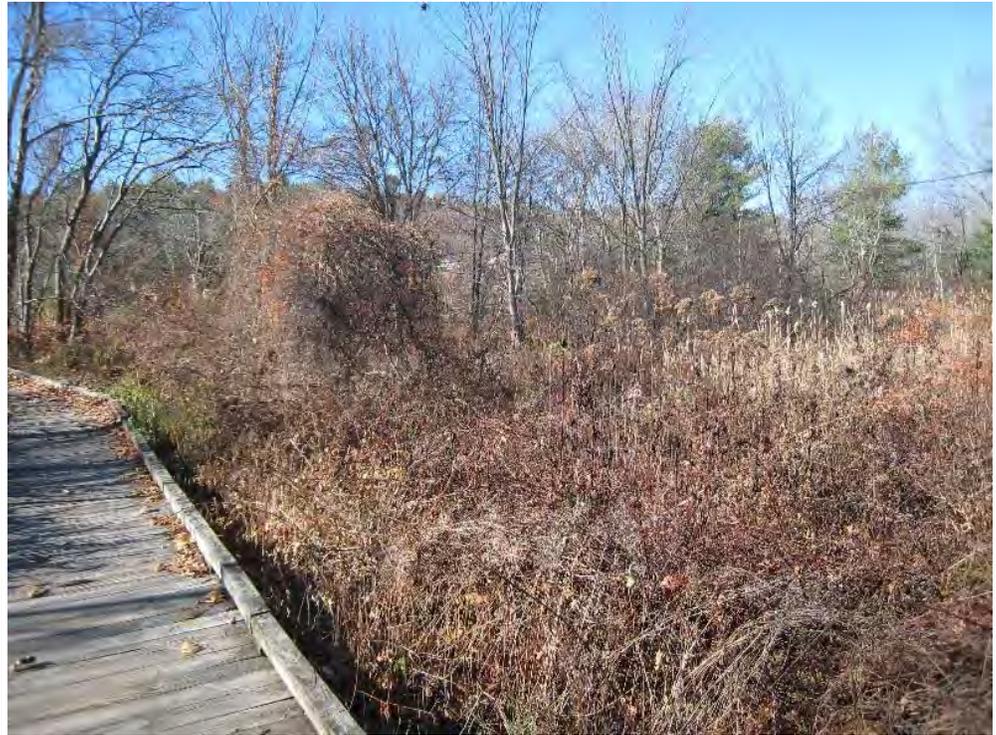
Photo No. 9	Date: 11/19/2015
-----------------------	----------------------------

Direction of Photo Taken: Northwest

Description:
 Helen's Way boardwalk crossing wetland, view Northeast.
 Cattail shown in background.

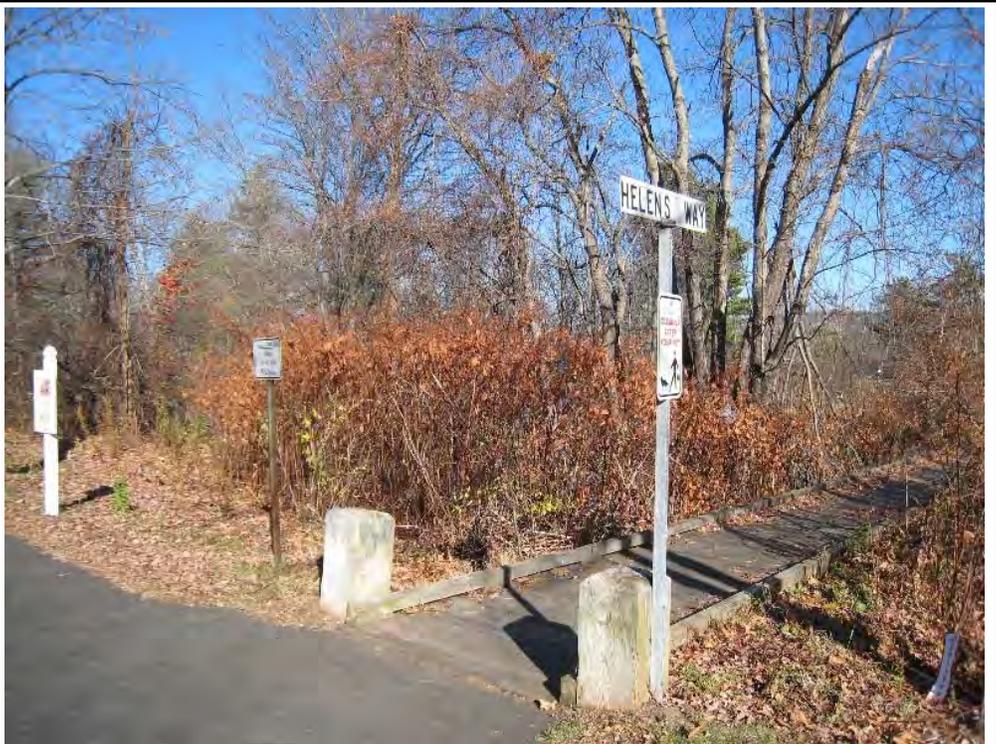
Photo No. 10	Date: 11/19/2015
------------------------	----------------------------

Direction of Photo Taken: Northeast

Description:
 Japanese knotweed, *Polygonum cuspidatum*, shown invading corner and area North along asphalt walkway.

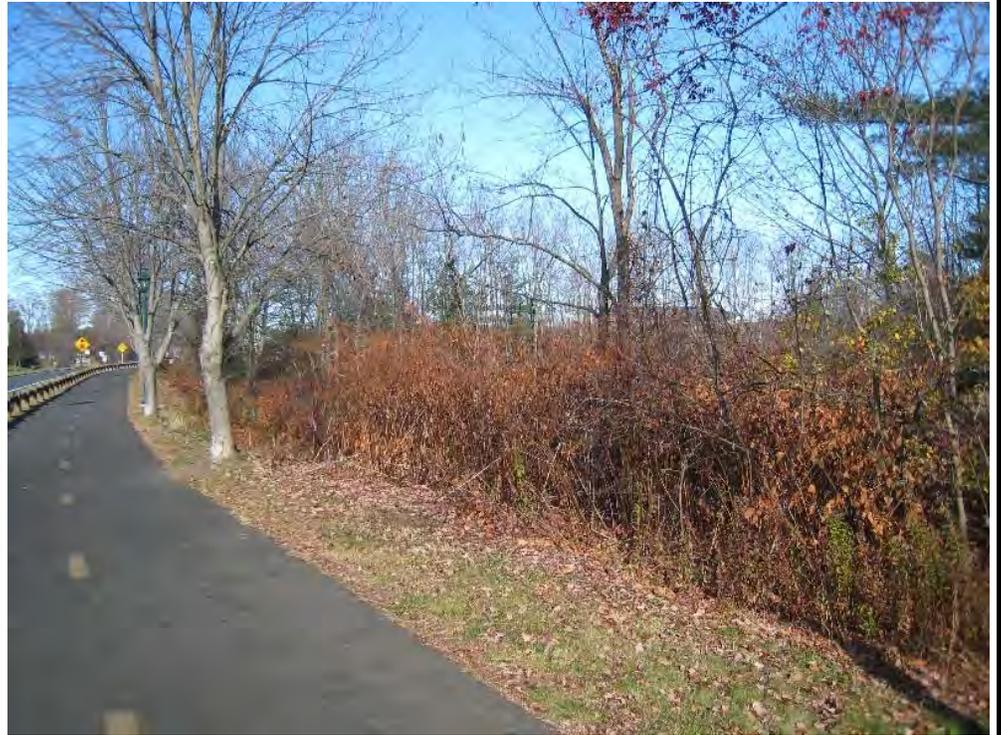
Photo No. 11 **Date:** 11/19/2015

Direction of Photo Taken:
 North

Description:
 Japanese knotweed
 (*Polygonum cuspidatum*)
 dominating the area bordering
 wetland.

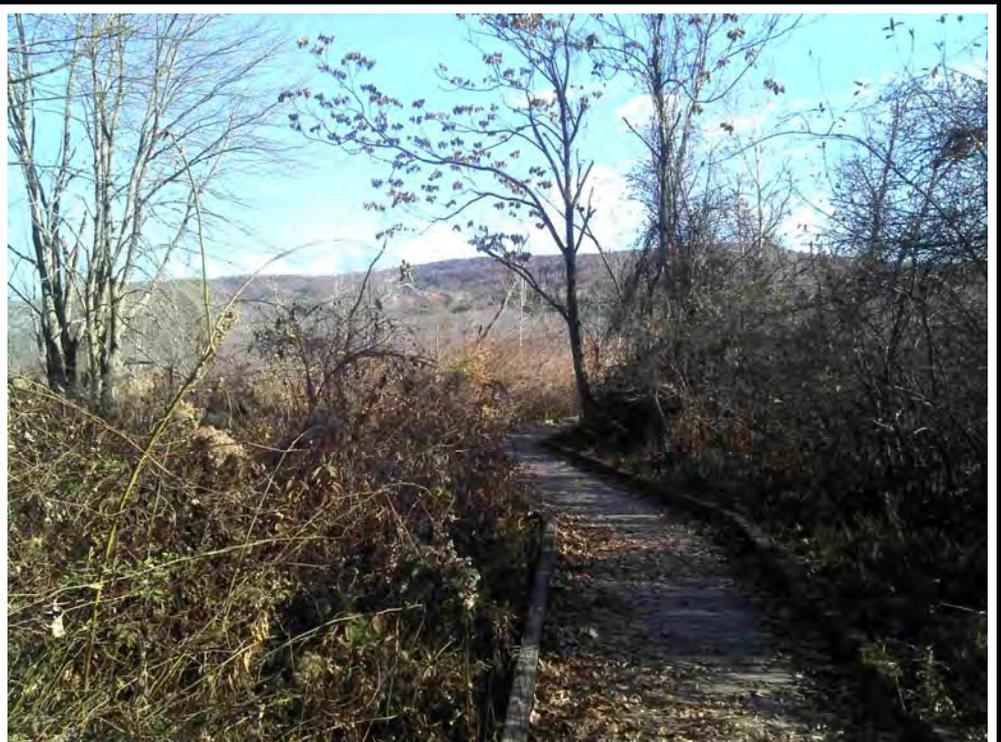
Photo No. 12 **Date:** 11/19/2015

Direction of Photo Taken:
 Northeast

Description:
 Helen's Way easterly
 boardwalk.

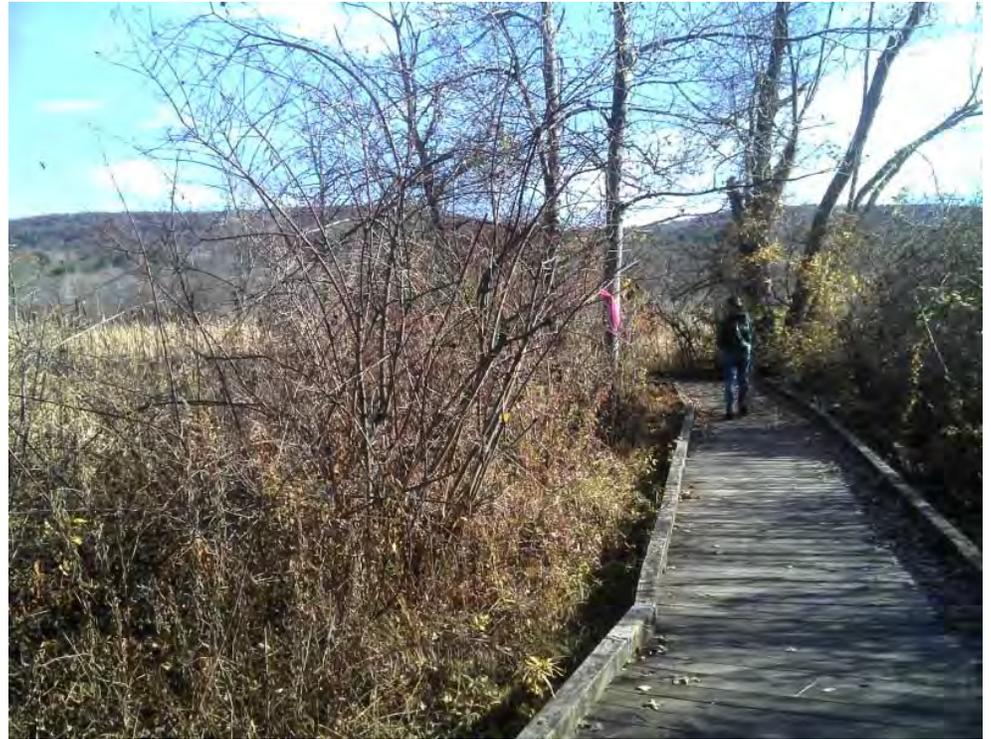
Photo No. 13 **Date:** 11/19/2015

Direction of Photo Taken:
 East

Description:
 Shrubs of a greater ecological significance shown being flagged by All Habitat Services personnel.

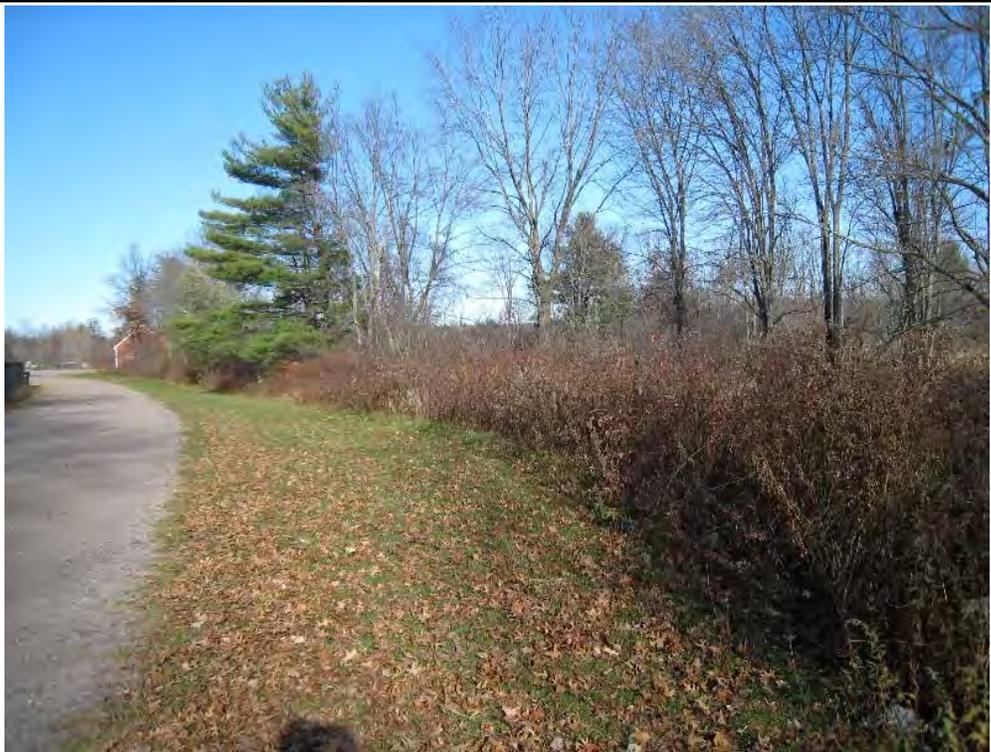
Photo No. 14 **Date:** 11/19/2015

Direction of Photo Taken:
 North

Description:
 Winterberry (*Ilex verticillata*), red osier dogwood (*Cornus alba*), willow (*Salix sp.*), were identified and flagged along this stretch towards the red garage including the invasive honeysuckle (*Lonicera sp.*).

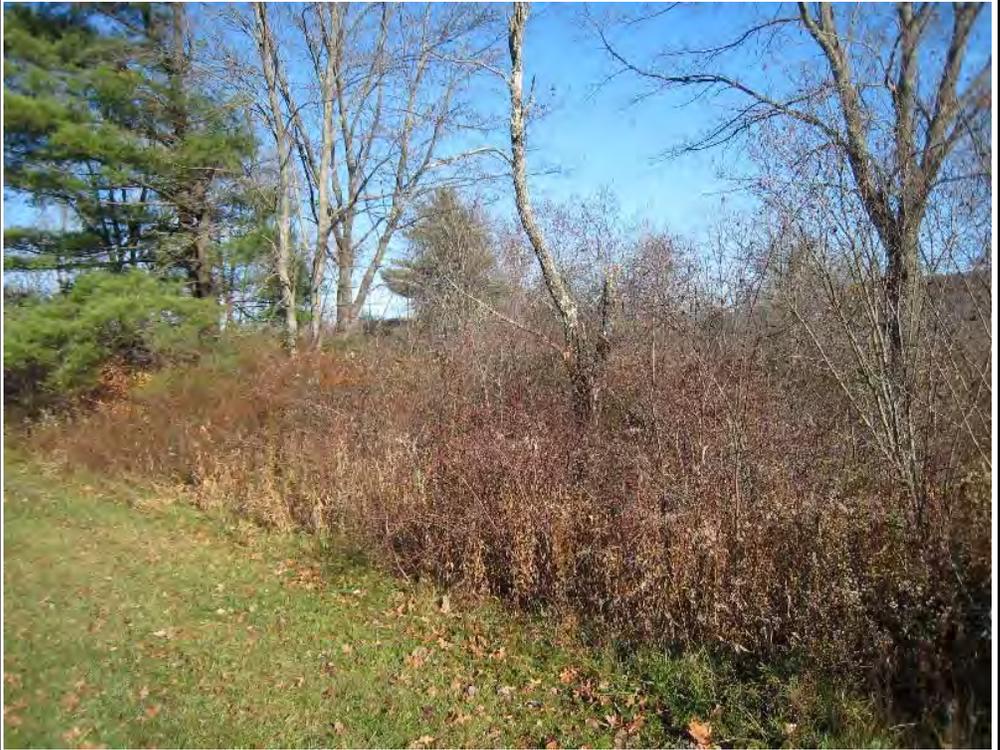
Photo No. 15
Date: 11/19/2015

Direction of Photo Taken:
 Northeast

Description:
 Winterberry (*Ilex verticillata*), red osier dogwood (*Cornus alba*), willow (*Salix sp.*), were identified and flagged along this stretch towards the red garage including the invasive honeysuckle (*Lonicera sp.*).

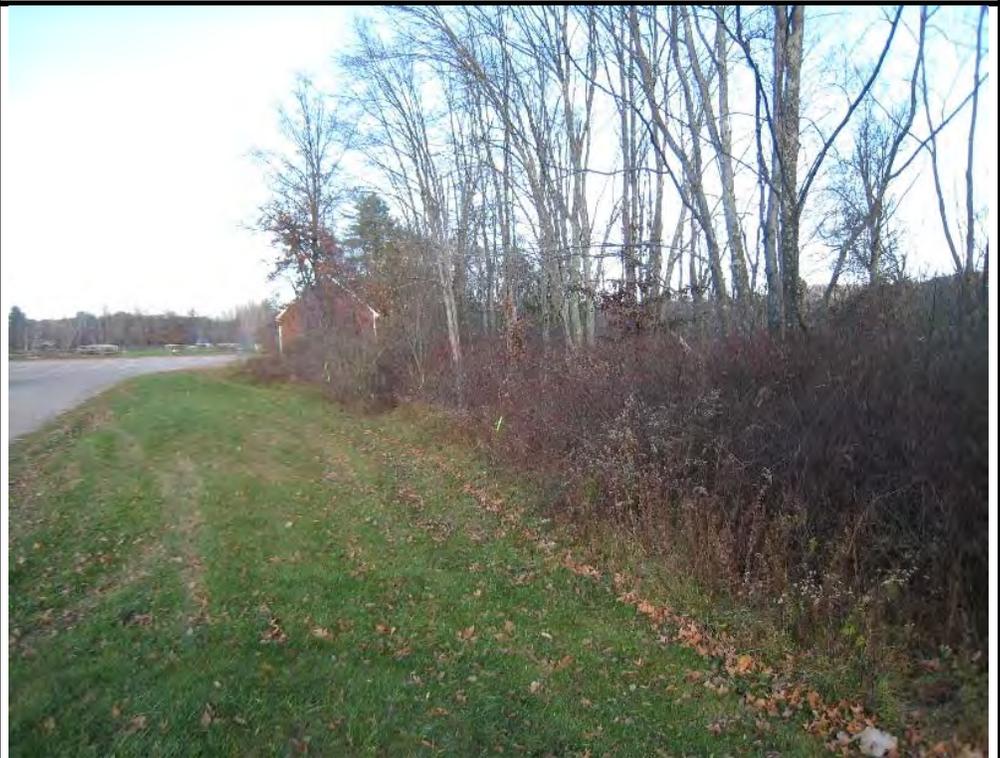
Photo No. 16
Date: 11/19/2015

Direction of Photo Taken:
 North

Description:
 Winterberry (*Ilex verticillata*), red osier dogwood (*Cornus alba*), willow (*Salix sp.*), were identified and flagged along this stretch towards the red building including the invasive honeysuckle (*Lonicera sp.*).

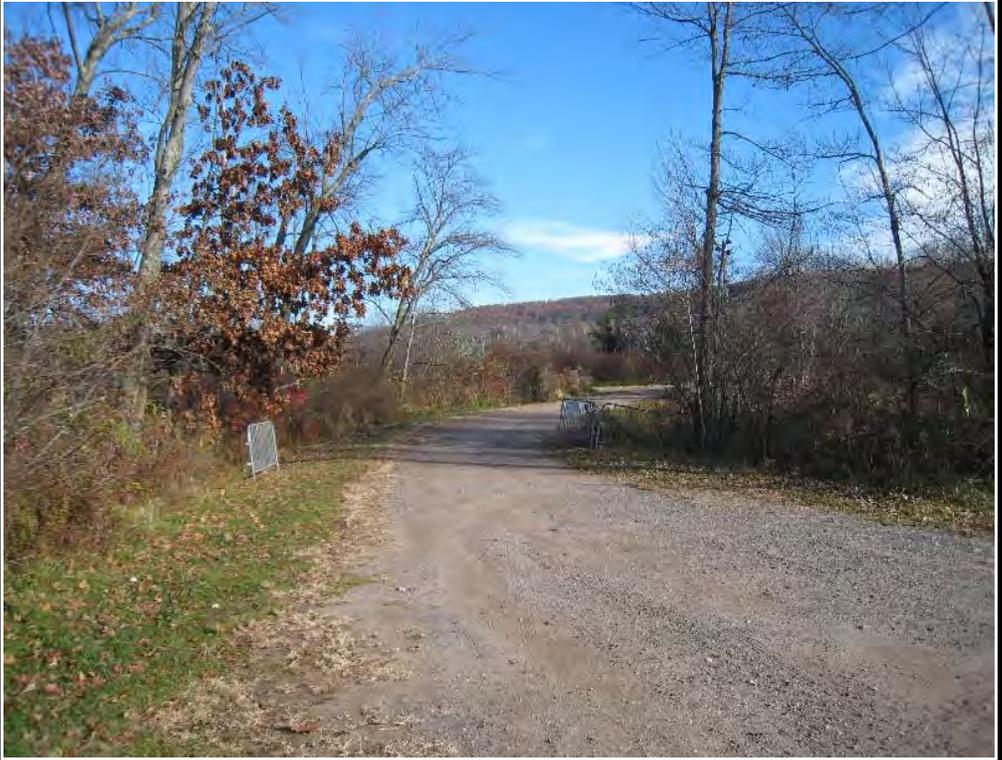
Photo No. 17 **Date:** 11/19/2015

Direction of Photo Taken:
 East

Description:
 Gated area northeast of red garage.

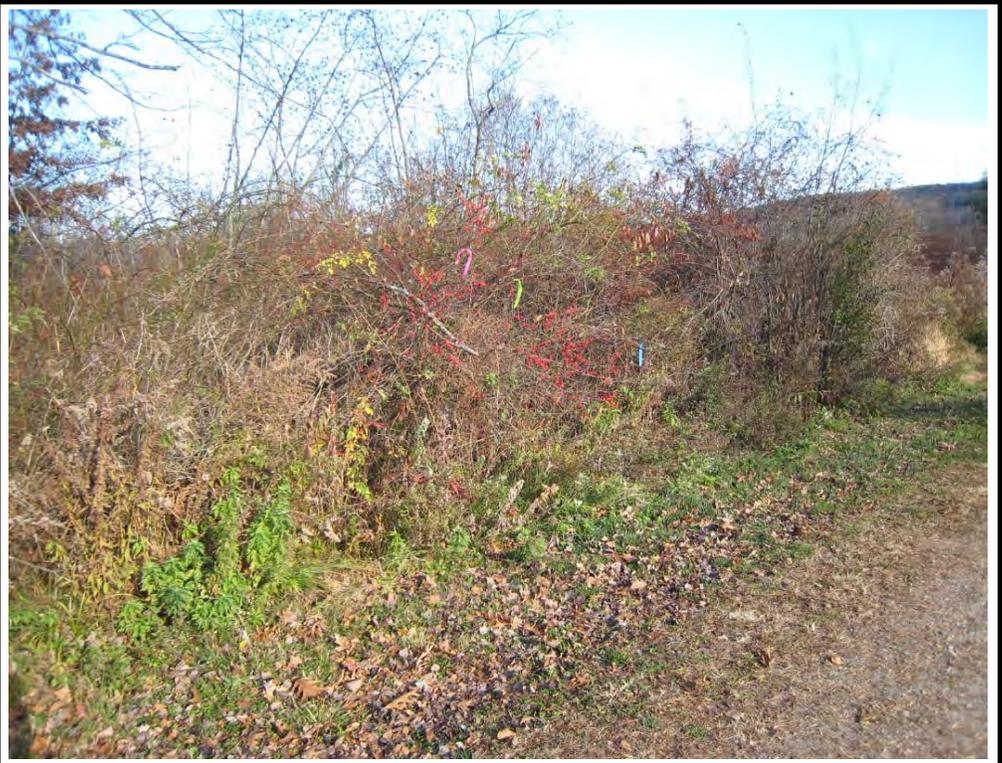
Photo No. 18 **Date:** 11/19/2015

Direction of Photo Taken:
 Northeast

Description:
 Winterberry with fruit shown flagged for saving.

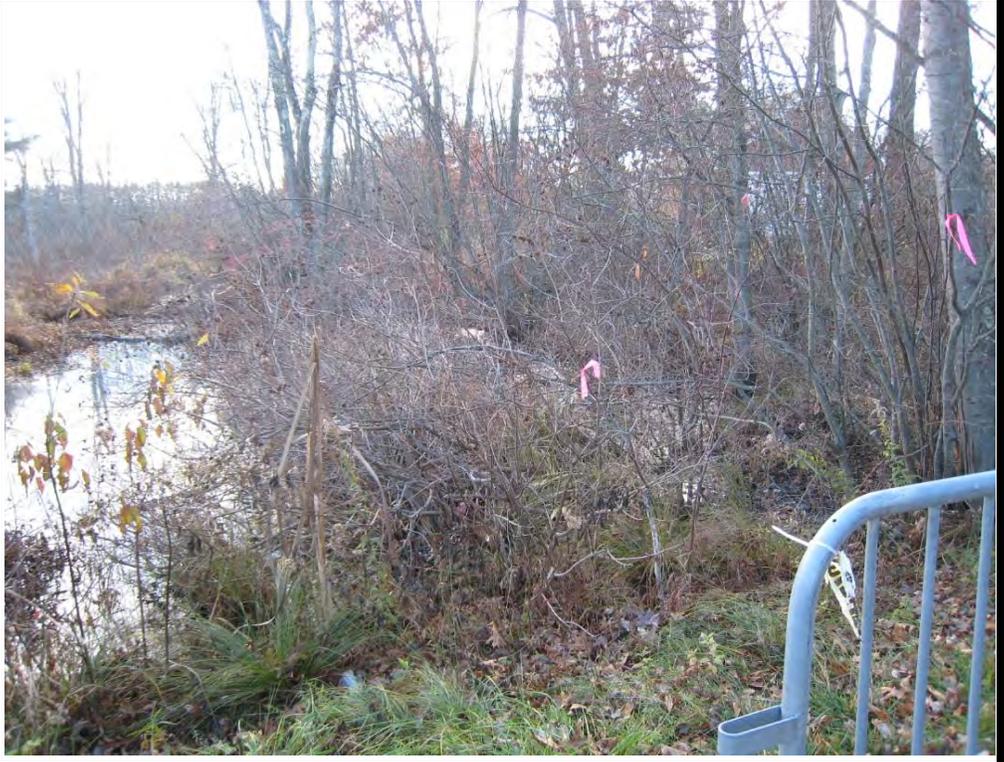
Photo No. 19 **Date:** 11/19/2015

Direction of Photo Taken:
 Southwest

Description:
 Pink ribbon on vegetation proposed to save as shown, included buttonbush (*Cephalanthus occidentalis*), and hazel alder (*Alnus serrulata*).

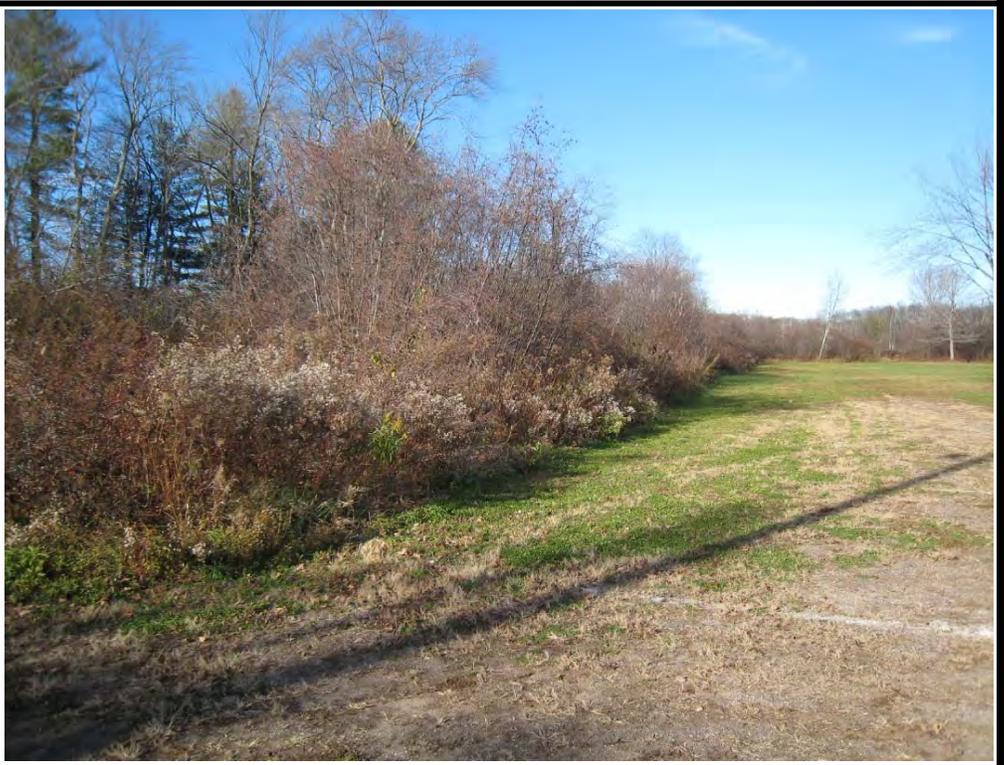
Photo No. 20 **Date:** 11/19/2015

Direction of Photo Taken:
 North

Description:
 Upland shrubs such as goldenrod (*Solidago sp.*) shown between open field and wetland.

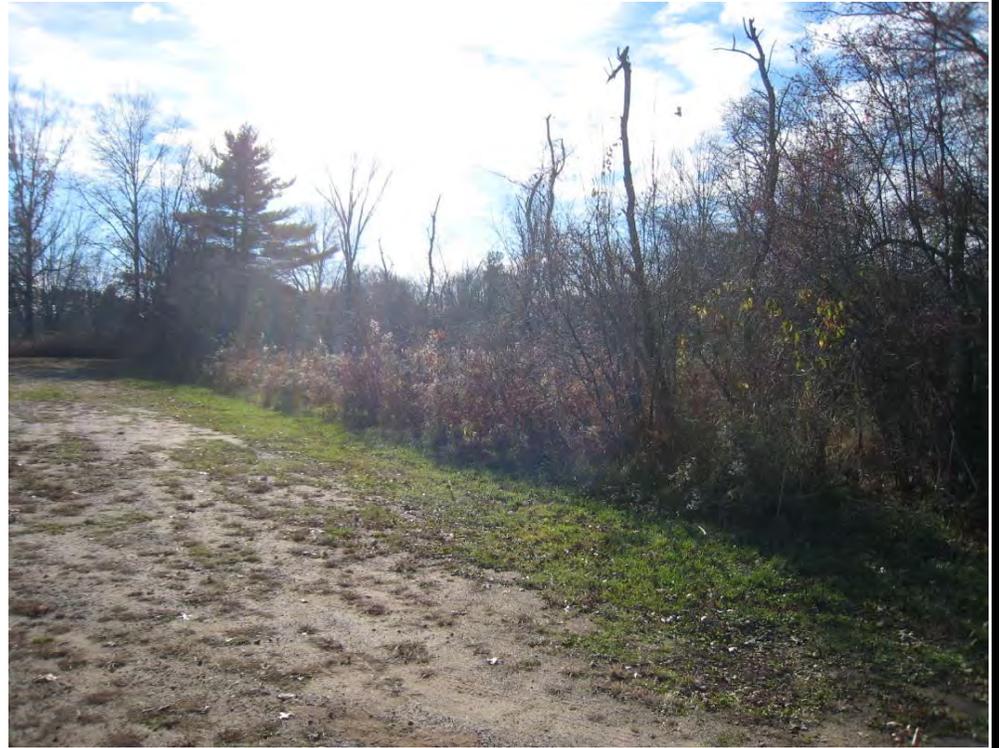
Photo No.	Date:
21	11/19/2015

Direction of Photo Taken:
South

Description:
Upland shrubs such as
goldenrod (*Solidago* sp.) shown
between open field and
wetland.
