# **Appendix B:**

**Test Sites**

#### Test Site #1: Simscroft Farms

Post-Development Conditions

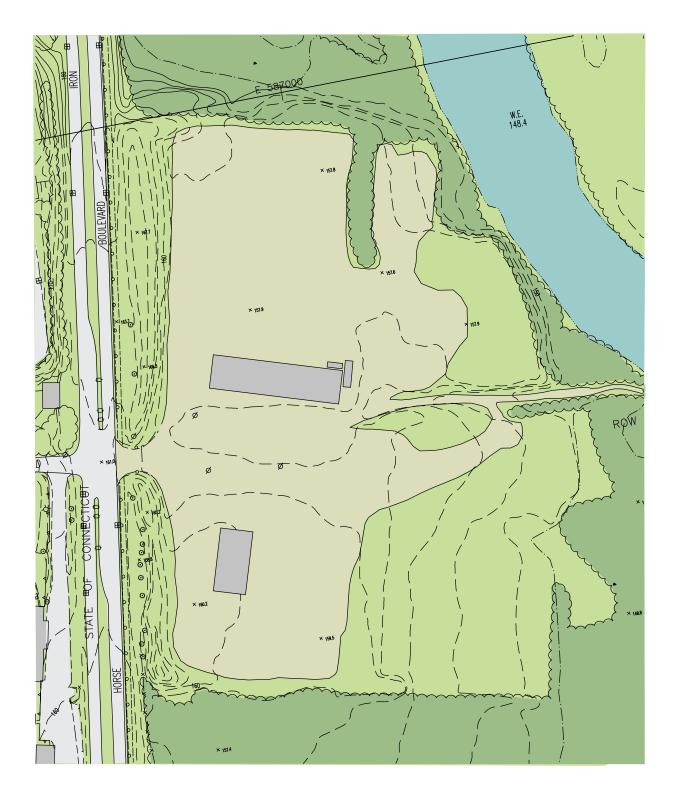
#### **Post-Development**

Total Area	555,44
Impervious Area (sf)	333,23
Redevelopment credit	no
Location-based credit	50%

40 34 60.0% Existing land cover to be verified 5 Simsbury Center Zone SC-5

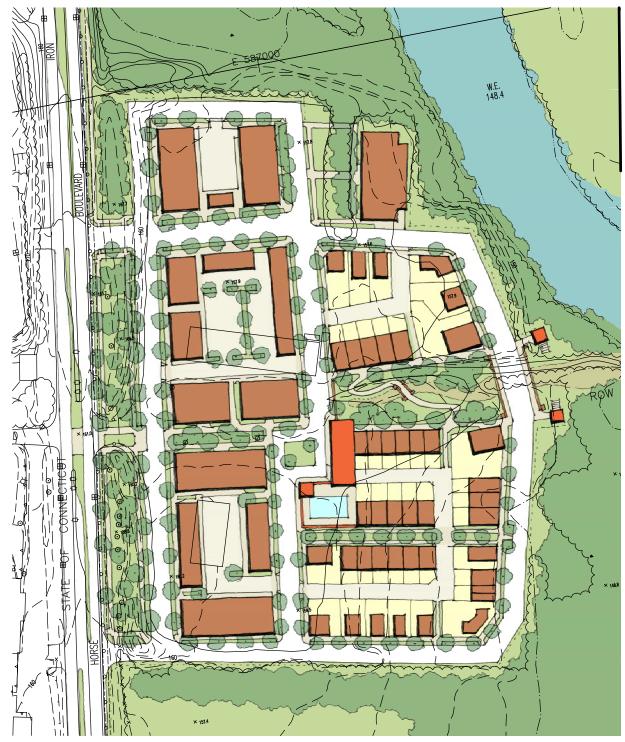
### Test Site #1: Simscroft Farms

Post-Development Conditions

Value	%	Notes
Post-Development			
Total Area	555,440		
Impervious Area (sf)	333,234	60.0%	
Redevelopment credit	no		Existing land cover to be verified
Location-based credit	50%		Simsbury Center Zone SC-5
Office Space (sf)	0		
Residential Units	224
