Office of Community Planning and Development - Inland Wetlands Permit Application

PROPERTY ADDRESS: Tariffville Road from Hopmeadow St. (Rt. 10) to Curtiss/Pattison Parks

TARRIFVILLE CONNECTION, MULTI-USE TRAIL
 HOPMEADOW ST. TO CURTISS/PATTISON PARKS
 TARRIFVILLE ROAD (CT ROUTE 315)
 SIMSBURY, CT

Inland Wetland Report
Tariffville Connection, Multiuse Trail
Tariffville Road from Hopmeadow Street (Route 10)
to Curtiss and Pattison Parks
Simsbury, Connecticut
July 1, 2020

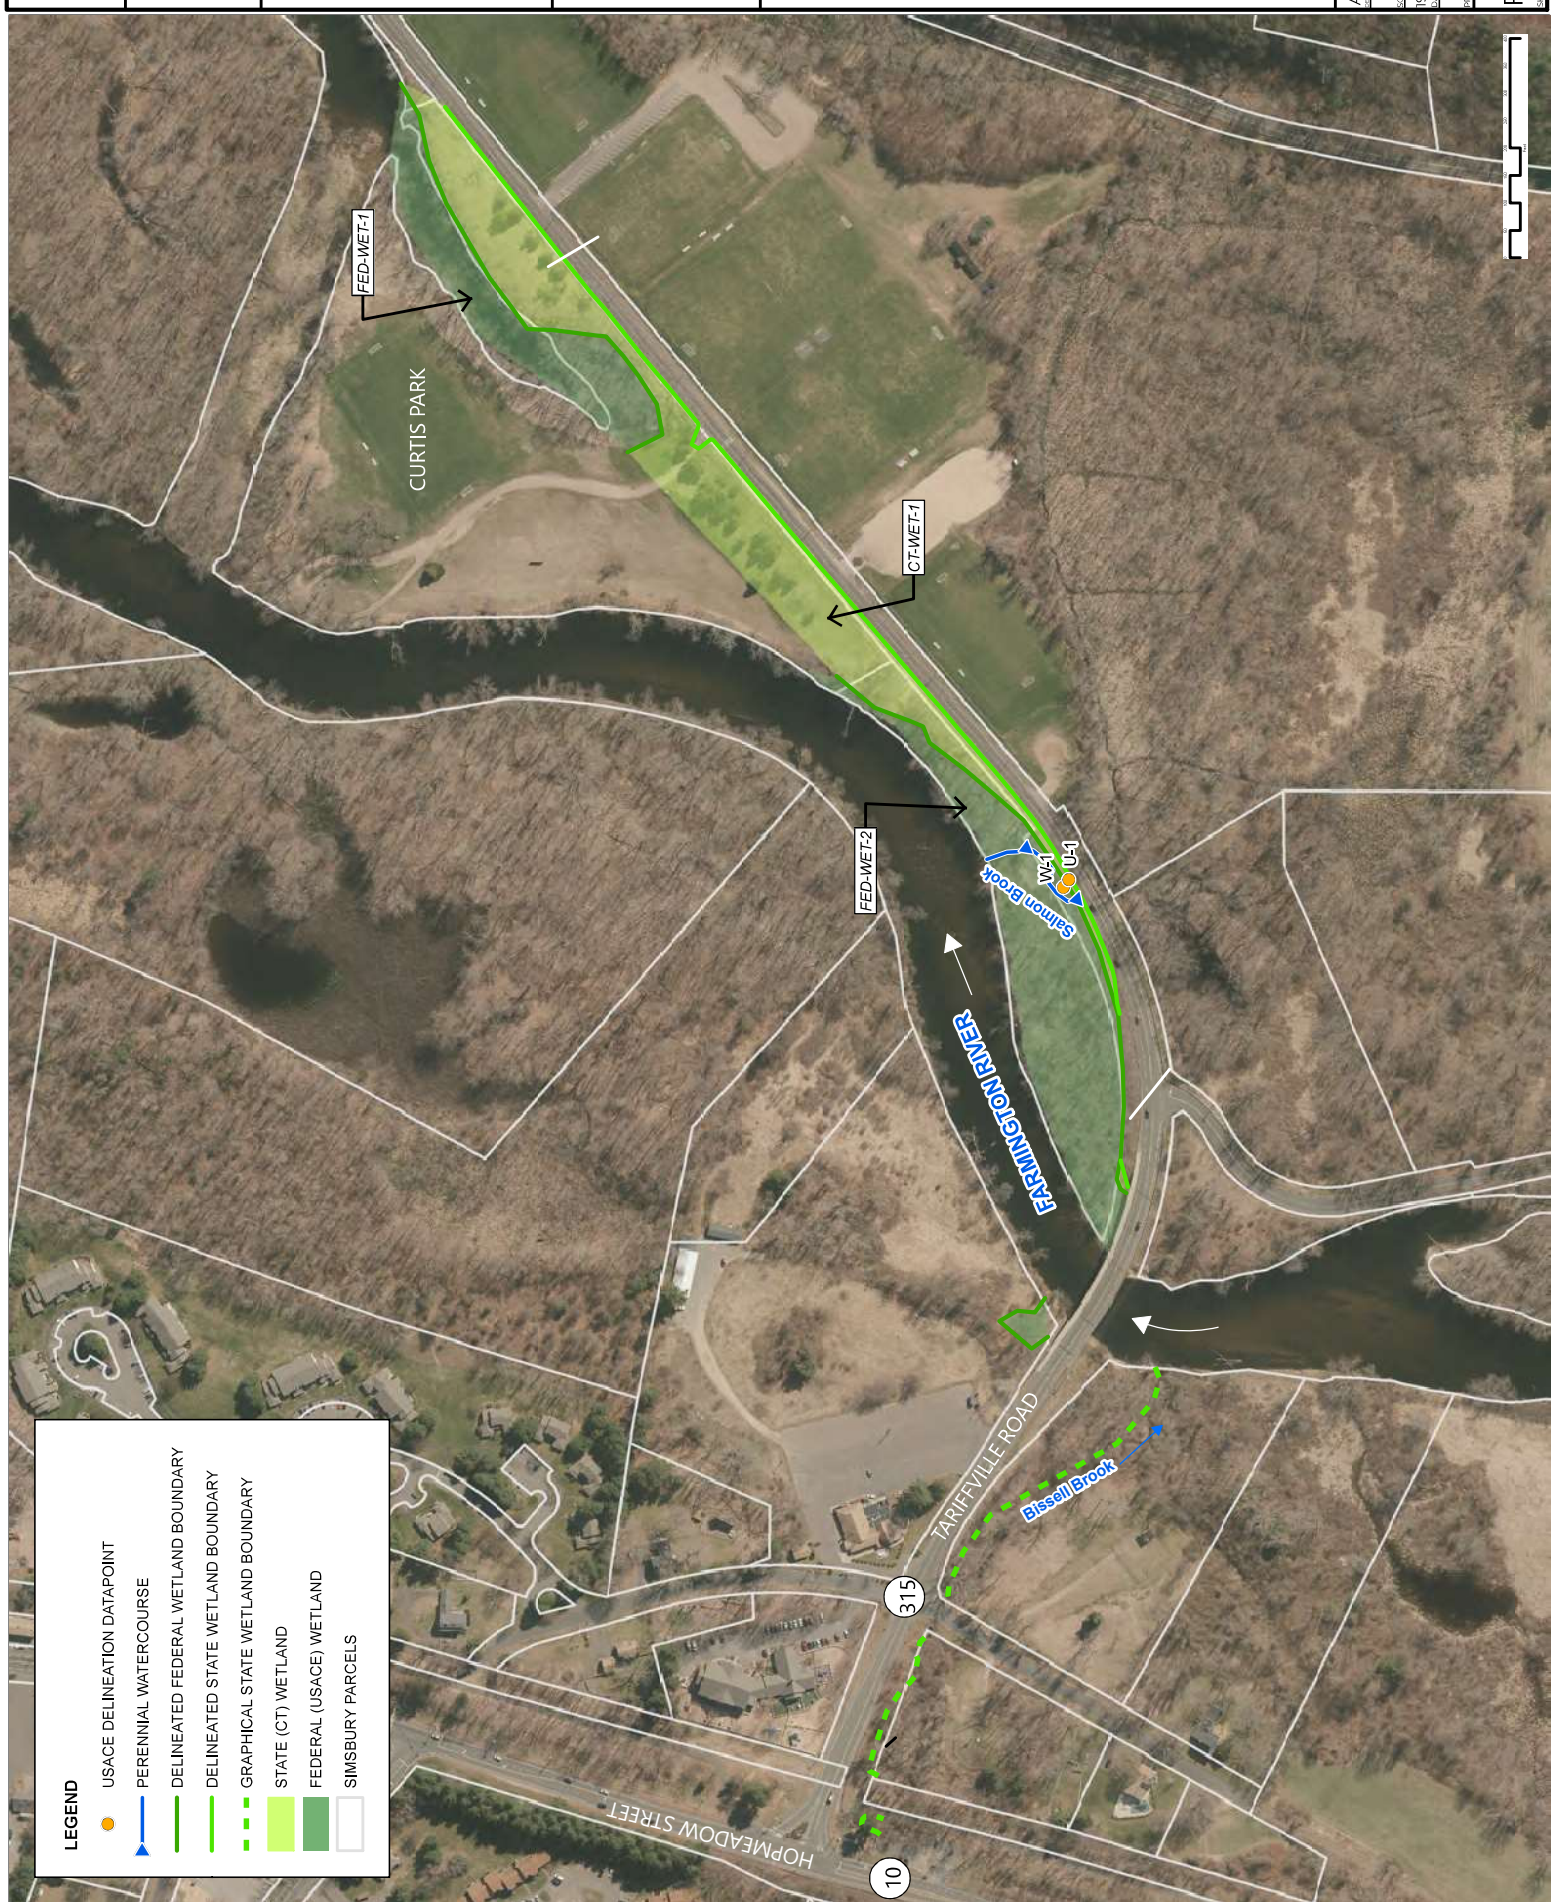
- USACE DELINEATION DATAPOINT
- ▲ PERENNIAL WATERCOURSE
- DELINEATED FEDERAL WETLAND BOUNDARY
- DELINEATED STATE WETLAND BOUNDARY
- - - GRAPHICAL STATE WETLAND BOUNDARY
- STATE (CT) WETLAND
- FEDERAL (USACE) WETLAND
- SIMSBURY PARCELS

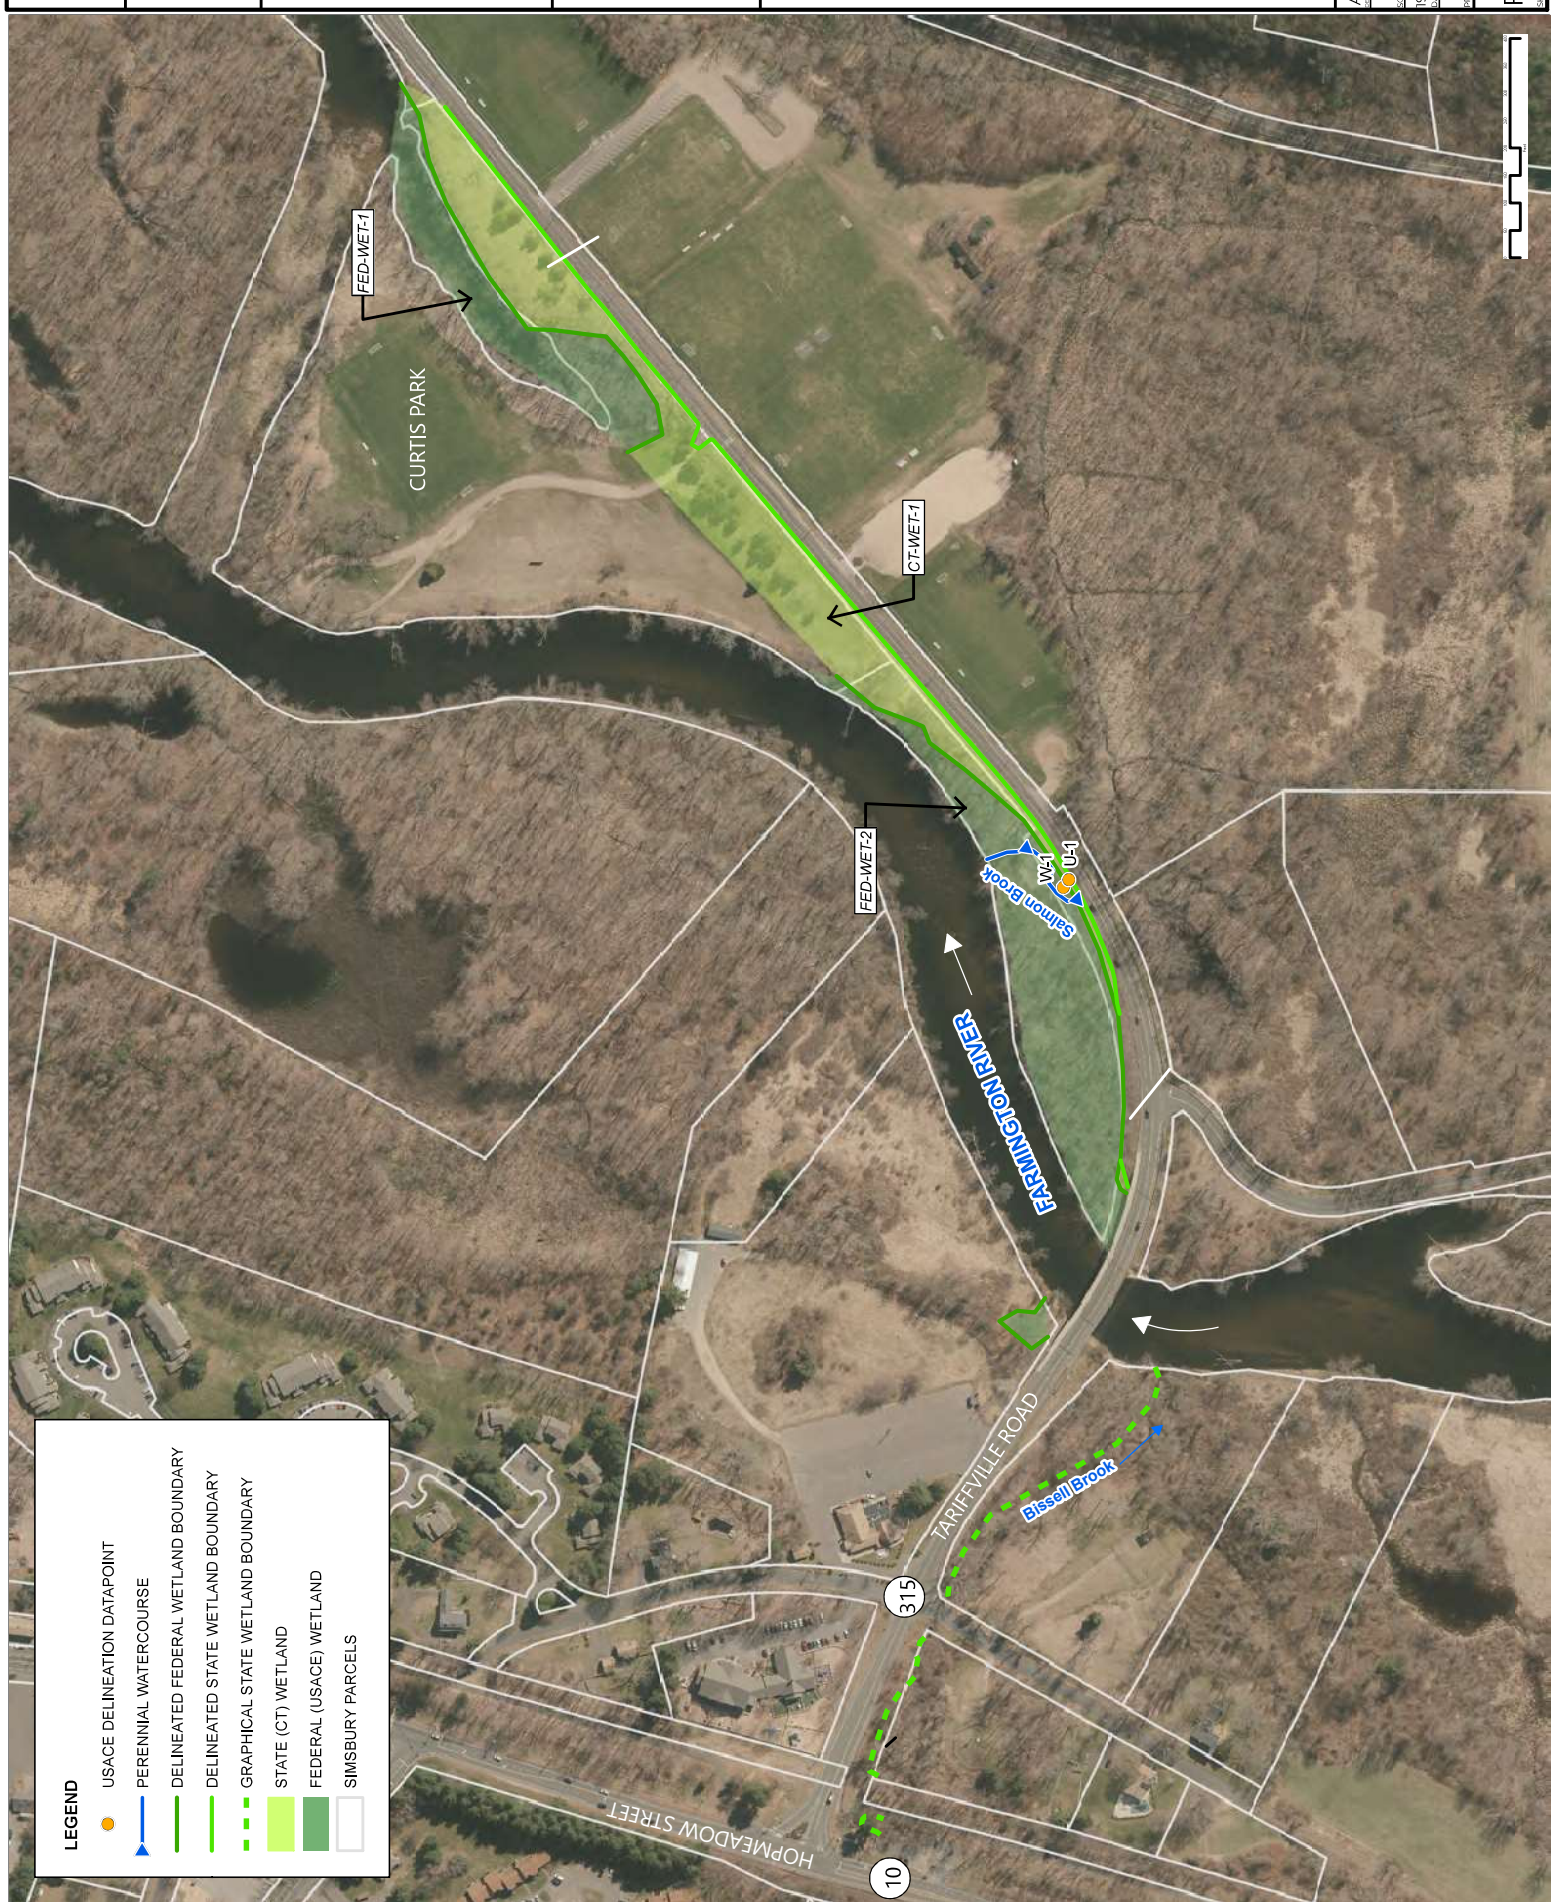
- USACE DELINEATION DATAPOINT
- ▲ PERENNIAL WATERCOURSE
- DELINEATED FEDERAL WETLAND BOUNDARY
- DELINEATED STATE WETLAND BOUNDARY
- - - GRAPHICAL STATE WETLAND BOUNDARY
- STATE (CT) WETLAND
- FEDERAL (USACE) WETLAND
- SIMSBURY PARCELS

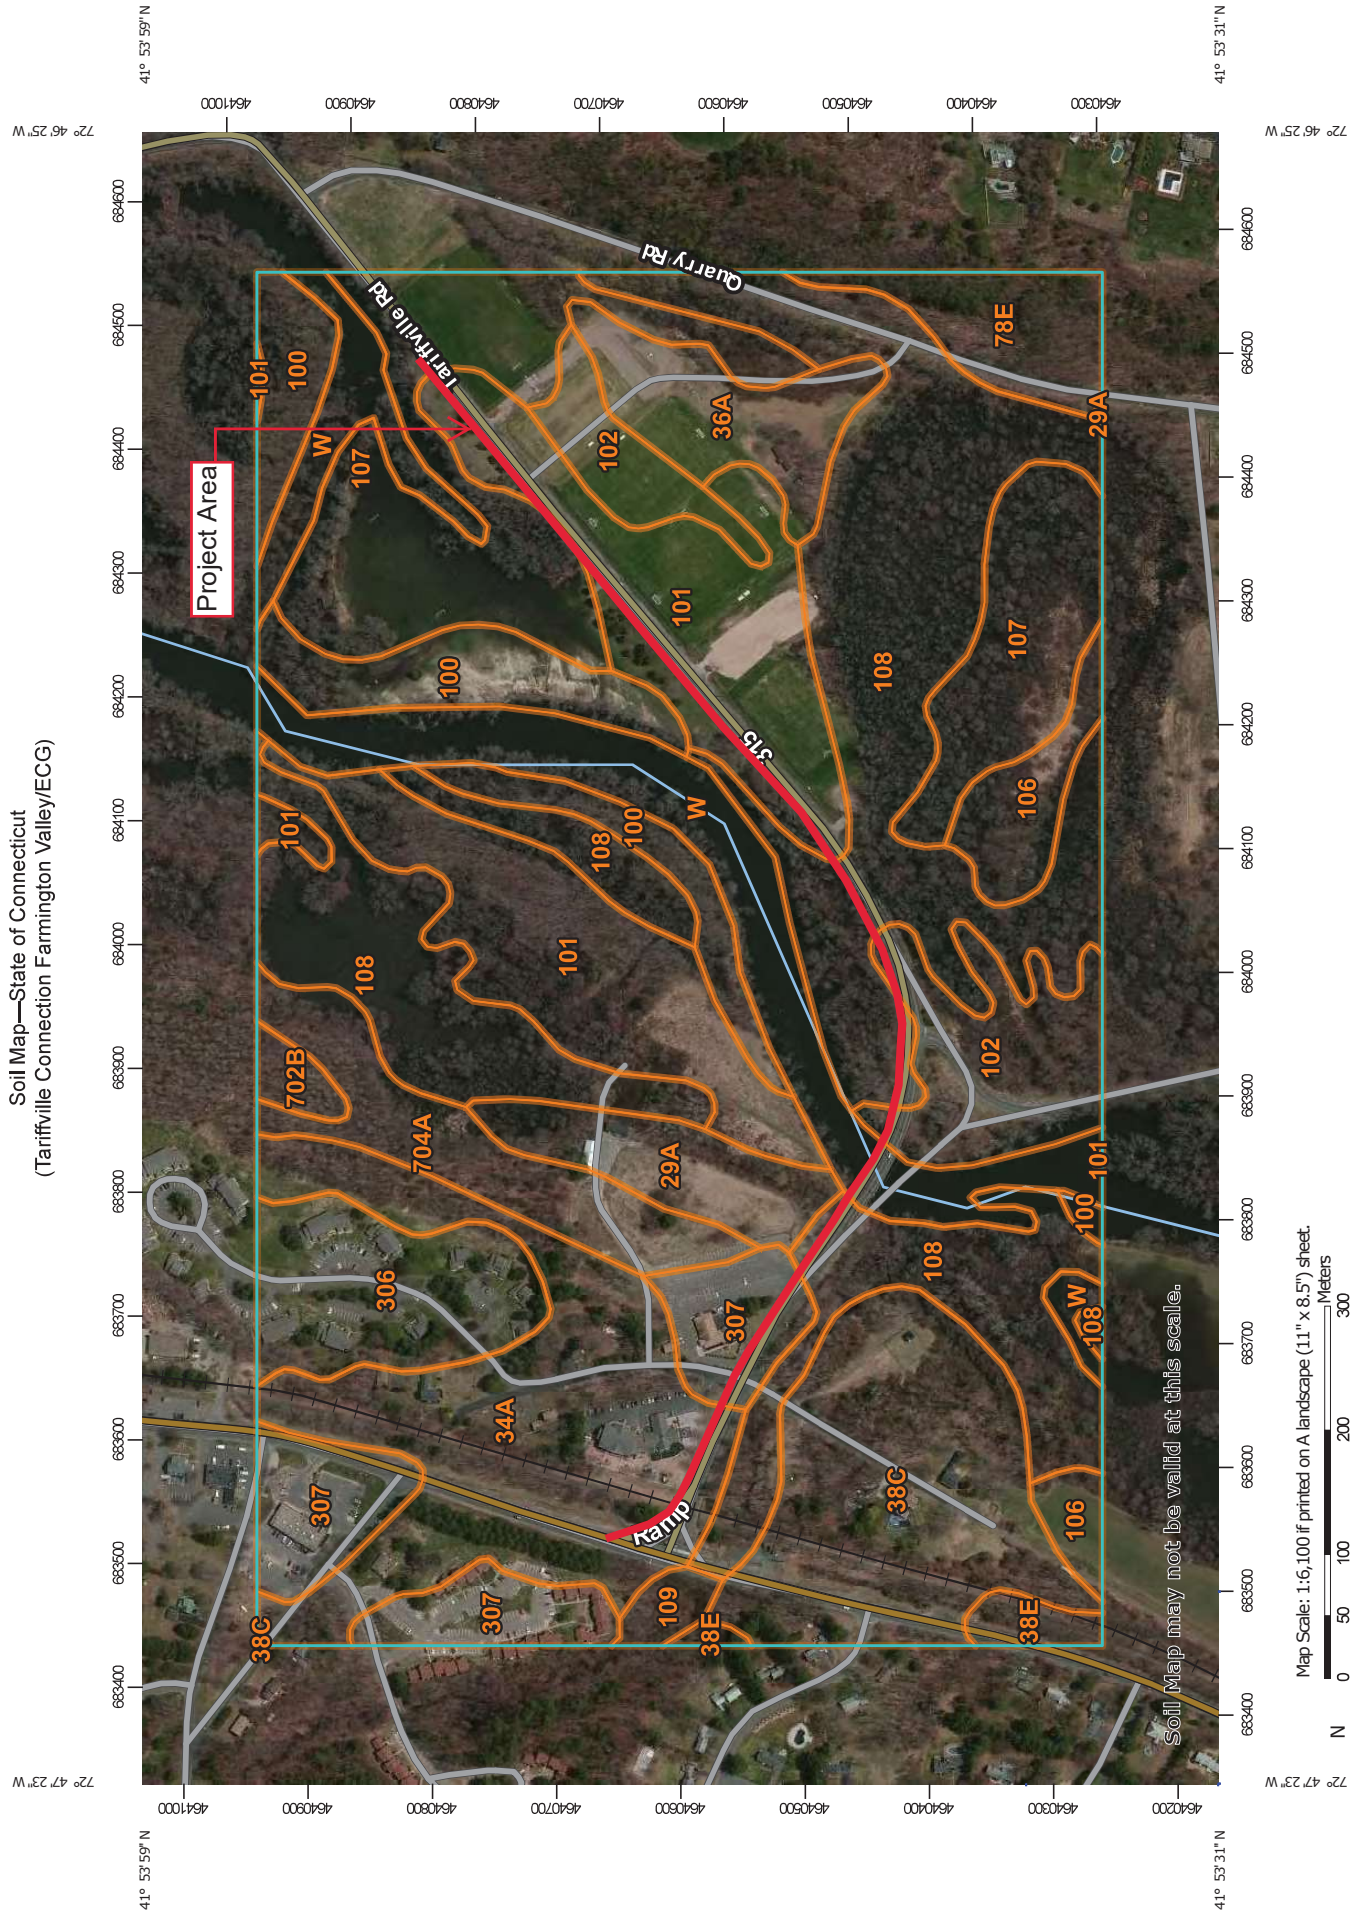
Soil Map—State of Connecticut
(Tarrifville Connection Farmington Valley/ECCG)

Map Scale: 1:6,100 if printed on A landscape (11" x 8.5") sheet.

According to the Natural Resources Conservation Service (NRCS) web soil survey, the following soil mapping units with associated NRCS map number are located in the project area:

- Agawam fine sandy loam (29A)
- Merrimac sandy loam (34A)
- Suncook loamy fine sand (100)
- Occum fine sandy loam (101)
- Pootatuck fine sandy loam (102)
- Limerick and Lim soils (107)
- Saco silt loam (108)
- Fluvaquents-Udifluvents complex, frequently flooded (109)
- Urban land (307)
- Water (W)

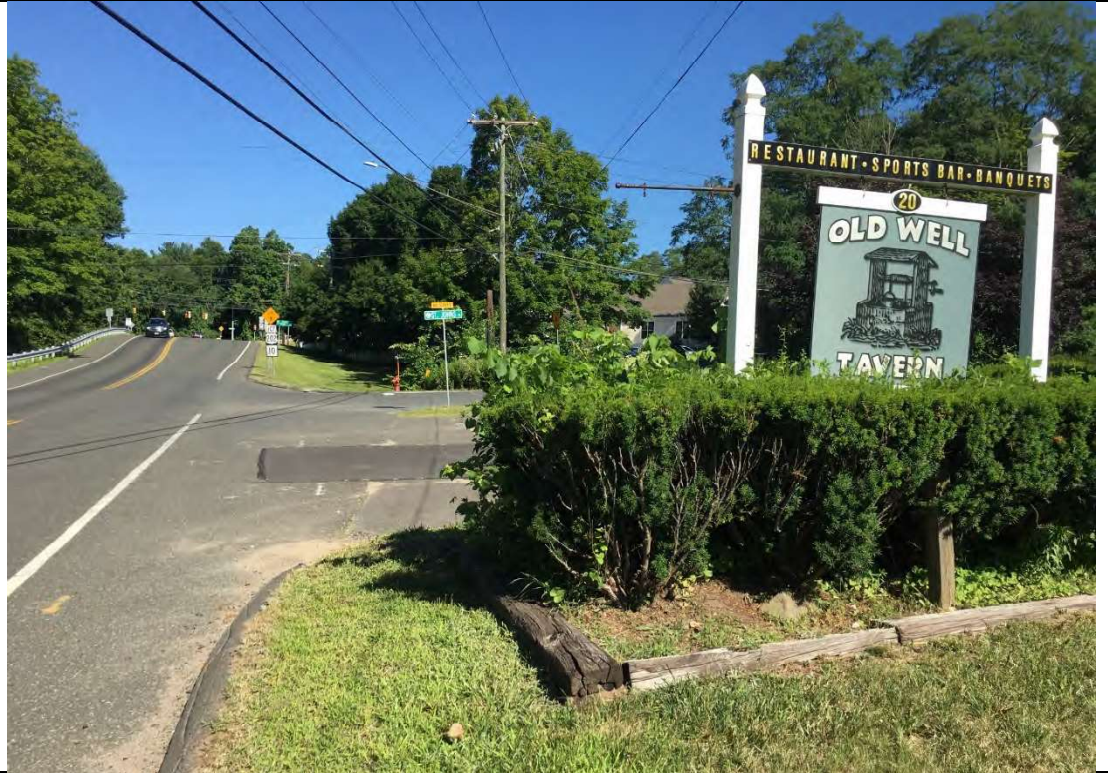
Direction Photo Taken:
West

Description:
Maintained lawn and intersection of St. John's Place along northern portion of Tariffville Road, within the footprint of the proposed trail. Road Stations 112+00 through 120+00.

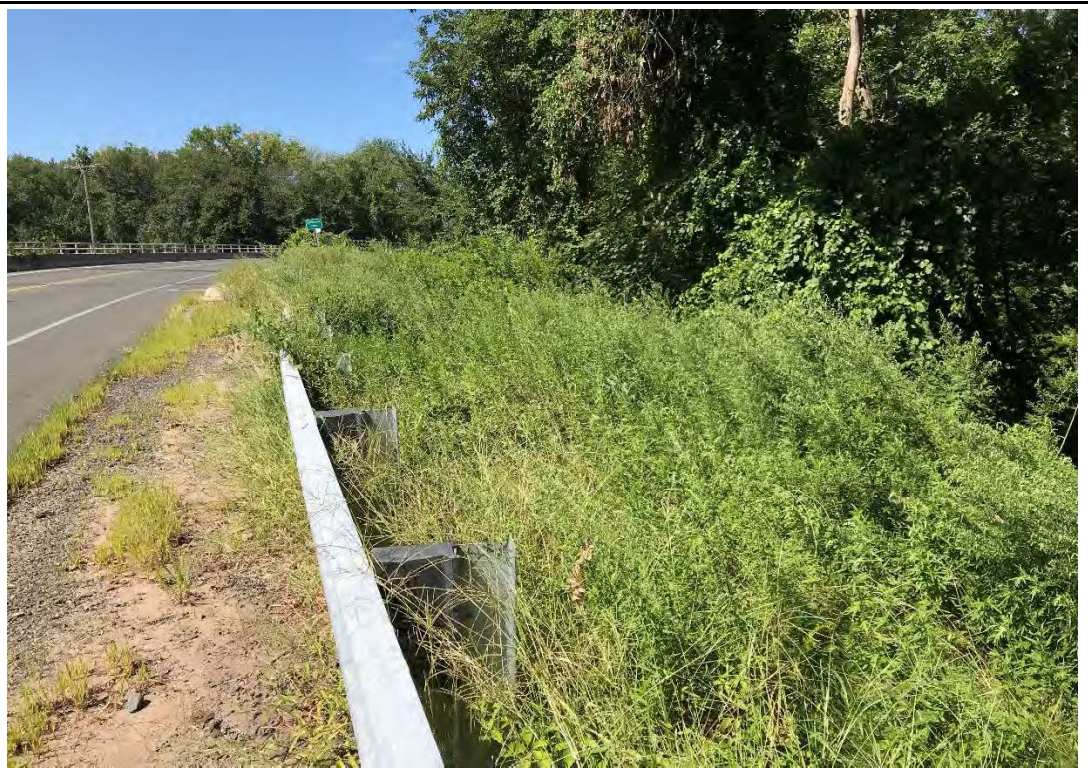
Photo No.
2 **Date:**
09/03/2018

Direction Photo Taken:
West

Description:
Dry slope meadow along northern portion of Tariffville Road. Tariffville Road bridge in background. Road Stations 125+00 to 128+00.

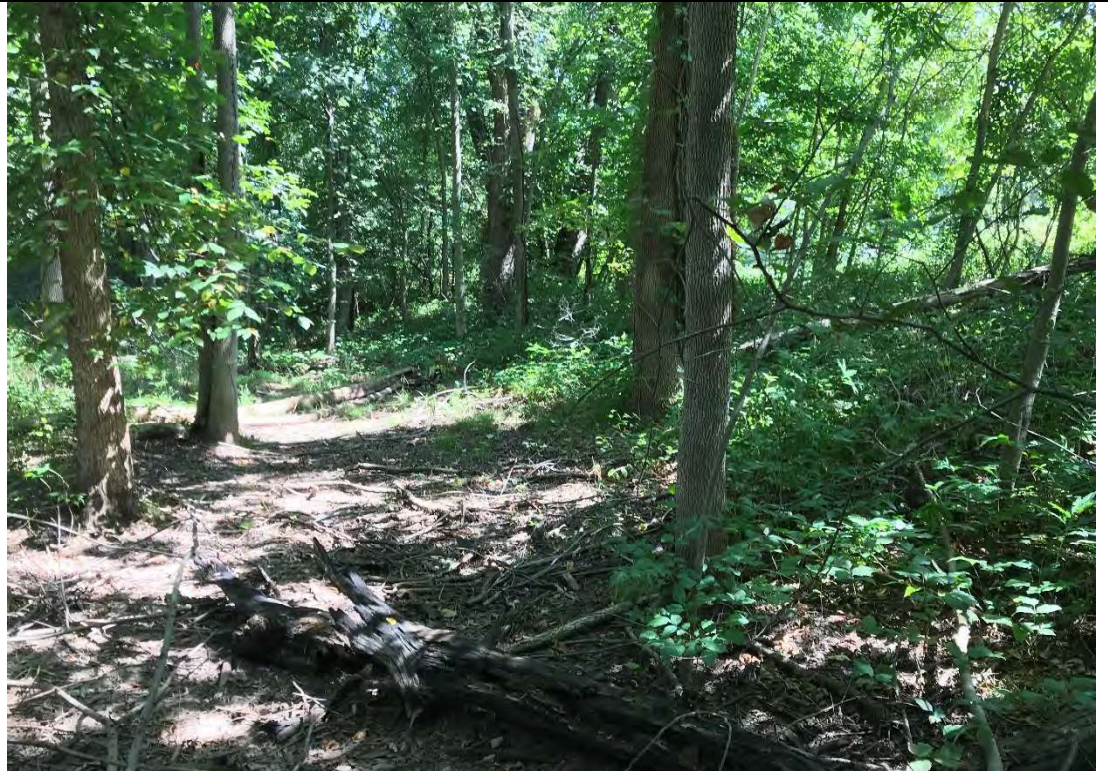
Direction Photo Taken:
East

Description:
Forested federal wetlands between the Farmington River and Tariffville Road. Road Station 128+00 to 129+00.

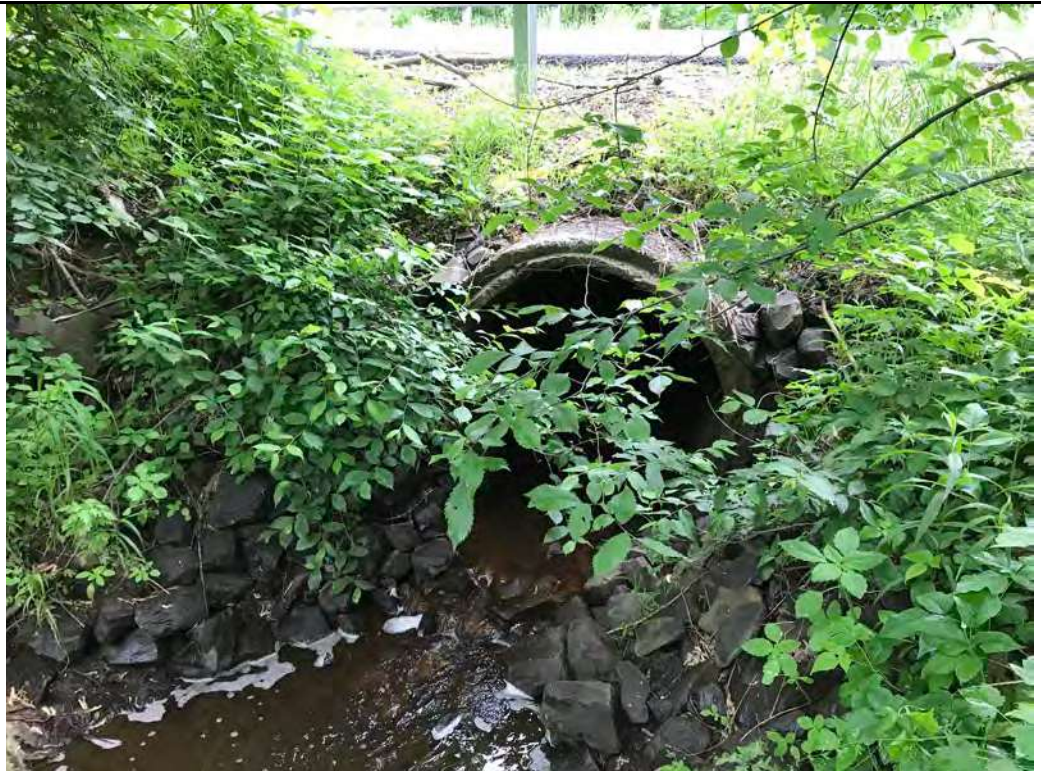
Photo No.
4 **Date:**
06/01/2018

Direction Photo Taken:
South

Description:
Salmon Brook looking upstream from downstream side of Tariffville Road. West of Road Station 130+00.

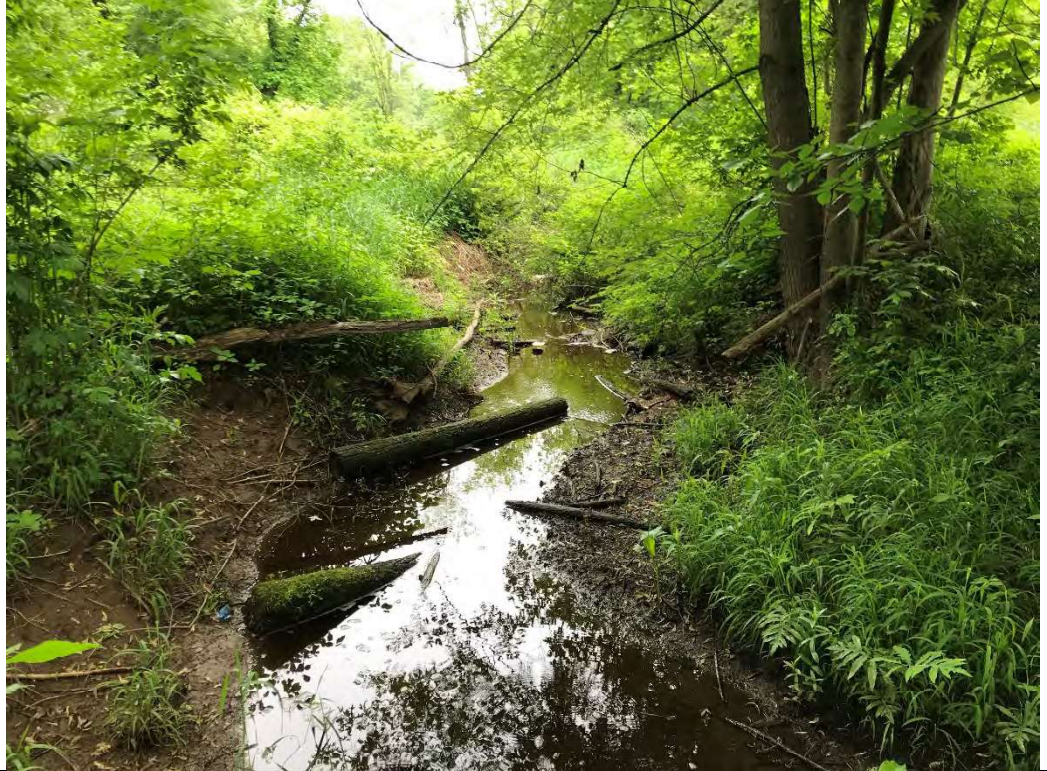
Direction Photo Taken:
Northeast

Description:
Salmon Brook flowing north through forested federal wetlands. West of Road Stations 130+00 to 131+50.

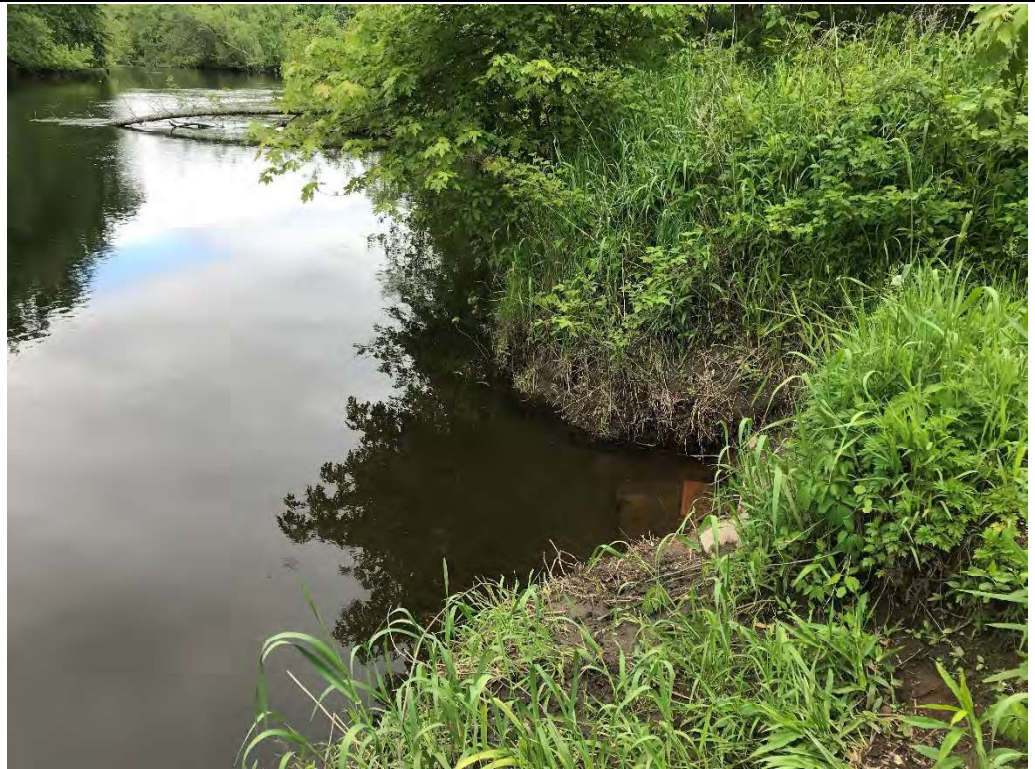
Photo No.
6

Direction Photo Taken:
East

Description:
South bank of Farmington River and existing informal access to the west of the entrance drive to Curtiss Park. North of Road Station 134+50.

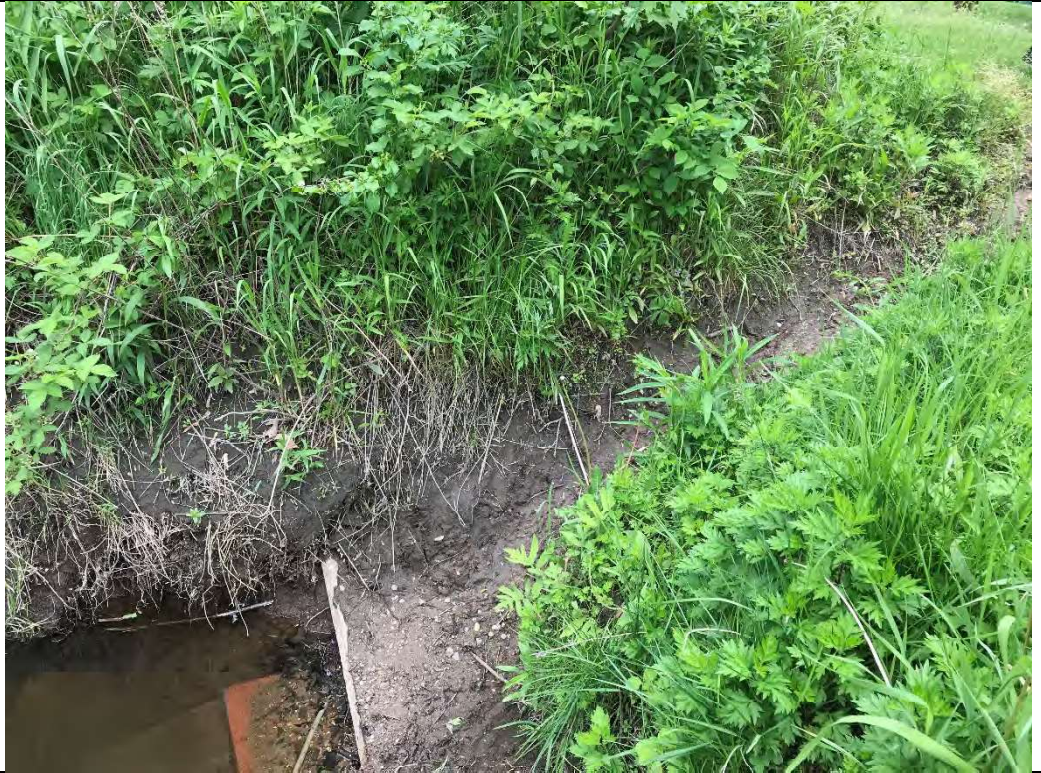
Direction Photo Taken:
East

Description:
Existing informal access to the Farmington River west of the entrance drive to Curtiss Park. North of Road Station 134+50.

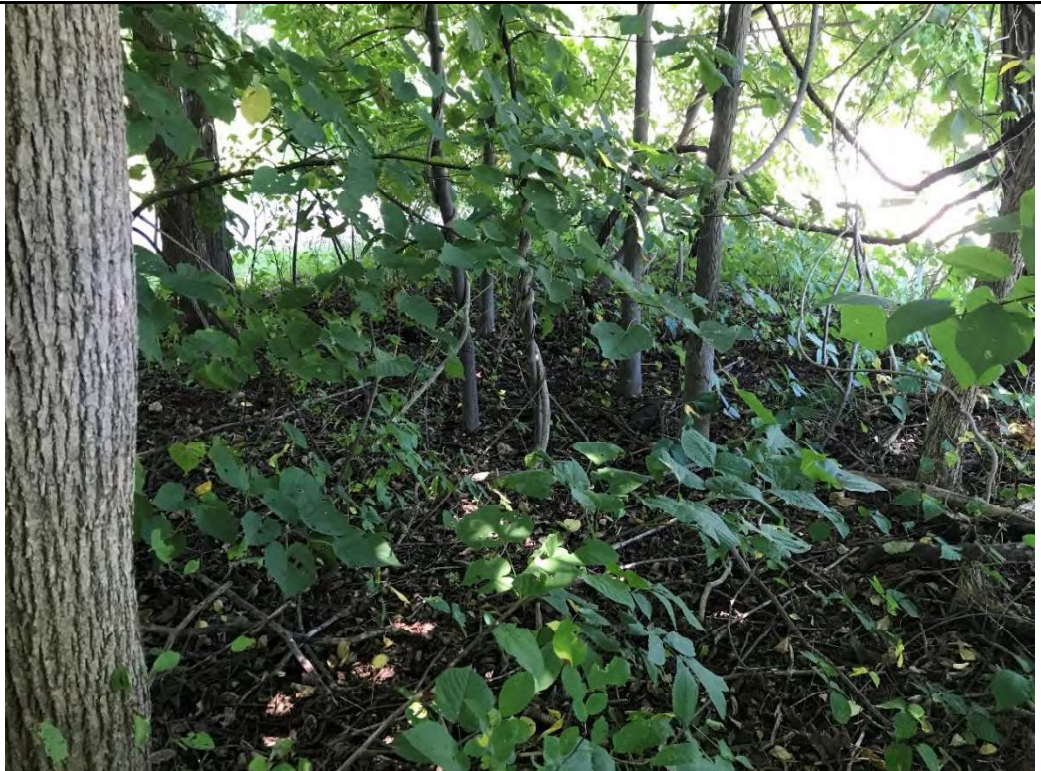
Photo No.
8 **Date:**
09/03/2018

Direction Photo Taken:
Northwest

Description:
Intersection of maintained lawn state wetlands, backwater pool/forested federal wetlands, and wet meadow federal wetlands. Adjacent to entrance of Curtis Park and Tariffville Road. West of Road Station 141+50.

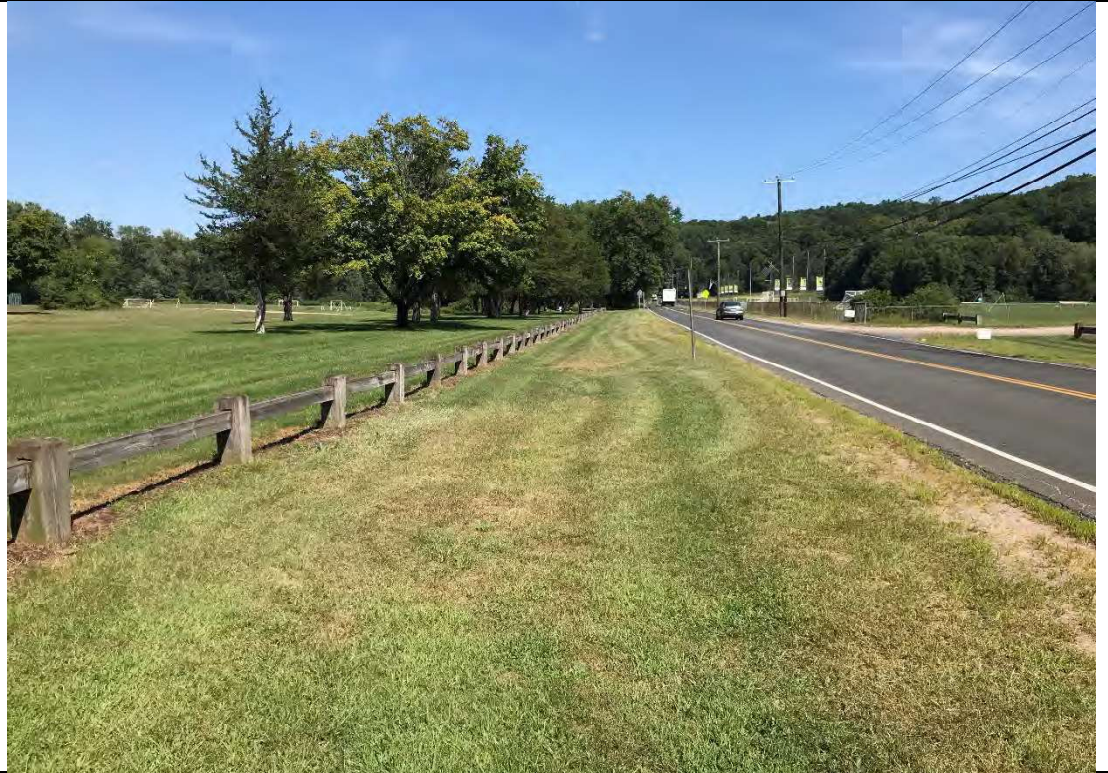
Direction Photo Taken:
Northeast

Description:
Dry maintained lawn state wetlands (floodplain soils) adjacent to Tariffville Road. West of Road Stations 136+00 to 141+00.

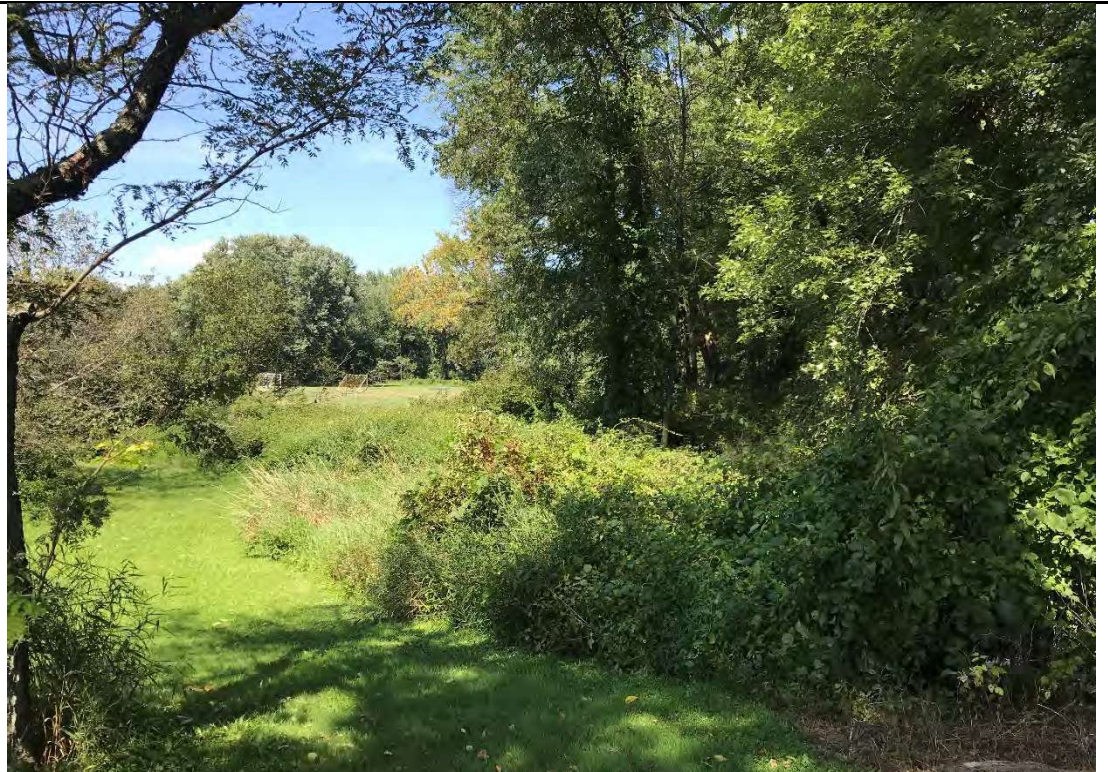
Photo No.
10 **Date:**
09/03/2018

Direction Photo Taken:
Northwest

Description:
Intersection of maintained lawn state wetlands, backwater pool/forested federal wetlands, and wet meadow federal wetlands. Adjacent to entrance of Curtis Park and Tariffville Road. West of Road Station 141+50.

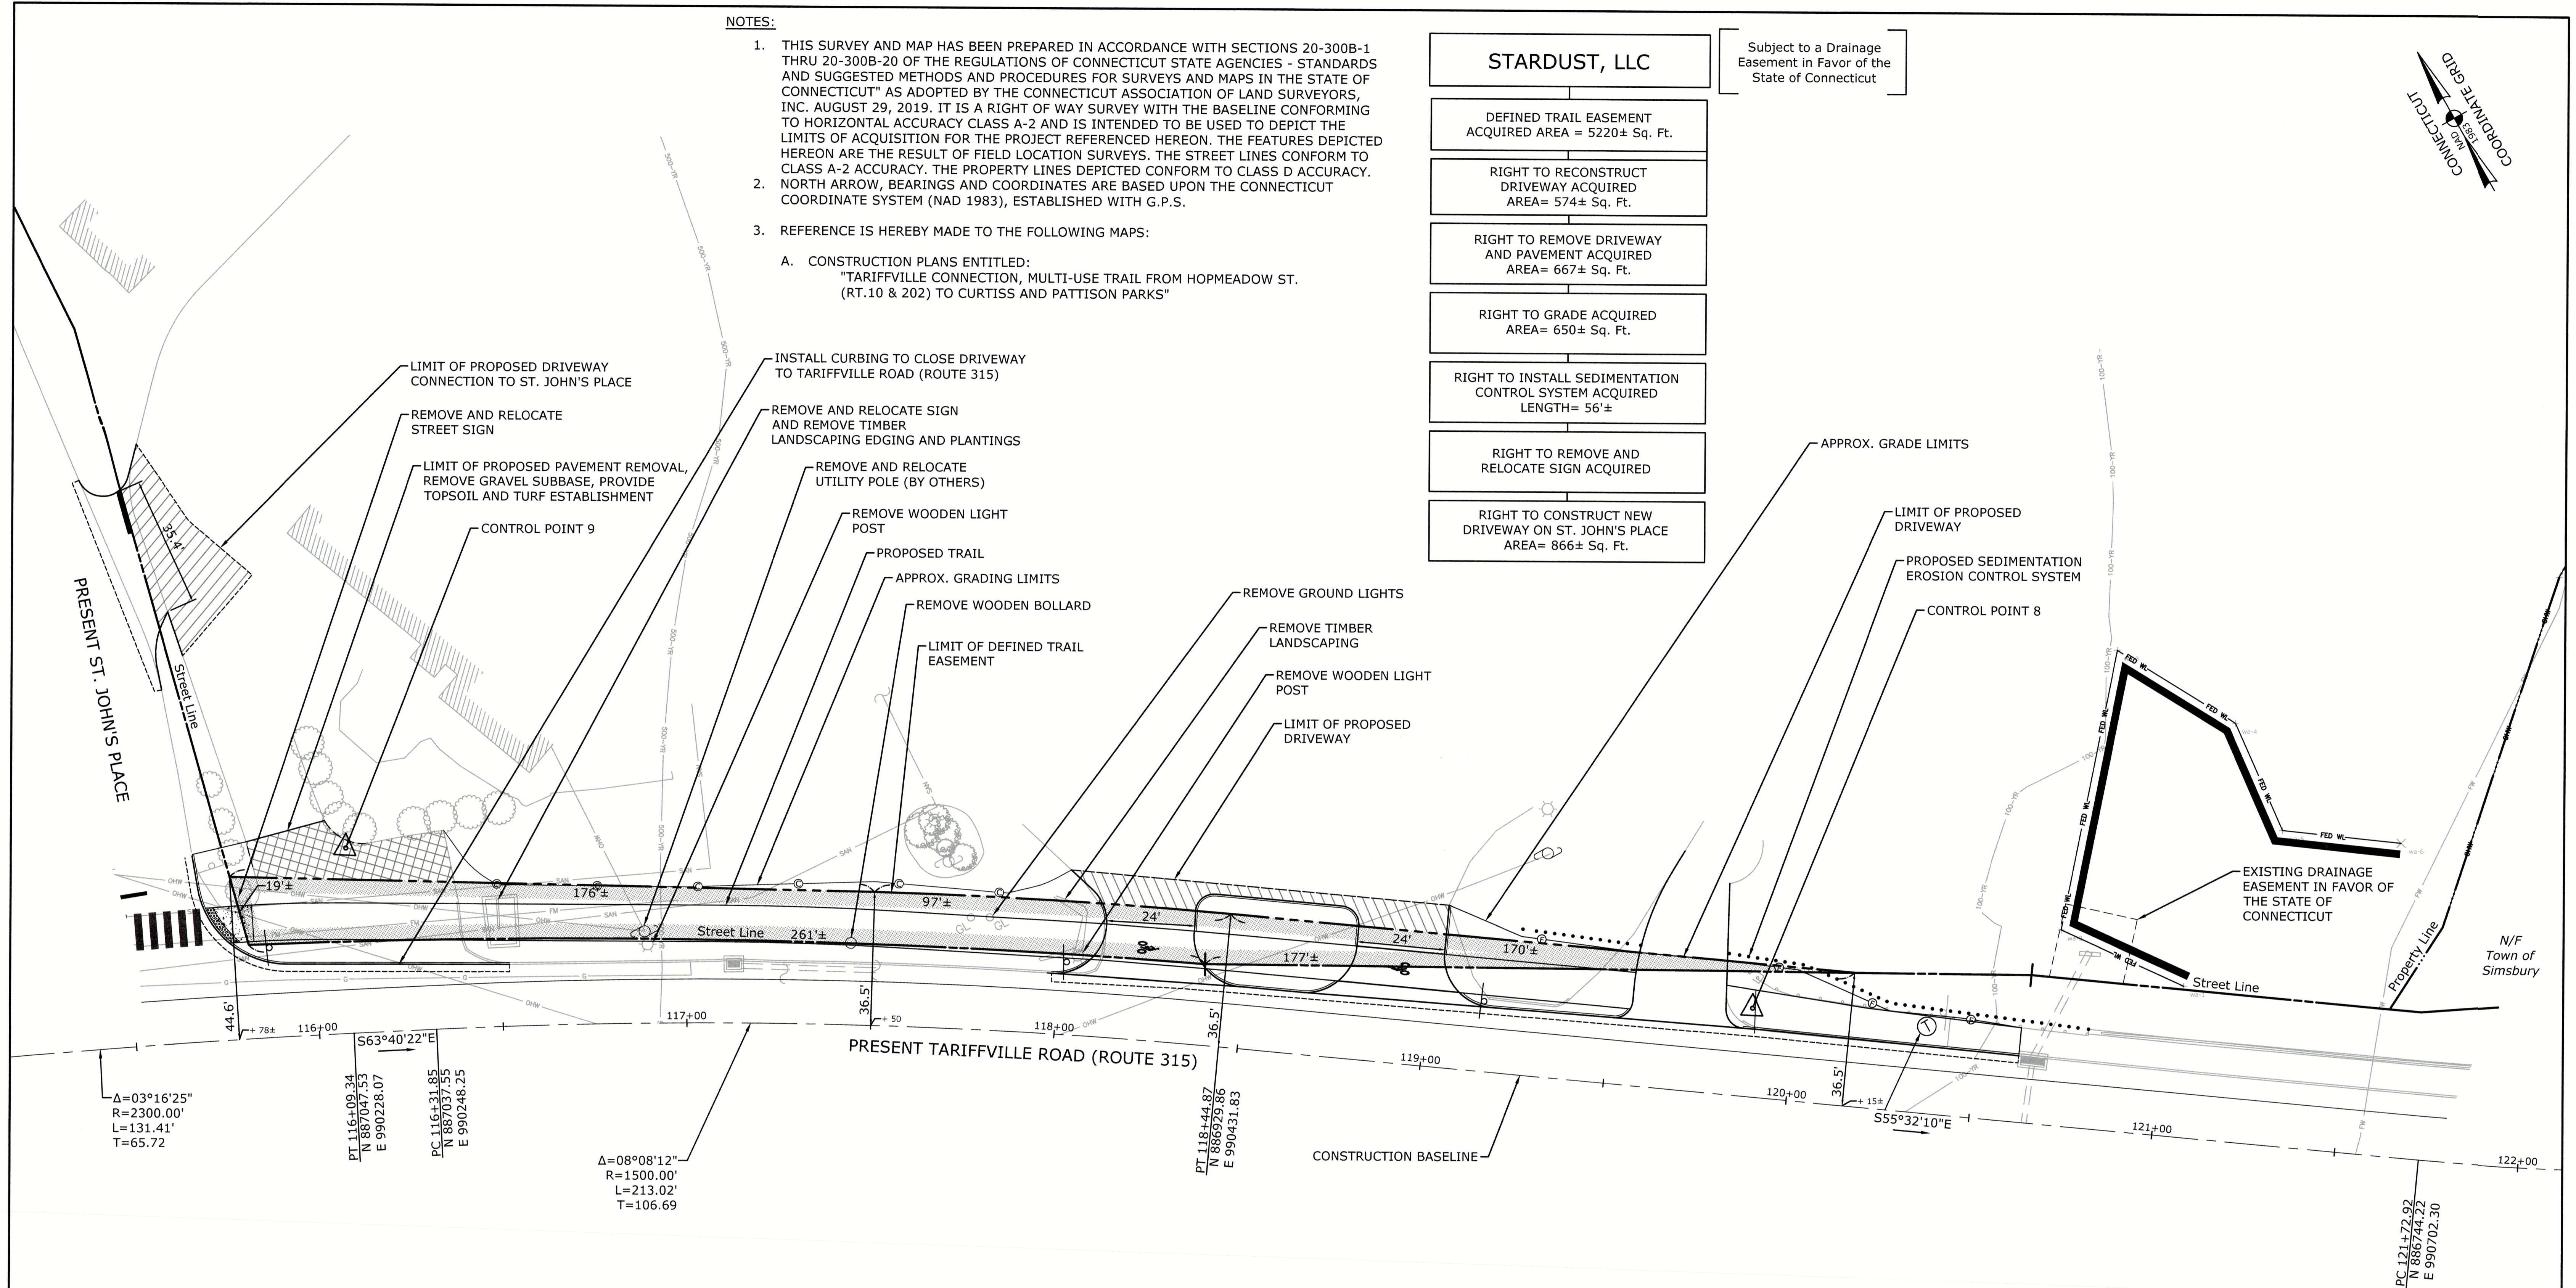
STARDUST, LLC	Subject to a Drainage Easement in Favor of the State of Connecticut
DEFINED TRAIL EASEMENT ACQUIRED AREA = 5220± Sq. Ft.	
RIGHT TO RECONSTRUCT DRIVEWAY ACQUIRED AREA= 574± Sq. Ft.	
RIGHT TO REMOVE DRIVEWAY AND PAVEMENT ACQUIRED AREA= 667± Sq. Ft.	
RIGHT TO GRADE ACQUIRED AREA= 650± Sq. Ft.	
RIGHT TO INSTALL SEDIMENTATION CONTROL SYSTEM ACQUIRED LENGTH= 56'±	
RIGHT TO REMOVE AND RELOCATE SIGN ACQUIRED	
RIGHT TO CONSTRUCT NEW DRIVEWAY ON ST. JOHN'S PLACE AREA= 866± Sq. Ft.

Δ=03°16'25"
R=2300.00'
L=131.41'
T=65.72
