DAM SAFETY PROGRAM DAM INSPECTION REPORT FORM – FOR REGULATORY INSPECTION

Dam Name:	House Rest Pond Dam	Inspection Date(s):	1/20/2016
Alternate Dam Name(s):	N/A	CT Dam ID #:	12812
Location (Municipality):	Simsbury	Temperature / Weather:	Clear 25°
Registered?: Yes or No If yes, provide the 9 digit registration number found on the notification letter.	Yes	Pool Level: See Instructions	= Crest of spillway
Emergency Action Plan?: Yes or No If Yes, see instructions	No	Impoundment Use: use options listed in instructions	Recreation
Hydraulic and Hydrologic Analysis?: Yes or No If Yes, see instructions	No	Stability Analysis?: Yes or No If Yes, see instructions	No
Overall Condition: (refer to Appendix A located at the end of this form) Poor

Dam Name:	Stoddard Reservoir	Inspection Date(s):	1/20/2016
Alternate Dam Name(s):	N/A	CT Dam ID #:	12804
Location (Municipality):	Simsbury	Temperature / Weather:	30°, clear
Registered?: Yes or No If yes, provide the 9 digit registration number found on the notification letter.	Yes	Pool Level: See Instructions	Spillway + 1"
Emergency Action Plan?: Yes or No If Yes, see instructions	No	Impoundment Use: use options listed in instructions	Recreation
Hydraul

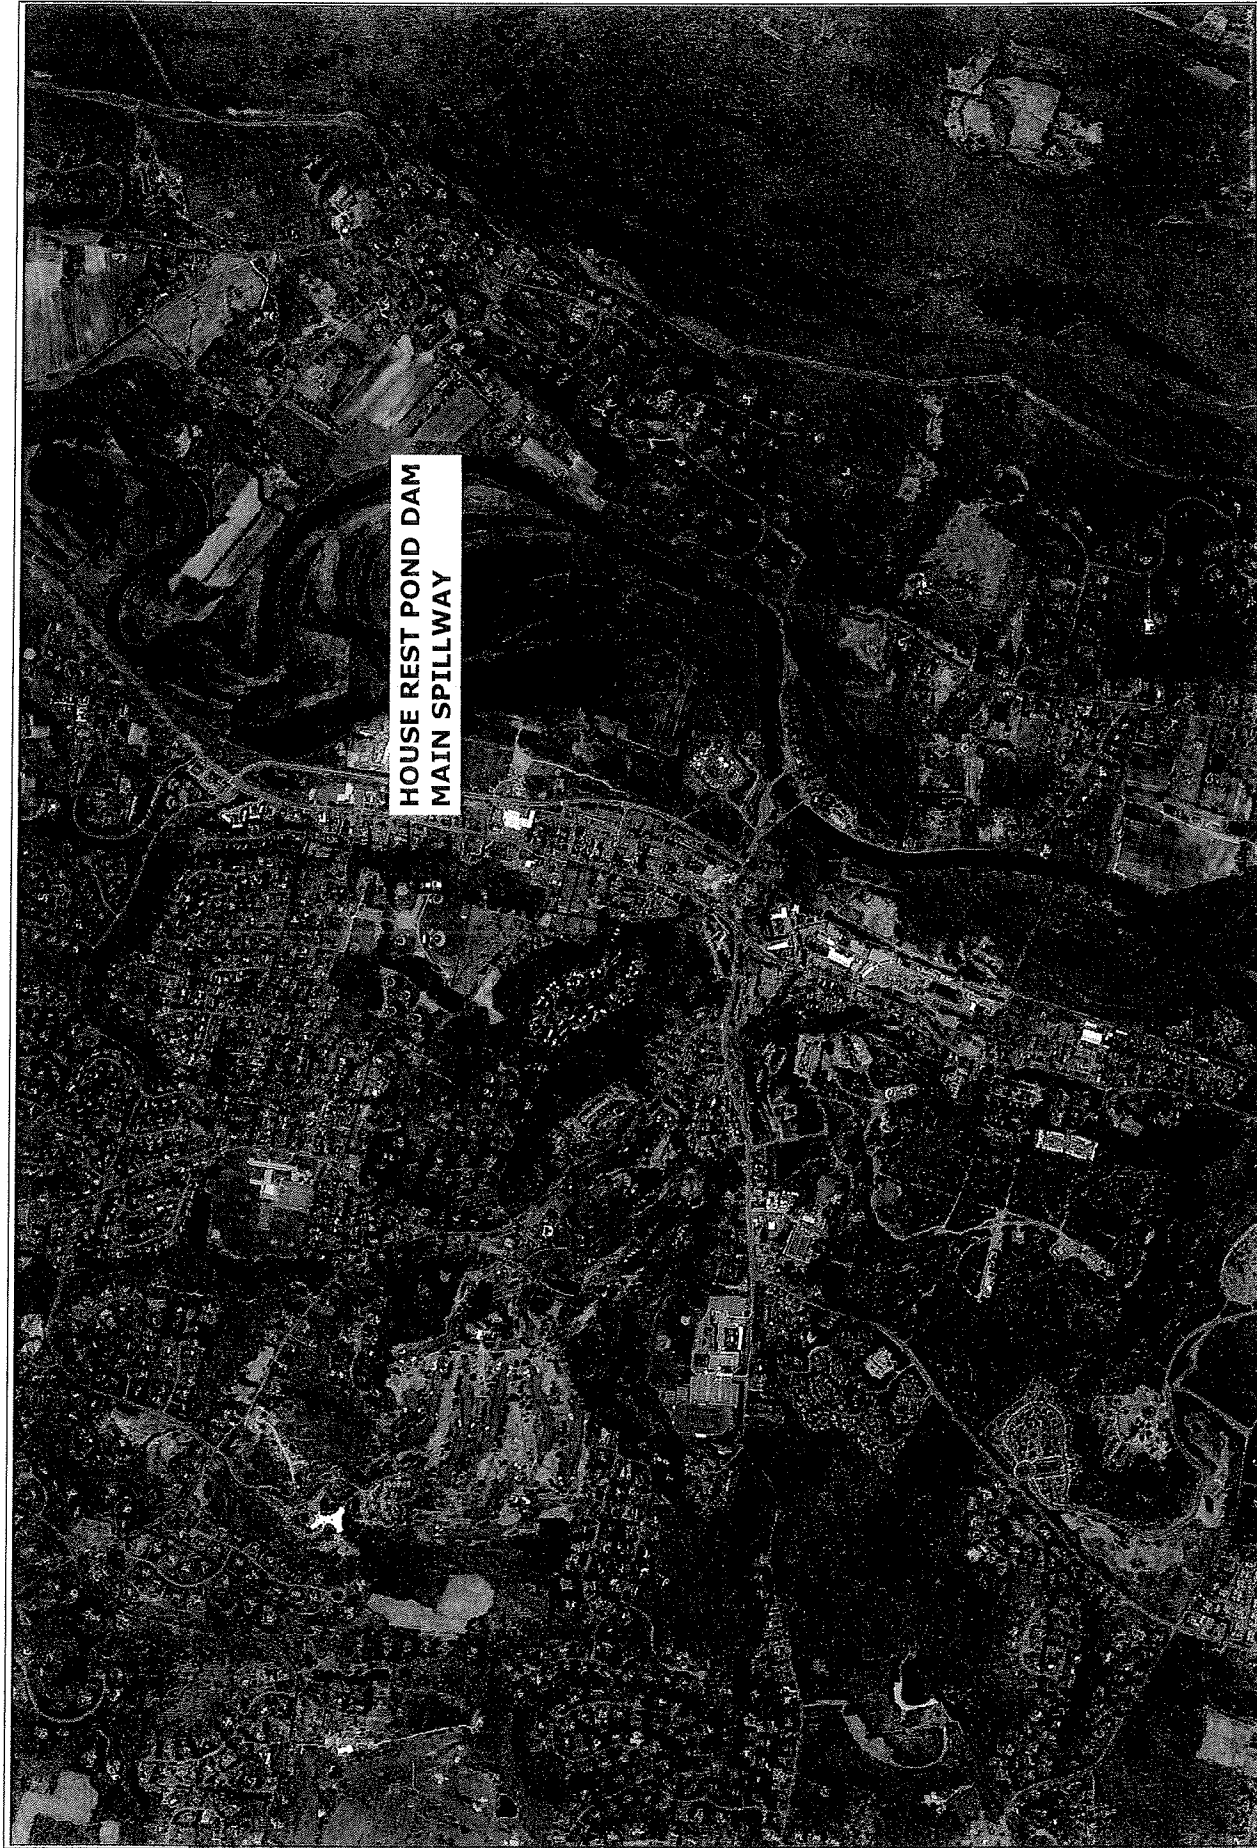
HOUSE REST POND DAM
MAIN SPILLWAY

Stone Masonry: Loose and leaking

Cracks: Gaps at top of spillway

Seepage/Foundation Drainage: Leaking throughout

Other: Poor connection to wing walls leaves gaps to sides, wings walls nearly completely failed

1. Drain pond, rebuild spillway and wing walls
2. Clear trees from embankment
3. Improve foundation for footbridge
4. Re-grade and reseed top of embankment
