# Town of Simsbury

#### **WATER POLLUTION CONTROL FACILITY PRIMARY CLARIFIER RESTORATION**

**TOWN OF SIMSBURY, CONNECTICUT**  
**PROFESSIONAL DESIGN SERVICES**  
**WATER POLLUTION CONTROL FACILITY**  
**PRIMARY CLARIFIER RESTORATION**

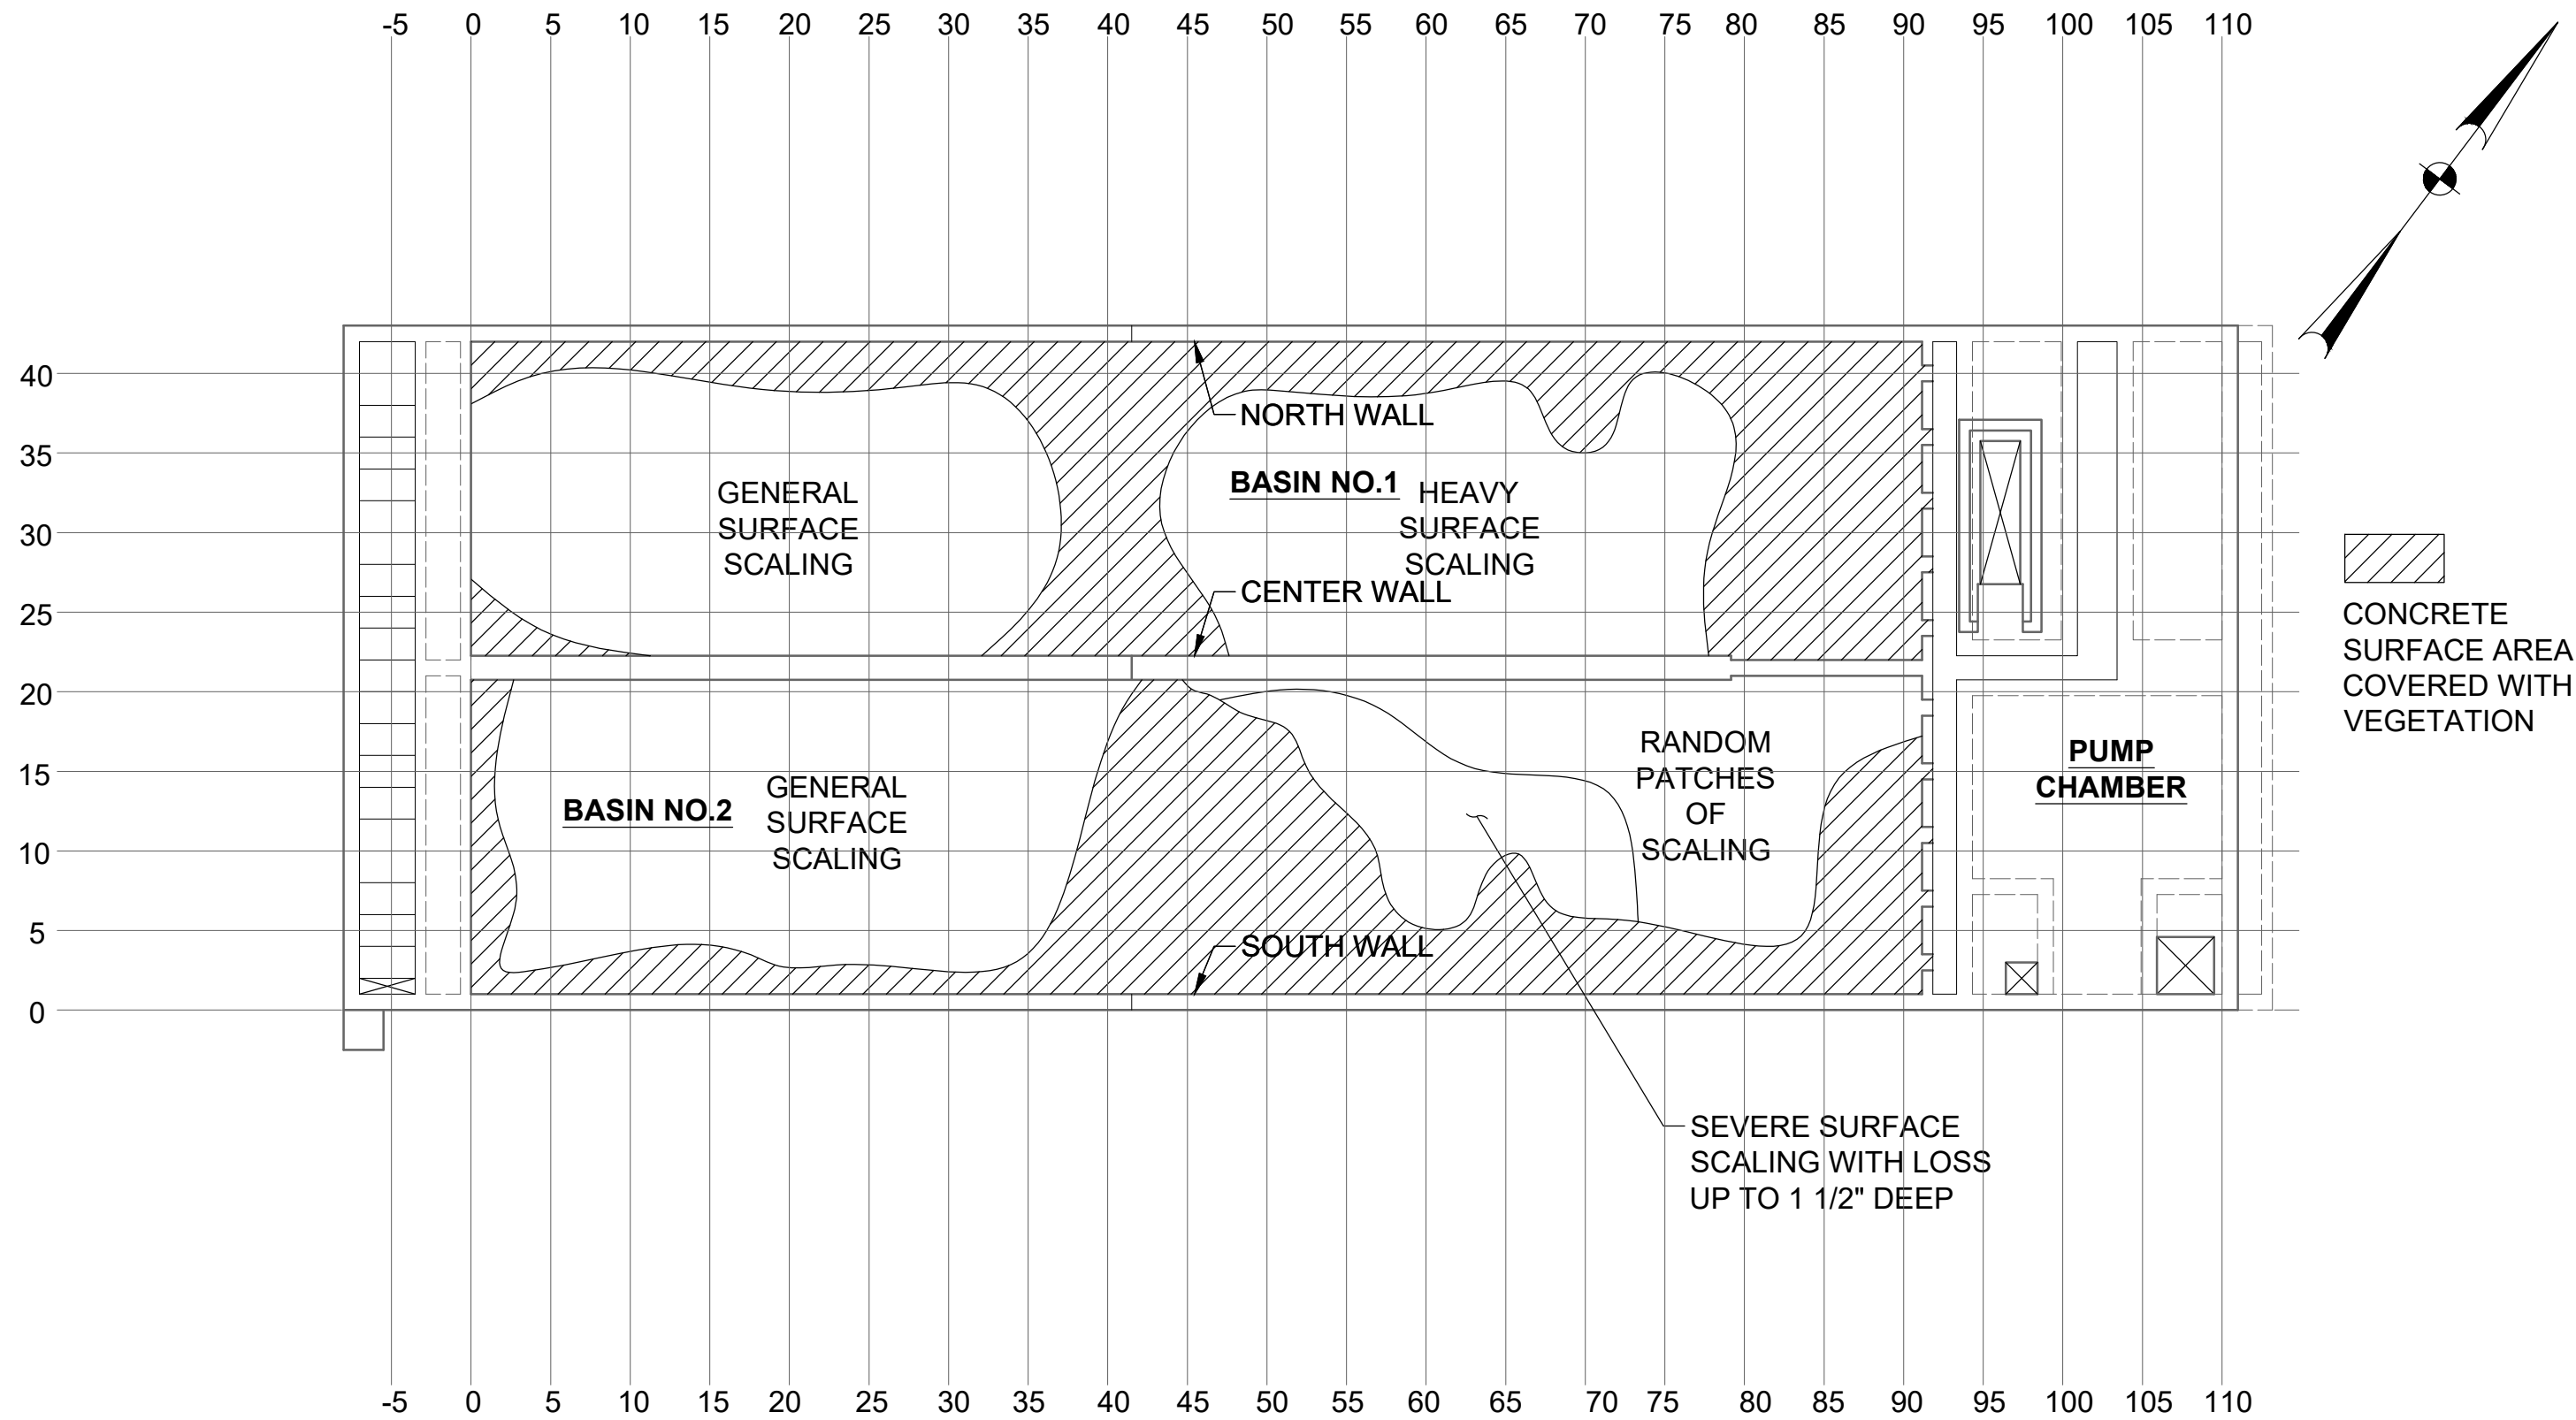
SKETCH SK-02

- The concrete slab surfaces (adjacent to the Effluent Channel and Pump Chamber) include areas of map cracking and light surface scaling. At several locations, surface patches / repairs in the concrete slab appear to be loose or hollow.
- The concrete surfaces of the catwalk slab at the center strut includes areas of surface scaling and exposed shallow steel reinforcement. The underside of the T-shaped strut also includes exposed stirrup reinforcement with concrete pop-outs.

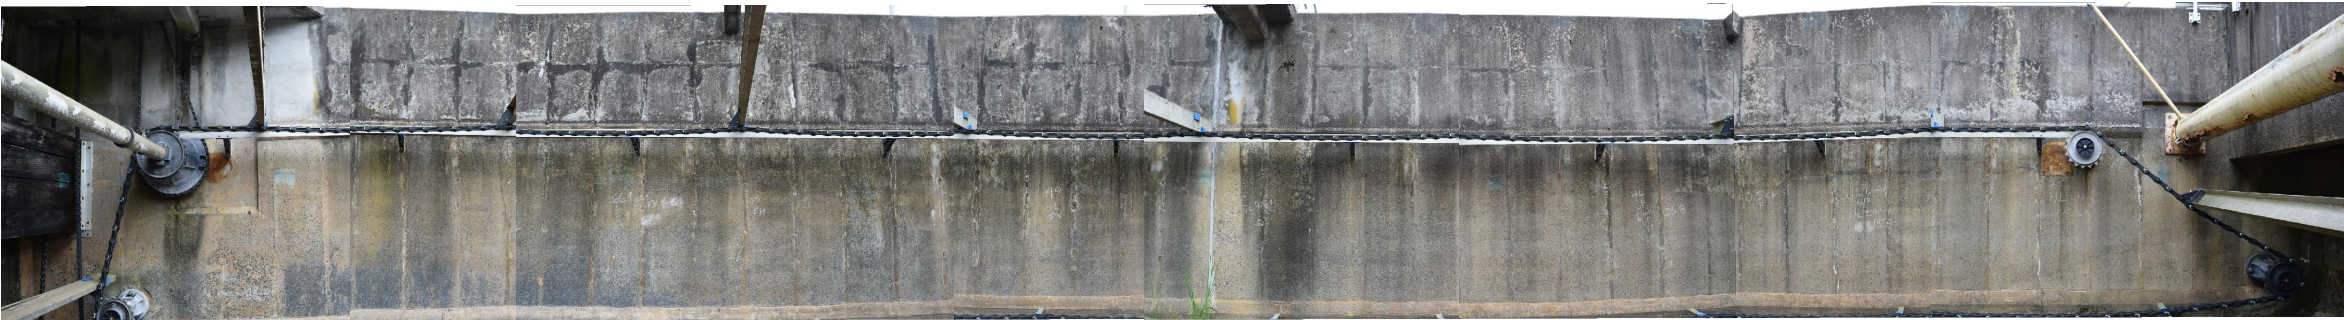
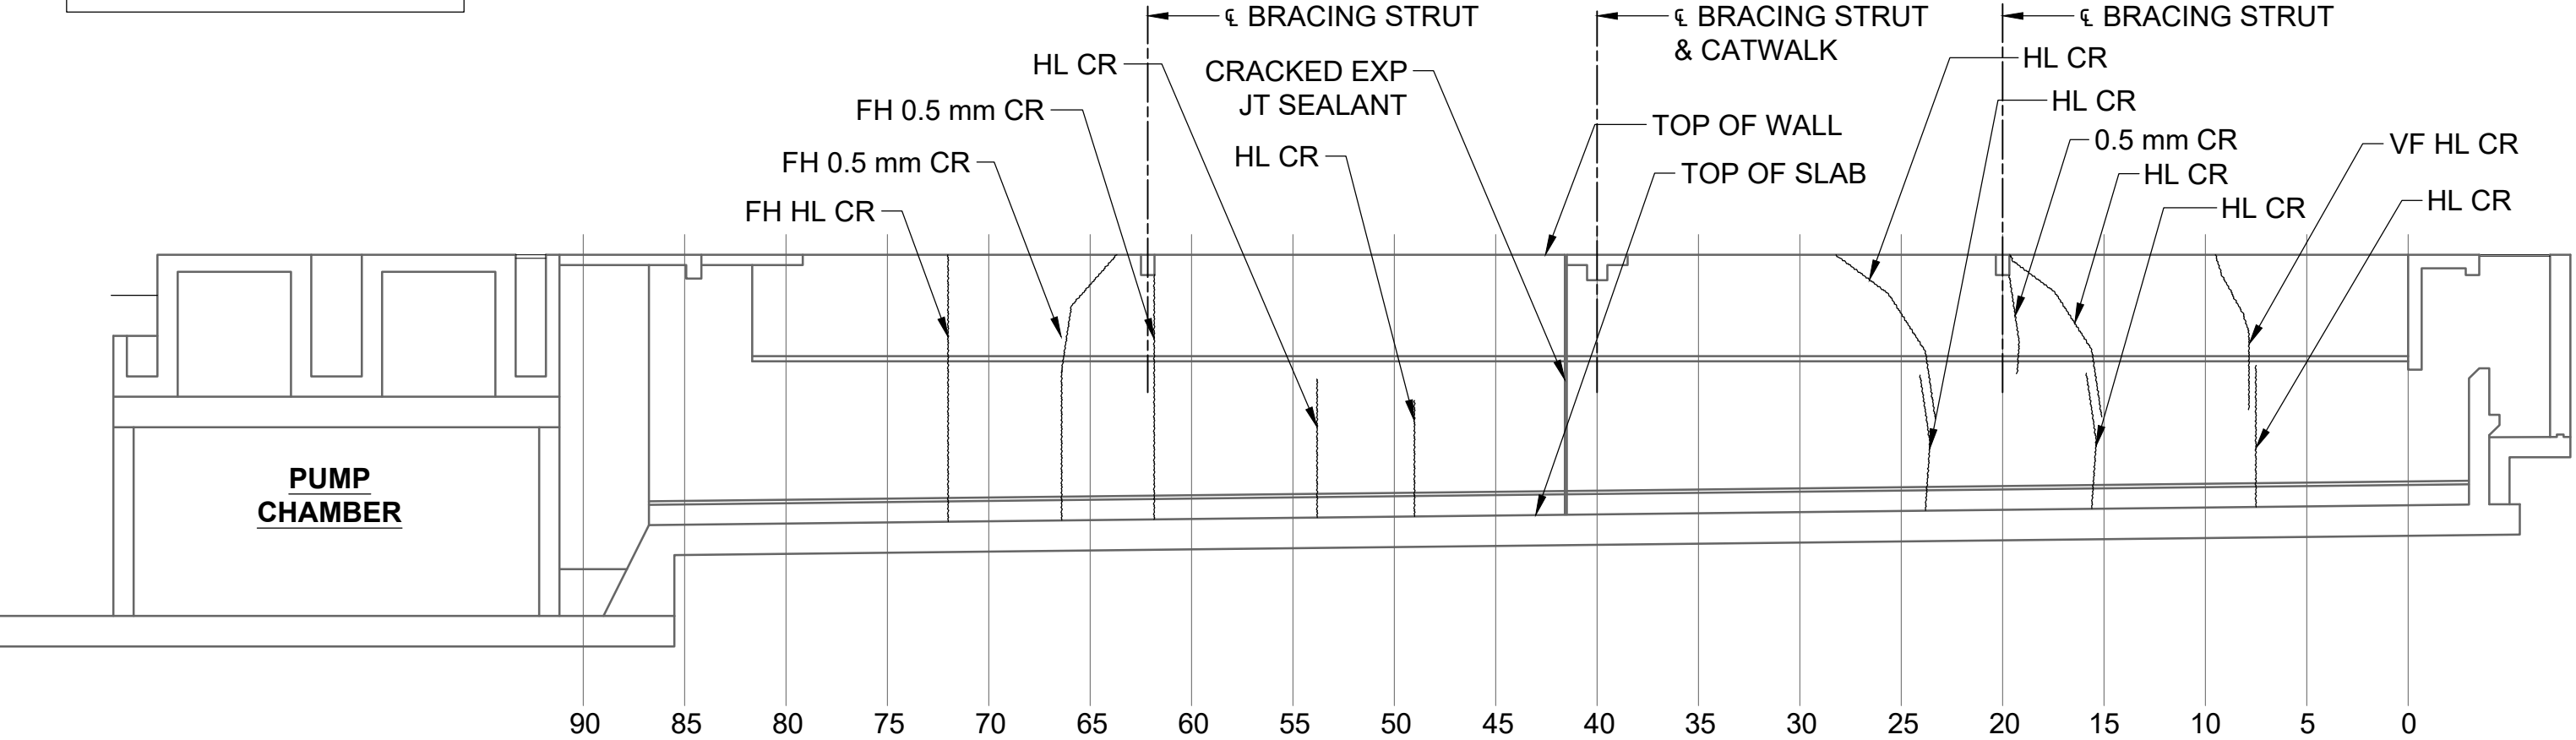
**BASIN NO. 1 - CENTER WALL ELEVATION**

NOTE:  
EXPOSED FOR TIES ARE PRESENT THROUGHOUT

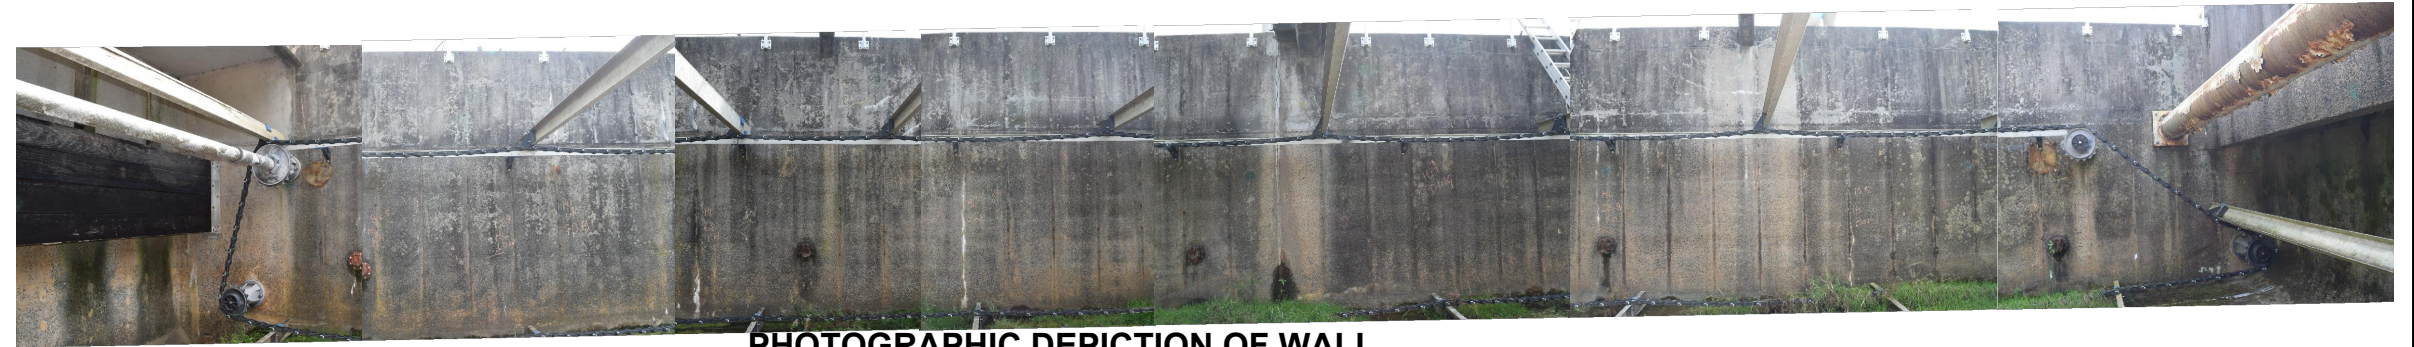
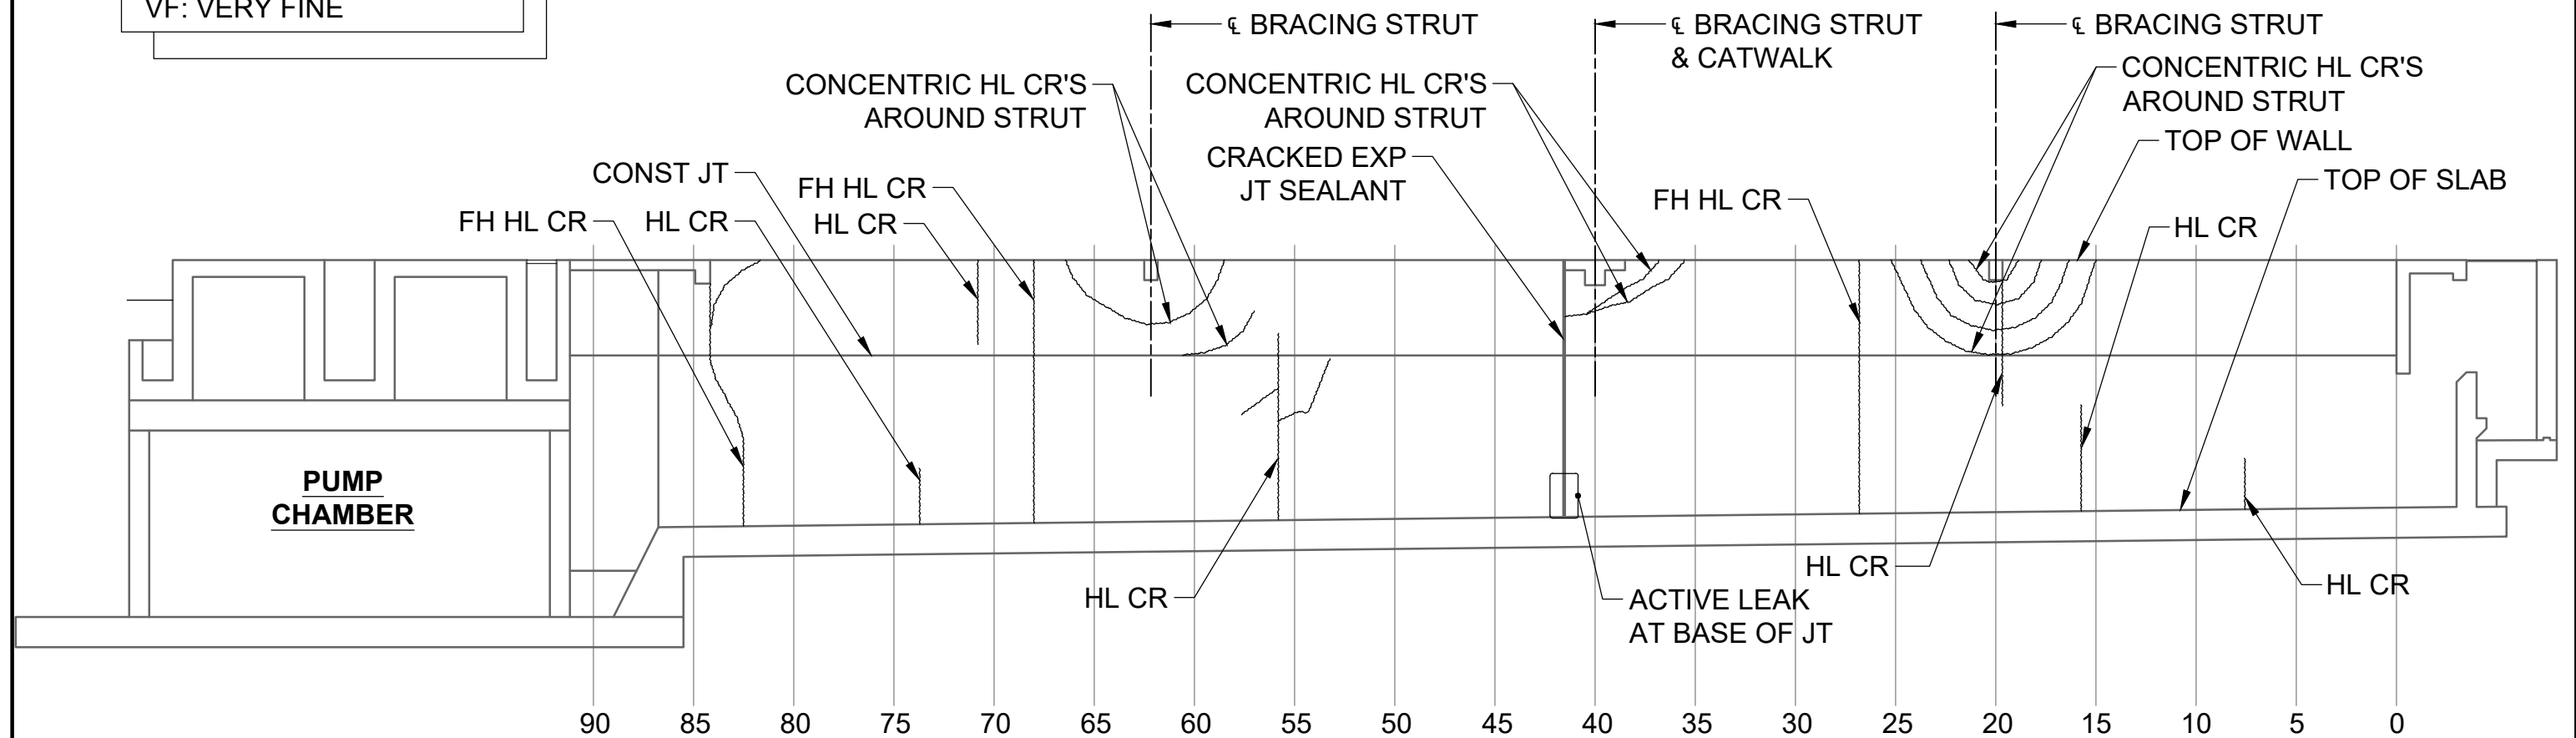
## **BASIN NO. 2 - SOUTH WALL ELEVATION**

The top of the south wall adjacent to the expansion joint included patching repairs which were completed in 2003. Spalling was observed around the patch, indicating active movement of the wall since the repairs were completed. The spalled concrete exposed a horizontal steel pin that is embedded into the original concrete on both sides of the expansion joint. The exposed steel pin was bent inward on the east side, indicating significant differential wall movement.

South wall concentric cracking was visible around each bracing strut and indicates areas of high tensile stress in the concrete, likely caused by the differential displacement of the wall between the struts.

Significant shear failure was observed in the top of the south wall on each side of the west bracing strut connection. Additionally, visible punching shear failure occurred to the longitudinal wall at the bracing strut connection. Similar but less significant punching shear distress was also observed in the north longitudinal wall at the east and west bracing strut connections.

The shear failure of the south longitudinal wall at the west bracing strut is of significant concern. The west bracing strut is no longer effective and does not provide adequate bracing to the top of the westerly half of the south longitudinal wall.

Additional evaluation will be required in order to identify the specific causes leading to the observed areas of structural failure. Regardless of the findings from any further studies, it is likely that the clarifier basins will need to undergo significant structural repairs, including removal and replacement of the top portion of the basin walls as well as the replacement of the bracing struts.

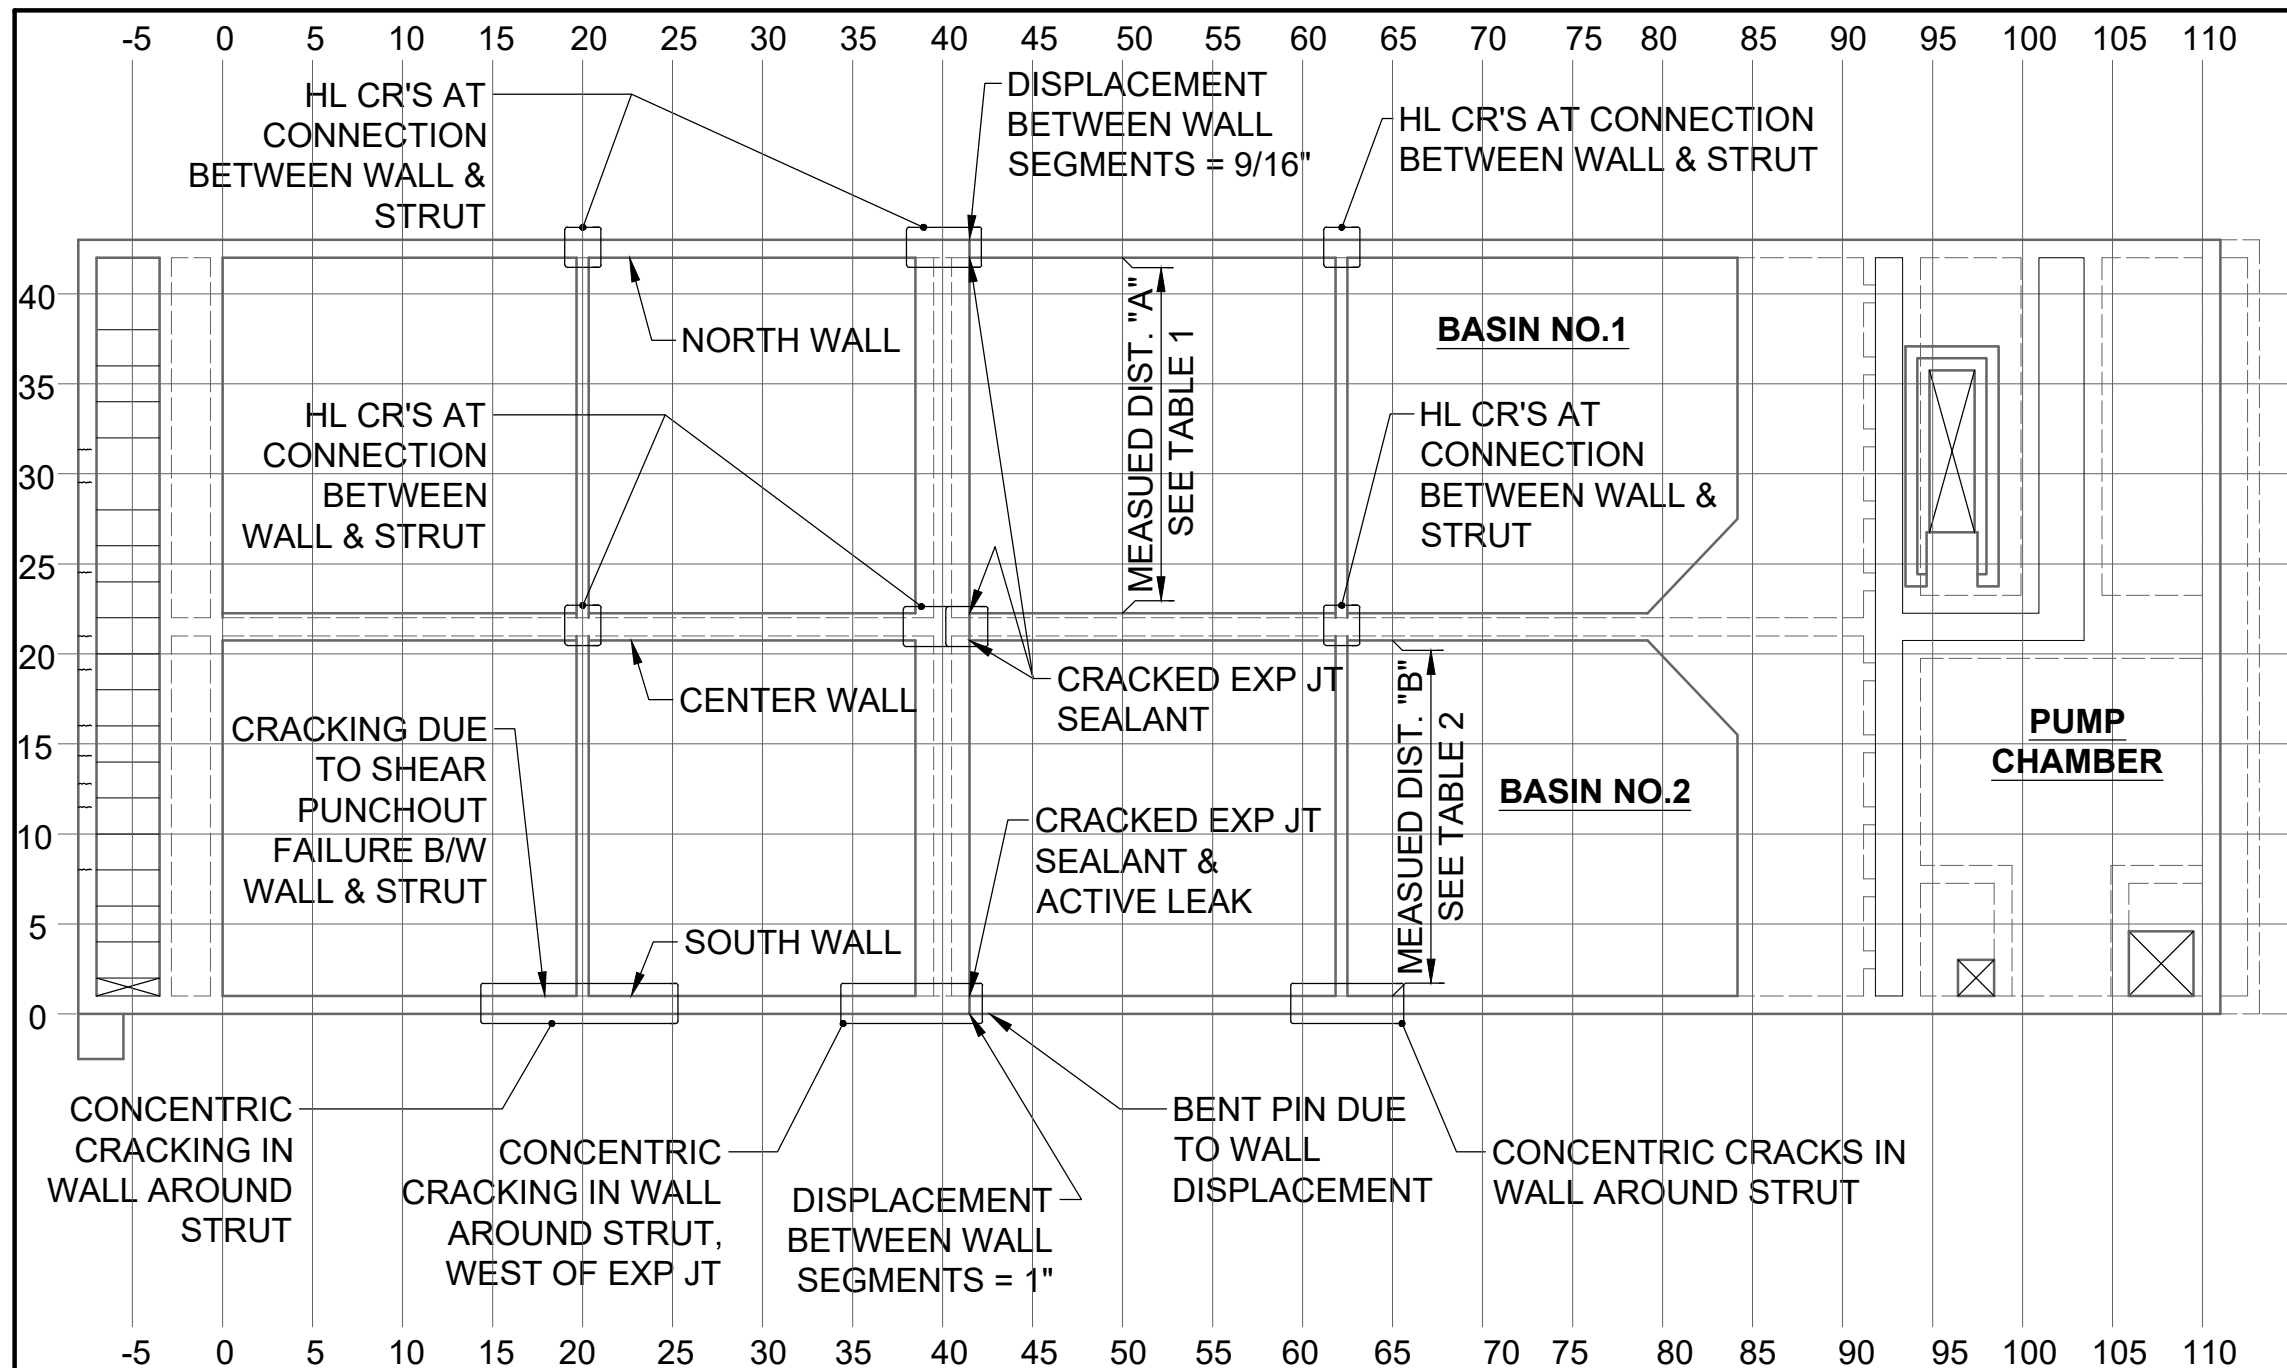
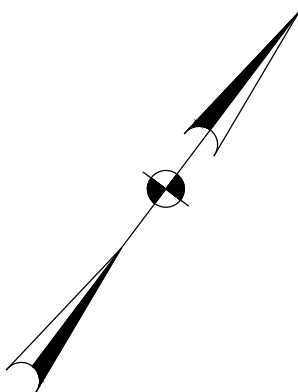
## STRUCTURAL DEFICIENCY PLAN

Signs of visible active lateral displacement were observed near the top of the north and south longitudinal walls. This wall displacement is most notable at the mid-point between the reinforced concrete bracing struts, and at the wall segment immediately east of the expansion joint. Attached Sketch SK-07 documents locations of structural distress related to the lateral displacement of the walls.

TABLES 1 & 2 SHOW MEASURED HORIZONTAL DISTANCE FROM CENTER WALL TO NORTH AND SOUTH WALLS, RESPECTIVELY. DISTANCES ARE SHOWN AT 5 FT INCREMENTS ALONG TOP OF WALL. TABULATED DEVIATION IS THE DIFFERENCE BETWEEN THE MEASURED DISTANCE AND THE DESIGN DISTANCE OF 19.75 FT.

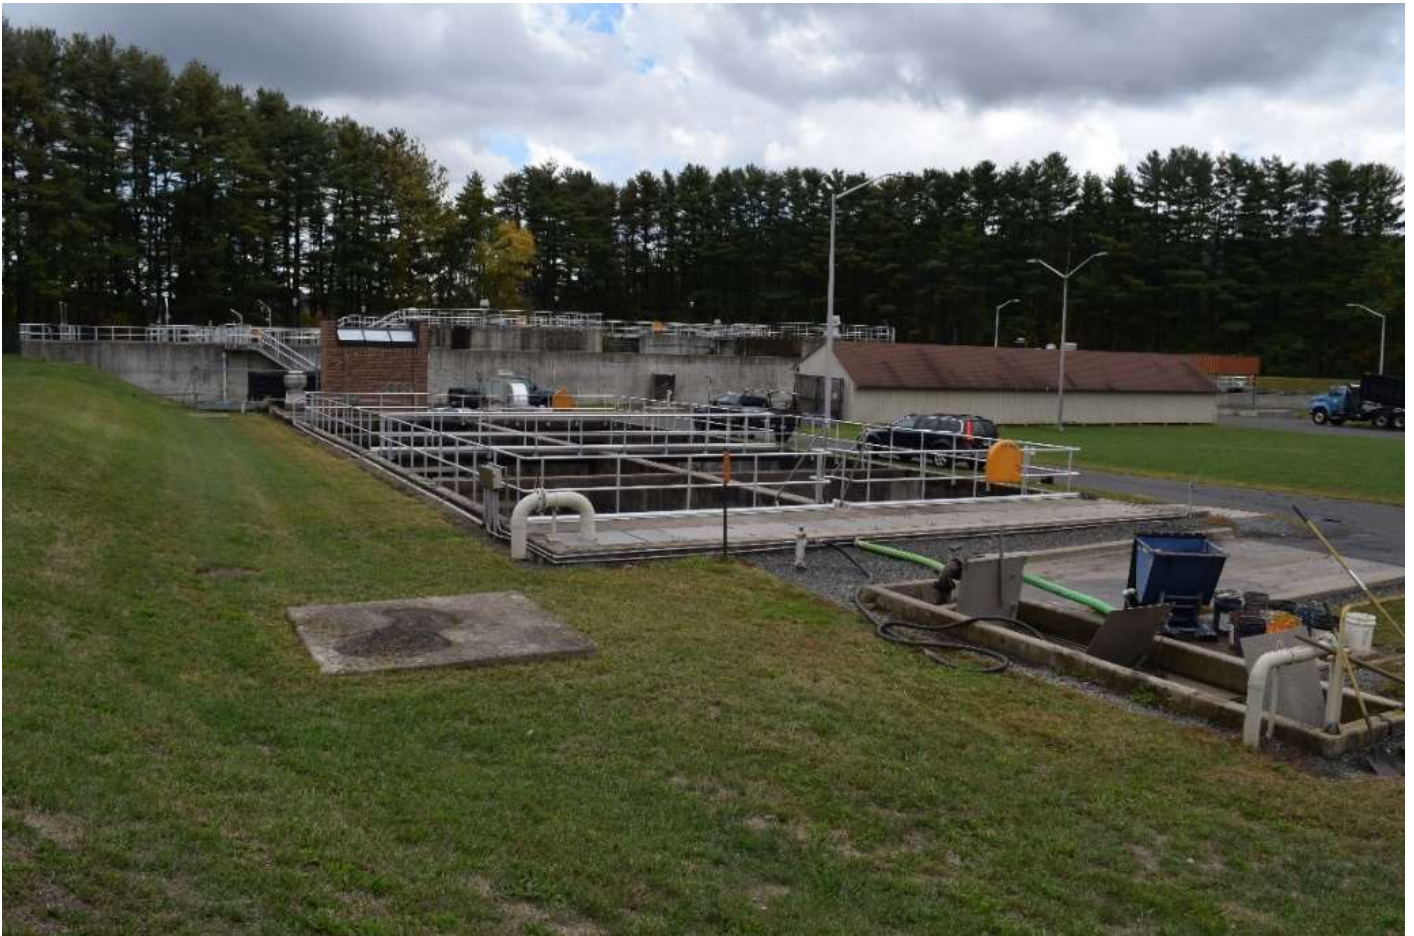
#### Photo 1– General View

General view of the clarifier looking towards the east from the northwest corner.

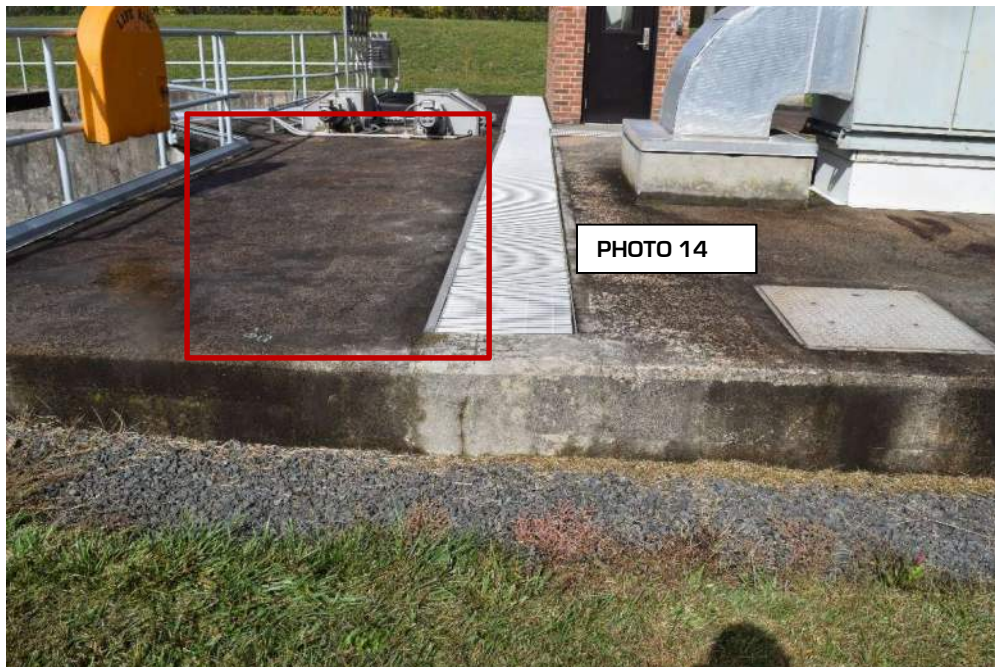
**Photo 13 – Clarifier Top Slab – East End (Looking North)**  
General view of the top slab on the east end of the clarifier.

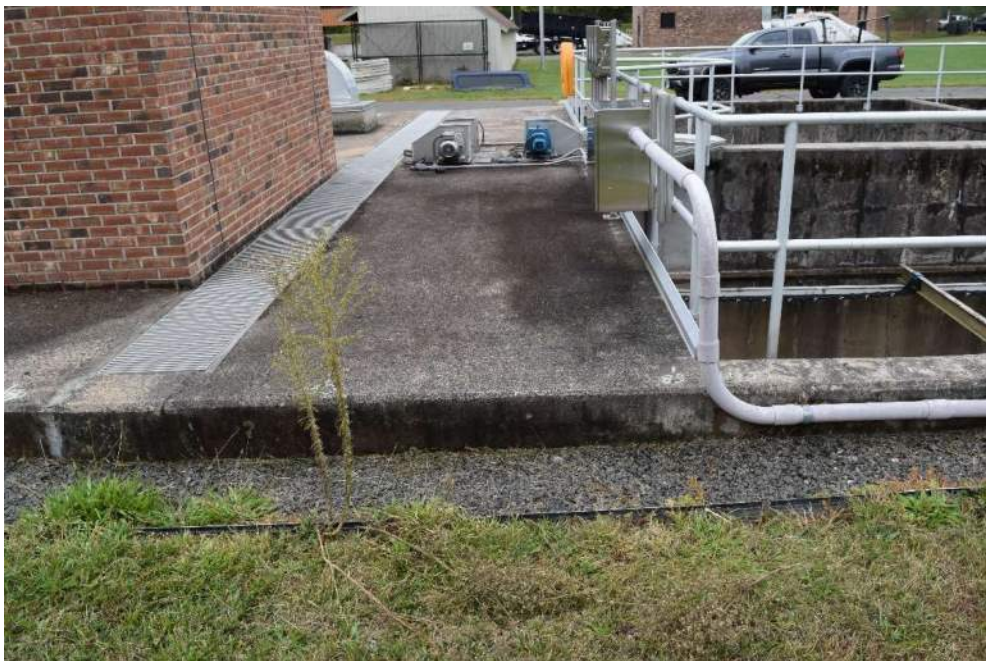
**Photo 20 – Clarifier Top Slab – East End (Looking South)**  
General view of the top slab on the east end of the clarifier.

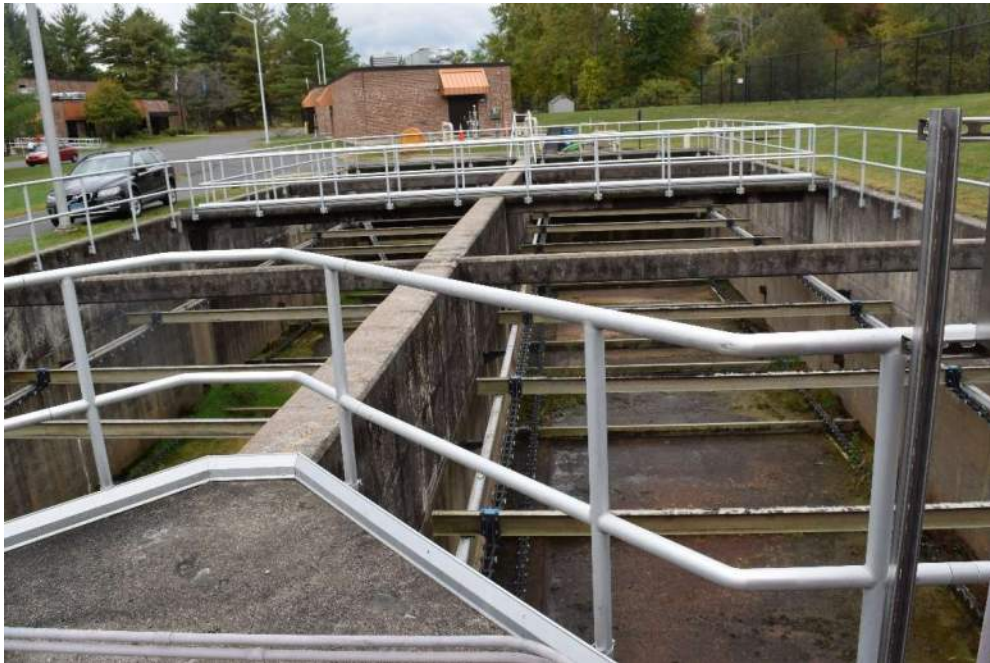
**Photo 21 – Center Wall between Clarifier Basins 1 and 2 (Looking West)**

General view of the Center Wall between Basin No. 1 (to the right) and Basin No. 2 (to the left).

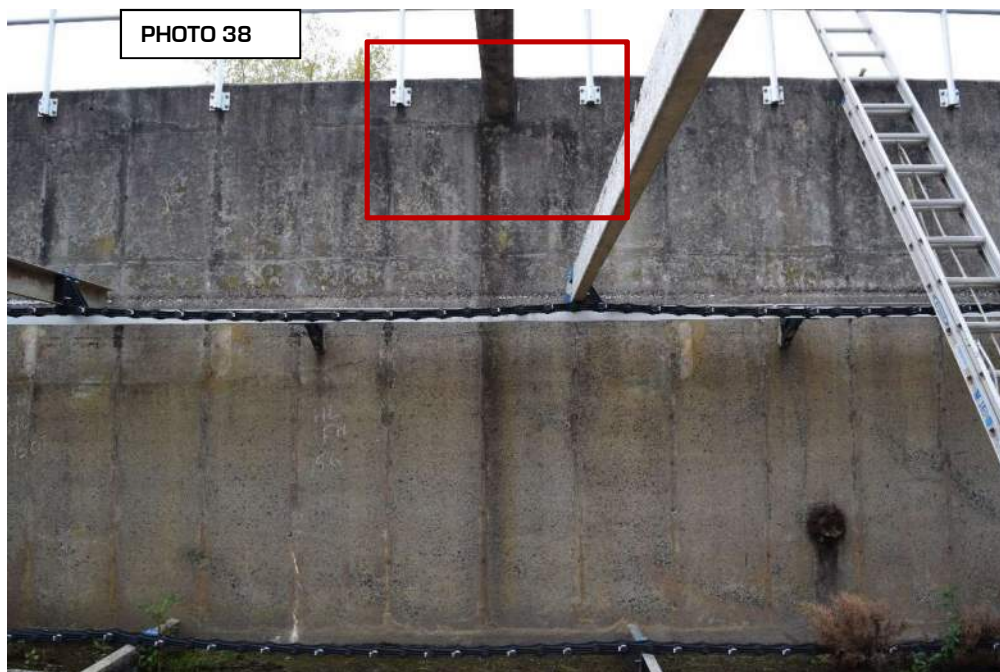
**Photo 37 – North Wall of Basin No. 1 at West Bracing Strut – (Looking North)**  
General view of the connection of the West Bracing Strut to the North Wall of Basin No. 1.

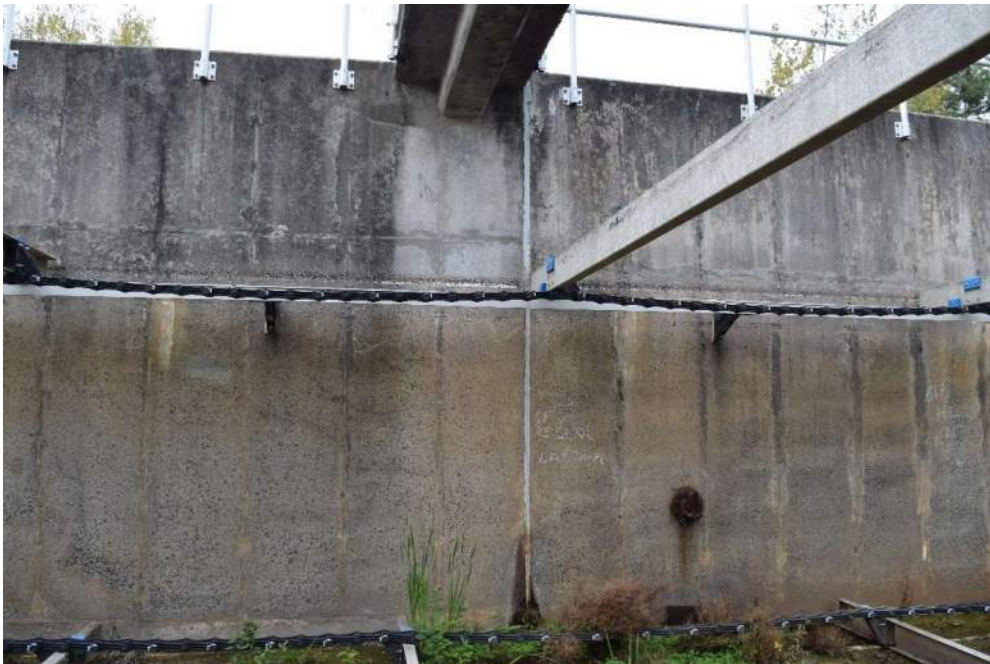
**Photo 39 – North Wall of Basin No. 1 at Center Bracing Strut/Catwalk – (Looking North)**  
General view of the connection between the Center Bracing Strut/Catwalk and the North Wall of Basin No. 1.

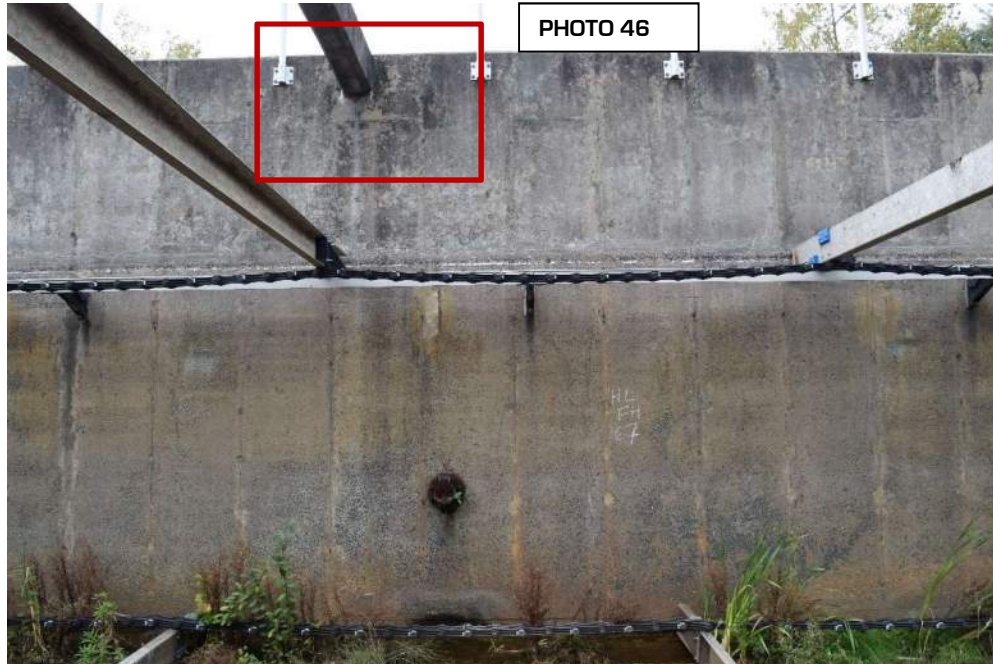
**Photo 45 – North Wall of Basin No. 1 at East Bracing Strut – (Looking North)**  
General view of the connection of the East Bracing Strut to the North Wall of Basin No. 1.
