Town of Simsbury, Connecticut Sidewalk and Curb Ramp Assessment

FINAL DRAFT

Prepared By:
BETA Group, Inc.
1010 Wethersfield Avenue
Suite 305
Hartford, CT 06114

September 2019

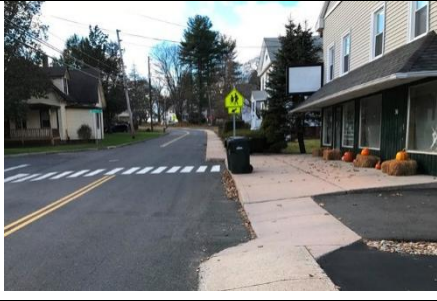
Condition Detail	Photographic Example
<p>Good: No distresses identified, only minor surface blemishes and deterioration observed on sidewalk. <i>Less than 10% of segment requires repairs.</i></p>

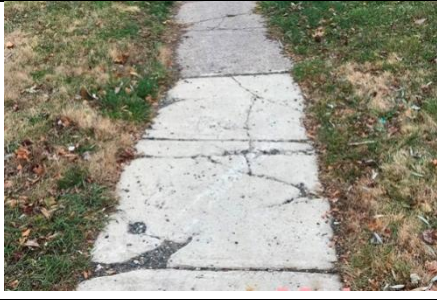
<p>Fair: Distresses start to develop, but provide minimal to no impedance (cracks, grass, depressions, bumps, patches, tree roots). <i>10%-25% of segment requires repairs.</i></p>

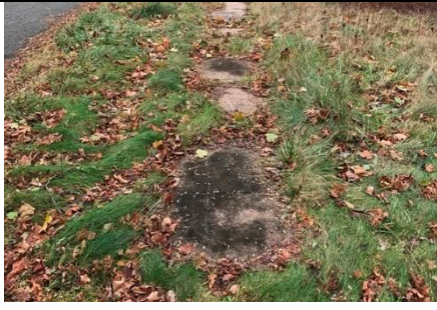
<p>Poor: Distresses and obstructions are actively found, proving the sidewalk to be hazardous. <i>More than 25% of segment requires repair/replace.</i></p>

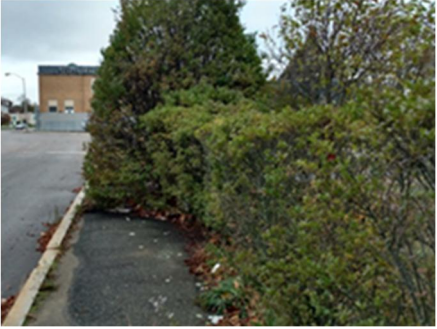
Observation Type	Photographic Example
<p>Maintenance: Locations that only require minor attention</p> <ul style="list-style-type: none"> • Bushes • Overgrown Grass • Overhanging Trees

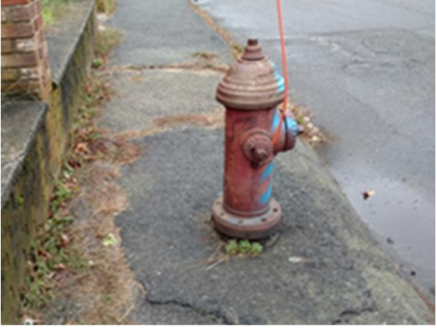
<p>Obstruction: Locations where minimal width (48") is not met due to an object</p> <ul style="list-style-type: none"> • Hydrants • Mailboxes • Signposts • Utility poles

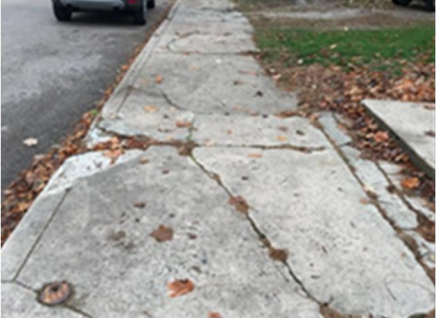
<p>Structural: Locations where spot repairs can be performed</p> <ul style="list-style-type: none"> • Cracking • Lifted panel • Poor patch • Spalling • Tree Roots

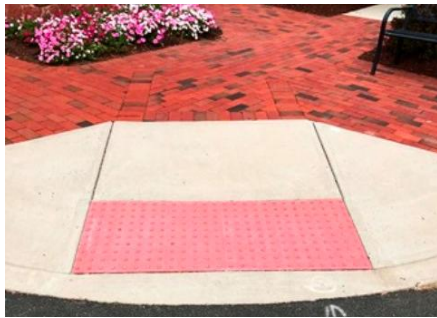
Condition Detail	Photographic Example
<p>Good: No distresses identified, only minor surface blemishes and deterioration observed on ramp. <i>Ramp does not require repairs.</i></p>

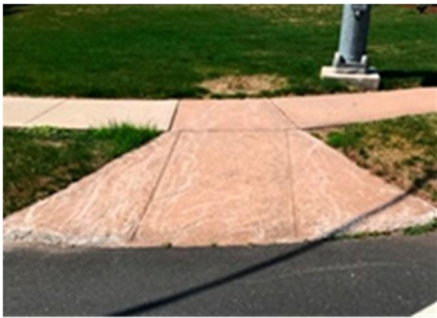
<p>Fair: Distresses start to develop, but provide minimal to no impediment (cracks, grass, depressions, bumps & patches). <i>Minor attention needed for ramp.</i></p>

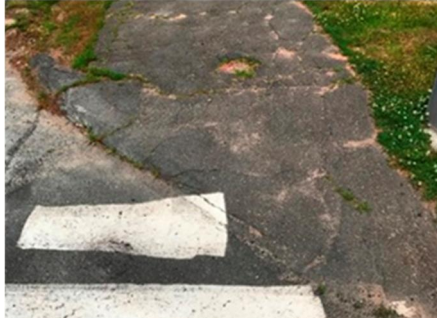
<p>Poor: Distresses and obstructions are actively found, proving the ramp to be hazardous. <i>Ramp requires replacement</i> <i>*Only Ramps rated as "Poor" will need to be replaced or considered Non-Compliant*</i></p>

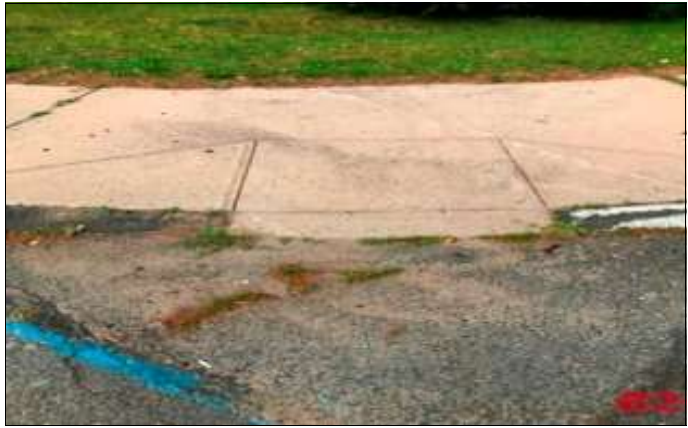
Ramp ID:	82-1
Street:	BICKFORD STREET
Intersecting Street:	BUSHY HILL ROAD
Ramp Material:	Concrete
Det. Warning Panel:	No
Panel Damage:	No
Obstructions:	Yes
Obstruction Type:	Vegetation
Condition:	Fair
Ramp Pass:	No

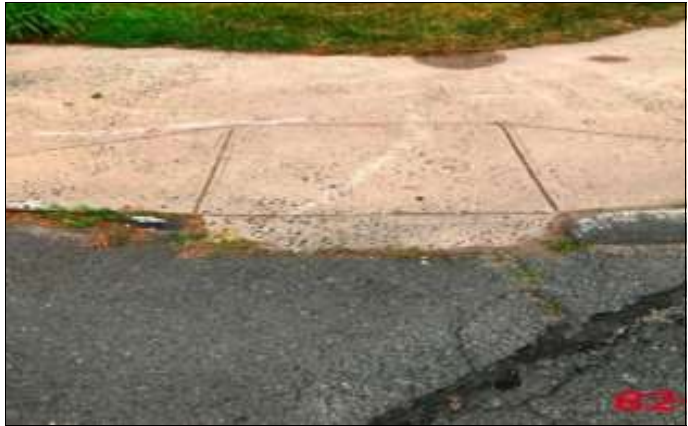
Ramp ID:	82-2
Street:	BICKFORD STREET
Intersecting Street:	BUSHY HILL ROAD
Ramp Material:	Concrete
Det. Warning Panel:	No
Panel Damage:	No
Obstructions:	Yes
Obstruction Type:	Curbing
Condition:	Fair
Ramp Pass:	No

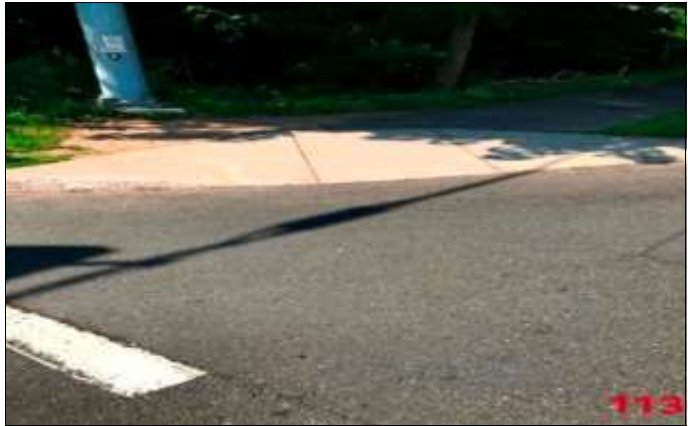
Ramp ID:	113-3
Street:	CANAL STREET
Intersecting Street:	HOPMEADOW STREET
Ramp Material:	Concrete
Det. Warning Panel:	No
Panel Damage:	No
Obstructions:	No
Obstruction Type:	None
Condition:	Good
Ramp Pass:	No

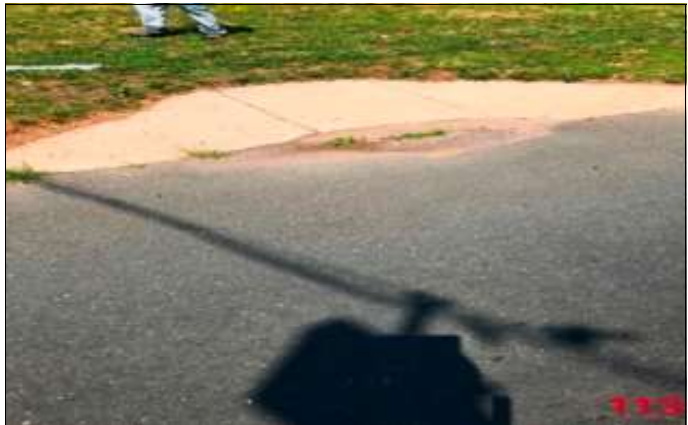
Ramp ID:	113-4
Street:	CANAL STREET
Intersecting Street:	HOPMEADOW STREET
Ramp Material:	Concrete
Det. Warning Panel:	No
Panel Damage:	No
Obstructions:	No
Obstruction Type:	None
Condition:	Good
Ramp Pass:	No

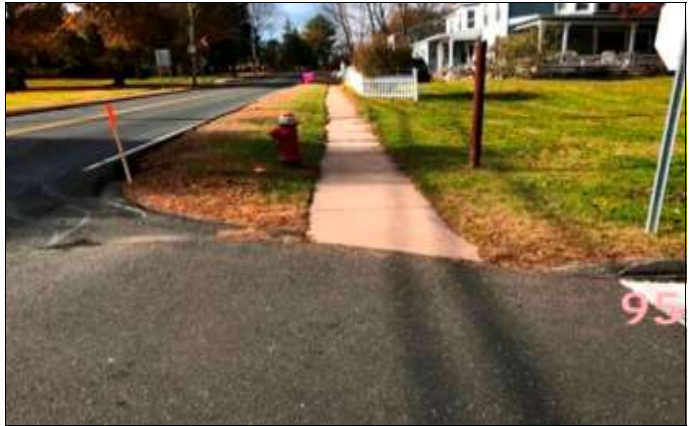
Ramp ID:	95-3
Street:	CHURCH STREET
Intersecting Street:	ELM STREET
Ramp Material:	Concrete
Det. Warning Panel:	No
Panel Damage:	No
Obstructions:	No
Obstruction Type:	None
Condition:	Good
Ramp Pass:	No

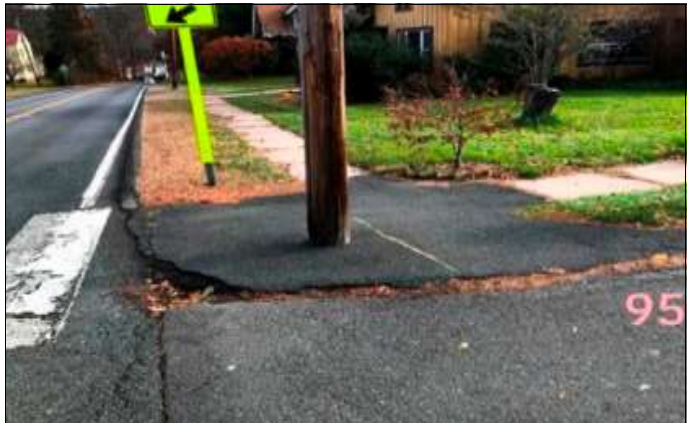
Ramp ID:	95-1
Street:	CHURCH STREET EXTENSION
Intersecting Street:	ELM STREET
Ramp Material:	Asphalt
Det. Warning Panel:	No
Panel Damage:	No
Obstructions:	No
Obstruction Type:	None
Condition:	Good
Ramp Pass:	No

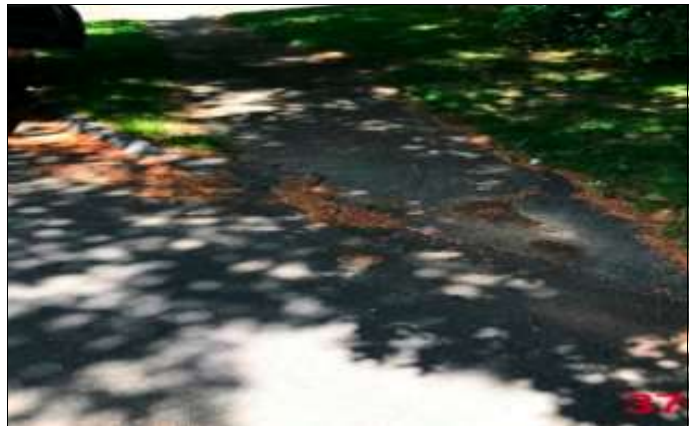
Ramp ID:	37-1
Street:	CRESTWOOD ROAD
Intersecting Street:	BUTTONWOOD DRIVE
Ramp Material:	Asphalt
Det. Warning Panel:	No
Panel Damage:	No
Obstructions:	No
Obstruction Type:	None
Condition:	Good
Ramp Pass:	No

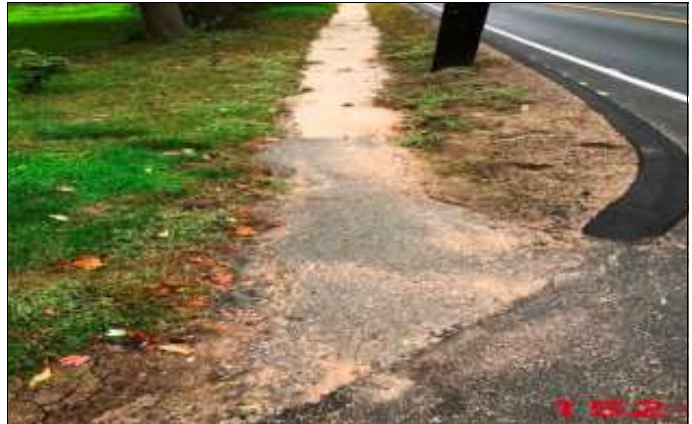
Ramp ID:	152-1
Street:	DAVEY STREET
Intersecting Street:	BUSHY HILL ROAD
Ramp Material:	Asphalt
Det. Warning Panel:	No
Panel Damage:	No
Obstructions:	Yes
Obstruction Type:	None
Condition:	Poor
Ramp Pass:	No

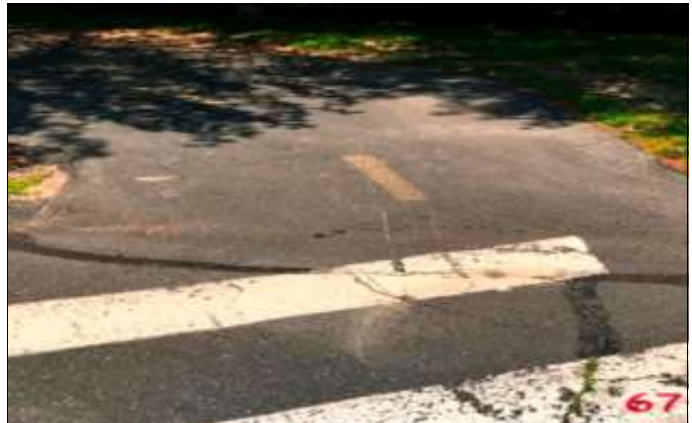
Ramp ID:	67-1
Street:	DRAKE HILL ROAD
Intersecting Street:	IRON HORSE BOULEVARD
Ramp Material:	Asphalt
Det. Warning Panel:	No
Panel Damage:	No
Obstructions:	No
Obstruction Type:	None
Condition:	Good
Ramp Pass:	No

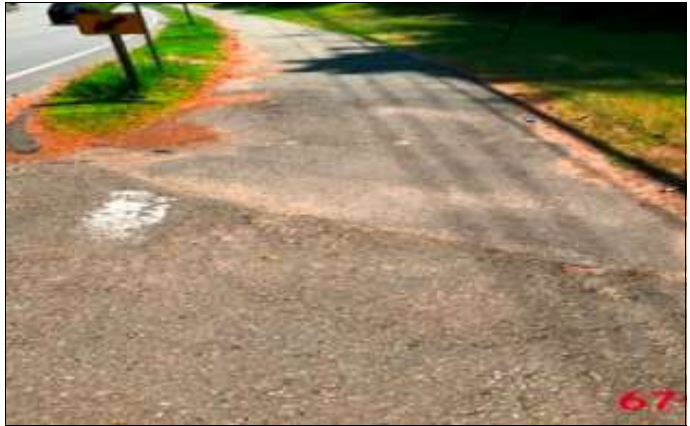
Ramp ID:	67-3
Street:	DRAKE HILL ROAD
Intersecting Street:	IRON HORSE BOULEVARD
Ramp Material:	Asphalt
Det. Warning Panel:	No
Panel Damage:	No
Obstructions:	No
Obstruction Type:	None
Condition:	Good
Ramp Pass:	No

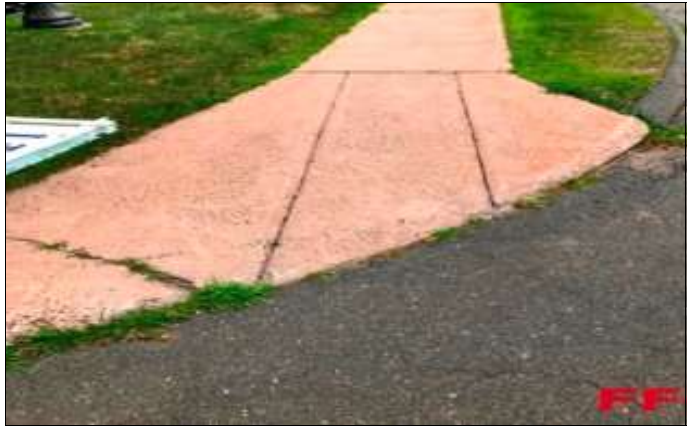
Ramp ID:	FF-1
Street:	DRIVEWAY
Intersecting Street:	PARKING LOT
Ramp Material:	Concrete
Det. Warning Panel:	No
Panel Damage:	No
Obstructions:	Yes
Obstruction Type:	Vegetation
Condition:	Fair
Ramp Pass:	No

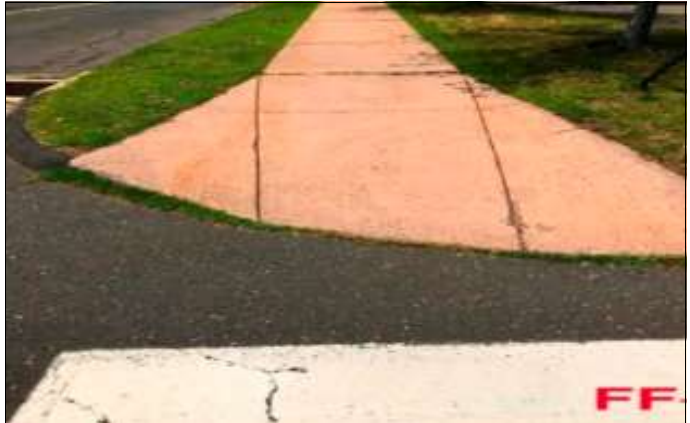
Ramp ID:	FF-2
Street:	DRIVEWAY
Intersecting Street:	PARKING LOT
Ramp Material:	Concrete
Det. Warning Panel:	No
Panel Damage:	No
Obstructions:	Yes
Obstruction Type:	Vegetation
Condition:	Fair
Ramp Pass:	No

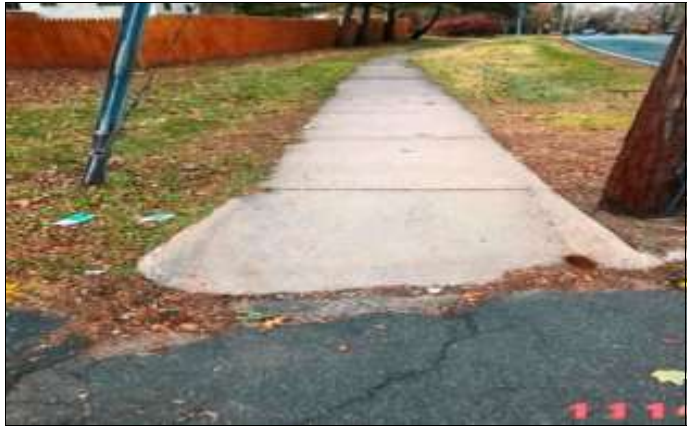
Ramp ID:	111-1
Street:	ELM STREET
Intersecting Street:	DRIVEWAY #55
Ramp Material:	Concrete
Det. Warning Panel:	No
Panel Damage:	No
Obstructions:	No
Obstruction Type:	None
Condition:	Good
Ramp Pass:	No

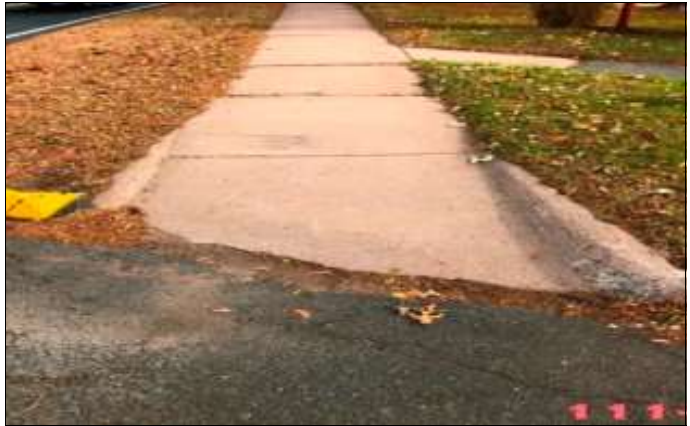
Ramp ID:	111-2
Street:	ELM STREET
Intersecting Street:	DRIVEWAY #55
Ramp Material:	Concrete
Det. Warning Panel:	No
Panel Damage:	No
Obstructions:	No
Obstruction Type:	None
Condition:	Good
Ramp Pass:	No

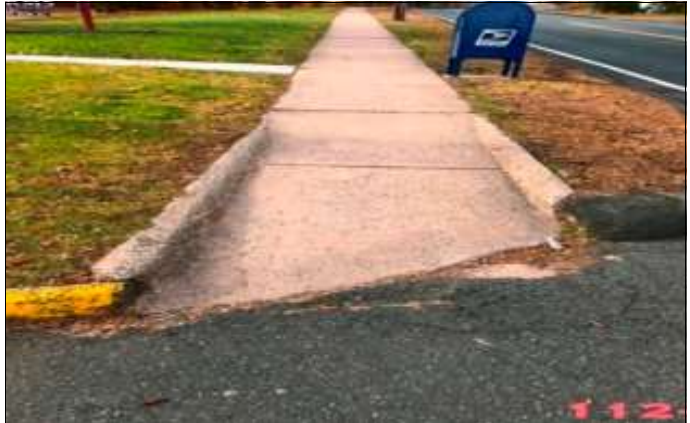
Ramp ID:	112-1
Street:	ELM STREET
Intersecting Street:	DRIVEWAY #55
Ramp Material:	Concrete
Det. Warning Panel:	No
Panel Damage:	No
Obstructions:	No
Obstruction Type:	None
Condition:	Good
Ramp Pass:	No

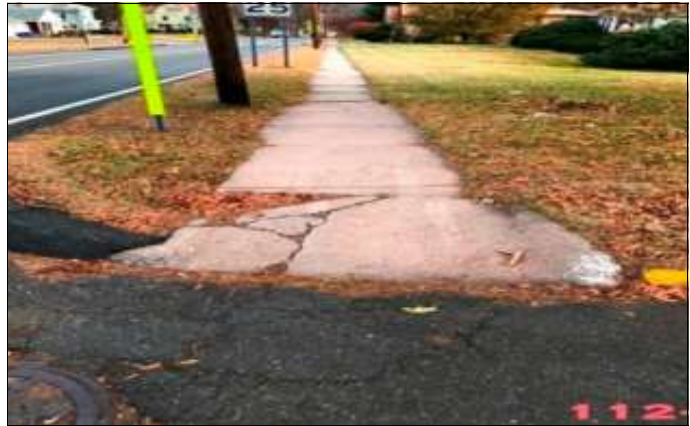
Ramp ID:	112-2
Street:	ELM STREET
Intersecting Street:	DRIVEWAY #55
Ramp Material:	Concrete
Det. Warning Panel:	No
Panel Damage:	No
Obstructions:	No
Obstruction Type:	None
Condition:	Poor
Ramp Pass:	No

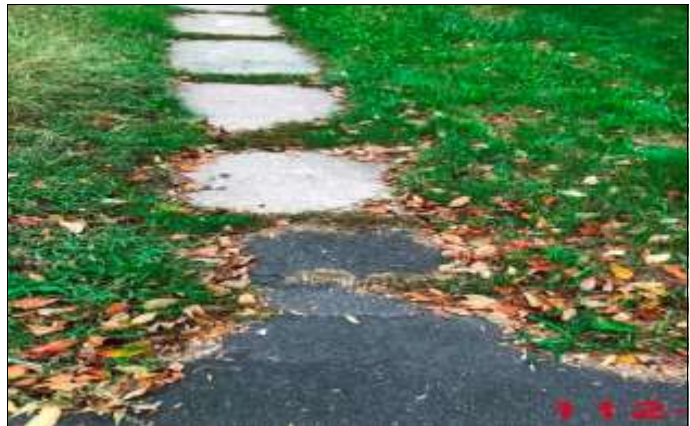
Ramp ID:	112-3
Street:	ELM STREET
Intersecting Street:	DRIVEWAY #54
Ramp Material:	Concrete
Det. Warning Panel:	No
Panel Damage:	No
Obstructions:	No
Obstruction Type:	None
Condition:	Poor
Ramp Pass:	No

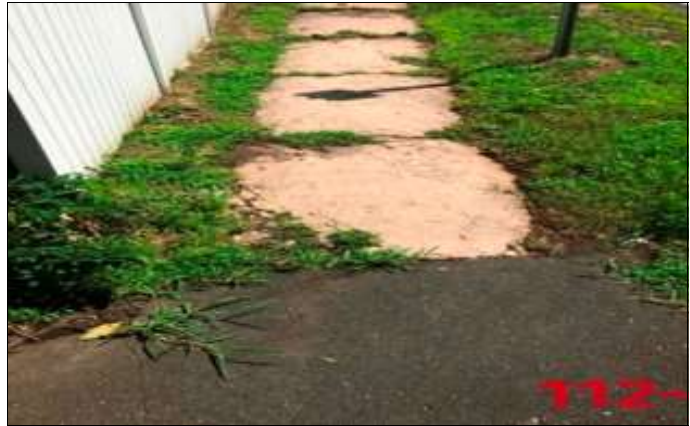
Ramp ID:	112-4
Street:	ELM STREET
Intersecting Street:	DRIVEWAY #48
Ramp Material:	Concrete
Det. Warning Panel:	No
Panel Damage:	No
Obstructions:	No
Obstruction Type:	None
Condition:	Poor
Ramp Pass:	No

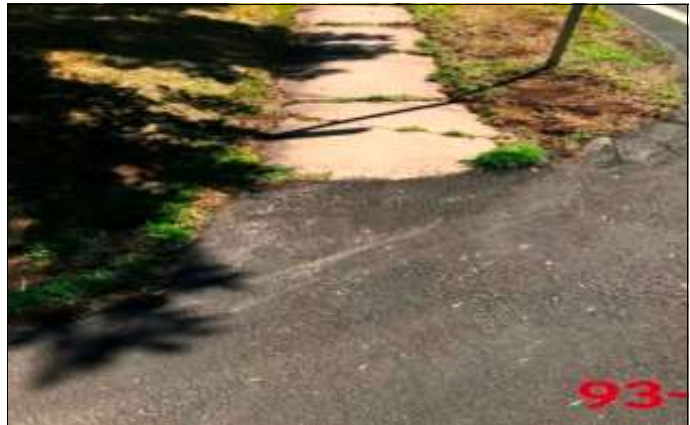
Ramp ID:	93-1
Street:	ELM STREET
Intersecting Street:	MAPLE STREET
Ramp Material:	Concrete
Det. Warning Panel:	No
Panel Damage:	No
Obstructions:	No
Obstruction Type:	None
Condition:	Good
Ramp Pass:	No

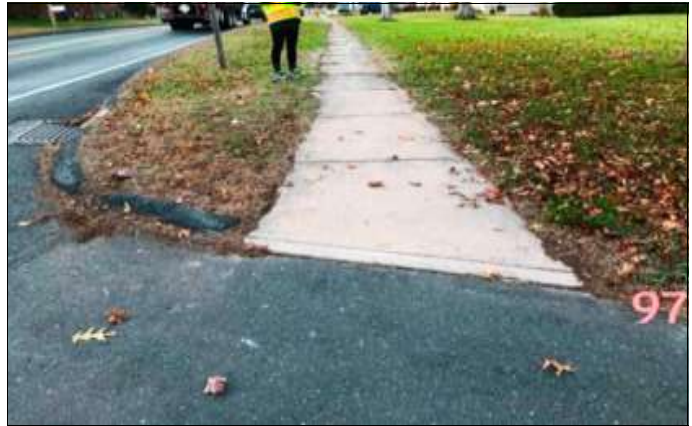
Ramp ID:	97-1
Street:	ELM STREET
Intersecting Street:	CENTER STREET
Ramp Material:	Concrete
Det. Warning Panel:	No
Panel Damage:	No
Obstructions:	No
Obstruction Type:	None
Condition:	Good
Ramp Pass:	No

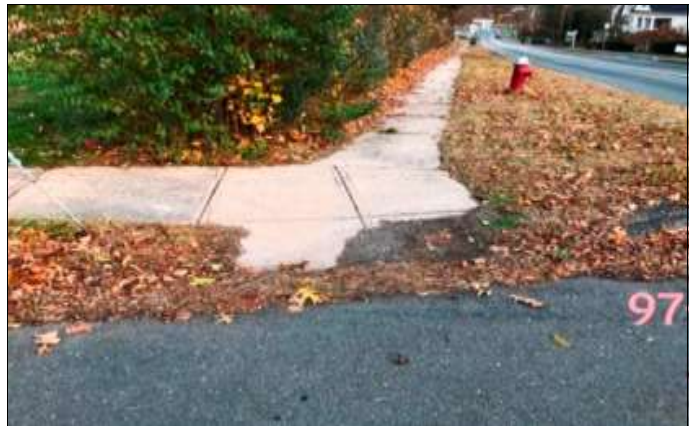
Ramp ID:	97-2
Street:	ELM STREET
Intersecting Street:	CENTER STREET
Ramp Material:	Concrete
Det. Warning Panel:	No
Panel Damage:	No
Obstructions:	No
Obstruction Type:	None
Condition:	Poor
Ramp Pass:	No

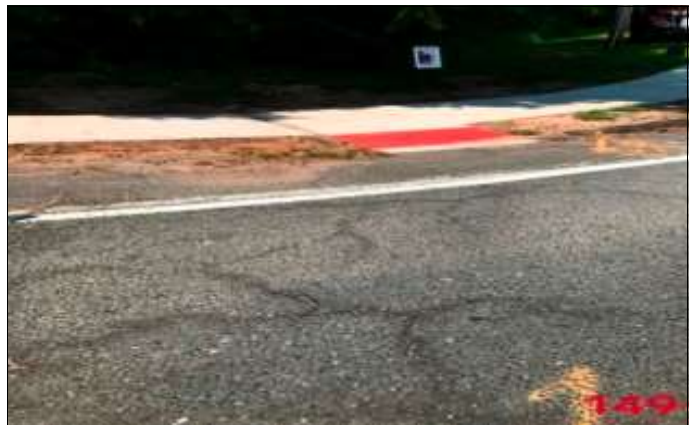
Ramp ID:	149-5
Street:	FARMS VILLAGE ROAD
Intersecting Street:	BUSHY HILL ROAD
Ramp Material:	Concrete
Det. Warning Panel:	Yes
Panel Damage:	No
Obstructions:	No
Obstruction Type:	None
Condition:	Good
Ramp Pass:	Yes

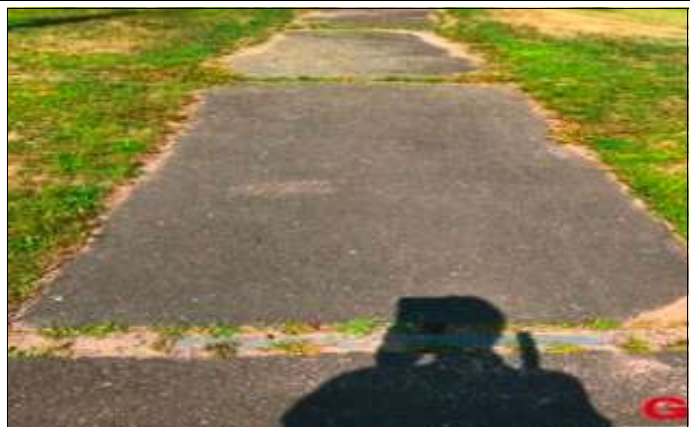
Ramp ID:	G-1
Street:	FARMS VILLAGE ROAD
Intersecting Street:	SIMSBURY HIGH SCHOOL
Ramp Material:	Asphalt
Det. Warning Panel:	No
Panel Damage:	No
Obstructions:	Yes
Obstruction Type:	Vegetation
Condition:	Fair
Ramp Pass:	No

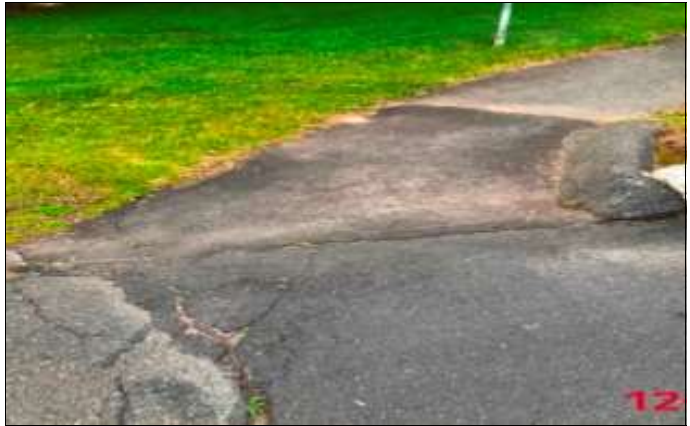
Ramp ID:	12-1
Street:	FIRETOWN ROAD
Intersecting Street:	SQUADRON LINE ROAD
Ramp Material:	Asphalt
Det. Warning Panel:	No
Panel Damage:	No
Obstructions:	No
Obstruction Type:	None
Condition:	Good
Ramp Pass:	No

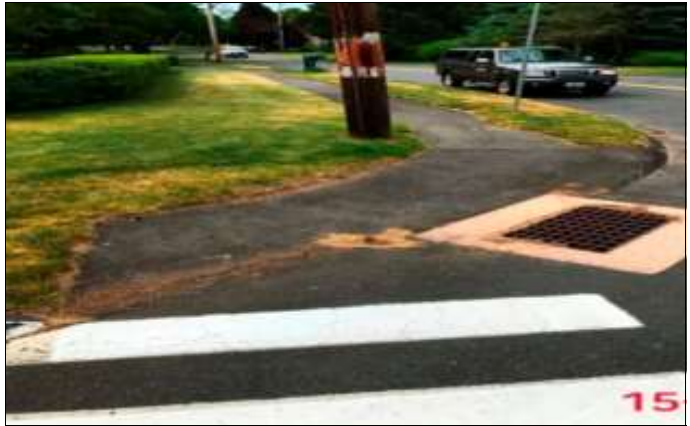
Ramp ID:	15-1
Street:	FIRETOWN ROAD
Intersecting Street:	CRESTWOOD ROAD
Ramp Material:	Asphalt
Det. Warning Panel:	No
Panel Damage:	No
Obstructions:	No
Obstruction Type:	None
Condition:	Good
Ramp Pass:	No

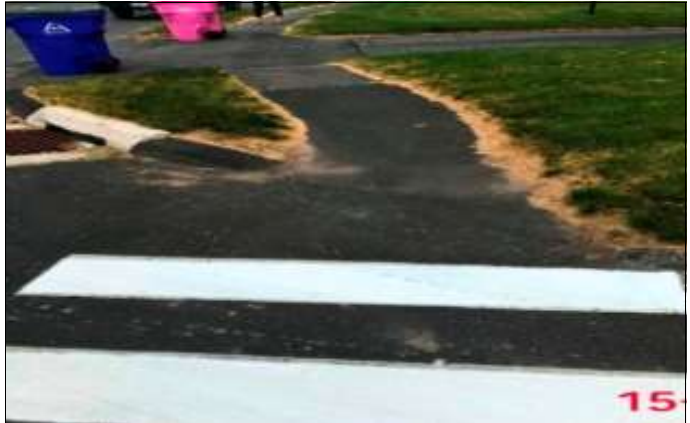
Ramp ID:	15-2
Street:	FIRETOWN ROAD
Intersecting Street:	CRESTWOOD ROAD
Ramp Material:	Asphalt
Det. Warning Panel:	No
Panel Damage:	No
Obstructions:	No
Obstruction Type:	None
Condition:	Good
Ramp Pass:	No

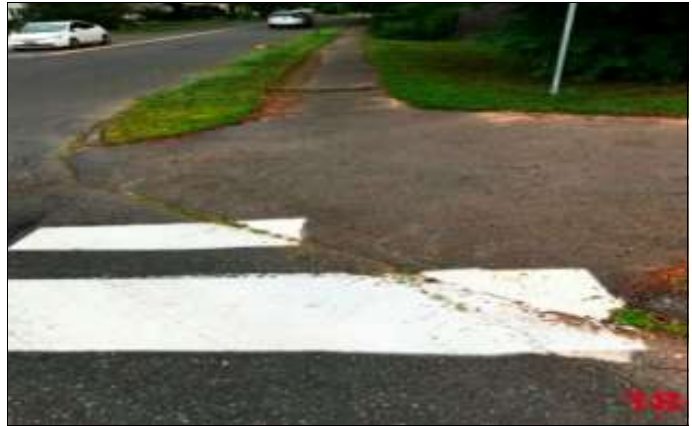
Ramp ID:	18-1
Street:	FIRETOWN ROAD
Intersecting Street:	OWENS BROOK BOULEVARD
Ramp Material:	Asphalt
Det. Warning Panel:	No
Panel Damage:	No
Obstructions:	No
Obstruction Type:	None
Condition:	Good
Ramp Pass:	No

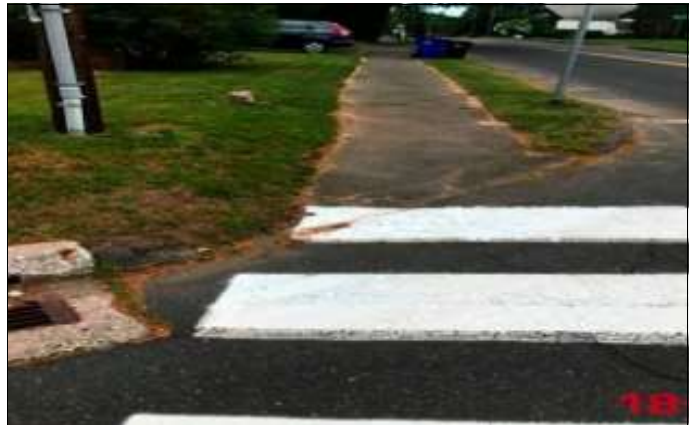
Ramp ID:	18-2
Street:	FIRETOWN ROAD
Intersecting Street:	OWENS BROOK BOULEVARD
Ramp Material:	Asphalt
Det. Warning Panel:	No
Panel Damage:	No
Obstructions:	No
Obstruction Type:	None
Condition:	Good
Ramp Pass:	No

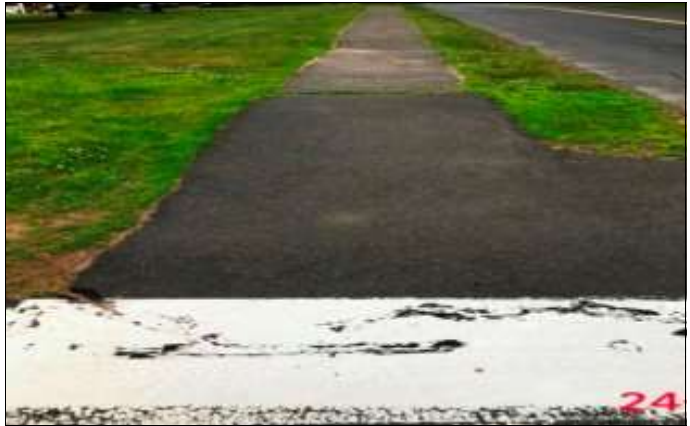
Ramp ID:	24-1
Street:	FIRETOWN ROAD
Intersecting Street:	HENRY JAMES MIDDLE SCHOOL
Ramp Material:	Asphalt
Det. Warning Panel:	No
Panel Damage:	No
Obstructions:	No
Obstruction Type:	None
Condition:	Good
Ramp Pass:	No

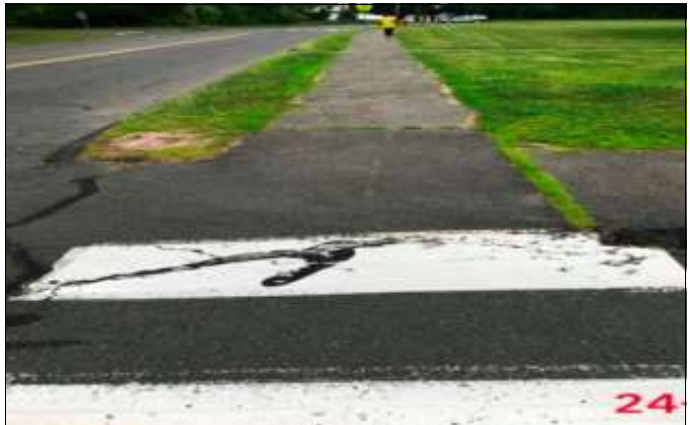
Ramp ID:	24-2
Street:	FIRETOWN ROAD
Intersecting Street:	HENRY JAMES MIDDLE SCHOOL
Ramp Material:	Asphalt
Det. Warning Panel:	No
Panel Damage:	No
Obstructions:	No
Obstruction Type:	None
Condition:	Good
Ramp Pass:	No

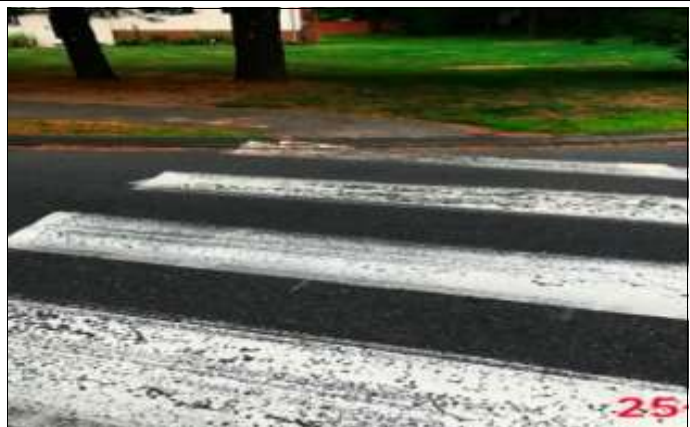
Ramp ID:	25-2
Street:	FIRETOWN ROAD
Intersecting Street:	SEMINARY ROAD
Ramp Material:	Asphalt
Det. Warning Panel:	No
Panel Damage:	No
Obstructions:	No
Obstruction Type:	None
Condition:	Fair
Ramp Pass:	No

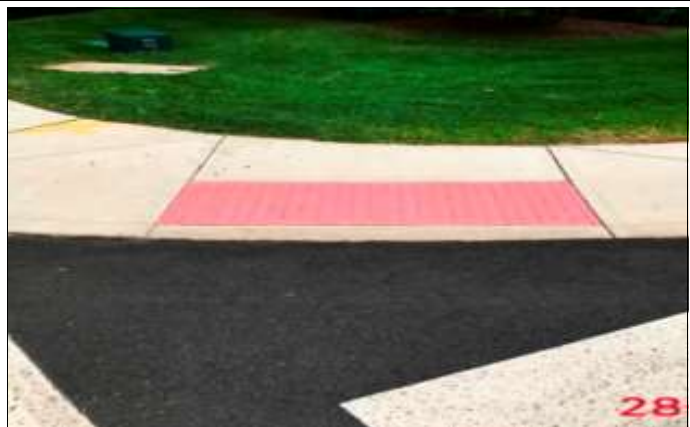
Ramp ID:	28-1
Street:	GRIST MILL LANE
Intersecting Street:	MILL POND LANE
Ramp Material:	Concrete
Det. Warning Panel:	Yes
Panel Damage:	No
Obstructions:	No
Obstruction Type:	None
Condition:	Good
Ramp Pass:	No

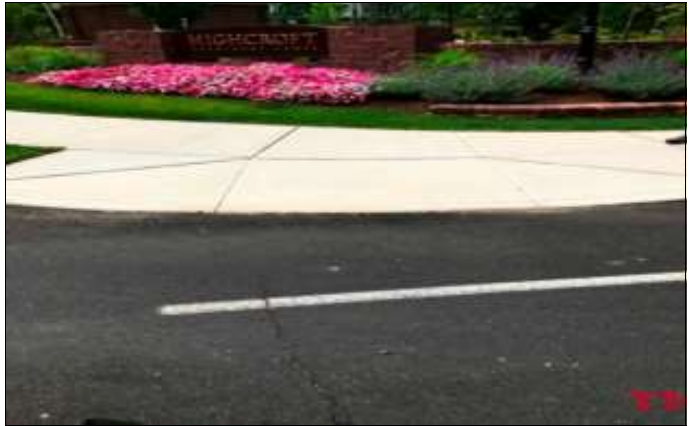
Ramp ID:	11-1
Street:	HIGHCROFT PLACE
Intersecting Street:	UNNAMED STREET
Ramp Material:	Concrete
Det. Warning Panel:	No
Panel Damage:	No
Obstructions:	No
Obstruction Type:	None
Condition:	Good
Ramp Pass:	No

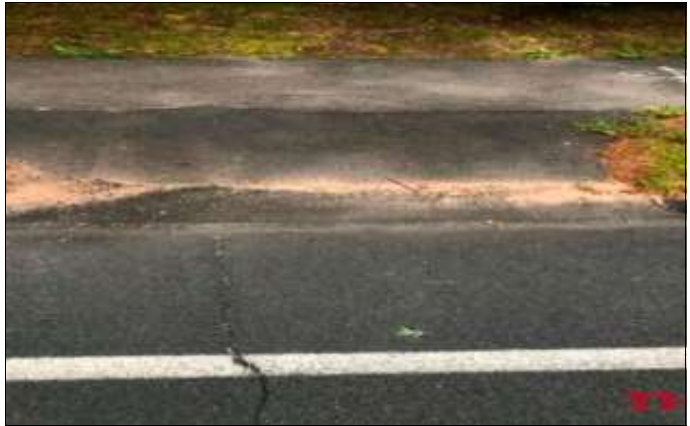
Ramp ID:	11-2
Street:	HIGHCROFT PLACE
Intersecting Street:	UNNAMED STREET
Ramp Material:	Asphalt
Det. Warning Panel:	No
Panel Damage:	No
Obstructions:	Yes
Obstruction Type:	Cracking
Condition:	Good
Ramp Pass:	No

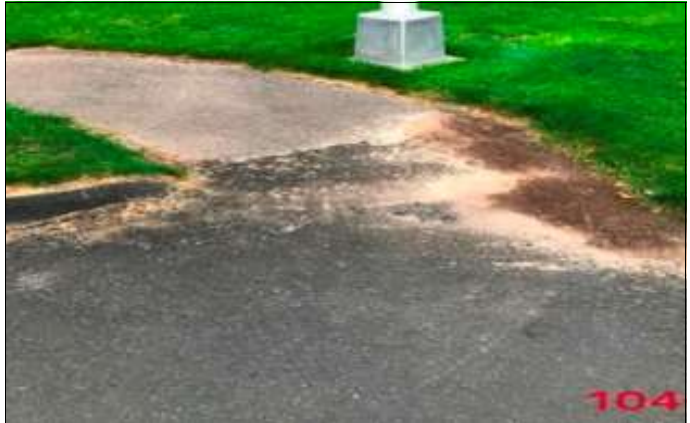
Ramp ID:	104-1
Street:	HOPMEADOW STREET
Intersecting Street:	POWDER FOREST DRIVE
Ramp Material:	Asphalt
Det. Warning Panel:	No
Panel Damage:	No
Obstructions:	No
Obstruction Type:	None
Condition:	Good
Ramp Pass:	No

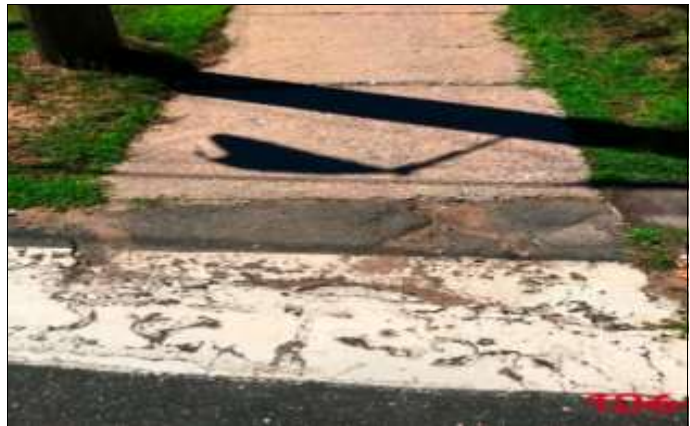
Ramp ID:	106-2
Street:	HOPMEADOW STREET
Intersecting Street:	MASSACO STREET
Ramp Material:	Concrete
Det. Warning Panel:	No
Panel Damage:	No
Obstructions:	Yes
Obstruction Type:	None
Condition:	Fair
Ramp Pass:	No

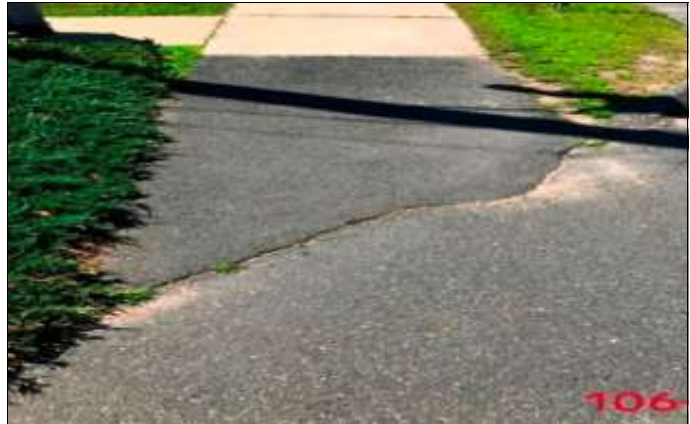
Ramp ID:	106-3
Street:	HOPMEADOW STREET
Intersecting Street:	MASSACO STREET
Ramp Material:	Asphalt
Det. Warning Panel:	No
Panel Damage:	No
Obstructions:	No
Obstruction Type:	None
Condition:	Good
Ramp Pass:	No

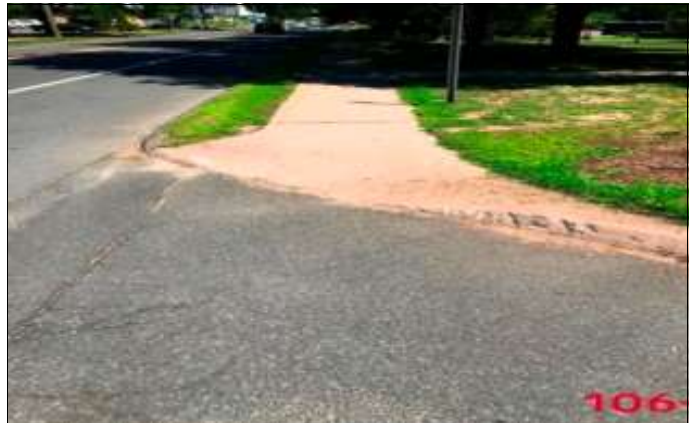
Ramp ID:	106-4
Street:	HOPMEADOW STREET
Intersecting Street:	MASSACO STREET
Ramp Material:	Concrete
Det. Warning Panel:	No
Panel Damage:	No
Obstructions:	No
Obstruction Type:	None
Condition:	Good
Ramp Pass:	No

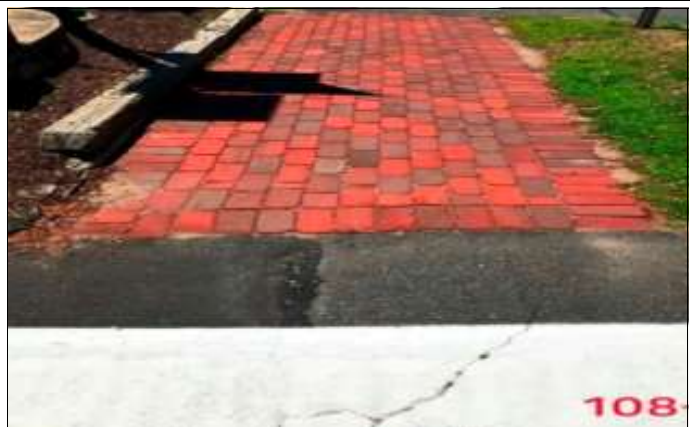
Ramp ID:	108-2
Street:	HOPMEADOW STREET
Intersecting Street:	PRIVATE STREET
Ramp Material:	Brick
Det. Warning Panel:	No
Panel Damage:	No
Obstructions:	No
Obstruction Type:	None
Condition:	Good
Ramp Pass:	No

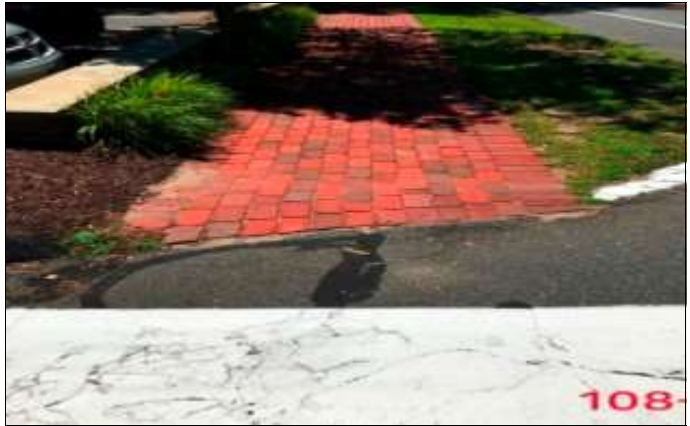
Ramp ID:	108-4
Street:	HOPMEADOW STREET
Intersecting Street:	PRIVATE STREET
Ramp Material:	Brick
Det. Warning Panel:	No
Panel Damage:	No
Obstructions:	No
Obstruction Type:	None
Condition:	Good
Ramp Pass:	No

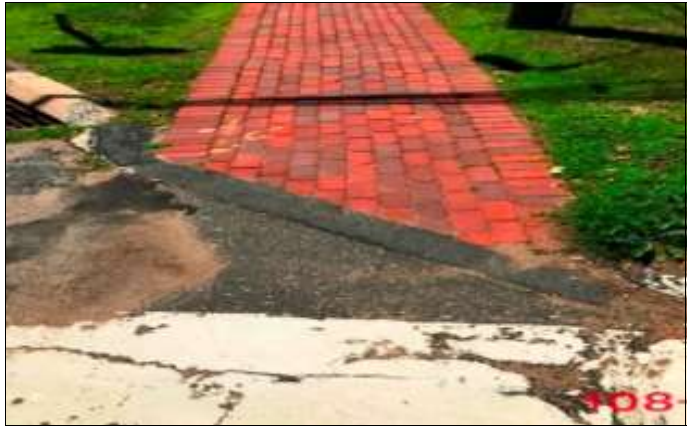
Ramp ID:	108-5
Street:	HOPMEADOW STREET
Intersecting Street:	PRIVATE STREET
Ramp Material:	Brick
Det. Warning Panel:	No
Panel Damage:	No
Obstructions:	No
Obstruction Type:	None
Condition:	Good
Ramp Pass:	No

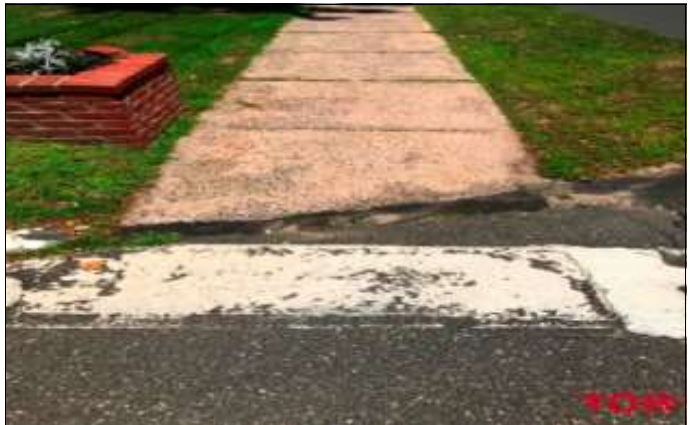
Ramp ID:	108-6
Street:	HOPMEADOW STREET
Intersecting Street:	PRIVATE STREET
Ramp Material:	Concrete
Det. Warning Panel:	No
Panel Damage:	No
Obstructions:	No
Obstruction Type:	None
Condition:	Good
Ramp Pass:	No

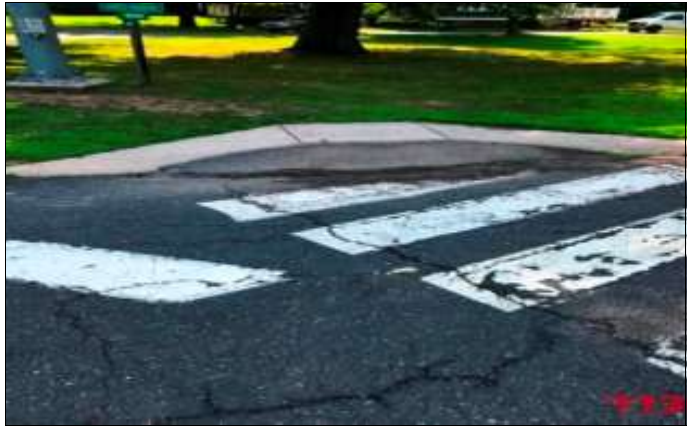
Ramp ID:	113-2
Street:	HOPMEADOW STREET
Intersecting Street:	WINSLOW PLACE
Ramp Material:	Concrete
Det. Warning Panel:	No
Panel Damage:	No
Obstructions:	Yes
Obstruction Type:	Vegetation
Condition:	Fair
Ramp Pass:	No

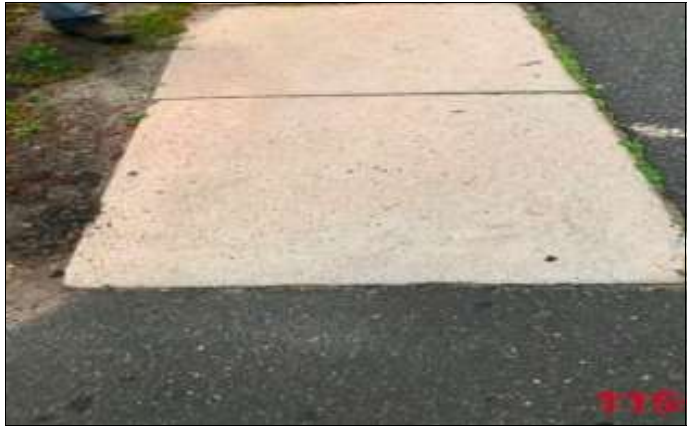
Ramp ID:	115-1
Street:	HOPMEADOW STREET
Intersecting Street:	HAZELMEADOW PLACE
Ramp Material:	Concrete
Det. Warning Panel:	No
Panel Damage:	No
Obstructions:	No
Obstruction Type:	None
Condition:	Good
Ramp Pass:	No

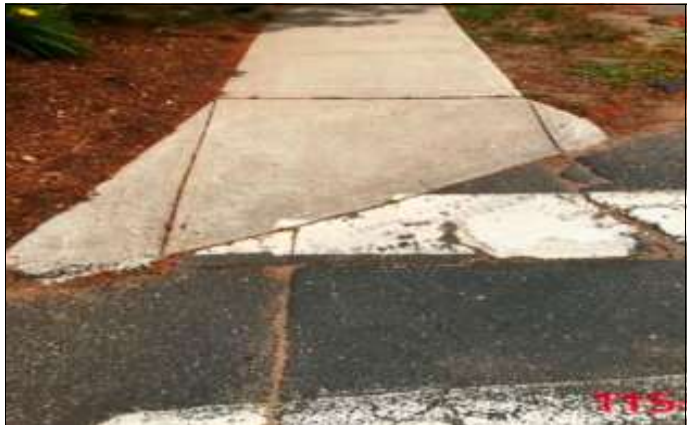
Ramp ID:	115-2
Street:	HOPMEADOW STREET
Intersecting Street:	WIGGINS FARM DRIVE
Ramp Material:	Concrete
Det. Warning Panel:	No
Panel Damage:	No
Obstructions:	No
Obstruction Type:	None
Condition:	Good
Ramp Pass:	No

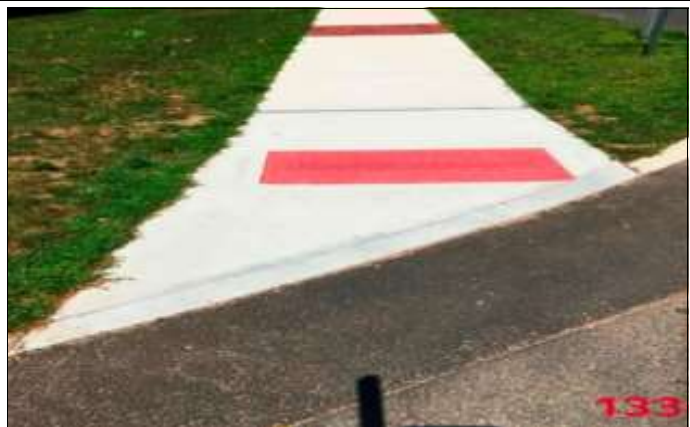
Ramp ID:	133-1
Street:	HOPMEADOW STREET
Intersecting Street:	EAGLEWOOD LANE
Ramp Material:	Concrete
Det. Warning Panel:	Yes
Panel Damage:	No
Obstructions:	No
Obstruction Type:	None
Condition:	Good
Ramp Pass:	Yes

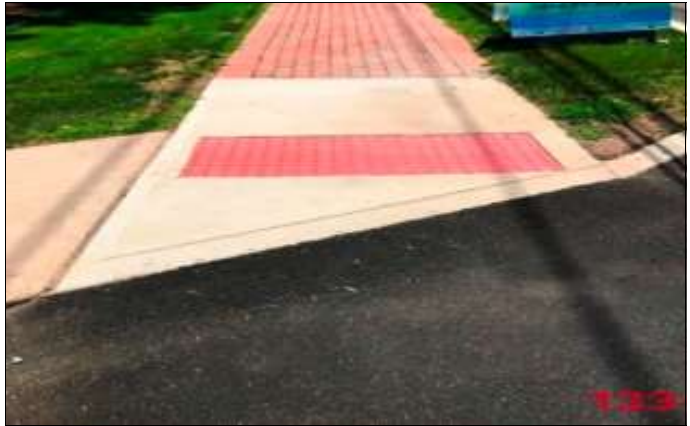
Ramp ID:	133-3
Street:	HOPMEADOW STREET
Intersecting Street:	EAGLEWOOD LANE
Ramp Material:	Concrete
Det. Warning Panel:	Yes
Panel Damage:	No
Obstructions:	No
Obstruction Type:	None
Condition:	Good
Ramp Pass:	Yes

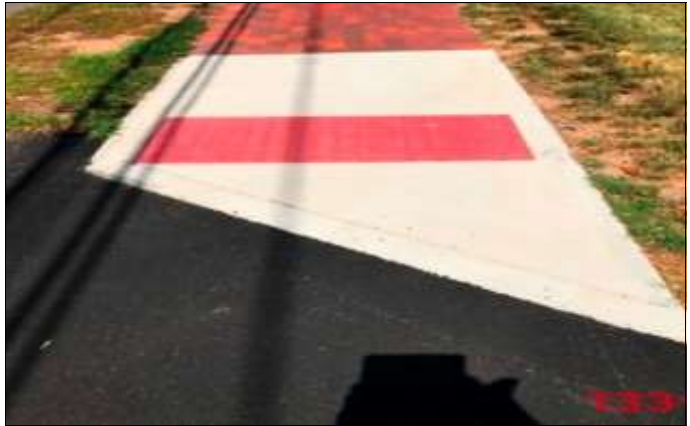
Ramp ID:	133-4
Street:	HOPMEADOW STREET
Intersecting Street:	EAGLEWOOD LANE
Ramp Material:	Concrete
Det. Warning Panel:	Yes
Panel Damage:	No
Obstructions:	No
Obstruction Type:	None
Condition:	Good
Ramp Pass:	Yes

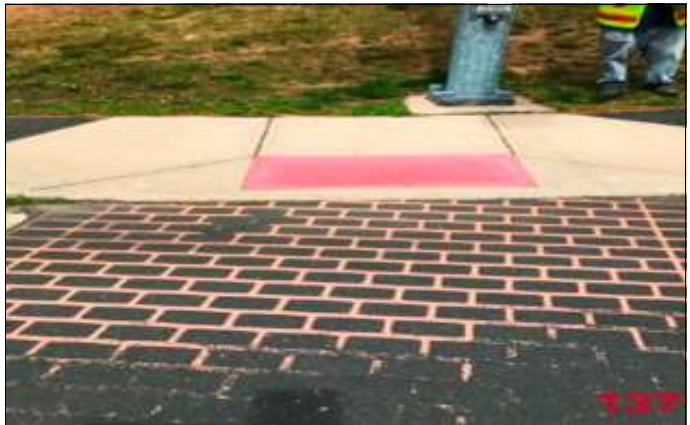
Ramp ID:	137-1
Street:	HOPMEADOW STREET
Intersecting Street:	WEST STREET
Ramp Material:	Concrete
Det. Warning Panel:	Yes
Panel Damage:	No
Obstructions:	No
Obstruction Type:	None
Condition:	Good
Ramp Pass:	No

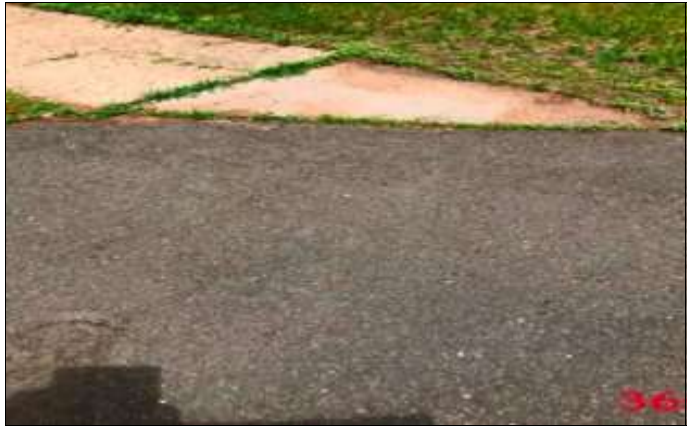
Ramp ID:	36-1
Street:	HOPMEADOW STREET
Intersecting Street:	WOODLAND STREET
Ramp Material:	Asphalt
Det. Warning Panel:	No
Panel Damage:	No
Obstructions:	Yes
Obstruction Type:	Vegetation
Condition:	Fair
Ramp Pass:	No

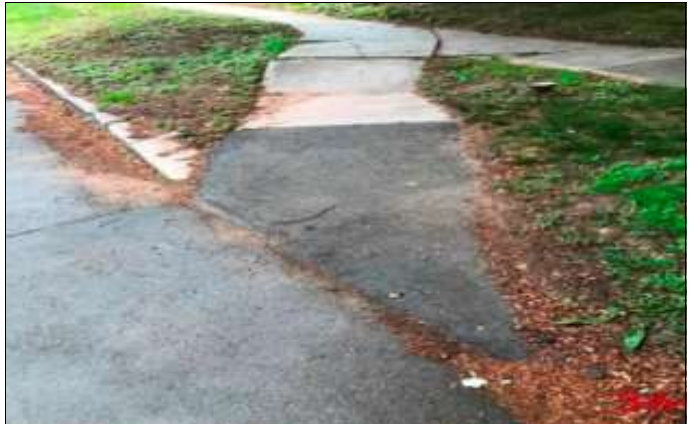
Ramp ID:	36-2
Street:	HOPMEADOW STREET
Intersecting Street:	WOODLAND STREET
Ramp Material:	Asphalt
Det. Warning Panel:	No
Panel Damage:	No
Obstructions:	No
Obstruction Type:	None
Condition:	Good
Ramp Pass:	No

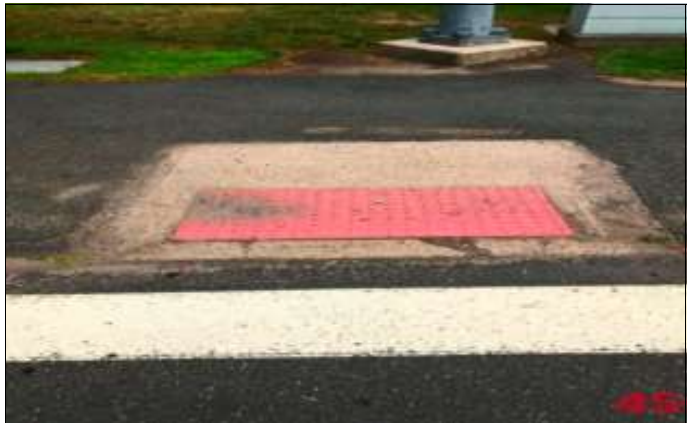
Ramp ID:	45-1
Street:	HOPMEADOW STREET
Intersecting Street:	WOODLAND PLACE
Ramp Material:	Concrete
Det. Warning Panel:	Yes
Panel Damage:	No
Obstructions:	No
Obstruction Type:	None
Condition:	Good
Ramp Pass:	Yes

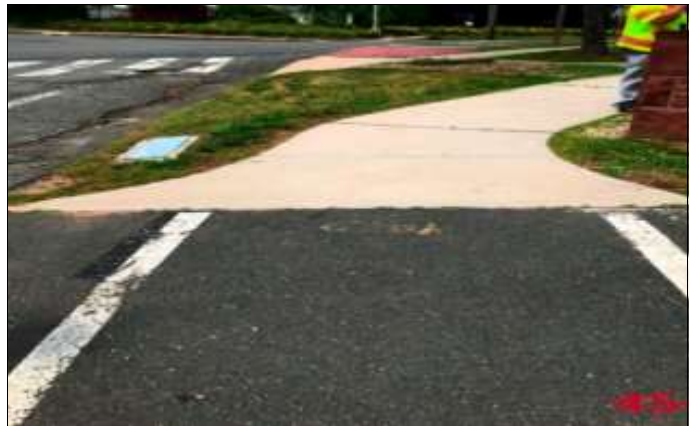
Ramp ID:	45-3
Street:	HOPMEADOW STREET
Intersecting Street:	WOODLAND PLACE
Ramp Material:	Concrete
Det. Warning Panel:	No
Panel Damage:	No
Obstructions:	No
Obstruction Type:	None
Condition:	Good
Ramp Pass:	No

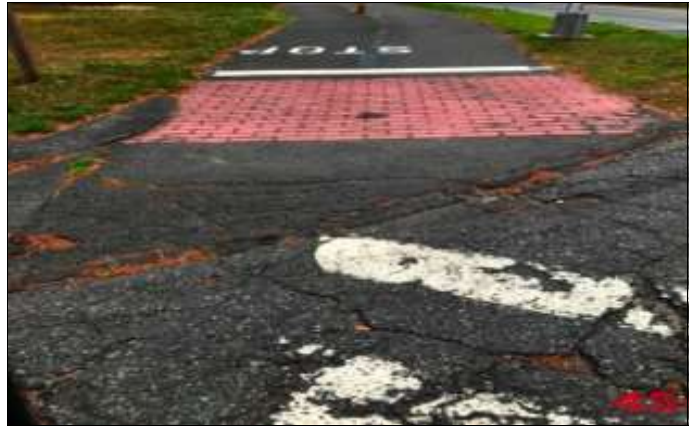
Ramp ID:	45-4
Street:	HOPMEADOW STREET
Intersecting Street:	WOODLAND PLACE
Ramp Material:	Asphalt
Det. Warning Panel:	No
Panel Damage:	Yes
Obstructions:	Yes
Obstruction Type:	Vegetation
Condition:	Fair
Ramp Pass:	No

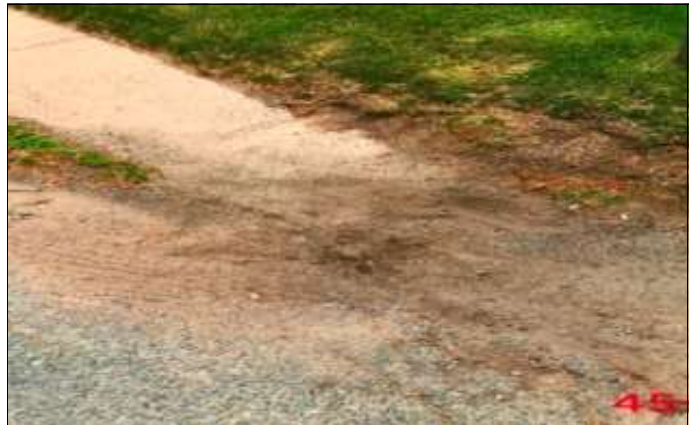
Ramp ID:	45-5
Street:	HOPMEADOW STREET
Intersecting Street:	WOODLAND PLACE
Ramp Material:	Concrete
Det. Warning Panel:	No
Panel Damage:	No
Obstructions:	No
Obstruction Type:	None
Condition:	Fair
Ramp Pass:	No

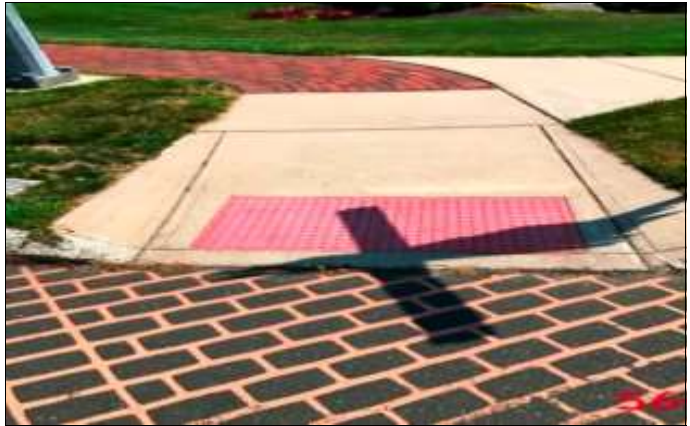
Ramp ID:	56-1
Street:	HOPMEADOW STREET
Intersecting Street:	DRAKE HILL ROAD
Ramp Material:	Concrete
Det. Warning Panel:	Yes
Panel Damage:	No
Obstructions:	No
Obstruction Type:	None
Condition:	Good
Ramp Pass:	Yes

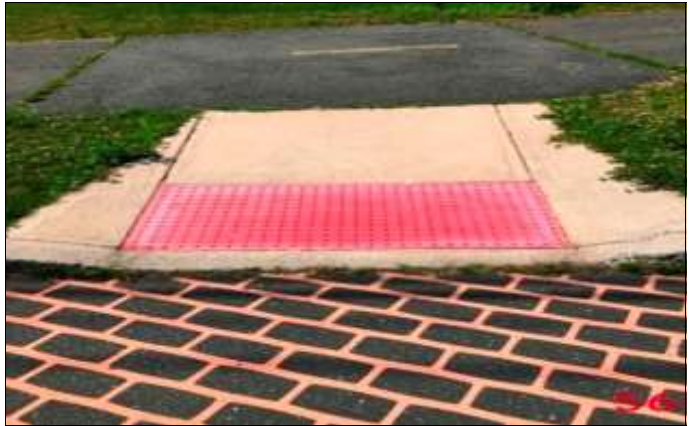
Ramp ID:	56-2
Street:	HOPMEADOW STREET
Intersecting Street:	DRAKE HILL ROAD
Ramp Material:	Concrete
Det. Warning Panel:	Yes
Panel Damage:	No
Obstructions:	Yes
Obstruction Type:	Vegetation
Condition:	Fair
Ramp Pass:	No

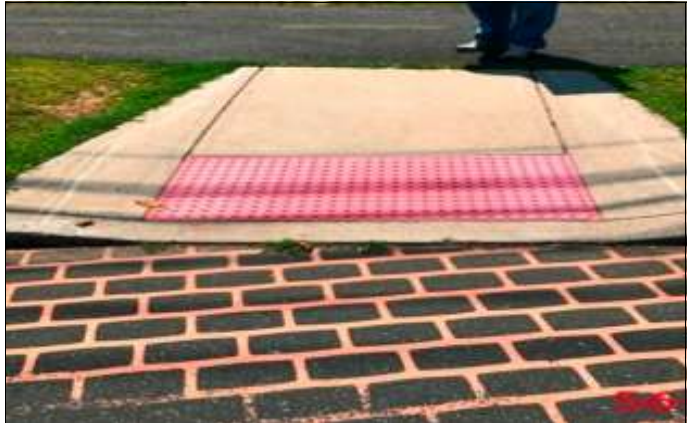
Ramp ID:	56-3
Street:	HOPMEADOW STREET
Intersecting Street:	DRAKE HILL ROAD
Ramp Material:	Concrete
Det. Warning Panel:	Yes
Panel Damage:	No
Obstructions:	Yes
Obstruction Type:	Curbing
Condition:	Fair
Ramp Pass:	Yes

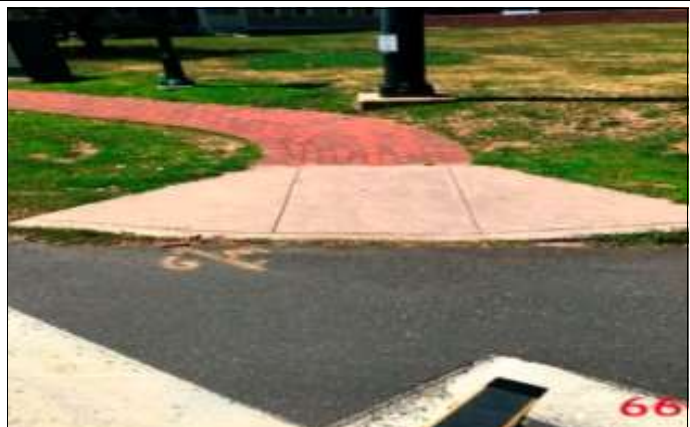
Ramp ID:	66-1
Street:	HOPMEADOW STREET
Intersecting Street:	LIBRARY LANE
Ramp Material:	Concrete
Det. Warning Panel:	No
Panel Damage:	No
Obstructions:	Yes
Obstruction Type:	Vegetation
Condition:	Fair
Ramp Pass:	No

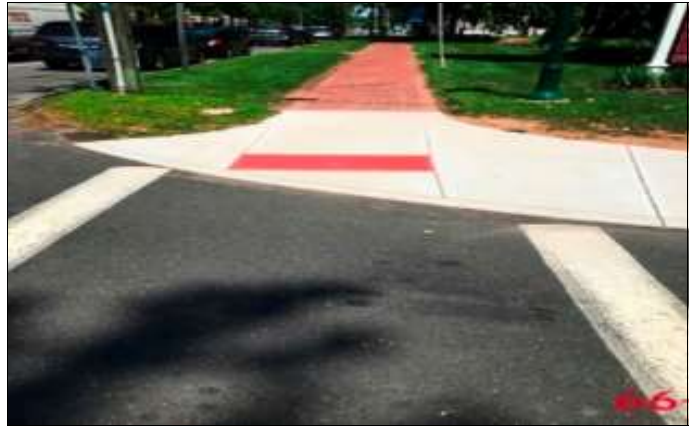
Ramp ID:	66-3
Street:	HOPMEADOW STREET
Intersecting Street:	LIBRARY LANE
Ramp Material:	Concrete
Det. Warning Panel:	Yes
Panel Damage:	No
Obstructions:	No
Obstruction Type:	None
Condition:	Good
Ramp Pass:	Yes
