Town of Simsbury, Connecticut Sidewalk and Curb Ramp Assessment

FINAL DRAFT

Prepared By:
BETA Group, Inc.
1010 Wethersfield Avenue
Suite 305
Hartford, CT 06114

September 2019

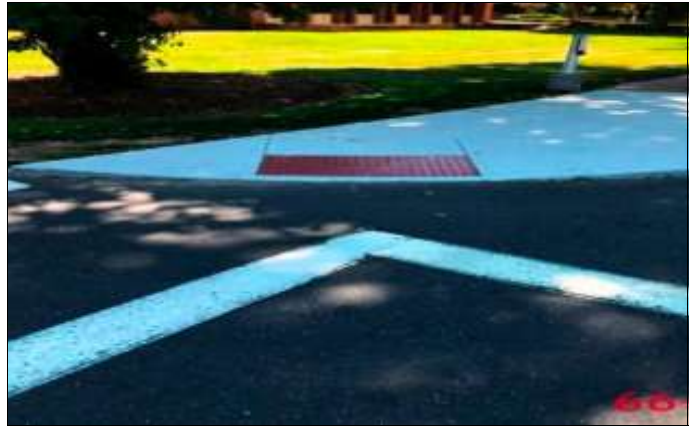
Ramp ID:	66-4
Street:	HOPMEADOW STREET
Intersecting Street:	LIBRARY LANE
Ramp Material:	Concrete
Det. Warning Panel:	Yes
Panel Damage:	No
Obstructions:	No
Obstruction Type:	None
Condition:	Good
Ramp Pass:	No

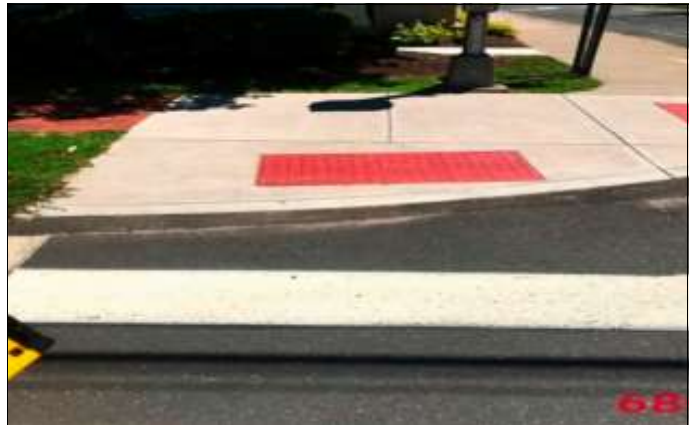
Ramp ID:	68-1
Street:	HOPMEADOW STREET
Intersecting Street:	STATION STREET
Ramp Material:	Concrete
Det. Warning Panel:	Yes
Panel Damage:	No
Obstructions:	No
Obstruction Type:	None
Condition:	Good
Ramp Pass:	Yes

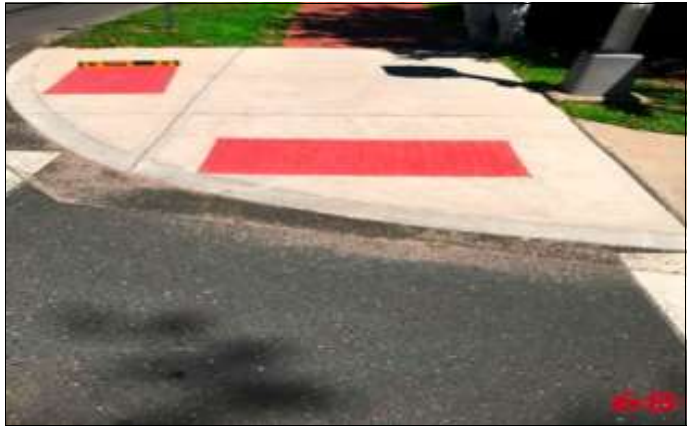
Ramp ID:	68-2
Street:	HOPMEADOW STREET
Intersecting Street:	STATION STREET
Ramp Material:	Concrete
Det. Warning Panel:	Yes
Panel Damage:	No
Obstructions:	No
Obstruction Type:	None
Condition:	Good
Ramp Pass:	Yes

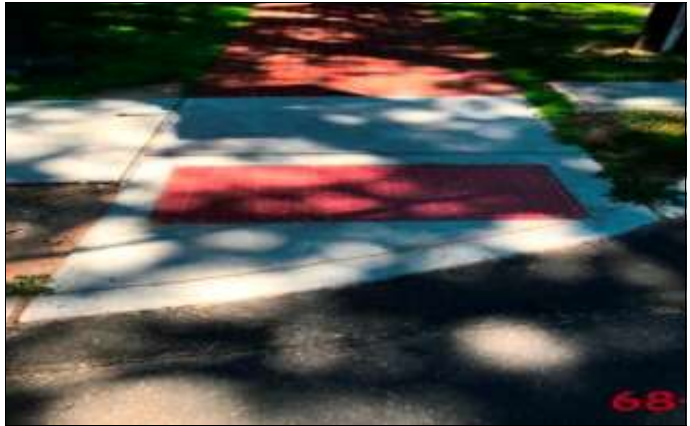
Ramp ID:	68-3
Street:	HOPMEADOW STREET
Intersecting Street:	STATION STREET
Ramp Material:	Concrete
Det. Warning Panel:	Yes
Panel Damage:	No
Obstructions:	No
Obstruction Type:	None
Condition:	Good
Ramp Pass:	Yes

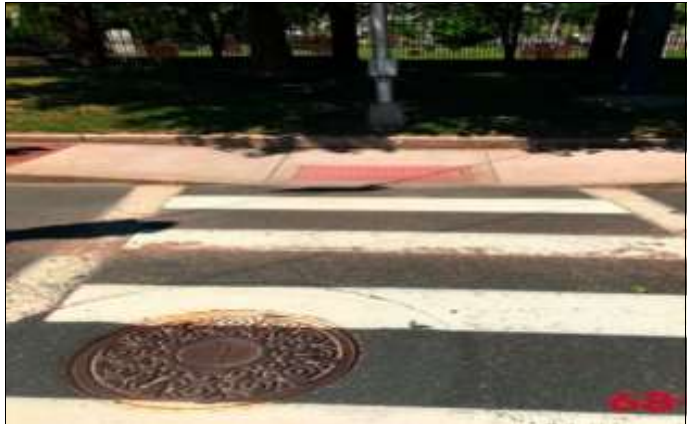
Ramp ID:	68-4
Street:	HOPMEADOW STREET
Intersecting Street:	STATION STREET
Ramp Material:	Concrete
Det. Warning Panel:	Yes
Panel Damage:	No
Obstructions:	No
Obstruction Type:	None
Condition:	Good
Ramp Pass:	No

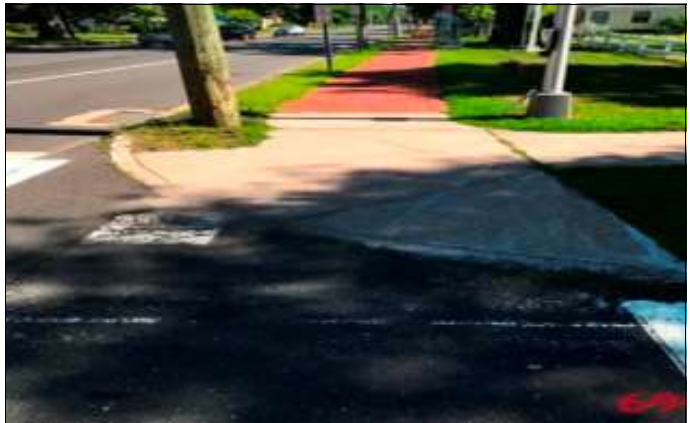
Ramp ID:	69-1
Street:	HOPMEADOW STREET
Intersecting Street:	PHELPS LANE
Ramp Material:	Concrete
Det. Warning Panel:	No
Panel Damage:	No
Obstructions:	No
Obstruction Type:	None
Condition:	Good
Ramp Pass:	No

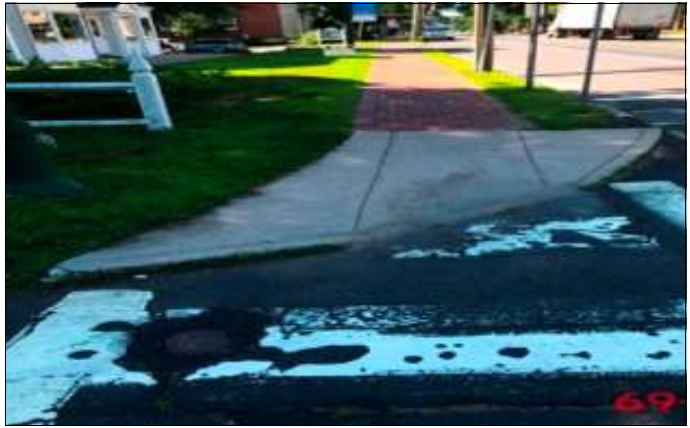
Ramp ID:	69-2
Street:	HOPMEADOW STREET
Intersecting Street:	PHELPS LANE
Ramp Material:	Concrete
Det. Warning Panel:	No
Panel Damage:	No
Obstructions:	No
Obstruction Type:	None
Condition:	Good
Ramp Pass:	No

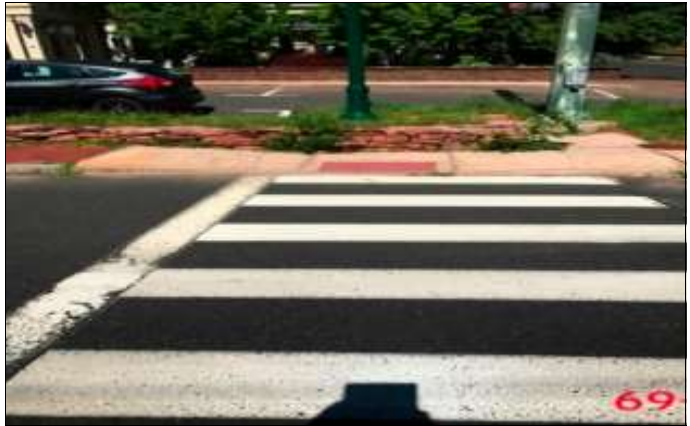
Ramp ID:	69-3
Street:	HOPMEADOW STREET
Intersecting Street:	PHELPS LANE
Ramp Material:	Concrete
Det. Warning Panel:	Yes
Panel Damage:	No
Obstructions:	No
Obstruction Type:	None
Condition:	Good
Ramp Pass:	No

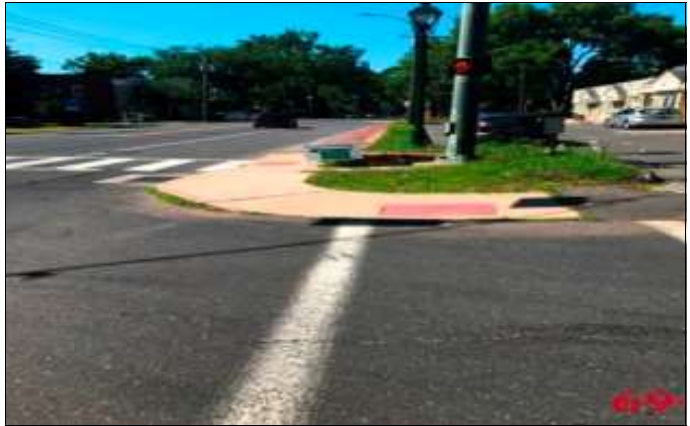
Ramp ID:	69-4
Street:	HOPMEADOW STREET
Intersecting Street:	PHELPS LANE
Ramp Material:	Concrete
Det. Warning Panel:	Yes
Panel Damage:	Yes
Obstructions:	Yes
Obstruction Type:	Vegetation
Condition:	Poor
Ramp Pass:	No

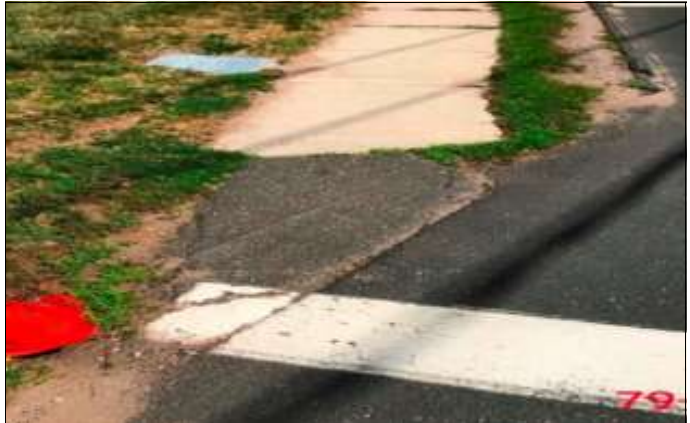
Ramp ID:	79-1
Street:	HOPMEADOW STREET
Intersecting Street:	SEMINARY ROAD
Ramp Material:	Asphalt
Det. Warning Panel:	No
Panel Damage:	No
Obstructions:	Yes
Obstruction Type:	Vegetation
Condition:	Fair
Ramp Pass:	No

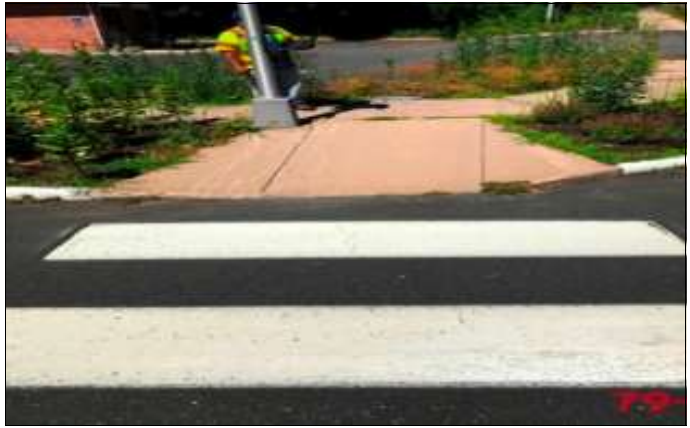
Ramp ID:	79-3
Street:	HOPMEADOW STREET
Intersecting Street:	SEMINARY ROAD
Ramp Material:	Concrete
Det. Warning Panel:	No
Panel Damage:	No
Obstructions:	No
Obstruction Type:	None
Condition:	Good
Ramp Pass:	No

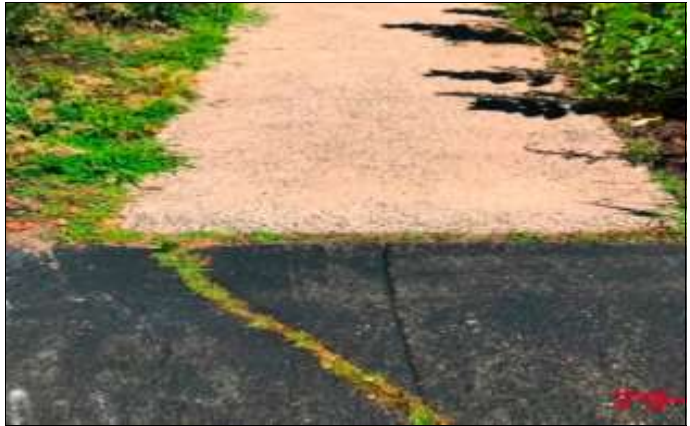
Ramp ID:	79-4
Street:	HOPMEADOW STREET
Intersecting Street:	SEMINARY ROAD
Ramp Material:	Concrete
Det. Warning Panel:	No
Panel Damage:	No
Obstructions:	Yes
Obstruction Type:	Vegetation
Condition:	Fair
Ramp Pass:	No

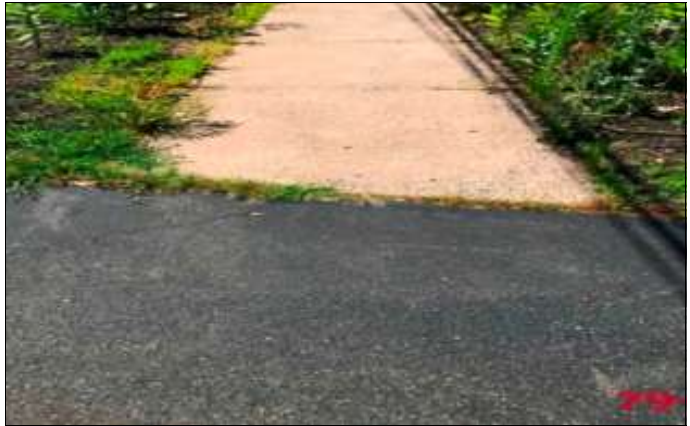
Ramp ID:	79-7
Street:	HOPMEADOW STREET
Intersecting Street:	DRIVEWAY #955
Ramp Material:	Concrete
Det. Warning Panel:	No
Panel Damage:	No
Obstructions:	Yes
Obstruction Type:	Vegetation
Condition:	Fair
Ramp Pass:	No

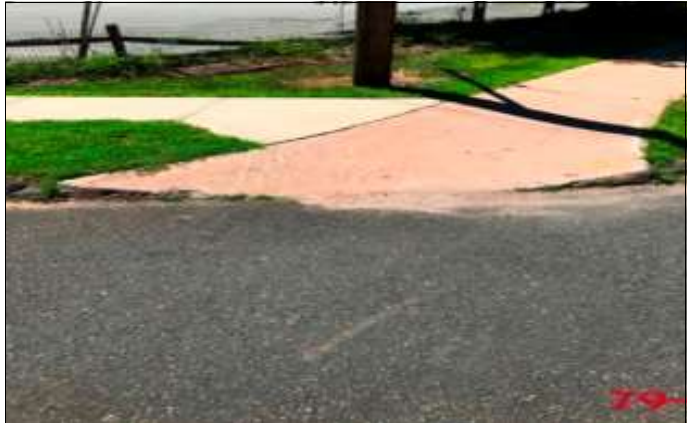
Ramp ID:	79-8
Street:	HOPMEADOW STREET
Intersecting Street:	SEMINARY ROAD
Ramp Material:	Concrete
Det. Warning Panel:	No
Panel Damage:	No
Obstructions:	No
Obstruction Type:	None
Condition:	Good
Ramp Pass:	No

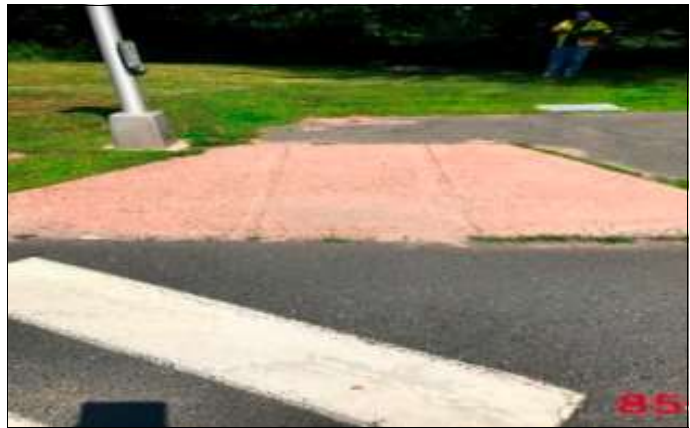
Ramp ID:	85-1
Street:	HOPMEADOW STREET
Intersecting Street:	OWENS BROOK BOULEVARD
Ramp Material:	Concrete
Det. Warning Panel:	No
Panel Damage:	No
Obstructions:	Yes
Obstruction Type:	Vegetation
Condition:	Fair
Ramp Pass:	No

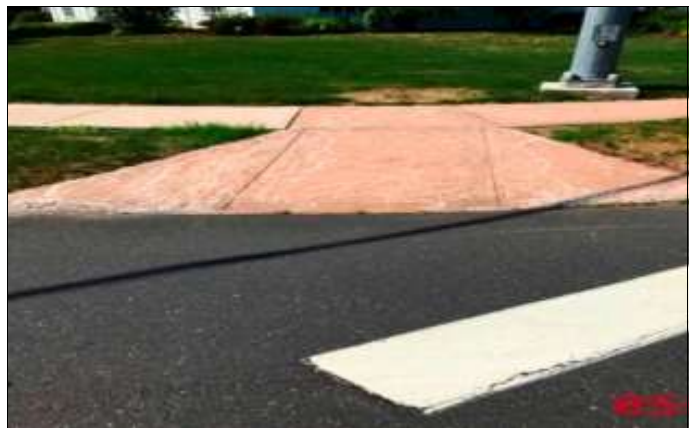
Ramp ID:	85-2
Street:	HOPMEADOW STREET
Intersecting Street:	OWENS BROOK BOULEVARD
Ramp Material:	Concrete
Det. Warning Panel:	No
Panel Damage:	No
Obstructions:	No
Obstruction Type:	None
Condition:	Good
Ramp Pass:	No

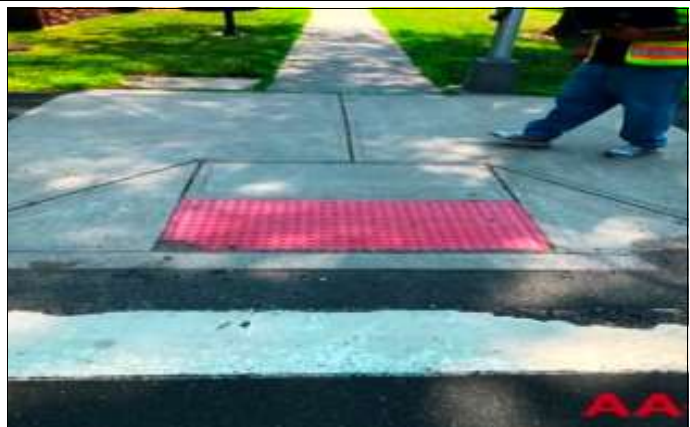
Ramp ID:	AA-1
Street:	HOPMEADOW STREET
Intersecting Street:	DRIVEWAY #632
Ramp Material:	Concrete
Det. Warning Panel:	Yes
Panel Damage:	No
Obstructions:	No
Obstruction Type:	None
Condition:	Good
Ramp Pass:	Yes

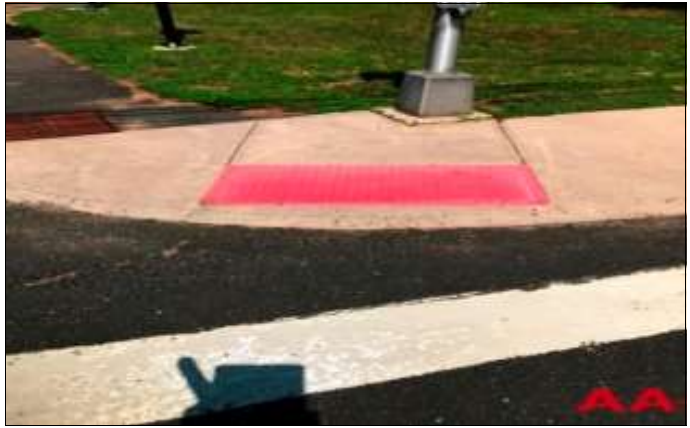
Ramp ID:	AA-2
Street:	HOPMEADOW STREET
Intersecting Street:	DRIVEWAY #1
Ramp Material:	Concrete
Det. Warning Panel:	Yes
Panel Damage:	No
Obstructions:	No
Obstruction Type:	None
Condition:	Good
Ramp Pass:	No

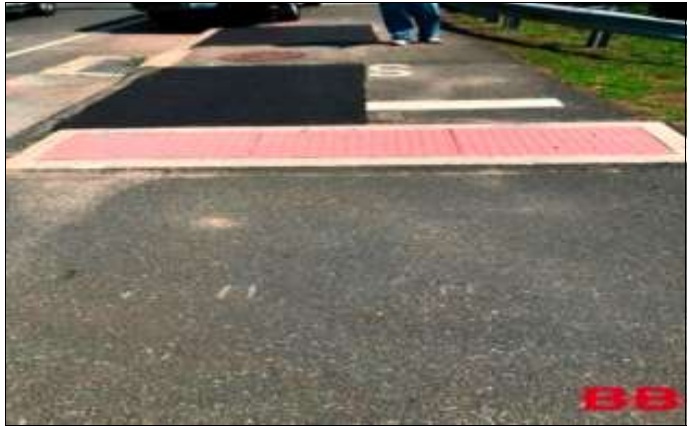
Ramp ID:	BB-1
Street:	HOPMEADOW STREET
Intersecting Street:	DRIVEWAY #632
Ramp Material:	Concrete
Det. Warning Panel:	Yes
Panel Damage:	No
Obstructions:	No
Obstruction Type:	None
Condition:	Good
Ramp Pass:	Yes

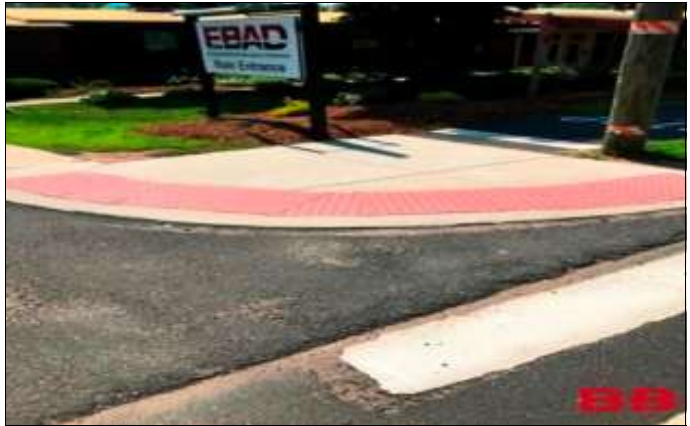
Ramp ID:	BB-2
Street:	HOPMEADOW STREET
Intersecting Street:	DRIVEWAY #632
Ramp Material:	Concrete
Det. Warning Panel:	Yes
Panel Damage:	No
Obstructions:	No
Obstruction Type:	None
Condition:	Good
Ramp Pass:	Yes

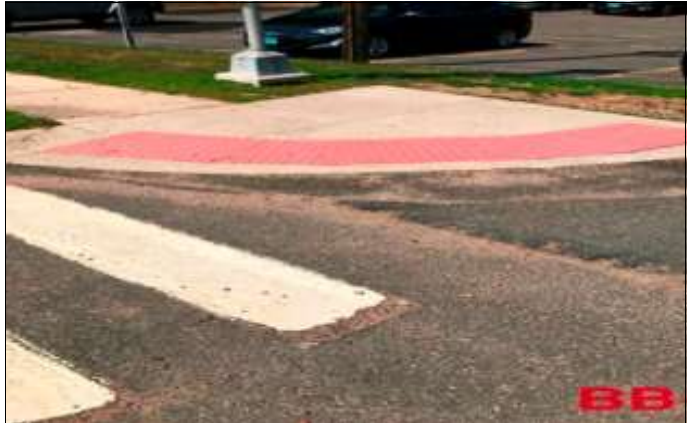
Ramp ID:	BB-3
Street:	HOPMEADOW STREET
Intersecting Street:	PARKING LOT
Ramp Material:	Concrete
Det. Warning Panel:	Yes
Panel Damage:	No
Obstructions:	No
Obstruction Type:	None
Condition:	Good
Ramp Pass:	Yes

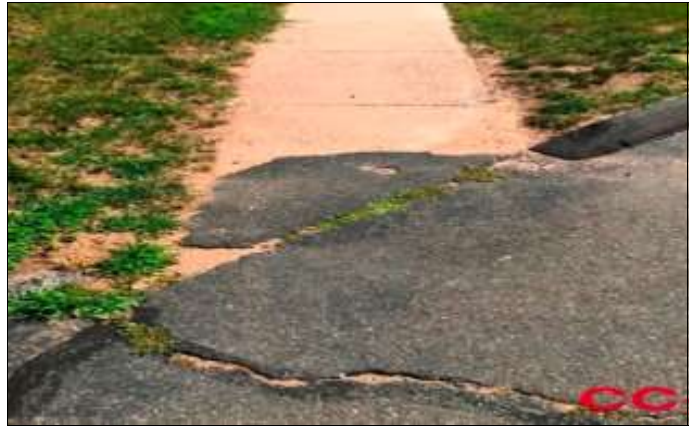
Ramp ID:	CC-2
Street:	HOPMEADOW STREET
Intersecting Street:	DRIVEWAY #981
Ramp Material:	Asphalt
Det. Warning Panel:	No
Panel Damage:	No
Obstructions:	Yes
Obstruction Type:	Vegetation
Condition:	Poor
Ramp Pass:	No

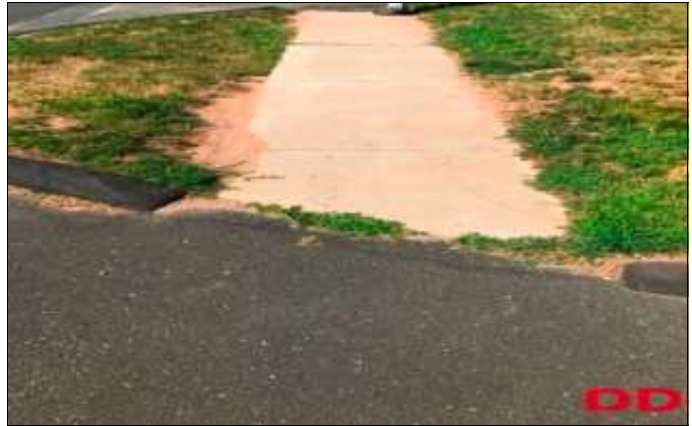
Ramp ID:	DD-1
Street:	HOPMEADOW STREET
Intersecting Street:	DRIVEWAY #981
Ramp Material:	Concrete
Det. Warning Panel:	No
Panel Damage:	No
Obstructions:	Yes
Obstruction Type:	Vegetation
Condition:	Fair
Ramp Pass:	No

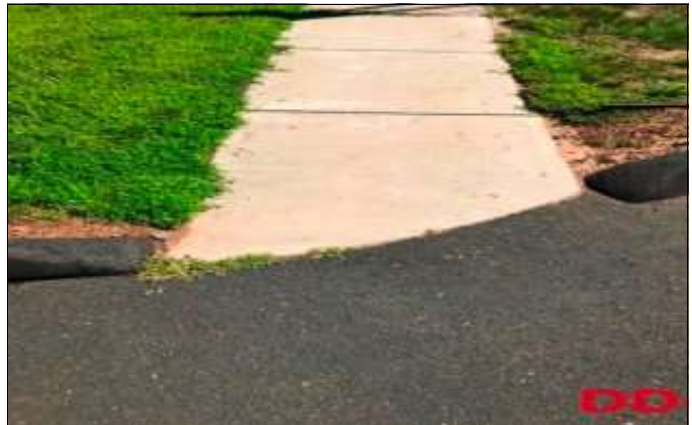
Ramp ID:	DD-2
Street:	HOPMEADOW STREET
Intersecting Street:	DRIVEWAY #981
Ramp Material:	Concrete
Det. Warning Panel:	No
Panel Damage:	No
Obstructions:	No
Obstruction Type:	None
Condition:	Poor
Ramp Pass:	No

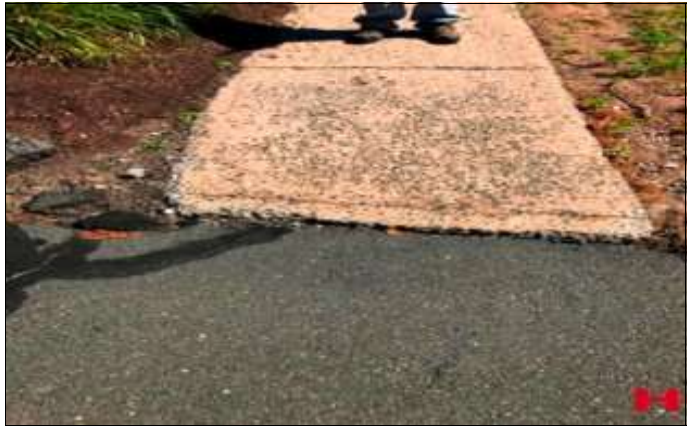
Ramp ID:	H-1
Street:	HOPMEADOW STREET
Intersecting Street:	DRIVEWAY #971
Ramp Material:	Concrete
Det. Warning Panel:	No
Panel Damage:	No
Obstructions:	Yes
Obstruction Type:	None
Condition:	Poor
Ramp Pass:	No

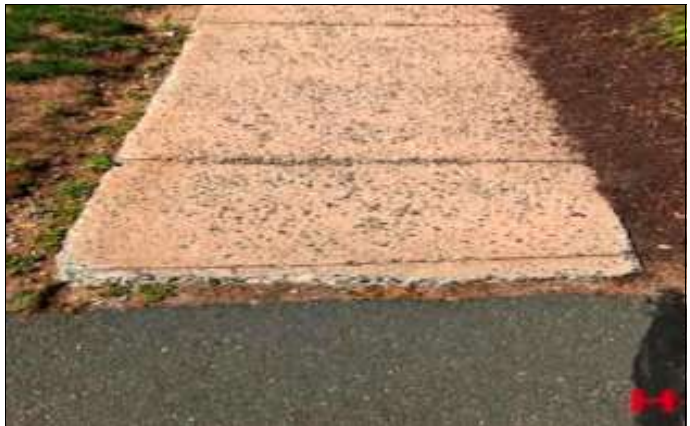
Ramp ID:	H-2
Street:	HOPMEADOW STREET
Intersecting Street:	DRIVEWAY #971
Ramp Material:	Concrete
Det. Warning Panel:	No
Panel Damage:	No
Obstructions:	Yes
Obstruction Type:	None
Condition:	Poor
Ramp Pass:	No

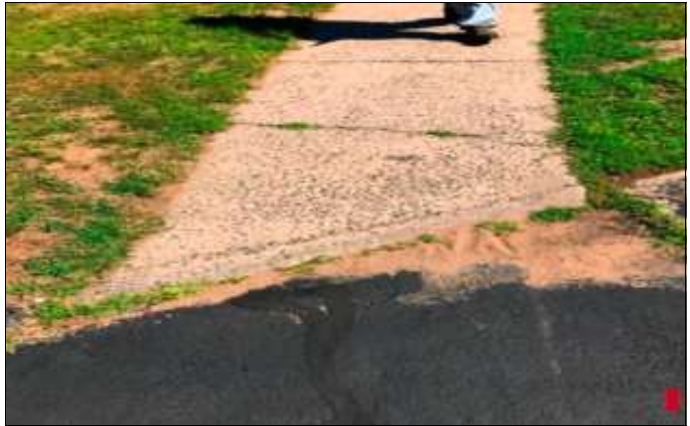
Ramp ID:	I-1
Street:	HOPMEADOW STREET
Intersecting Street:	DRIVEWAY #969
Ramp Material:	Concrete
Det. Warning Panel:	No
Panel Damage:	No
Obstructions:	Yes
Obstruction Type:	Vegetation
Condition:	Fair
Ramp Pass:	No

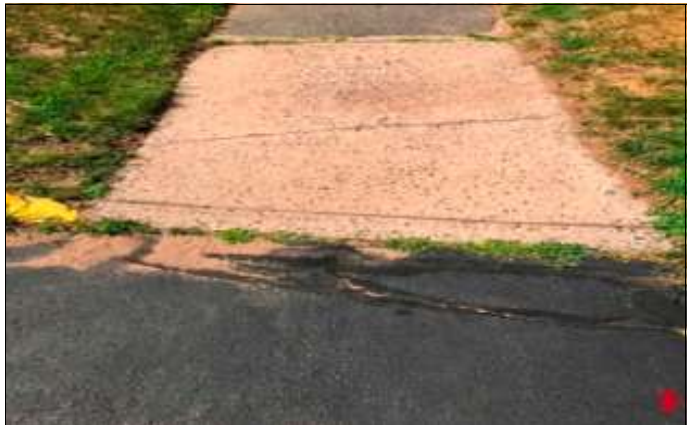
Ramp ID:	I-2
Street:	HOPMEADOW STREET
Intersecting Street:	DRIVEWAY #969
Ramp Material:	Concrete
Det. Warning Panel:	No
Panel Damage:	No
Obstructions:	Yes
Obstruction Type:	Vegetation
Condition:	Fair
Ramp Pass:	No

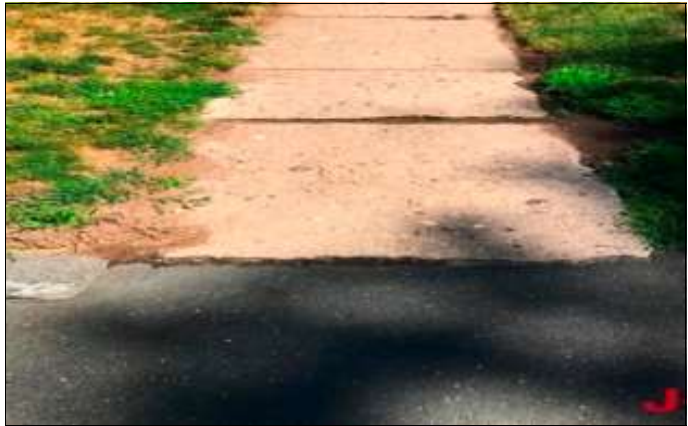
Ramp ID:	J-1
Street:	HOPMEADOW STREET
Intersecting Street:	DRIVEWAY #965
Ramp Material:	Concrete
Det. Warning Panel:	No
Panel Damage:	No
Obstructions:	Yes
Obstruction Type:	Curbing
Condition:	Poor
Ramp Pass:	No

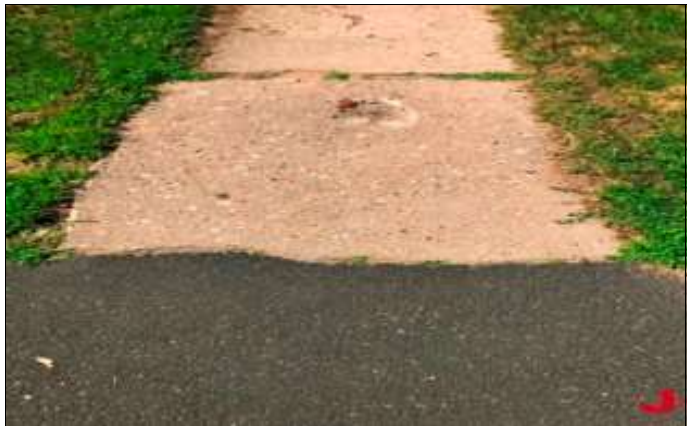
Ramp ID:	J-2
Street:	HOPMEADOW STREET
Intersecting Street:	DRIVEWAY #965
Ramp Material:	Concrete
Det. Warning Panel:	No
Panel Damage:	No
Obstructions:	Yes
Obstruction Type:	Vegetation
Condition:	Poor
Ramp Pass:	No

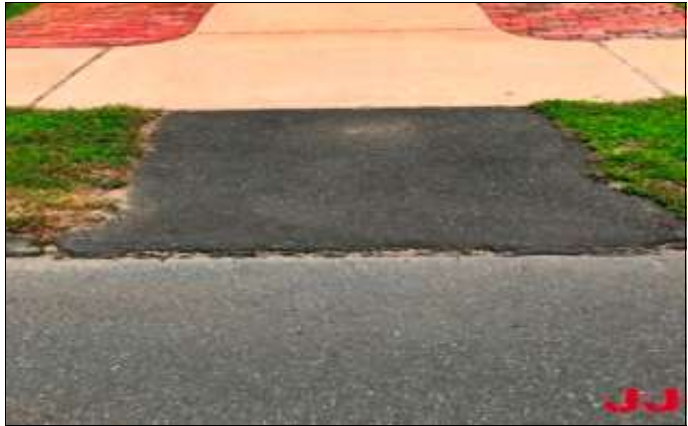
Ramp ID:	JJ-1
Street:	HOPMEADOW STREET
Intersecting Street:	DRIVEWAY #944
Ramp Material:	Asphalt
Det. Warning Panel:	No
Panel Damage:	No
Obstructions:	Yes
Obstruction Type:	Curbing
Condition:	Good
Ramp Pass:	No

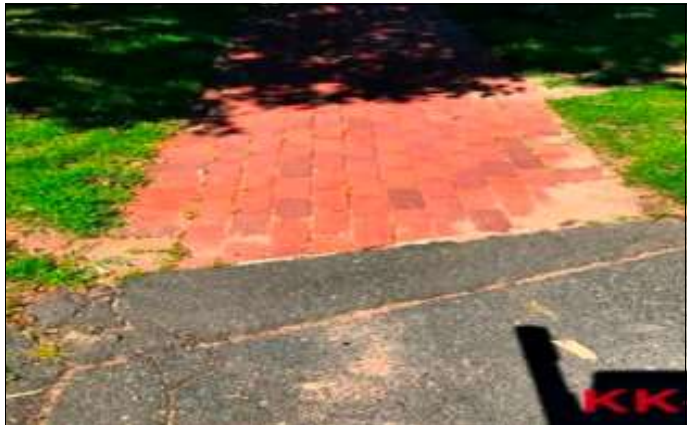
Ramp ID:	KK-1
Street:	HOPMEADOW STREET
Intersecting Street:	DRIVEWAY #849
Ramp Material:	Brick
Det. Warning Panel:	No
Panel Damage:	No
Obstructions:	No
Obstruction Type:	None
Condition:	Good
Ramp Pass:	No

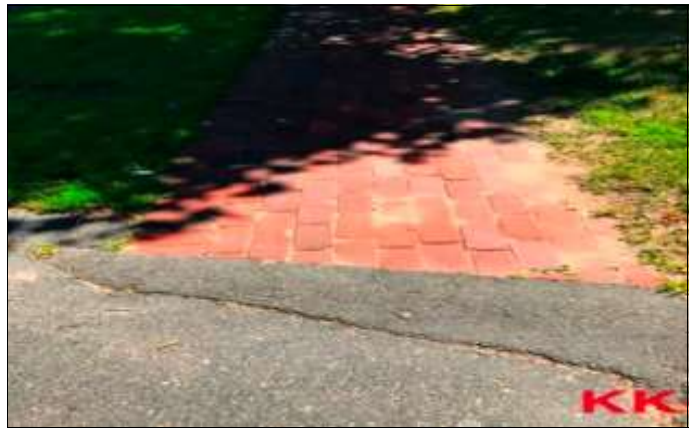
Ramp ID:	KK-2
Street:	HOPMEADOW STREET
Intersecting Street:	DRIVEWAY #849
Ramp Material:	Brick
Det. Warning Panel:	No
Panel Damage:	No
Obstructions:	No
Obstruction Type:	None
Condition:	Good
Ramp Pass:	No

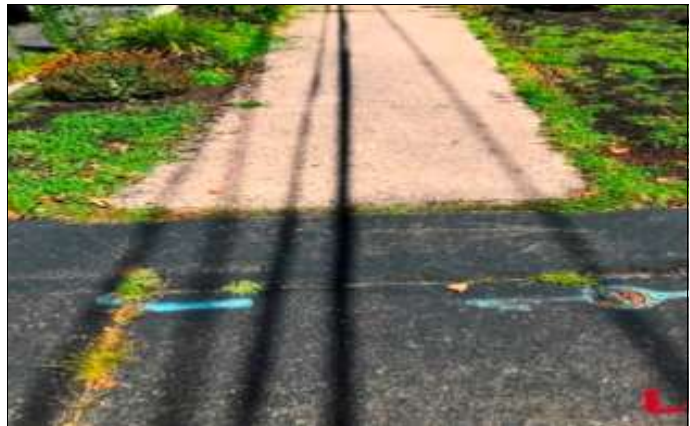
Ramp ID:	L-1
Street:	HOPMEADOW STREET
Intersecting Street:	DRIVEWAY #955
Ramp Material:	Concrete
Det. Warning Panel:	No
Panel Damage:	No
Obstructions:	Yes
Obstruction Type:	Vegetation
Condition:	Fair
Ramp Pass:	No

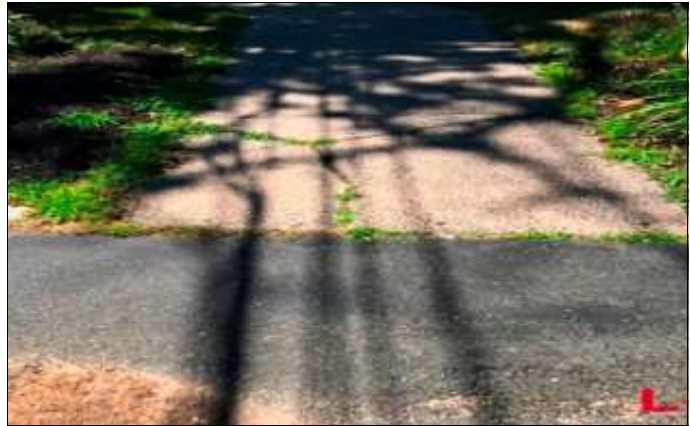
Ramp ID:	L-2
Street:	HOPMEADOW STREET
Intersecting Street:	DRIVEWAY #955
Ramp Material:	Concrete
Det. Warning Panel:	No
Panel Damage:	No
Obstructions:	Yes
Obstruction Type:	Vegetation
Condition:	Fair
Ramp Pass:	No

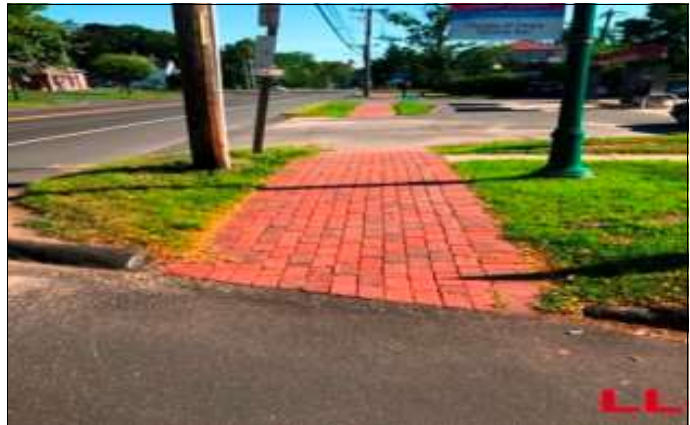
Ramp ID:	LL-1
Street:	HOPMEADOW STREET
Intersecting Street:	DRIVEWAY #828
Ramp Material:	Brick
Det. Warning Panel:	No
Panel Damage:	No
Obstructions:	No
Obstruction Type:	None
Condition:	Good
Ramp Pass:	No

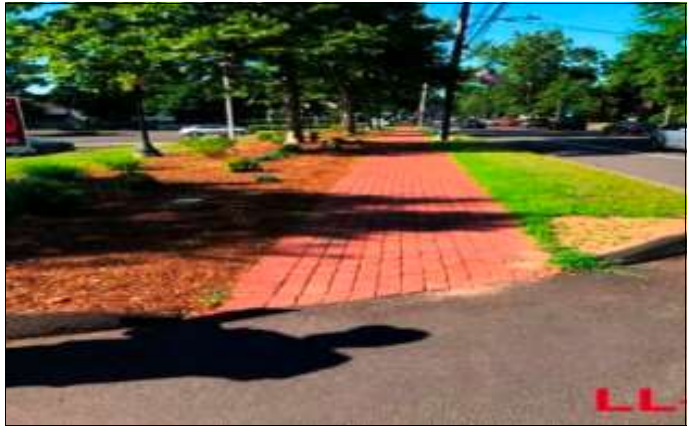
Ramp ID:	LL-2
Street:	HOPMEADOW STREET
Intersecting Street:	DRIVEWAY #828
Ramp Material:	Brick
Det. Warning Panel:	No
Panel Damage:	No
Obstructions:	No
Obstruction Type:	None
Condition:	Good
Ramp Pass:	No

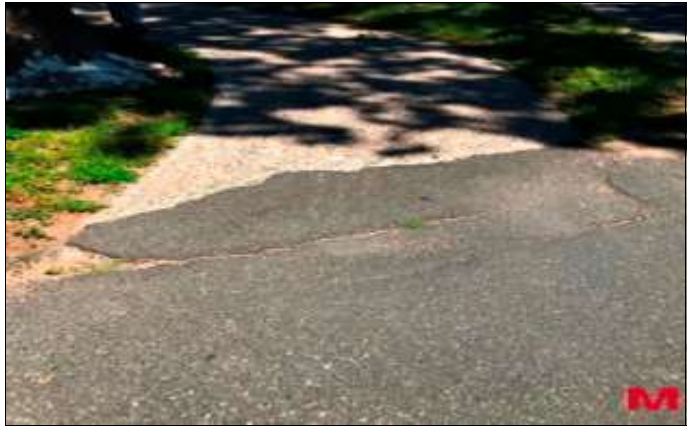
Ramp ID:	M-1
Street:	HOPMEADOW STREET
Intersecting Street:	DRIVEWAY #949
Ramp Material:	Concrete
Det. Warning Panel:	No
Panel Damage:	No
Obstructions:	No
Obstruction Type:	None
Condition:	Good
Ramp Pass:	No

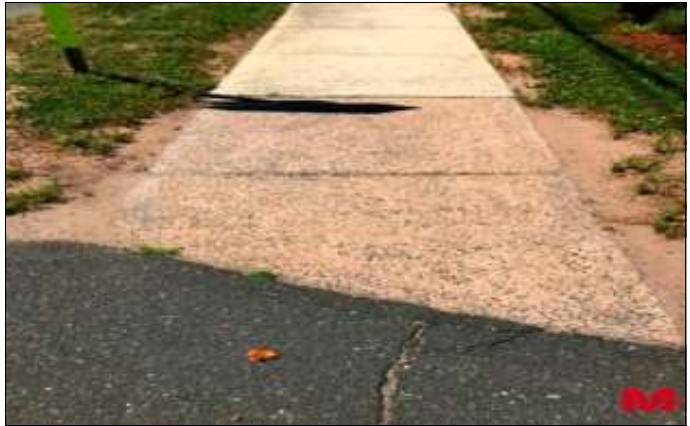
Ramp ID:	M-2
Street:	HOPMEADOW STREET
Intersecting Street:	DRIVEWAY #949
Ramp Material:	Concrete
Det. Warning Panel:	No
Panel Damage:	No
Obstructions:	No
Obstruction Type:	None
Condition:	Good
Ramp Pass:	No

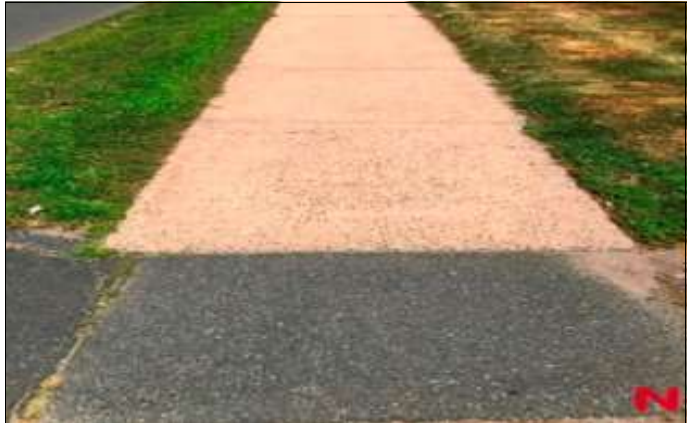
Ramp ID:	N-1
Street:	HOPMEADOW STREET
Intersecting Street:	DRIVEWAY #944
Ramp Material:	Concrete
Det. Warning Panel:	No
Panel Damage:	No
Obstructions:	No
Obstruction Type:	None
Condition:	Good
Ramp Pass:	No

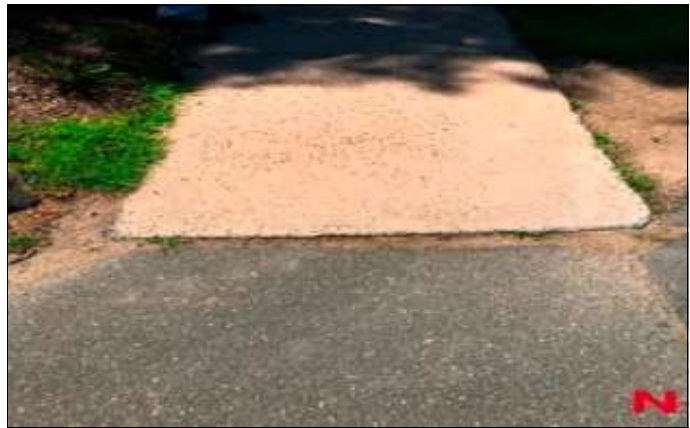
Ramp ID:	N-2
Street:	HOPMEADOW STREET
Intersecting Street:	DRIVEWAY #944
Ramp Material:	Concrete
Det. Warning Panel:	No
Panel Damage:	No
Obstructions:	Yes
Obstruction Type:	Curbing
Condition:	Fair
Ramp Pass:	No

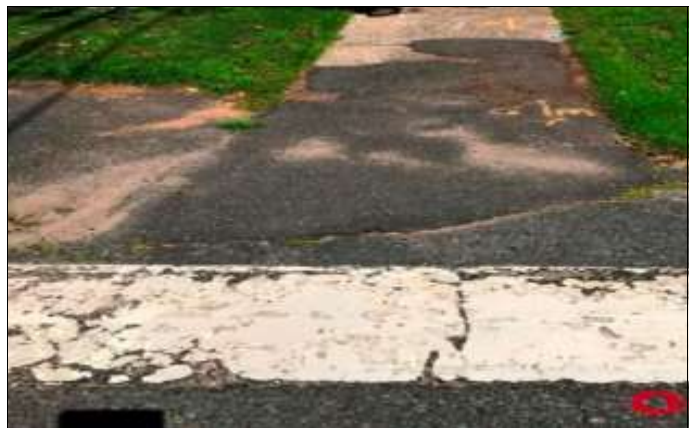
Ramp ID:	O-1
Street:	HOPMEADOW STREET
Intersecting Street:	DRIVEWAY #933
Ramp Material:	Asphalt
Det. Warning Panel:	No
Panel Damage:	No
Obstructions:	Yes
Obstruction Type:	Curbing
Condition:	Fair
Ramp Pass:	No

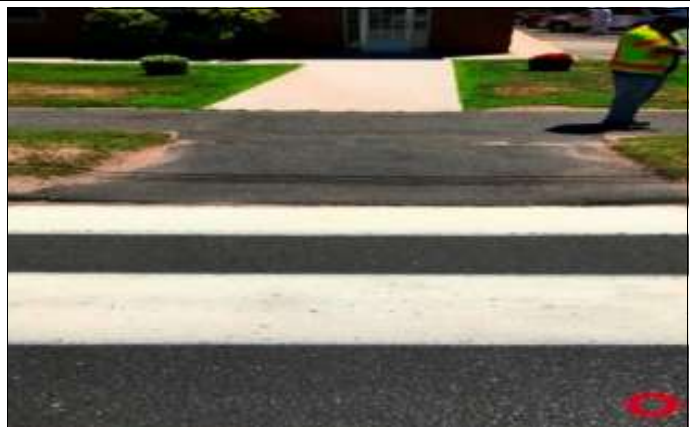
Ramp ID:	O-3
Street:	HOPMEADOW STREET
Intersecting Street:	DRIVEWAY #932
Ramp Material:	Asphalt
Det. Warning Panel:	No
Panel Damage:	No
Obstructions:	No
Obstruction Type:	None
Condition:	Good
Ramp Pass:	No

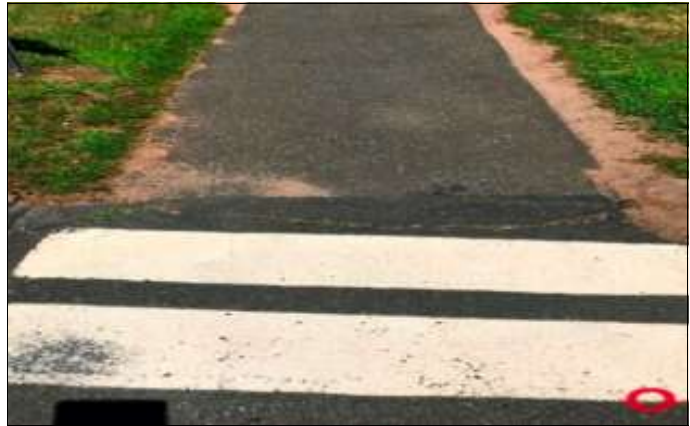
Ramp ID:	O-4
Street:	HOPMEADOW STREET
Intersecting Street:	DRIVEWAY #932
Ramp Material:	Asphalt
Det. Warning Panel:	No
Panel Damage:	No
Obstructions:	No
Obstruction Type:	None
Condition:	Good
Ramp Pass:	No

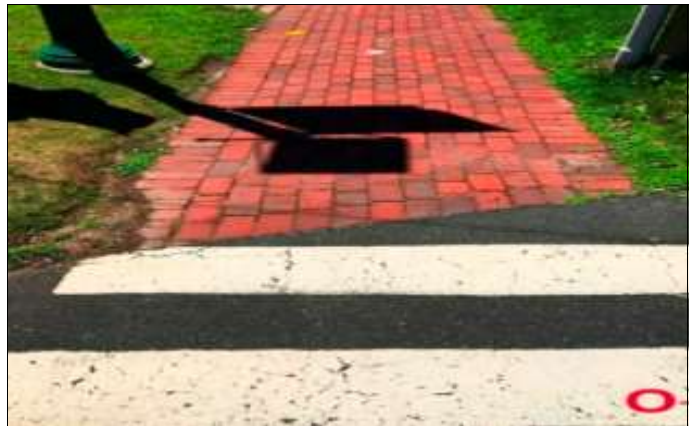
Ramp ID:	O-5
Street:	HOPMEADOW STREET
Intersecting Street:	DRIVEWAY #932
Ramp Material:	Brick
Det. Warning Panel:	No
Panel Damage:	No
Obstructions:	No
Obstruction Type:	None
Condition:	Good
Ramp Pass:	No

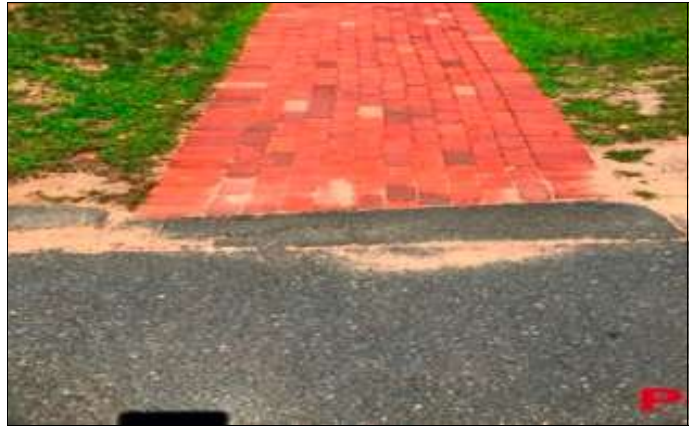
Ramp ID:	P-1
Street:	HOPMEADOW STREET
Intersecting Street:	DRIVEWAY #923
Ramp Material:	Brick
Det. Warning Panel:	No
Panel Damage:	No
Obstructions:	No
Obstruction Type:	None
Condition:	Good
Ramp Pass:	No

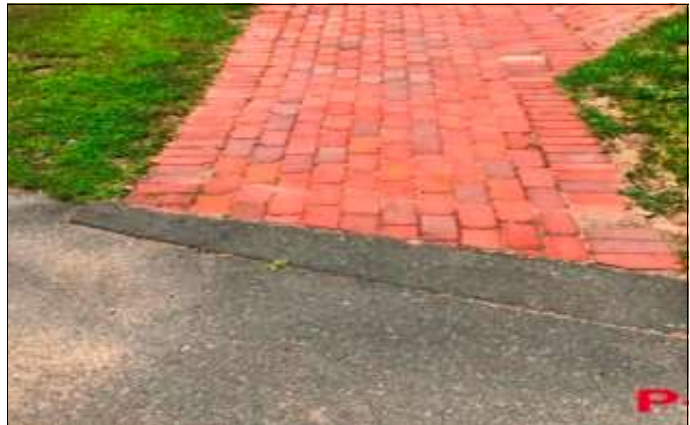
Ramp ID:	P-2
Street:	HOPMEADOW STREET
Intersecting Street:	DRIVEWAY #923
Ramp Material:	Brick
Det. Warning Panel:	No
Panel Damage:	No
Obstructions:	No
Obstruction Type:	None
Condition:	Good
Ramp Pass:	No

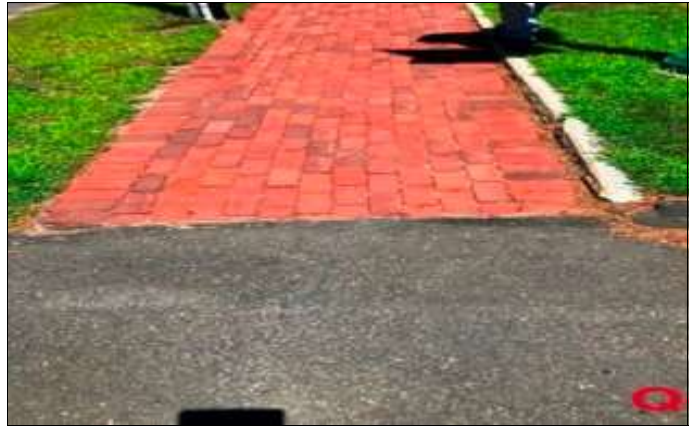
Ramp ID:	Q-1
Street:	HOPMEADOW STREET
Intersecting Street:	DRIVEWAY #940
Ramp Material:	Brick
Det. Warning Panel:	No
Panel Damage:	No
Obstructions:	No
Obstruction Type:	None
Condition:	Good
Ramp Pass:	No

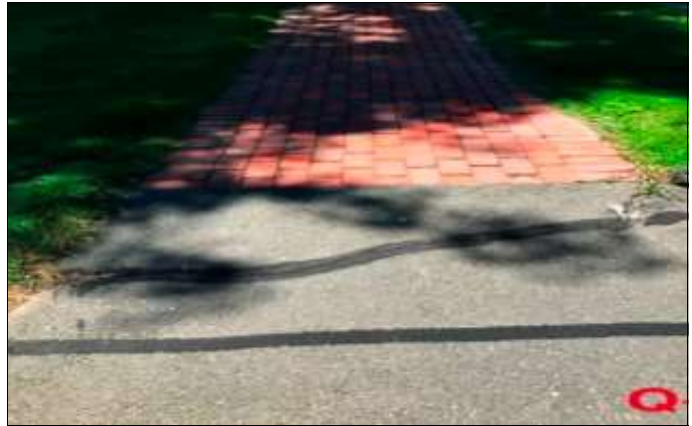
Ramp ID:	Q-2
Street:	HOPMEADOW STREET
Intersecting Street:	DRIVEWAY #940
Ramp Material:	Brick
Det. Warning Panel:	No
Panel Damage:	No
Obstructions:	No
Obstruction Type:	None
Condition:	Good
Ramp Pass:	No

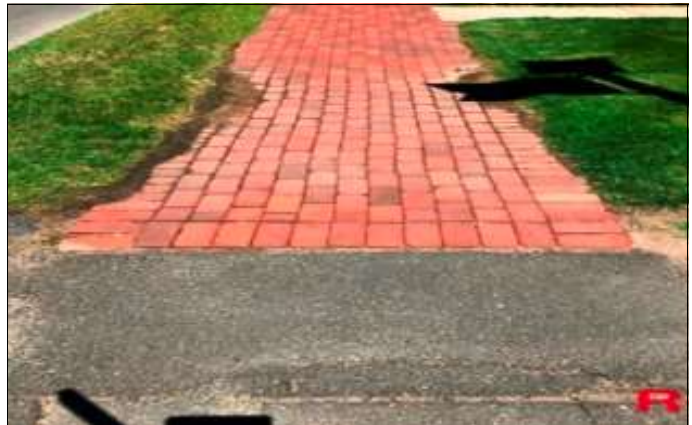
Ramp ID:	R-1
Street:	HOPMEADOW STREET
Intersecting Street:	DRIVEWAY #894
Ramp Material:	Brick
Det. Warning Panel:	No
Panel Damage:	No
Obstructions:	No
Obstruction Type:	None
Condition:	Good
Ramp Pass:	No

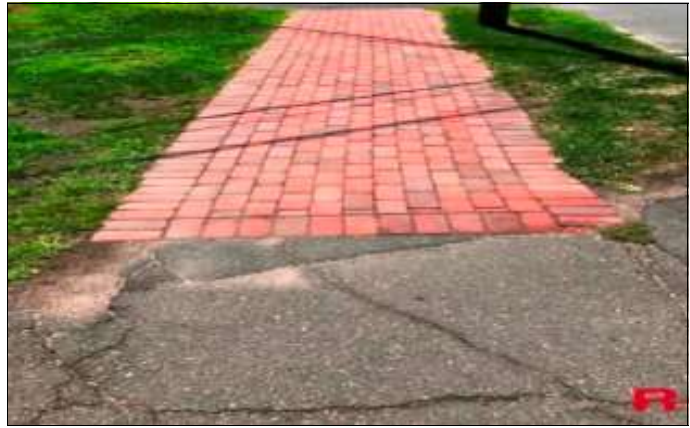
Ramp ID:	R-2
Street:	HOPMEADOW STREET
Intersecting Street:	DRIVEWAY #894
Ramp Material:	Brick
Det. Warning Panel:	No
Panel Damage:	No
Obstructions:	No
Obstruction Type:	None
Condition:	Good
Ramp Pass:	No

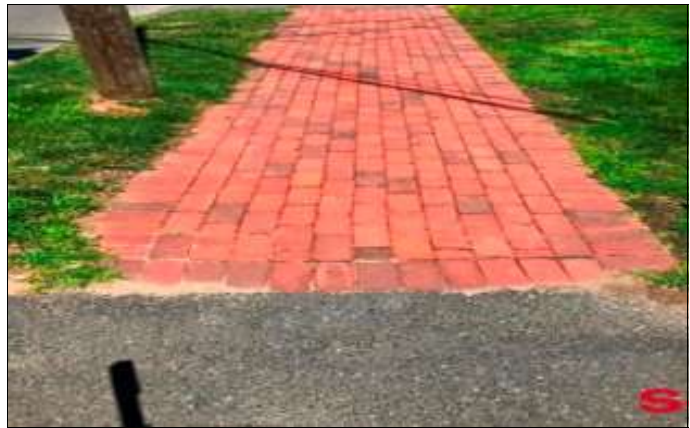
Ramp ID:	S-1
Street:	HOPMEADOW STREET
Intersecting Street:	DRIVEWAY #880
Ramp Material:	Brick
Det. Warning Panel:	No
Panel Damage:	No
Obstructions:	No
Obstruction Type:	None
Condition:	Good
Ramp Pass:	No

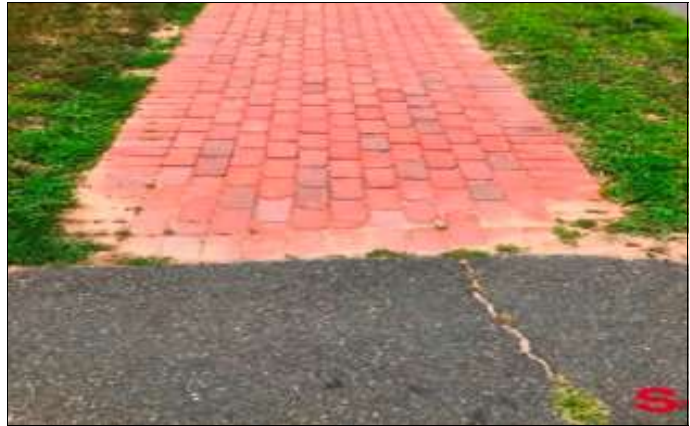
Ramp ID:	S-2
Street:	HOPMEADOW STREET
Intersecting Street:	DRIVEWAY #880
Ramp Material:	Brick
Det. Warning Panel:	No
Panel Damage:	No
Obstructions:	No
Obstruction Type:	None
Condition:	Good
Ramp Pass:	No

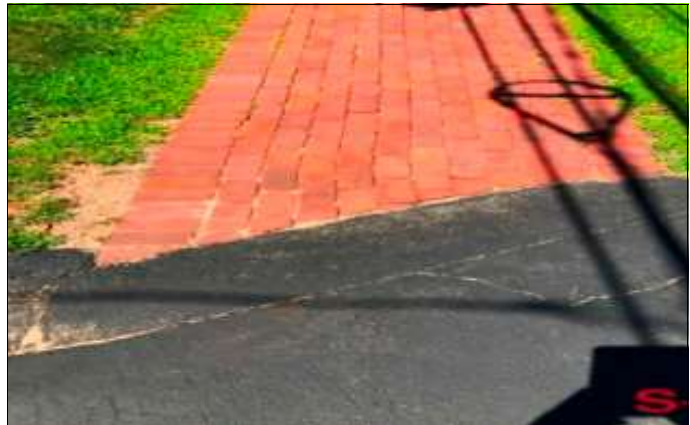
Ramp ID:	S-3
Street:	HOPMEADOW STREET
Intersecting Street:	DRIVEWAY #883
Ramp Material:	Brick
Det. Warning Panel:	No
Panel Damage:	No
Obstructions:	No
Obstruction Type:	None
Condition:	Good
Ramp Pass:	No

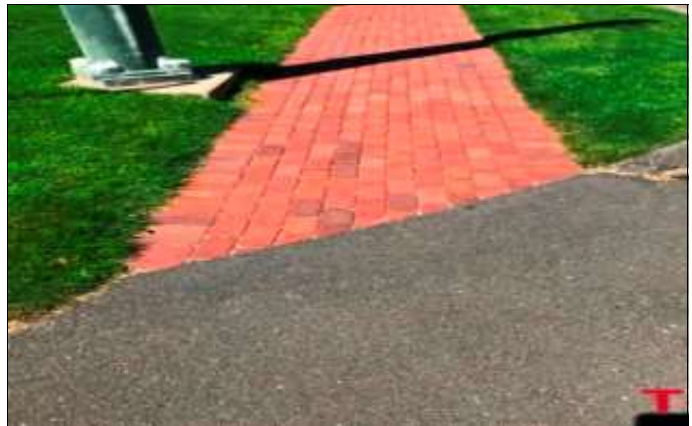
Ramp ID:	T-1
Street:	HOPMEADOW STREET
Intersecting Street:	DRIVEWAY #869
Ramp Material:	Brick
Det. Warning Panel:	No
Panel Damage:	No
Obstructions:	No
Obstruction Type:	None
Condition:	Good
Ramp Pass:	No

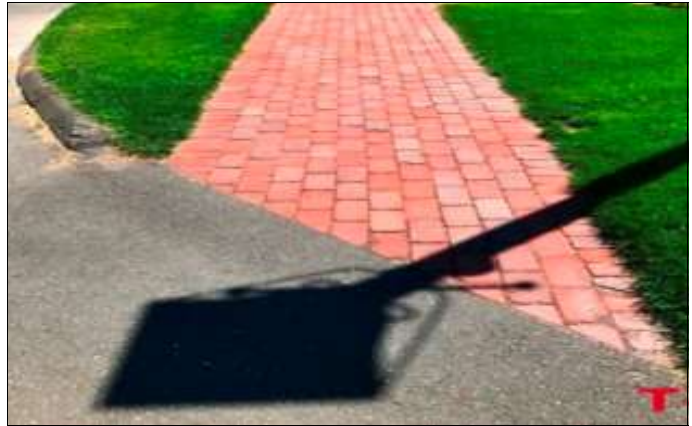
Ramp ID:	T-2
Street:	HOPMEADOW STREET
Intersecting Street:	DRIVEWAY #869
Ramp Material:	Brick
Det. Warning Panel:	No
Panel Damage:	No
Obstructions:	No
Obstruction Type:	None
Condition:	Good
Ramp Pass:	No

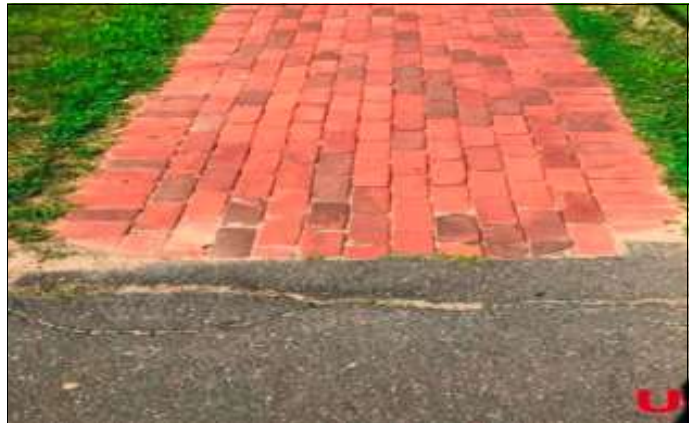
Ramp ID:	U-1
Street:	HOPMEADOW STREET
Intersecting Street:	DRIVEWAY #880
Ramp Material:	Brick
Det. Warning Panel:	No
Panel Damage:	No
Obstructions:	No
Obstruction Type:	None
Condition:	Good
Ramp Pass:	No

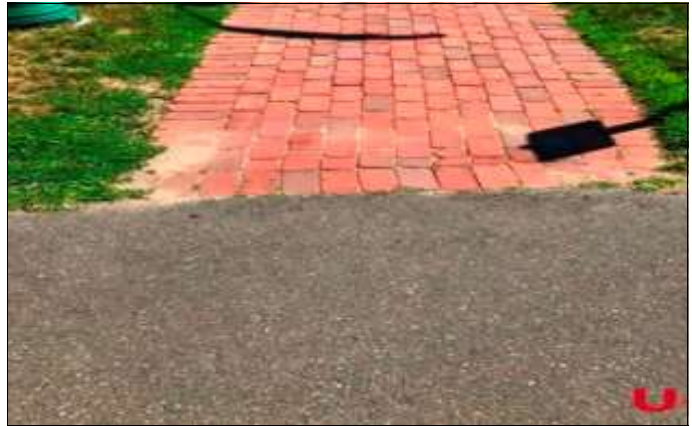
Ramp ID:	U-2
Street:	HOPMEADOW STREET
Intersecting Street:	DRIVEWAY #880
Ramp Material:	Brick
Det. Warning Panel:	No
Panel Damage:	No
Obstructions:	No
Obstruction Type:	None
Condition:	Good
Ramp Pass:	No

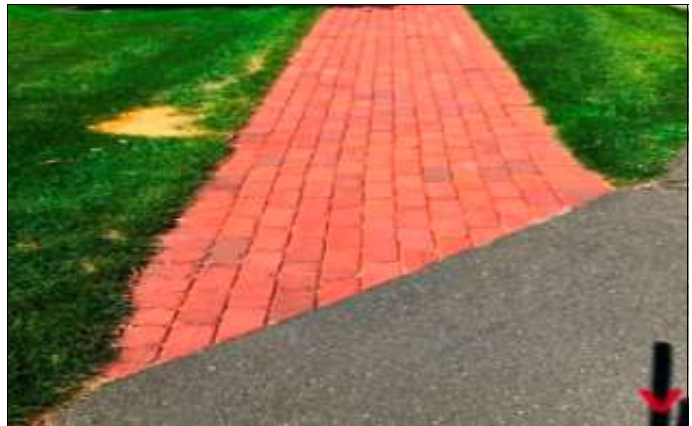
Ramp ID:	V-1
Street:	HOPMEADOW STREET
Intersecting Street:	DRIVEWAY #863
Ramp Material:	Brick
Det. Warning Panel:	No
Panel Damage:	No
Obstructions:	No
Obstruction Type:	None
Condition:	Good
Ramp Pass:	No

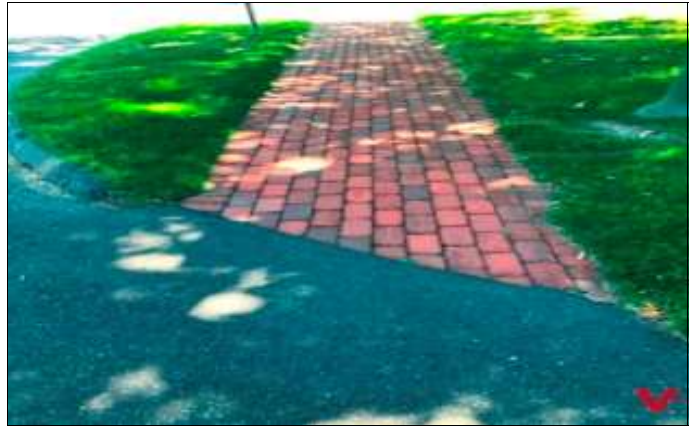
Ramp ID:	V-2
Street:	HOPMEADOW STREET
Intersecting Street:	DRIVEWAY #863
Ramp Material:	Brick
Det. Warning Panel:	No
Panel Damage:	No
Obstructions:	No
Obstruction Type:	None
Condition:	Good
Ramp Pass:	No

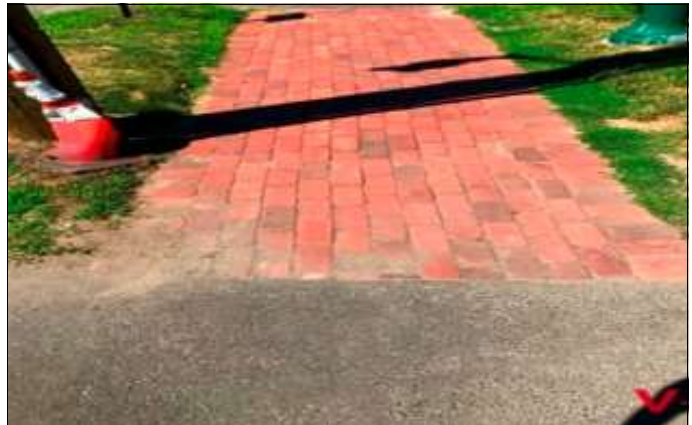
Ramp ID:	V-3
Street:	HOPMEADOW STREET
Intersecting Street:	DRIVEWAY #850
Ramp Material:	Brick
Det. Warning Panel:	No
Panel Damage:	No
Obstructions:	No
Obstruction Type:	None
Condition:	Good
Ramp Pass:	No

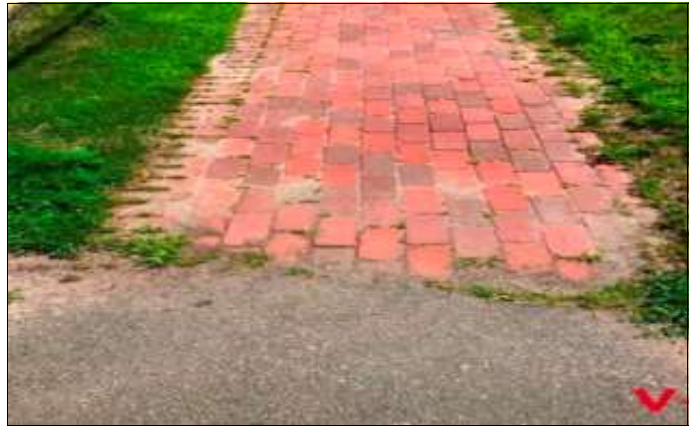
Ramp ID:	V-4
Street:	HOPMEADOW STREET
Intersecting Street:	DRIVEWAY #850
Ramp Material:	Brick
Det. Warning Panel:	No
Panel Damage:	No
Obstructions:	No
Obstruction Type:	None
Condition:	Good
Ramp Pass:	No

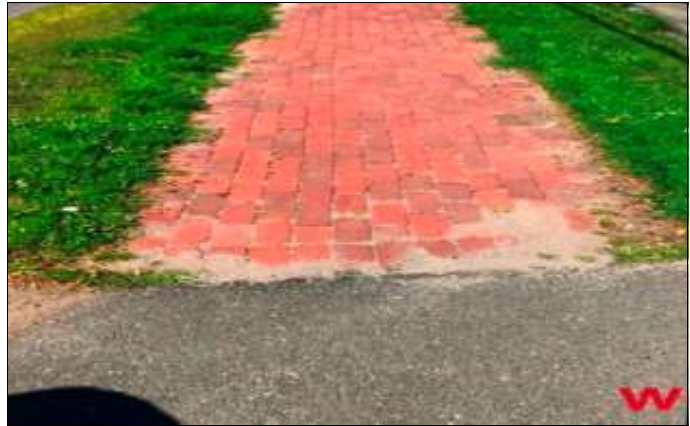
Ramp ID:	W-1
Street:	HOPMEADOW STREET
Intersecting Street:	DRIVEWAY #850
Ramp Material:	Brick
Det. Warning Panel:	No
Panel Damage:	No
Obstructions:	No
Obstruction Type:	None
Condition:	Good
Ramp Pass:	No

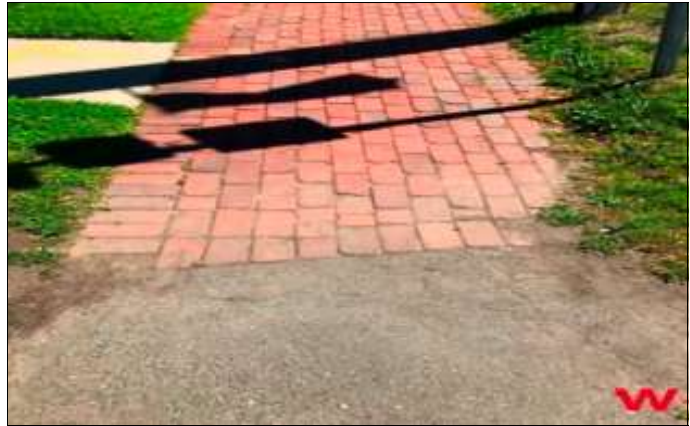
Ramp ID:	W-2
Street:	HOPMEADOW STREET
Intersecting Street:	DRIVEWAY #850
Ramp Material:	Brick
Det. Warning Panel:	No
Panel Damage:	No
Obstructions:	No
Obstruction Type:	None
Condition:	Good
Ramp Pass:	No

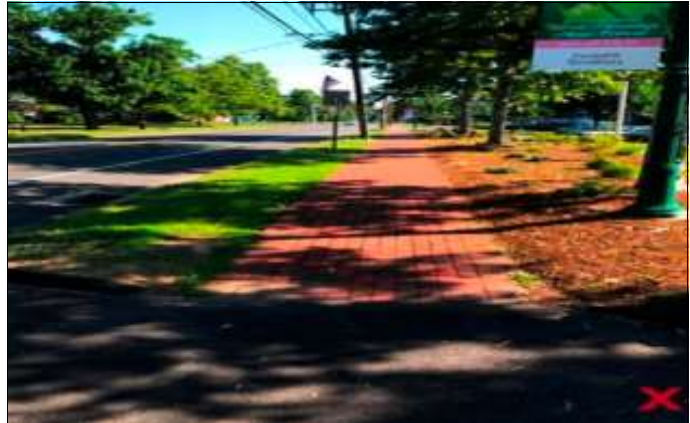
Ramp ID:	X-1
Street:	HOPMEADOW STREET
Intersecting Street:	DRIVEWAY #828
Ramp Material:	Brick
Det. Warning Panel:	No
Panel Damage:	No
Obstructions:	No
Obstruction Type:	None
Condition:	Good
Ramp Pass:	No
