Town of Simsbury, Connecticut Sidewalk and Curb Ramp Assessment

FINAL DRAFT

Prepared By:
BETA Group, Inc.
1010 Wethersfield Avenue
Suite 305
Hartford, CT 06114

September 2019

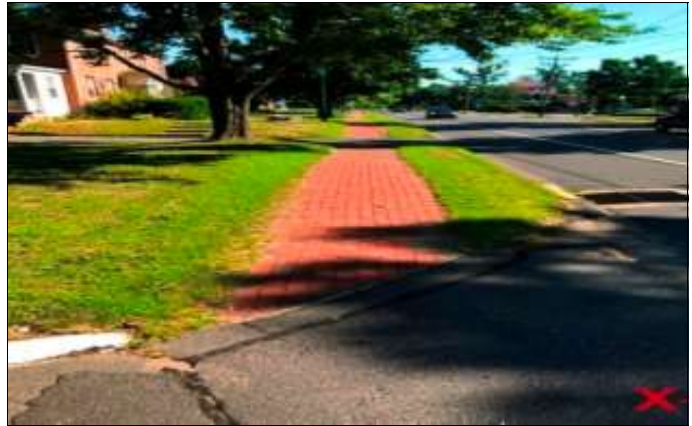
Ramp ID:	X-3
Street:	HOPMEADOW STREET
Intersecting Street:	DRIVEWAY #809
Ramp Material:	Brick
Det. Warning Panel:	No
Panel Damage:	No
Obstructions:	No
Obstruction Type:	None
Condition:	Good
Ramp Pass:	No

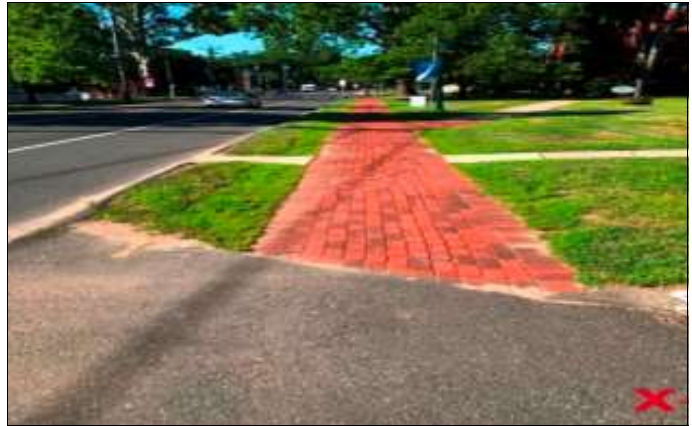
Ramp ID:	X-4
Street:	HOPMEADOW STREET
Intersecting Street:	DRIVEWAY #809
Ramp Material:	Brick
Det. Warning Panel:	No
Panel Damage:	No
Obstructions:	No
Obstruction Type:	None
Condition:	Good
Ramp Pass:	No

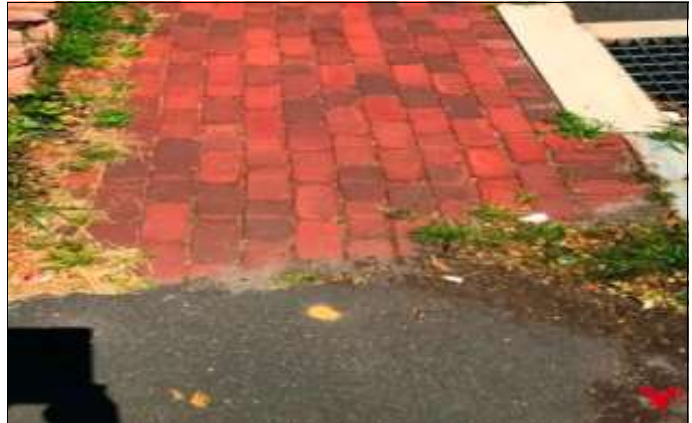
Ramp ID:	Y-1
Street:	HOPMEADOW STREET
Intersecting Street:	DRIVEWAY #765
Ramp Material:	Brick
Det. Warning Panel:	No
Panel Damage:	No
Obstructions:	Yes
Obstruction Type:	Vegetation
Condition:	Fair
Ramp Pass:	No

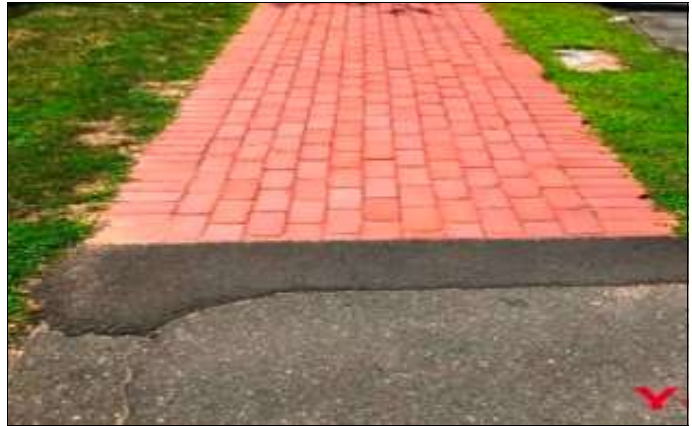
Ramp ID:	Y-3
Street:	HOPMEADOW STREET
Intersecting Street:	DRIVEWAY #760
Ramp Material:	Brick
Det. Warning Panel:	No
Panel Damage:	No
Obstructions:	No
Obstruction Type:	None
Condition:	Good
Ramp Pass:	No

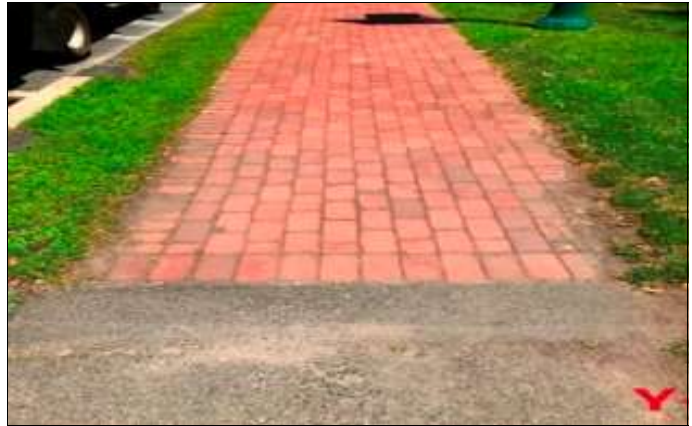
Ramp ID:	Y-4
Street:	HOPMEADOW STREET
Intersecting Street:	DRIVEWAY #760
Ramp Material:	Brick
Det. Warning Panel:	No
Panel Damage:	No
Obstructions:	No
Obstruction Type:	None
Condition:	Good
Ramp Pass:	No

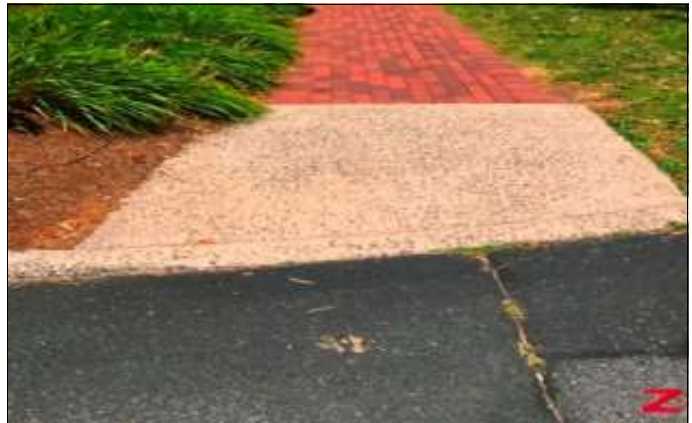
Ramp ID:	Z-1
Street:	HOPMEADOW STREET
Intersecting Street:	DRIVEWAY #741
Ramp Material:	Concrete
Det. Warning Panel:	No
Panel Damage:	No
Obstructions:	No
Obstruction Type:	None
Condition:	Good
Ramp Pass:	No

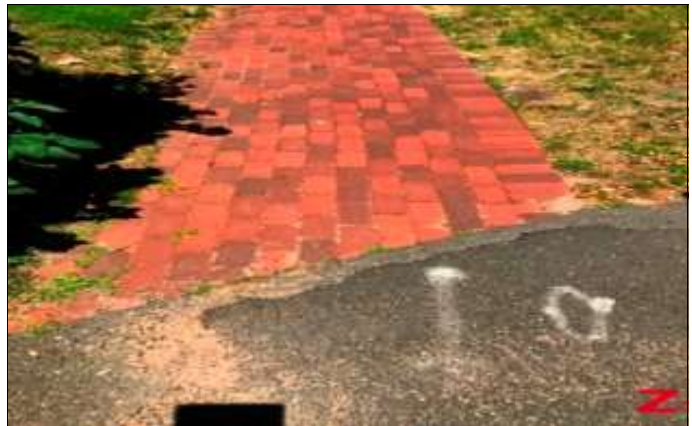
Ramp ID:	Z-3
Street:	HOPMEADOW STREET
Intersecting Street:	DRIVEWAY #731
Ramp Material:	Brick
Det. Warning Panel:	No
Panel Damage:	No
Obstructions:	No
Obstruction Type:	None
Condition:	Good
Ramp Pass:	No

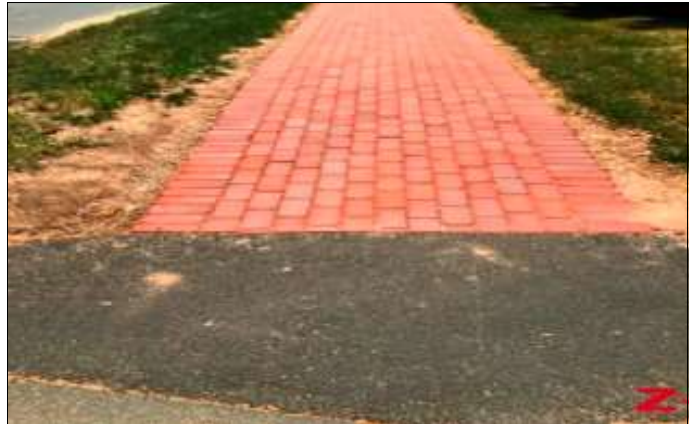
Ramp ID:	Z-4
Street:	HOPMEADOW STREET
Intersecting Street:	DRIVEWAY #731
Ramp Material:	Brick
Det. Warning Panel:	No
Panel Damage:	No
Obstructions:	No
Obstruction Type:	None
Condition:	Good
Ramp Pass:	No

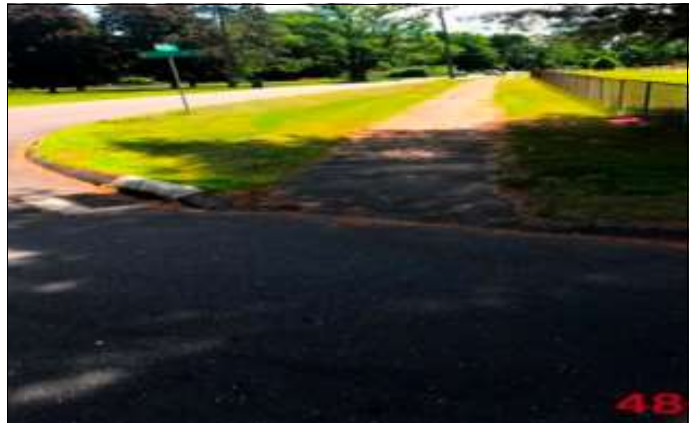
Ramp ID:	48-1
Street:	HOSKINS ROAD
Intersecting Street:	SQUADRON LINE ROAD
Ramp Material:	Asphalt
Det. Warning Panel:	No
Panel Damage:	No
Obstructions:	No
Obstruction Type:	None
Condition:	Good
Ramp Pass:	No

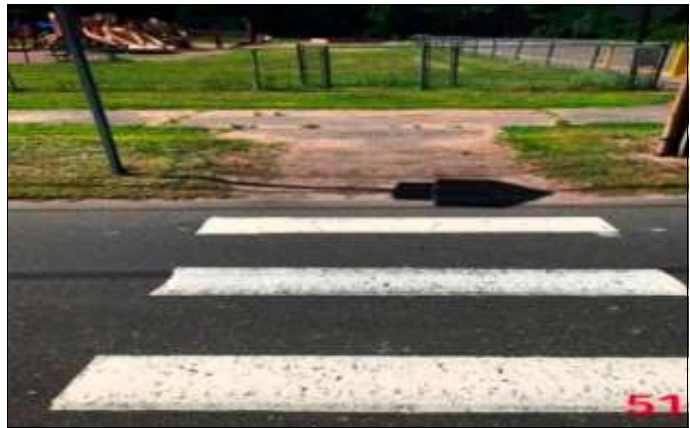
Ramp ID:	51-1
Street:	HOSKINS ROAD
Intersecting Street:	NORTH DRIVE
Ramp Material:	Asphalt
Det. Warning Panel:	No
Panel Damage:	No
Obstructions:	No
Obstruction Type:	None
Condition:	Fair
Ramp Pass:	No

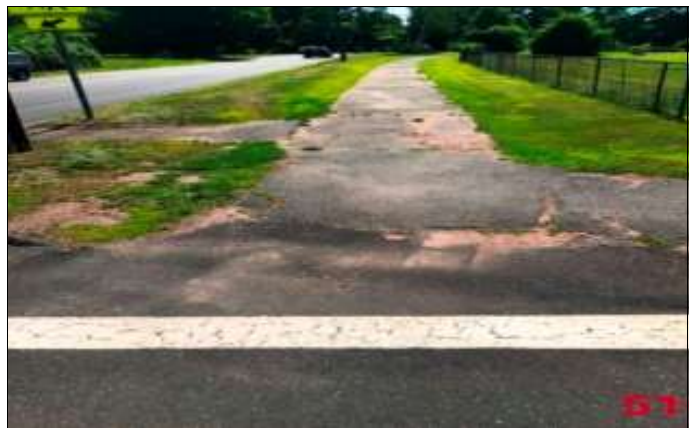
Ramp ID:	51-2
Street:	HOSKINS ROAD
Intersecting Street:	NORTH DRIVE
Ramp Material:	Asphalt
Det. Warning Panel:	No
Panel Damage:	No
Obstructions:	No
Obstruction Type:	None
Condition:	Good
Ramp Pass:	No

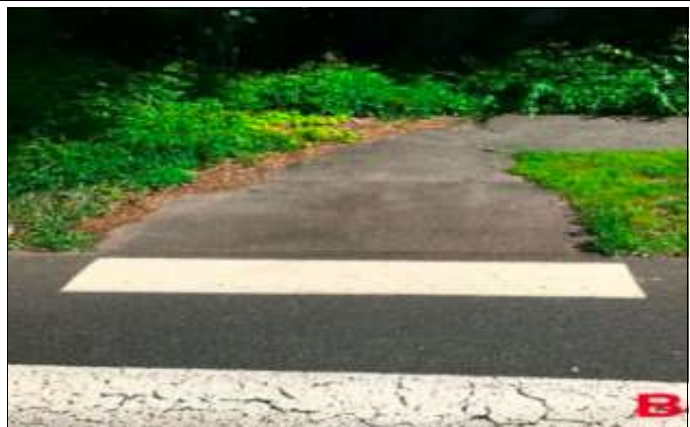
Ramp ID:	B-1
Street:	HOSKINS ROAD
Intersecting Street:	DRIVEWAY #96
Ramp Material:	Asphalt
Det. Warning Panel:	No
Panel Damage:	No
Obstructions:	No
Obstruction Type:	None
Condition:	Good
Ramp Pass:	No

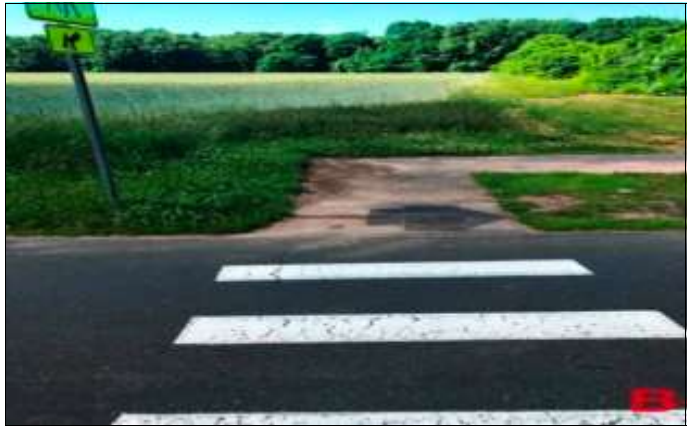
Ramp ID:	B-2
Street:	HOSKINS ROAD
Intersecting Street:	SQUADRON LINE SCHOOL
Ramp Material:	Asphalt
Det. Warning Panel:	No
Panel Damage:	No
Obstructions:	No
Obstruction Type:	None
Condition:	Good
Ramp Pass:	No

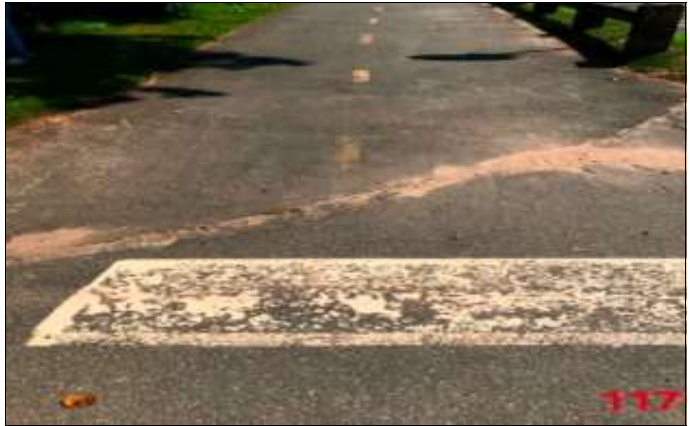
Ramp ID:	117-1
Street:	IRON HORSE BOULEVARD
Intersecting Street:	PENT ROAD
Ramp Material:	Asphalt
Det. Warning Panel:	No
Panel Damage:	No
Obstructions:	No
Obstruction Type:	None
Condition:	Good
Ramp Pass:	No

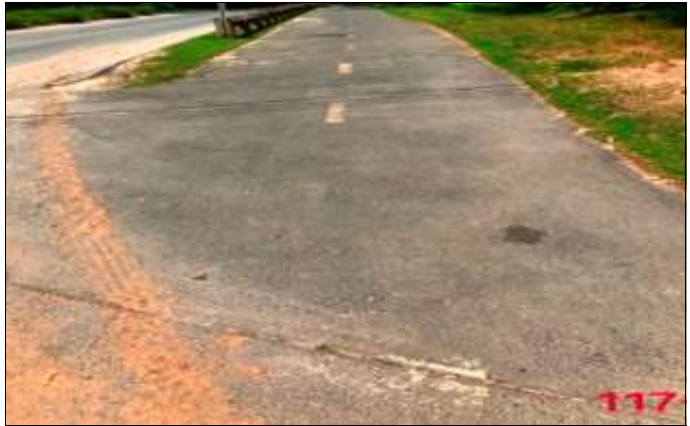
Ramp ID:	117-2
Street:	IRON HORSE BOULEVARD
Intersecting Street:	PENT ROAD
Ramp Material:	Asphalt
Det. Warning Panel:	No
Panel Damage:	No
Obstructions:	No
Obstruction Type:	None
Condition:	Good
Ramp Pass:	No

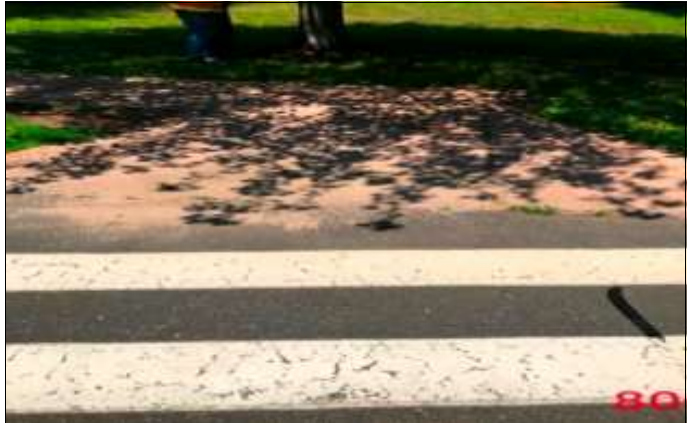
Ramp ID:	80-1
Street:	IRON HORSE BOULEVARD
Intersecting Street:	WILCOX STREET
Ramp Material:	Concrete
Det. Warning Panel:	No
Panel Damage:	No
Obstructions:	No
Obstruction Type:	None
Condition:	Good
Ramp Pass:	No

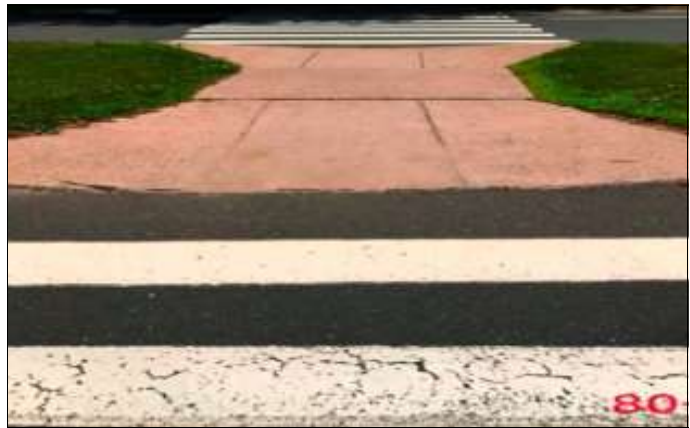
Ramp ID:	80-2
Street:	IRON HORSE BOULEVARD
Intersecting Street:	WILCOX STREET
Ramp Material:	Concrete
Det. Warning Panel:	No
Panel Damage:	No
Obstructions:	No
Obstruction Type:	None
Condition:	Good
Ramp Pass:	No

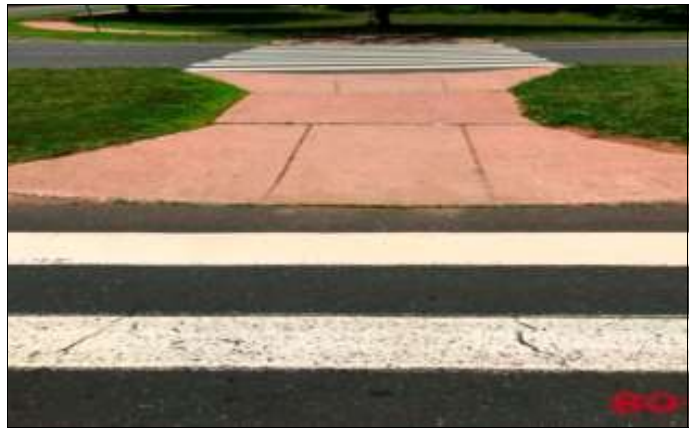
Ramp ID:	80-3
Street:	IRON HORSE BOULEVARD
Intersecting Street:	WILCOX STREET
Ramp Material:	Concrete
Det. Warning Panel:	No
Panel Damage:	No
Obstructions:	No
Obstruction Type:	None
Condition:	Good
Ramp Pass:	No

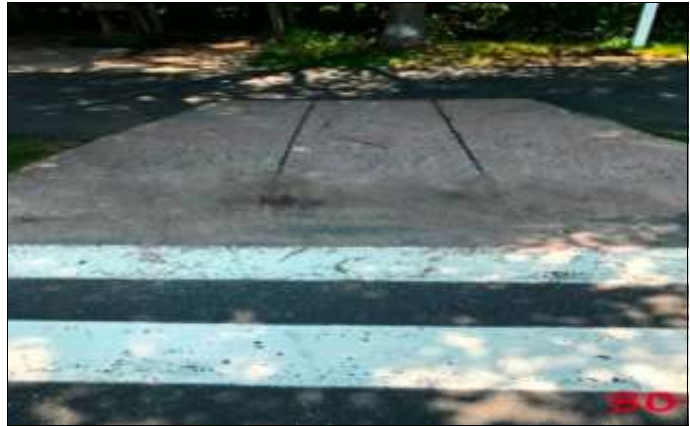
Ramp ID:	80-4
Street:	IRON HORSE BOULEVARD
Intersecting Street:	WILCOX STREET
Ramp Material:	Concrete
Det. Warning Panel:	No
Panel Damage:	No
Obstructions:	No
Obstruction Type:	None
Condition:	Good
Ramp Pass:	No

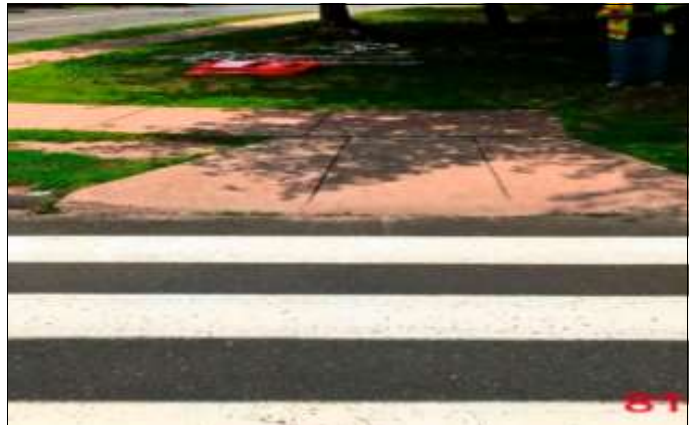
Ramp ID:	81-1
Street:	IRON HORSE BOULEVARD
Intersecting Street:	PHELPS LANE
Ramp Material:	Concrete
Det. Warning Panel:	No
Panel Damage:	No
Obstructions:	No
Obstruction Type:	None
Condition:	Good
Ramp Pass:	No

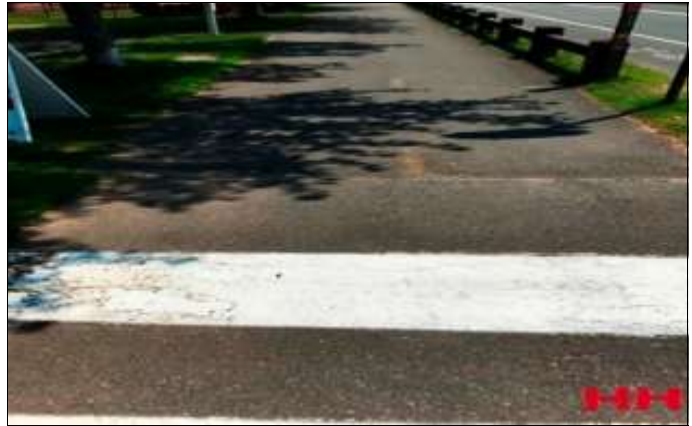
Ramp ID:	HH-1
Street:	IRON HORSE BOULEVARD
Intersecting Street:	DRIVEWAY #22
Ramp Material:	Asphalt
Det. Warning Panel:	No
Panel Damage:	No
Obstructions:	No
Obstruction Type:	None
Condition:	Good
Ramp Pass:	No

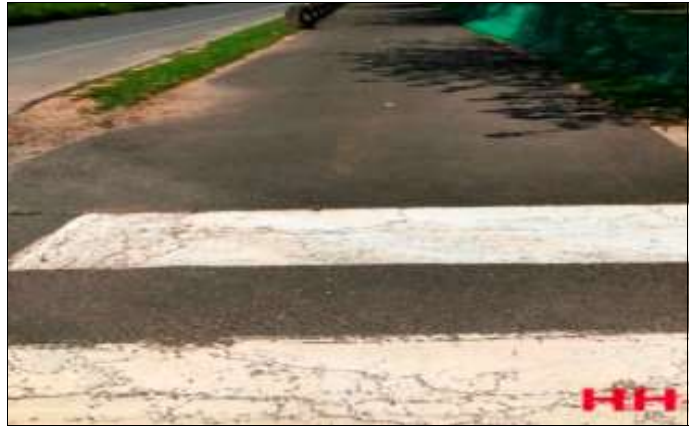
Ramp ID:	HH-2
Street:	IRON HORSE BOULEVARD
Intersecting Street:	DRIVEWAY #22
Ramp Material:	Asphalt
Det. Warning Panel:	No
Panel Damage:	No
Obstructions:	No
Obstruction Type:	None
Condition:	Good
Ramp Pass:	No

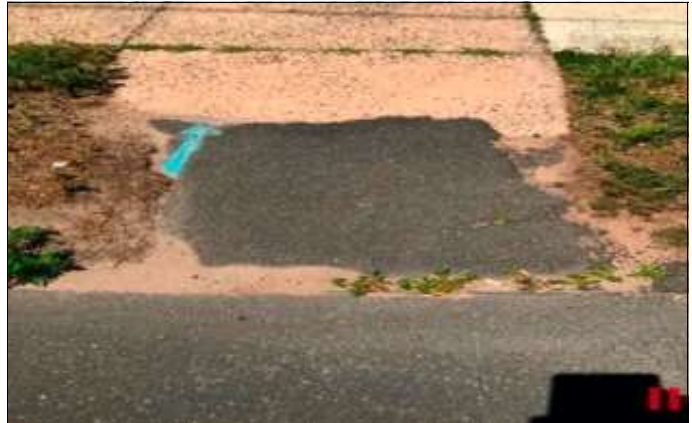
Ramp ID:	II-1
Street:	IRON HORSE BOULEVARD
Intersecting Street:	CONN STATE OF
Ramp Material:	Asphalt
Det. Warning Panel:	No
Panel Damage:	0
Obstructions:	0
Obstruction Type:	0
Condition:	Good
Ramp Pass:	No

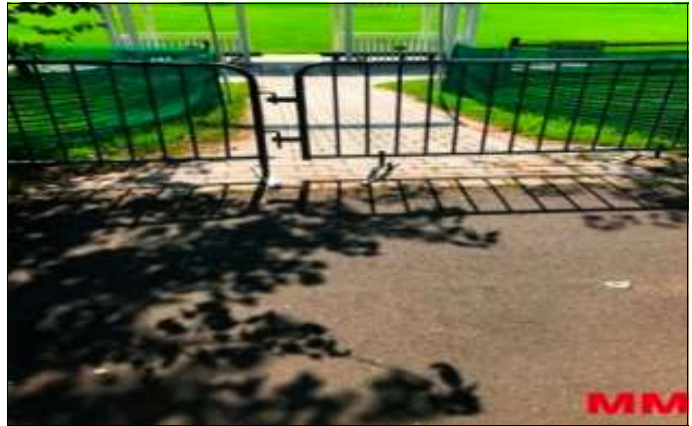
Ramp ID:	MM-1
Street:	IRON HORSE BOULEVARD
Intersecting Street:	DRIVEWAY #28
Ramp Material:	Brick
Det. Warning Panel:	No
Panel Damage:	No
Obstructions:	No
Obstruction Type:	None
Condition:	Good
Ramp Pass:	No

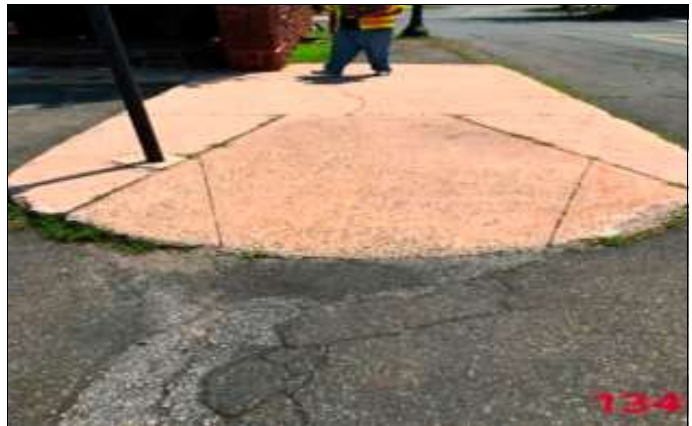
Ramp ID:	134-1
Street:	JIM GALLAGHER WAY
Intersecting Street:	DRIVEWAY #10
Ramp Material:	Concrete
Det. Warning Panel:	No
Panel Damage:	No
Obstructions:	No
Obstruction Type:	None
Condition:	Good
Ramp Pass:	No

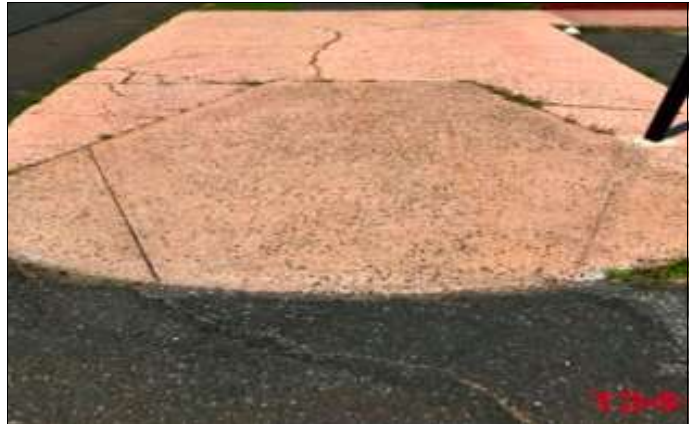
Ramp ID:	134-2
Street:	JIM GALLAGHER WAY
Intersecting Street:	DRIVEWAY #10
Ramp Material:	Concrete
Det. Warning Panel:	No
Panel Damage:	No
Obstructions:	No
Obstruction Type:	None
Condition:	Good
Ramp Pass:	No

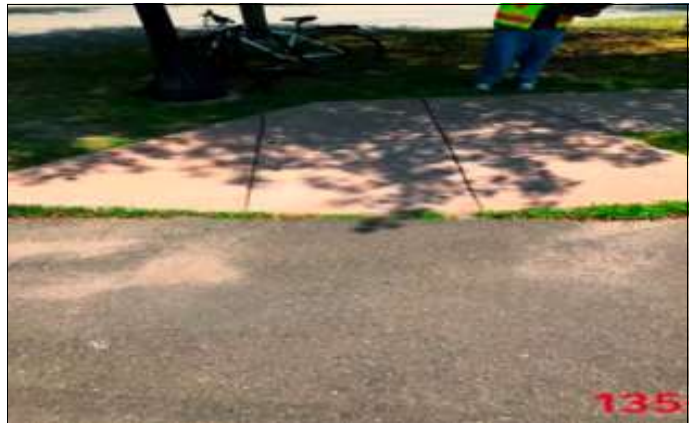
Ramp ID:	135-1
Street:	JIM GALLAGHER WAY
Intersecting Street:	PARKING LOT
Ramp Material:	Concrete
Det. Warning Panel:	No
Panel Damage:	No
Obstructions:	Yes
Obstruction Type:	Vegetation
Condition:	Fair
Ramp Pass:	No

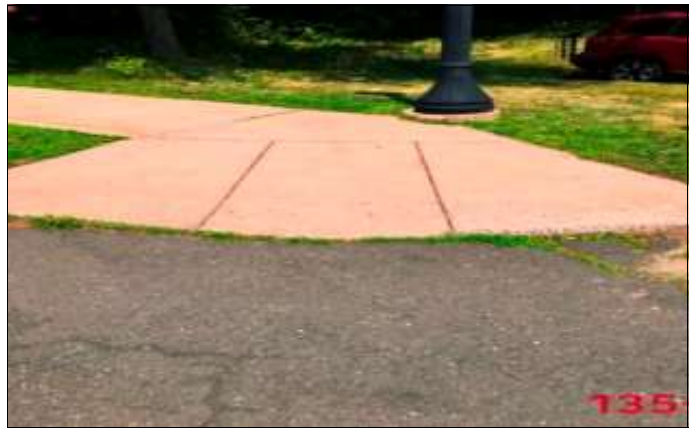
Ramp ID:	135-2
Street:	JIM GALLAGHER WAY
Intersecting Street:	PARKING LOT
Ramp Material:	Concrete
Det. Warning Panel:	No
Panel Damage:	No
Obstructions:	Yes
Obstruction Type:	Vegetation
Condition:	Fair
Ramp Pass:	No

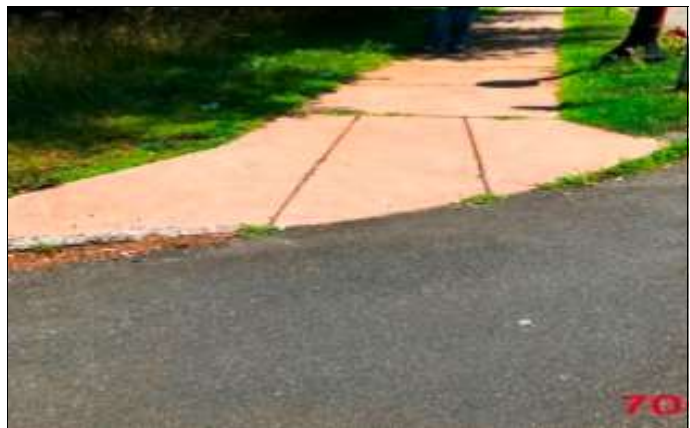
Ramp ID:	70-1
Street:	JIM GALLAGHER WAY
Intersecting Street:	DRIVEWAY #10
Ramp Material:	Concrete
Det. Warning Panel:	No
Panel Damage:	No
Obstructions:	No
Obstruction Type:	None
Condition:	Good
Ramp Pass:	No

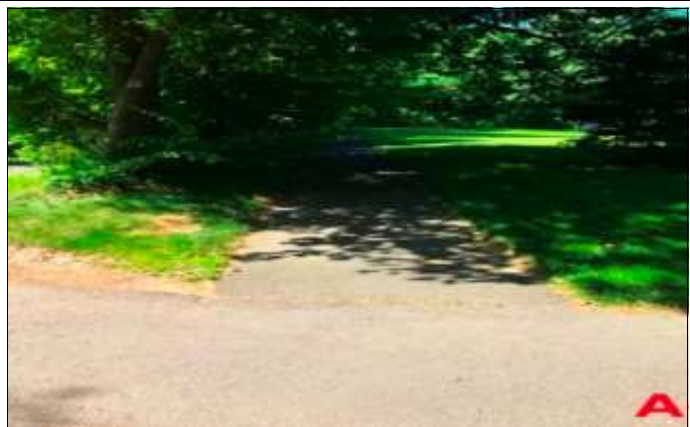
Ramp ID:	A-1
Street:	KILBOURN ROAD
Intersecting Street:	KILBOURN FARMS
Ramp Material:	Asphalt
Det. Warning Panel:	Yes
Panel Damage:	No
Obstructions:	No
Obstruction Type:	None
Condition:	Good
Ramp Pass:	No

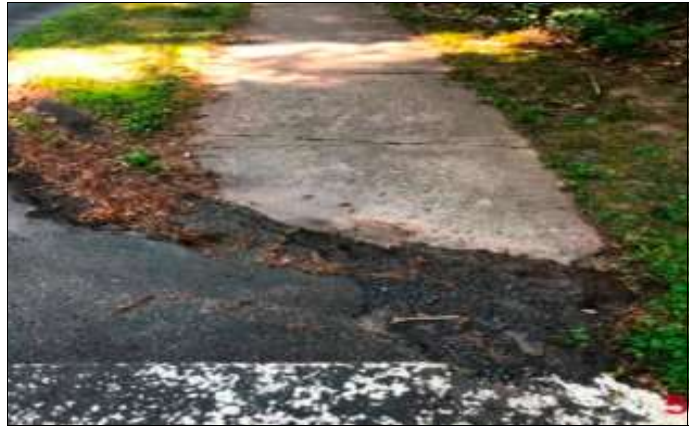
Ramp ID:	5-1
Street:	LATIMER LANE
Intersecting Street:	HARRIET LANE
Ramp Material:	Concrete
Det. Warning Panel:	No
Panel Damage:	No
Obstructions:	No
Obstruction Type:	None
Condition:	Good
Ramp Pass:	No

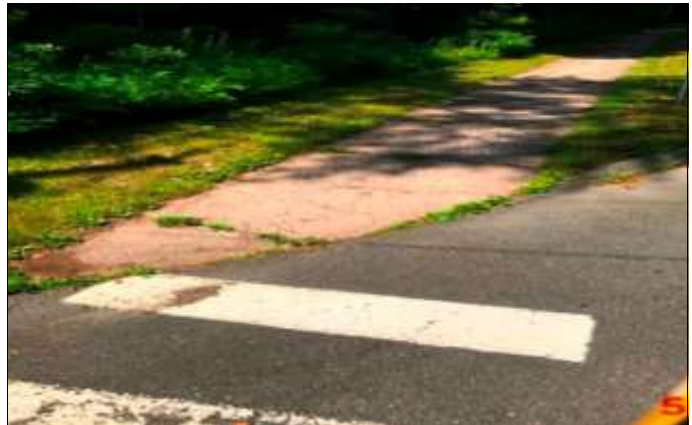
Ramp ID:	5-2
Street:	LATIMER LANE
Intersecting Street:	HARRIET LANE
Ramp Material:	Concrete
Det. Warning Panel:	No
Panel Damage:	No
Obstructions:	Yes
Obstruction Type:	Vegetation
Condition:	Fair
Ramp Pass:	No

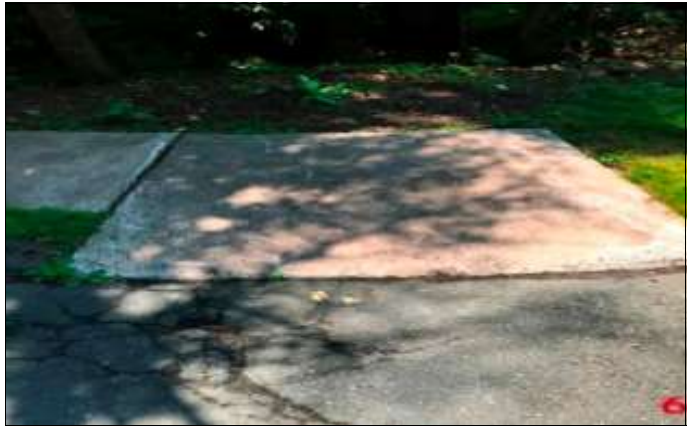
Ramp ID:	6-1
Street:	LATIMER LANE
Intersecting Street:	RED STONE DRIVE
Ramp Material:	Concrete
Det. Warning Panel:	No
Panel Damage:	No
Obstructions:	No
Obstruction Type:	None
Condition:	Good
Ramp Pass:	No

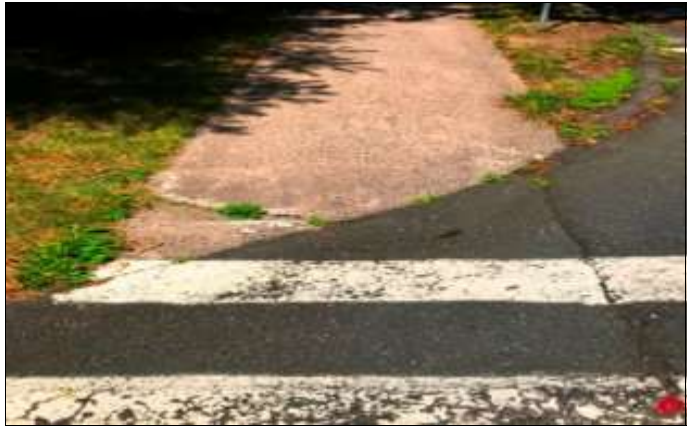
Ramp ID:	6-2
Street:	LATIMER LANE
Intersecting Street:	RED STONE DRIVE
Ramp Material:	Concrete
Det. Warning Panel:	No
Panel Damage:	No
Obstructions:	No
Obstruction Type:	None
Condition:	Good
Ramp Pass:	No

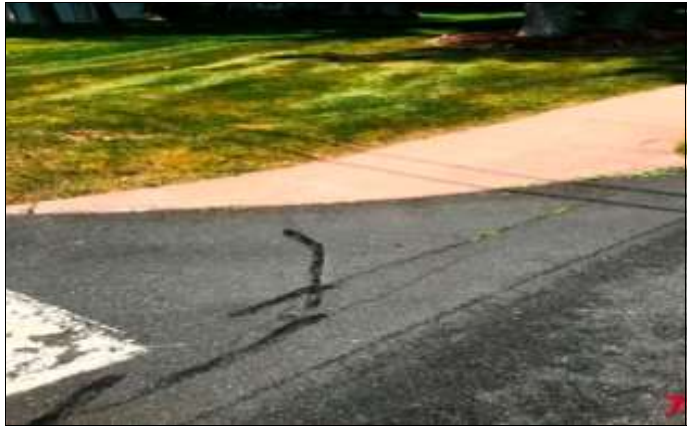
Ramp ID:	7-1
Street:	LATIMER LANE
Intersecting Street:	VALLEY VIEW DRIVE
Ramp Material:	Concrete
Det. Warning Panel:	No
Panel Damage:	No
Obstructions:	No
Obstruction Type:	None
Condition:	Good
Ramp Pass:	No

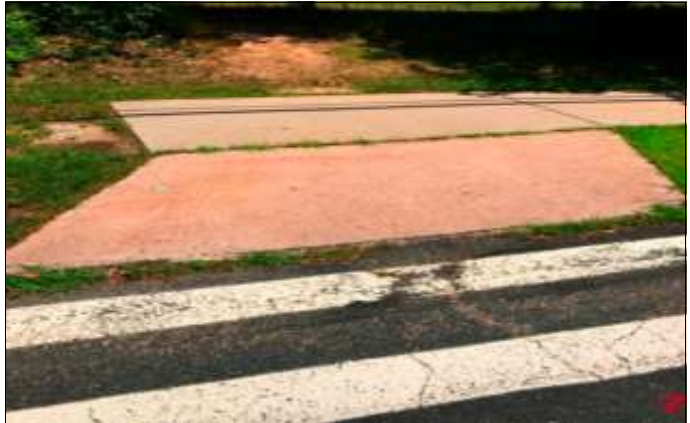
Ramp ID:	7-2
Street:	LATIMER LANE
Intersecting Street:	VALLEY VIEW DRIVE
Ramp Material:	Concrete
Det. Warning Panel:	No
Panel Damage:	No
Obstructions:	Yes
Obstruction Type:	Vegetation
Condition:	Fair
Ramp Pass:	No

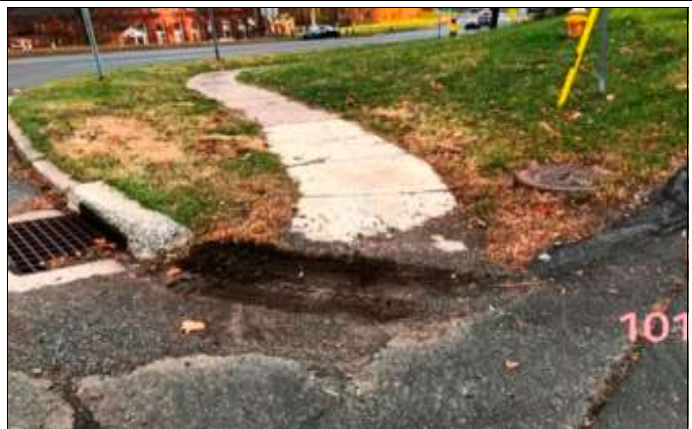
Ramp ID:	101-1
Street:	MAIN STREET
Intersecting Street:	RED HILL ROAD
Ramp Material:	Concrete
Det. Warning Panel:	No
Panel Damage:	No
Obstructions:	No
Obstruction Type:	None
Condition:	Fair
Ramp Pass:	No

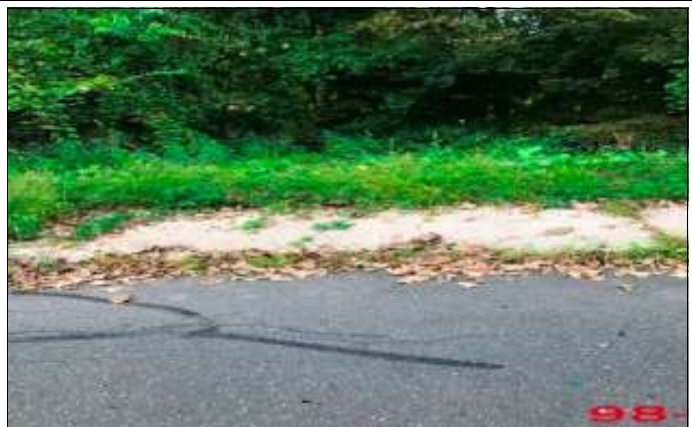
Ramp ID:	98-1
Street:	MAIN STREET EXTENSION
Intersecting Street:	WOOSTER ROAD
Ramp Material:	Asphalt
Det. Warning Panel:	No
Panel Damage:	No
Obstructions:	No
Obstruction Type:	None
Condition:	Good
Ramp Pass:	No

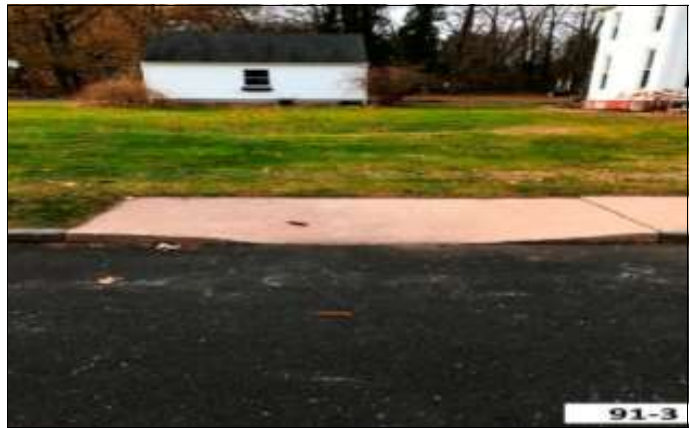
Ramp ID:	91-3
Street:	MAPLE STREET
Intersecting Street:	MAPLE STREET
Ramp Material:	Concrete
Det. Warning Panel:	No
Panel Damage:	No
Obstructions:	No
Obstruction Type:	None
Condition:	Good
Ramp Pass:	No

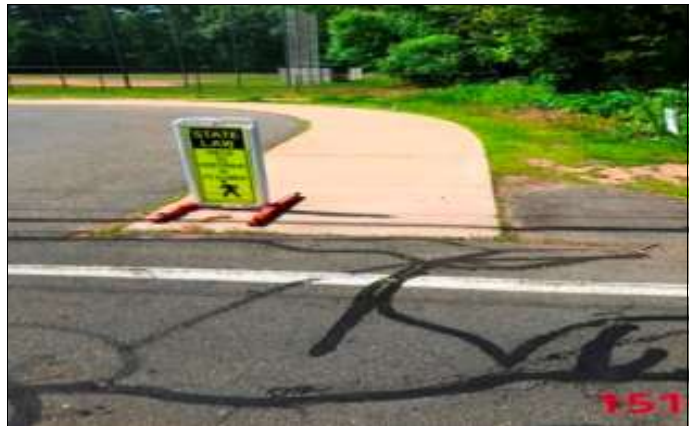
Ramp ID:	151-1
Street:	MASSACO STREET
Intersecting Street:	GRIFFIN STREET
Ramp Material:	Concrete
Det. Warning Panel:	No
Panel Damage:	No
Obstructions:	Yes
Obstruction Type:	Vegetation
Condition:	Good
Ramp Pass:	No

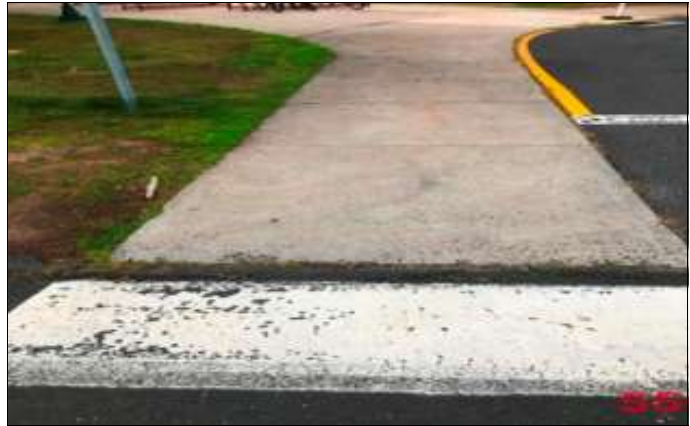
Ramp ID:	55-1
Street:	MASSACO STREET
Intersecting Street:	MCLEAN STREET
Ramp Material:	Concrete
Det. Warning Panel:	No
Panel Damage:	No
Obstructions:	No
Obstruction Type:	None
Condition:	Good
Ramp Pass:	No

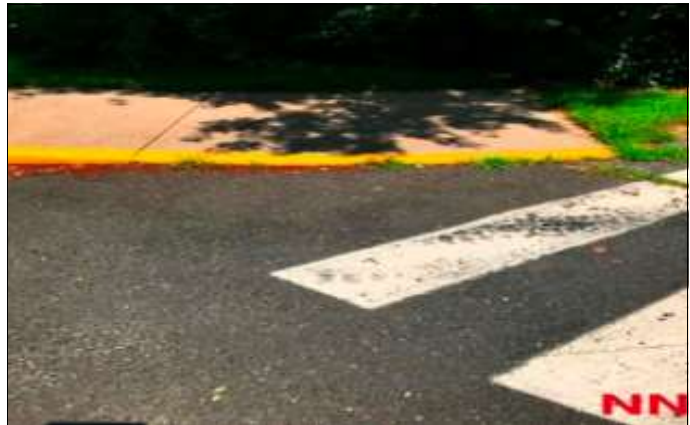
Ramp ID:	NN-1
Street:	MOUNTAIN VIEW DRIVE
Intersecting Street:	LATIMER LANE SCHOOL
Ramp Material:	Concrete
Det. Warning Panel:	No
Panel Damage:	No
Obstructions:	Yes
Obstruction Type:	Vegetation
Condition:	Fair
Ramp Pass:	No

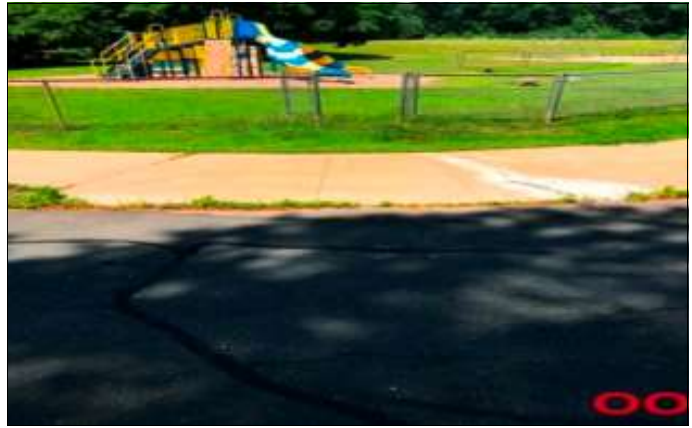
Ramp ID:	OO-1
Street:	MOUNTAIN VIEW DRIVE
Intersecting Street:	LATIMER LANE SCHOOL
Ramp Material:	Concrete
Det. Warning Panel:	No
Panel Damage:	No
Obstructions:	Yes
Obstruction Type:	Vegetation
Condition:	Poor
Ramp Pass:	No

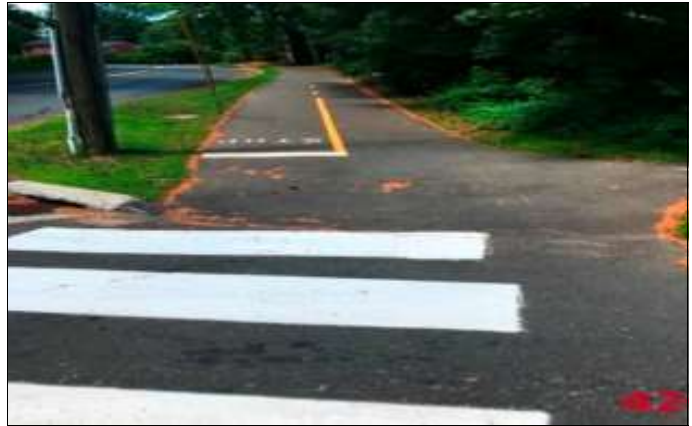
Ramp ID:	42-1
Street:	MUSKET TRAIL
Intersecting Street:	OWENS BROOK BOULEVARD
Ramp Material:	Asphalt
Det. Warning Panel:	No
Panel Damage:	No
Obstructions:	No
Obstruction Type:	None
Condition:	Good
Ramp Pass:	No

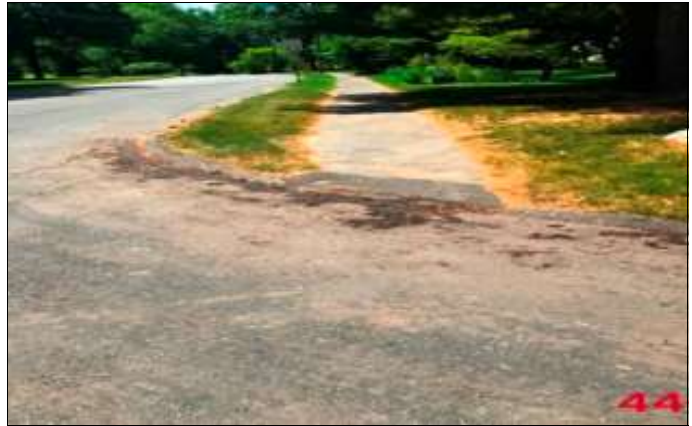
Ramp ID:	44-1
Street:	MUSKET TRAIL
Intersecting Street:	CRESTWOOD ROAD
Ramp Material:	Asphalt
Det. Warning Panel:	No
Panel Damage:	No
Obstructions:	No
Obstruction Type:	None
Condition:	Good
Ramp Pass:	No

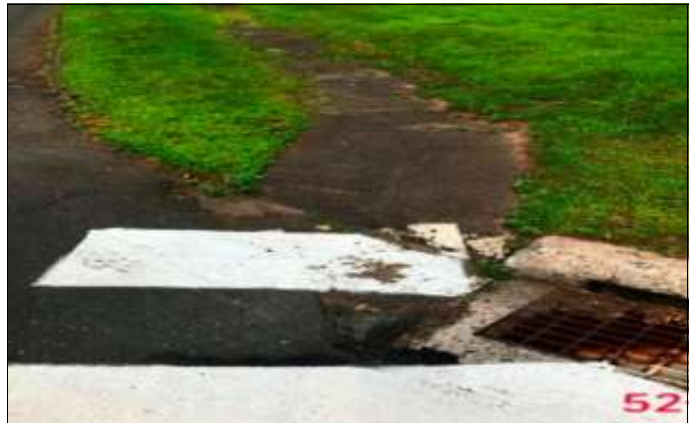
Ramp ID:	52-1
Street:	MUSKET TRAIL
Intersecting Street:	POWDER HORN DRIVE
Ramp Material:	Asphalt
Det. Warning Panel:	No
Panel Damage:	No
Obstructions:	No
Obstruction Type:	None
Condition:	Good
Ramp Pass:	No

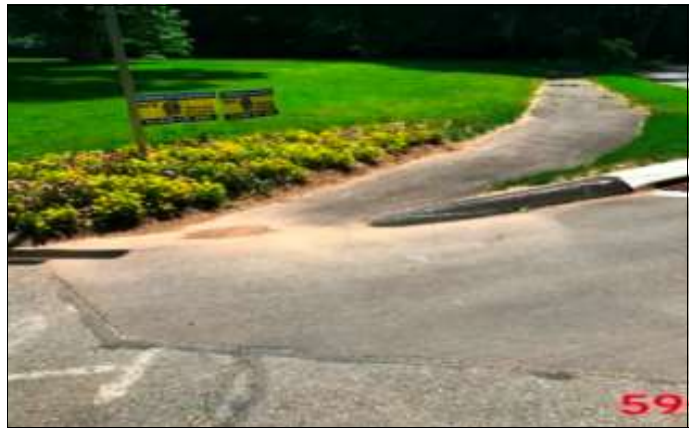
Ramp ID:	59-1
Street:	MUSKET TRAIL
Intersecting Street:	FLINTLOCK ROAD
Ramp Material:	Asphalt
Det. Warning Panel:	No
Panel Damage:	No
Obstructions:	No
Obstruction Type:	None
Condition:	Good
Ramp Pass:	No

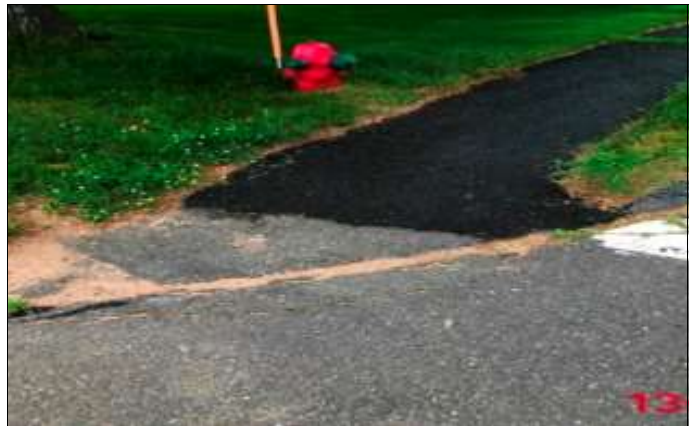
Ramp ID:	13-1
Street:	NEWBURY COURT
Intersecting Street:	HOSKINS ROAD
Ramp Material:	Asphalt
Det. Warning Panel:	No
Panel Damage:	No
Obstructions:	Yes
Obstruction Type:	Vegetation
Condition:	Fair
Ramp Pass:	No

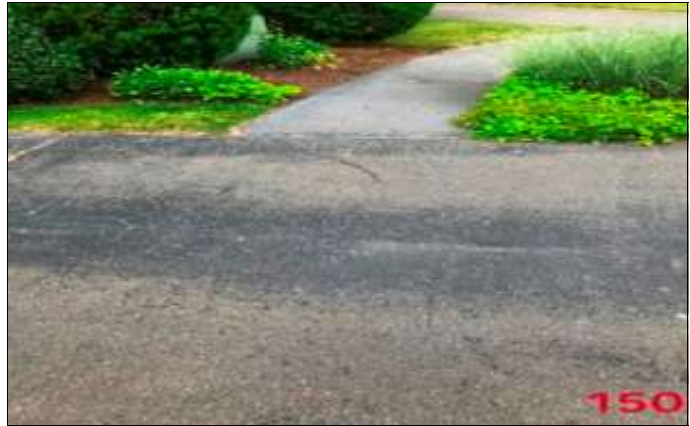
Ramp ID:	150-1
Street:	NEWBURY COURT
Intersecting Street:	NEWBURY COURT
Ramp Material:	Asphalt
Det. Warning Panel:	No
Panel Damage:	No
Obstructions:	No
Obstruction Type:	None
Condition:	Fair
Ramp Pass:	No

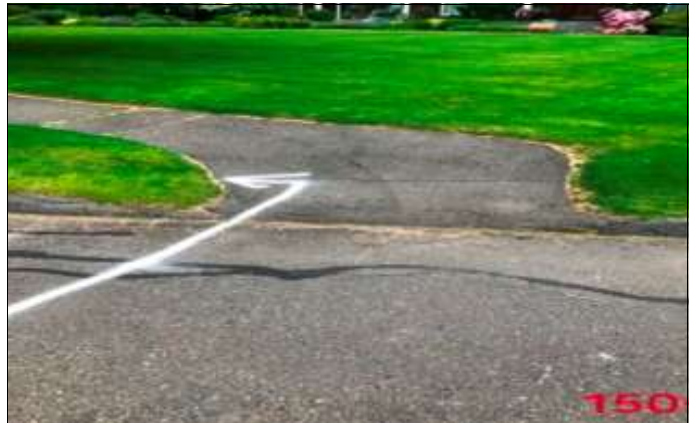
Ramp ID:	150-2
Street:	NEWBURY COURT
Intersecting Street:	NEWBURY COURT
Ramp Material:	Asphalt
Det. Warning Panel:	No
Panel Damage:	No
Obstructions:	No
Obstruction Type:	None
Condition:	Good
Ramp Pass:	No

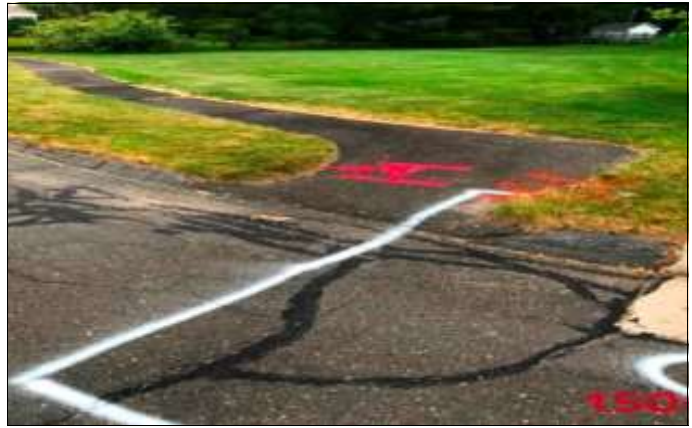
Ramp ID:	150-3
Street:	NEWBURY COURT
Intersecting Street:	NEWBURY COURT
Ramp Material:	Asphalt
Det. Warning Panel:	No
Panel Damage:	No
Obstructions:	No
Obstruction Type:	None
Condition:	Fair
Ramp Pass:	No

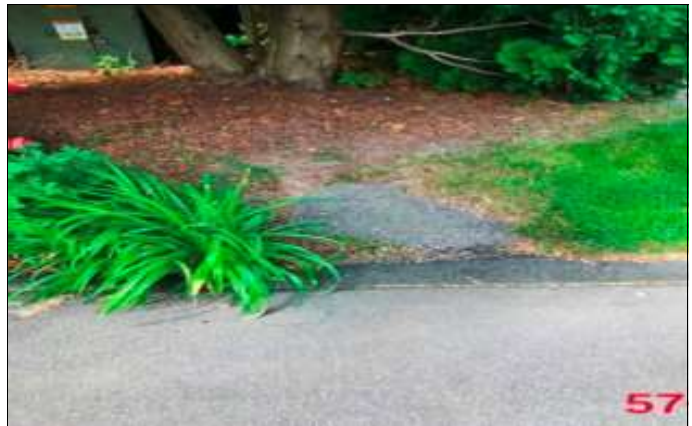
Ramp ID:	57-1
Street:	NORTH DRIVE
Intersecting Street:	NORTH DRIVE
Ramp Material:	Asphalt
Det. Warning Panel:	No
Panel Damage:	No
Obstructions:	No
Obstruction Type:	None
Condition:	Poor
Ramp Pass:	No

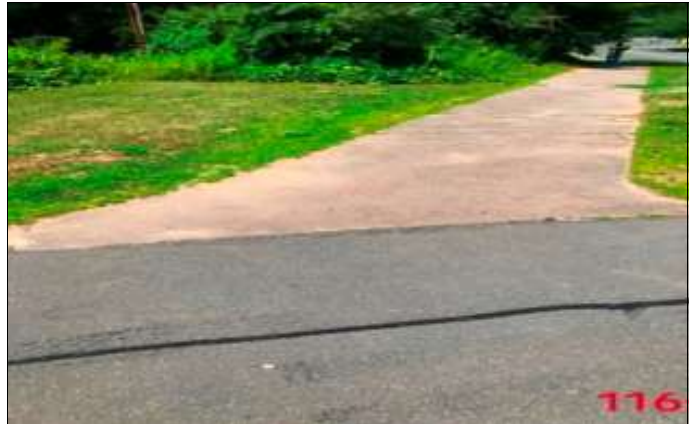
Ramp ID:	116-1
Street:	OLD BRIDGE ROAD
Intersecting Street:	DRAKE HILL ROAD
Ramp Material:	Asphalt
Det. Warning Panel:	No
Panel Damage:	No
Obstructions:	No
Obstruction Type:	None
Condition:	Good
Ramp Pass:	No

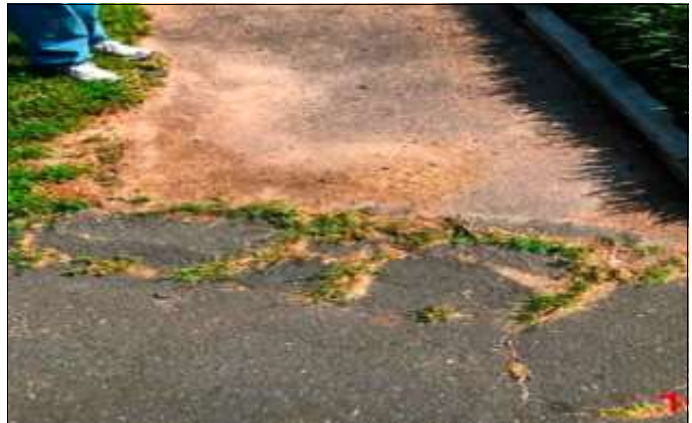
Ramp ID:	1-1
Street:	OLD FARMS ROAD
Intersecting Street:	SIMSBURY FARMS DRIVE
Ramp Material:	Asphalt
Det. Warning Panel:	No
Panel Damage:	No
Obstructions:	Yes
Obstruction Type:	Vegetation
Condition:	Poor
Ramp Pass:	No

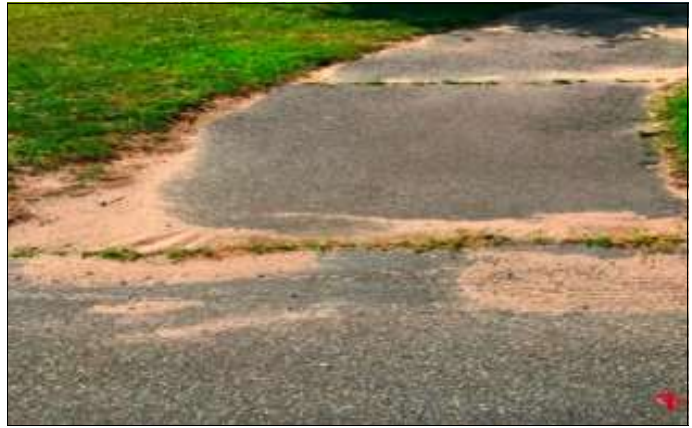
Ramp ID:	1-2
Street:	OLD FARMS ROAD
Intersecting Street:	SIMSBURY FARMS DRIVE
Ramp Material:	Asphalt
Det. Warning Panel:	No
Panel Damage:	No
Obstructions:	Yes
Obstruction Type:	Vegetation
Condition:	Fair
Ramp Pass:	No

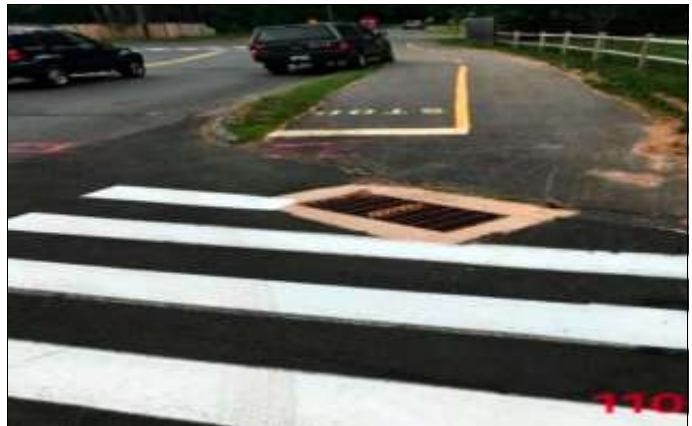
Ramp ID:	110-1
Street:	OWENS BROOK BOULEVARD
Intersecting Street:	FIRE BRICK LANE
Ramp Material:	Asphalt
Det. Warning Panel:	No
Panel Damage:	No
Obstructions:	No
Obstruction Type:	None
Condition:	Good
Ramp Pass:	No

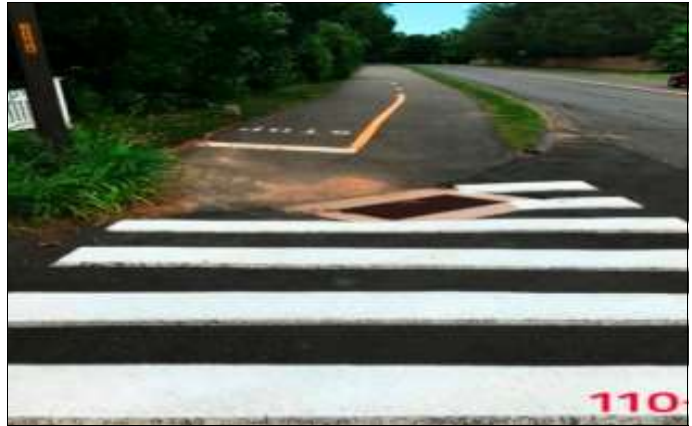
Ramp ID:	110-2
Street:	OWENS BROOK BOULEVARD
Intersecting Street:	FIRE BRICK LANE
Ramp Material:	Asphalt
Det. Warning Panel:	No
Panel Damage:	No
Obstructions:	No
Obstruction Type:	None
Condition:	Good
Ramp Pass:	No

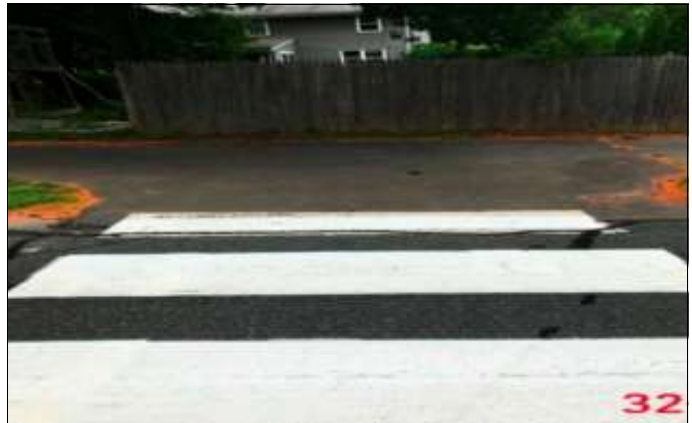
Ramp ID:	32-1
Street:	OWENS BROOK BOULEVARD
Intersecting Street:	HEARTHSTONE DRIVE
Ramp Material:	Asphalt
Det. Warning Panel:	No
Panel Damage:	No
Obstructions:	No
Obstruction Type:	None
Condition:	Good
Ramp Pass:	No

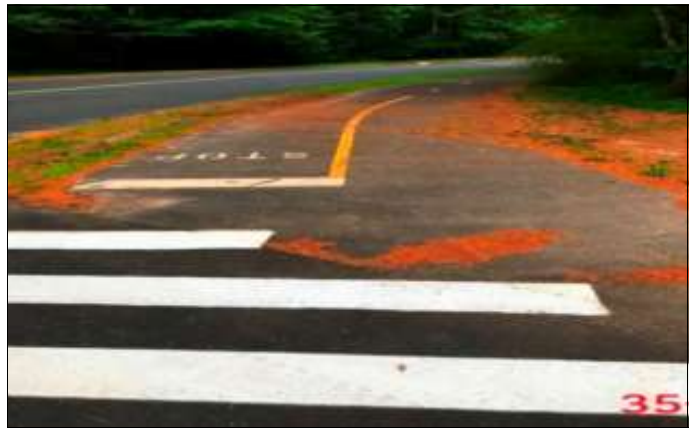
Ramp ID:	35-1
Street:	OWENS BROOK BOULEVARD
Intersecting Street:	HORSESHOE CIRCLE
Ramp Material:	Asphalt
Det. Warning Panel:	No
Panel Damage:	No
Obstructions:	No
Obstruction Type:	None
Condition:	Good
Ramp Pass:	No

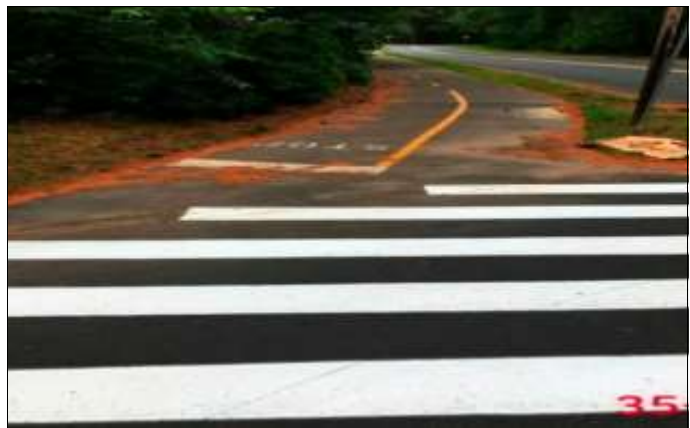
Ramp ID:	35-2
Street:	OWENS BROOK BOULEVARD
Intersecting Street:	HORSESHOE CIRCLE
Ramp Material:	Asphalt
Det. Warning Panel:	No
Panel Damage:	No
Obstructions:	No
Obstruction Type:	None
Condition:	Good
Ramp Pass:	No

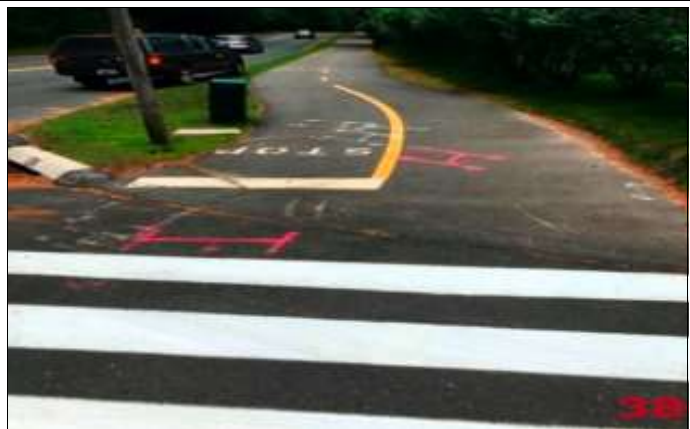
Ramp ID:	38-1
Street:	OWENS BROOK BOULEVARD
Intersecting Street:	OWENS BROOK CIRCLE
Ramp Material:	Asphalt
Det. Warning Panel:	No
Panel Damage:	No
Obstructions:	No
Obstruction Type:	None
Condition:	Good
Ramp Pass:	No

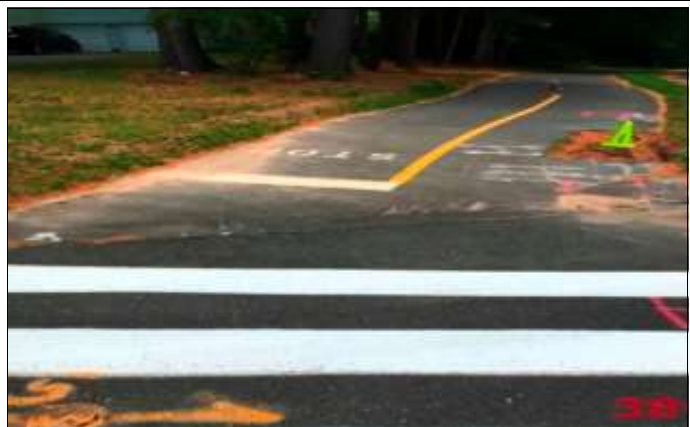
Ramp ID:	38-2
Street:	OWENS BROOK BOULEVARD
Intersecting Street:	OWENS BROOK CIRCLE
Ramp Material:	Asphalt
Det. Warning Panel:	No
Panel Damage:	No
Obstructions:	No
Obstruction Type:	None
Condition:	Good
Ramp Pass:	No

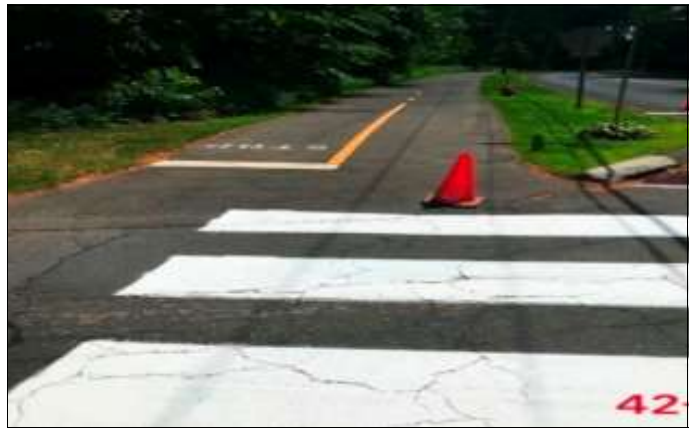
Ramp ID:	42-2
Street:	OWENS BROOK BOULEVARD
Intersecting Street:	MUSKET TRAIL
Ramp Material:	Asphalt
Det. Warning Panel:	No
Panel Damage:	No
Obstructions:	No
Obstruction Type:	None
Condition:	Good
Ramp Pass:	No

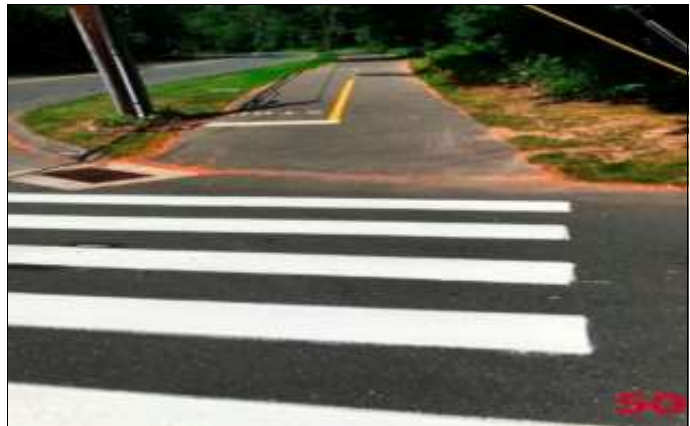
Ramp ID:	50-1
Street:	OWENS BROOK BOULEVARD
Intersecting Street:	WINTERSET LANE
Ramp Material:	Asphalt
Det. Warning Panel:	No
Panel Damage:	No
Obstructions:	No
Obstruction Type:	None
Condition:	Good
Ramp Pass:	No

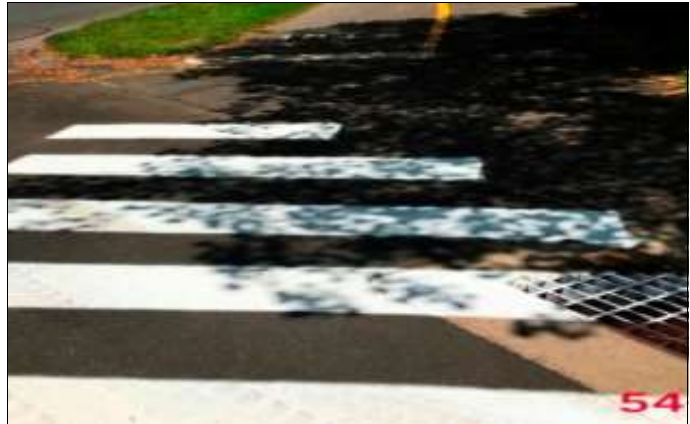
Ramp ID:	54-1
Street:	OWENS BROOK BOULEVARD
Intersecting Street:	SOMERSET LANE
Ramp Material:	Asphalt
Det. Warning Panel:	No
Panel Damage:	No
Obstructions:	No
Obstruction Type:	None
Condition:	Good
Ramp Pass:	No
