Town of Simsbury, Connecticut Sidewalk and Curb Ramp Assessment

FINAL DRAFT

Prepared By:
BETA Group, Inc.
1010 Wethersfield Avenue
Suite 305
Hartford, CT 06114

September 2019

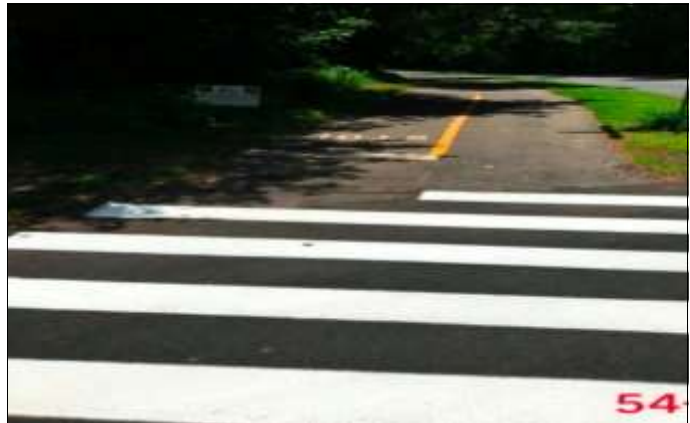
Ramp ID:	54-2
Street:	OWENS BROOK BOULEVARD
Intersecting Street:	SOMERSET LANE
Ramp Material:	Asphalt
Det. Warning Panel:	No
Panel Damage:	No
Obstructions:	No
Obstruction Type:	None
Condition:	Good
Ramp Pass:	No

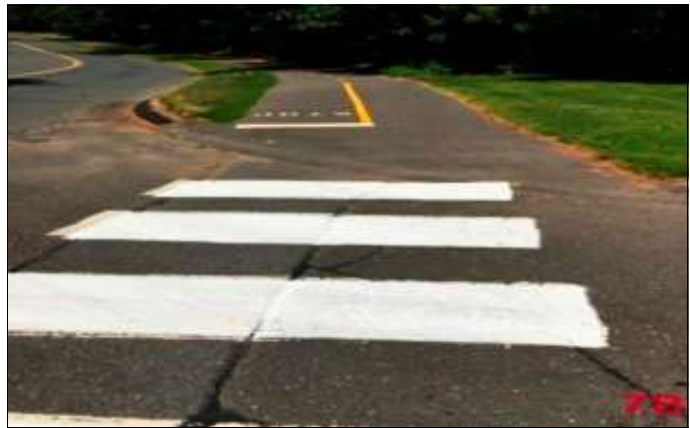
Ramp ID:	78-1
Street:	OWENS BROOK BOULEVARD
Intersecting Street:	OWENS PLACE
Ramp Material:	Asphalt
Det. Warning Panel:	No
Panel Damage:	No
Obstructions:	No
Obstruction Type:	None
Condition:	Good
Ramp Pass:	No

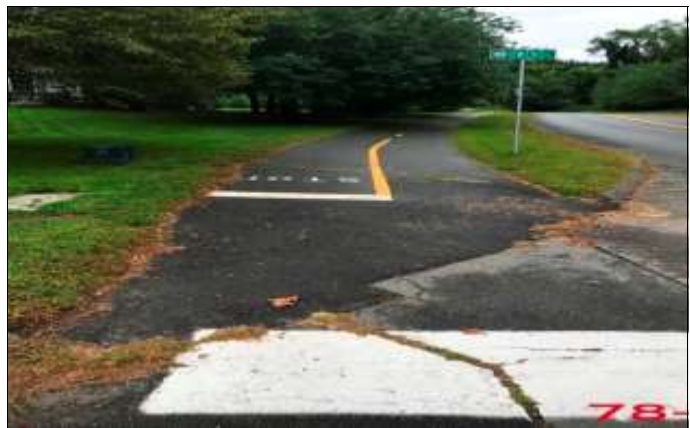
Ramp ID:	78-2
Street:	OWENS BROOK BOULEVARD
Intersecting Street:	OWENS PLACE
Ramp Material:	Asphalt
Det. Warning Panel:	No
Panel Damage:	No
Obstructions:	No
Obstruction Type:	None
Condition:	Good
Ramp Pass:	No

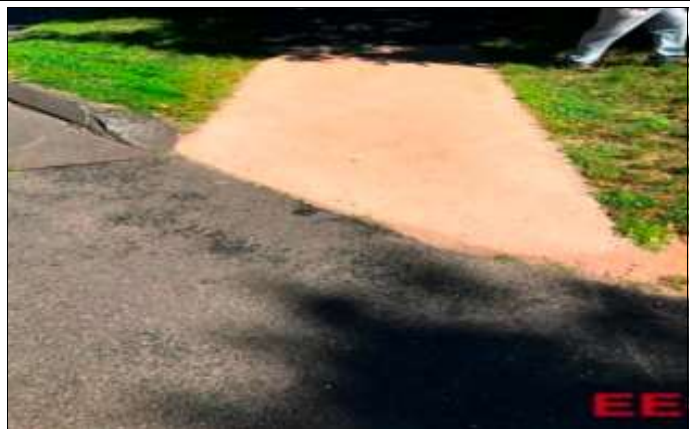
Ramp ID:	EE-1
Street:	OWENS BROOK BOULEVARD
Intersecting Street:	DRIVEWAY #981
Ramp Material:	Concrete
Det. Warning Panel:	No
Panel Damage:	No
Obstructions:	No
Obstruction Type:	None
Condition:	Good
Ramp Pass:	No

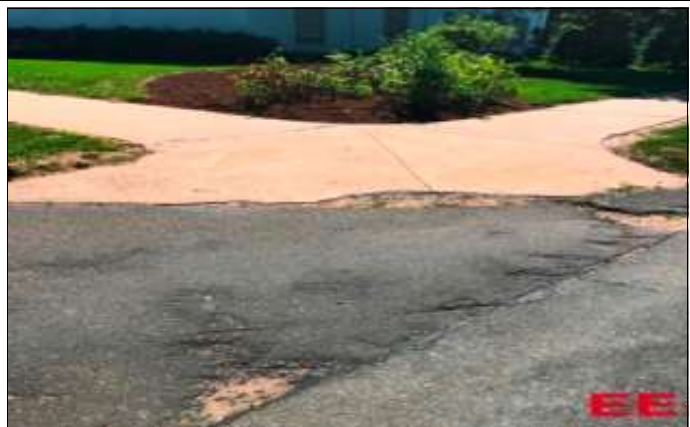
Ramp ID:	EE-2
Street:	OWENS BROOK BOULEVARD
Intersecting Street:	DRIVEWAY #981
Ramp Material:	Concrete
Det. Warning Panel:	No
Panel Damage:	No
Obstructions:	Yes
Obstruction Type:	None
Condition:	Poor
Ramp Pass:	No

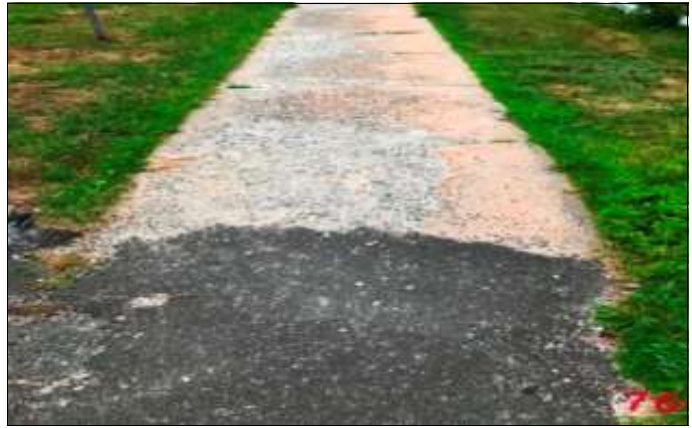
Ramp ID:	76-1
Street:	PHELPS LANE
Intersecting Street:	RAILROAD STREET
Ramp Material:	Concrete
Det. Warning Panel:	No
Panel Damage:	No
Obstructions:	Yes
Obstruction Type:	None
Condition:	Poor
Ramp Pass:	No

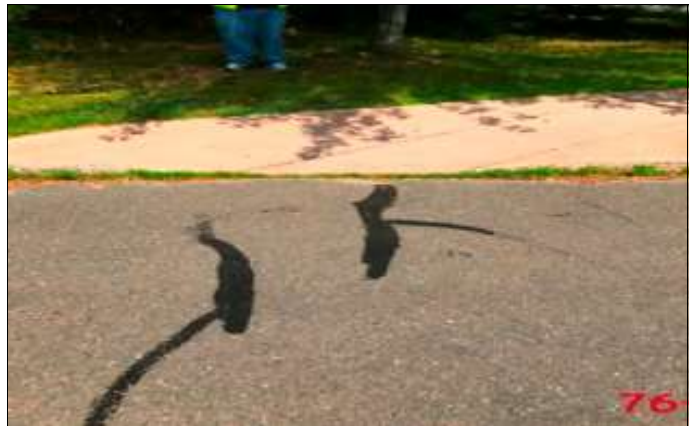
Ramp ID:	76-2
Street:	PHELPS LANE
Intersecting Street:	RAILROAD STREET
Ramp Material:	Concrete
Det. Warning Panel:	No
Panel Damage:	No
Obstructions:	Yes
Obstruction Type:	Vegetation
Condition:	Fair
Ramp Pass:	No

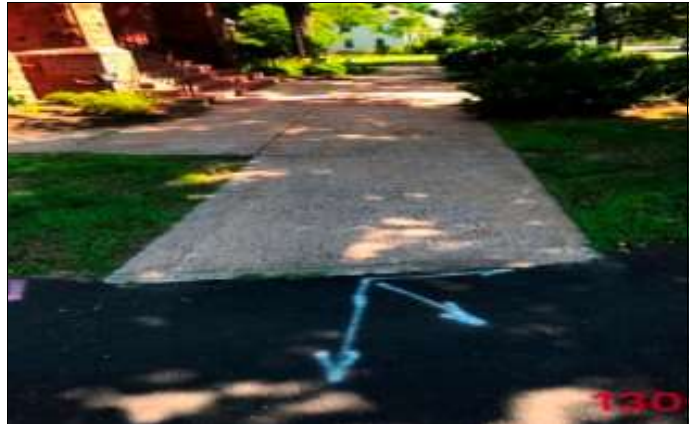
Ramp ID:	130-1
Street:	PLANK HILL ROAD
Intersecting Street:	HOPMEADOW STREET
Ramp Material:	Concrete
Det. Warning Panel:	No
Panel Damage:	No
Obstructions:	No
Obstruction Type:	None
Condition:	Good
Ramp Pass:	No

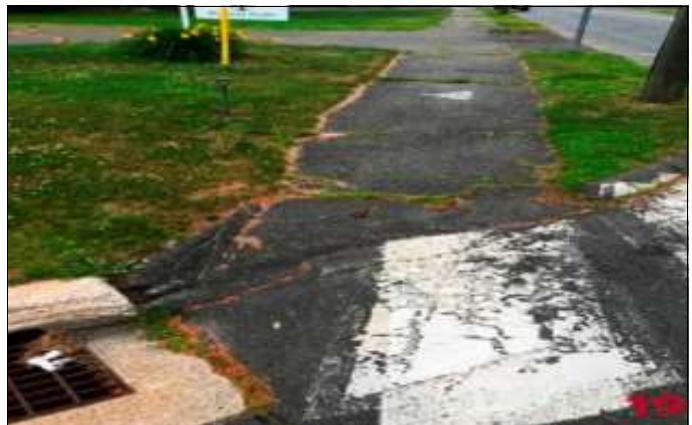
Ramp ID:	19-1
Street:	PLANK HILL ROAD
Intersecting Street:	FIRETOWN ROAD
Ramp Material:	Asphalt
Det. Warning Panel:	No
Panel Damage:	No
Obstructions:	No
Obstruction Type:	None
Condition:	Poor
Ramp Pass:	No

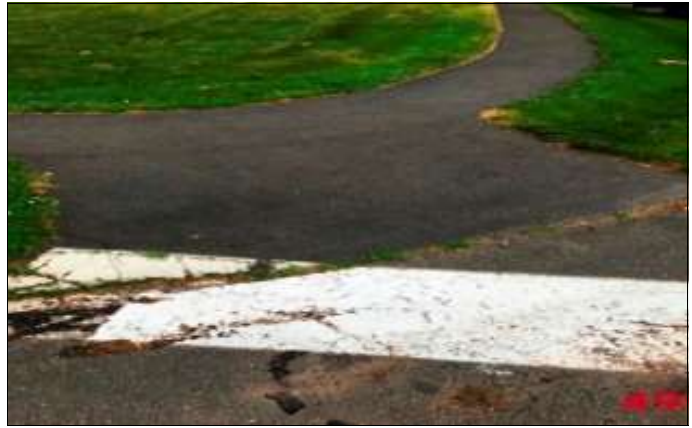
Ramp ID:	49-1
Street:	POWDER HORN DRIVE
Intersecting Street:	OX YOKE DRIVE
Ramp Material:	Asphalt
Det. Warning Panel:	No
Panel Damage:	No
Obstructions:	No
Obstruction Type:	None
Condition:	Good
Ramp Pass:	No

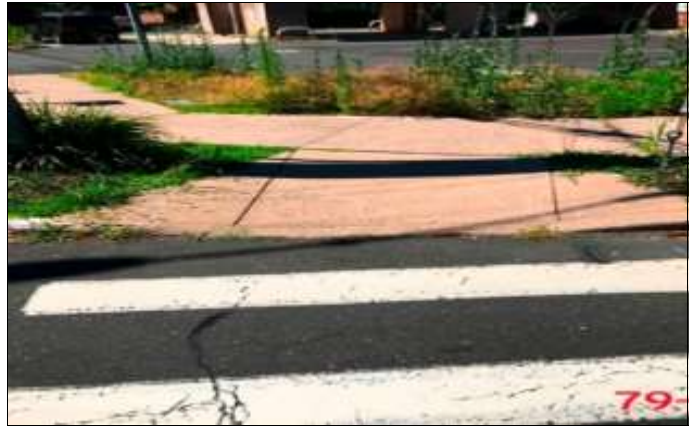
Ramp ID:	79-2
Street:	SEMINARY ROAD
Intersecting Street:	HOPMEADOW STREET
Ramp Material:	Concrete
Det. Warning Panel:	No
Panel Damage:	No
Obstructions:	No
Obstruction Type:	None
Condition:	Good
Ramp Pass:	No

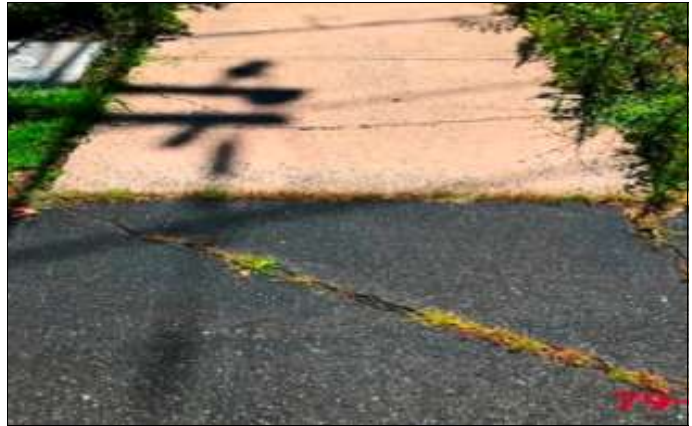
Ramp ID:	79-5
Street:	SEMINARY ROAD
Intersecting Street:	HOPMEADOW STREET
Ramp Material:	Concrete
Det. Warning Panel:	No
Panel Damage:	No
Obstructions:	Yes
Obstruction Type:	Vegetation
Condition:	Fair
Ramp Pass:	No

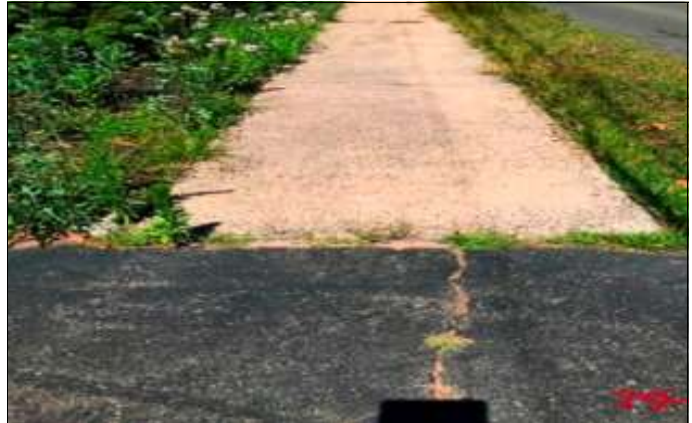
Ramp ID:	79-6
Street:	SEMINARY ROAD
Intersecting Street:	HOPMEADOW STREET
Ramp Material:	Concrete
Det. Warning Panel:	No
Panel Damage:	No
Obstructions:	Yes
Obstruction Type:	Vegetation
Condition:	Fair
Ramp Pass:	No

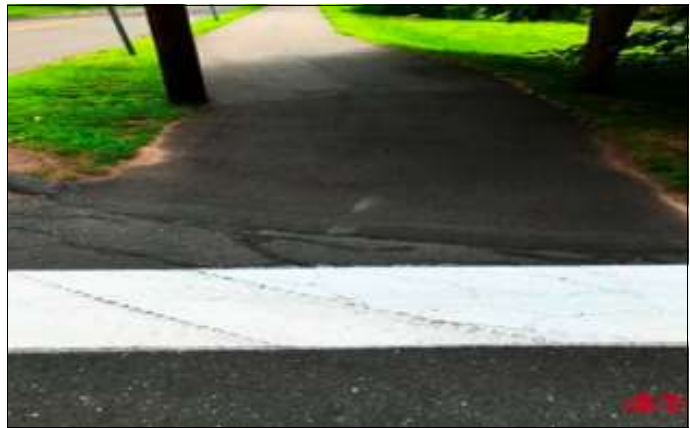
Ramp ID:	41-1
Street:	SQUADRON LINE ROAD
Intersecting Street:	POWDER HORN DRIVE
Ramp Material:	Asphalt
Det. Warning Panel:	No
Panel Damage:	No
Obstructions:	No
Obstruction Type:	None
Condition:	Good
Ramp Pass:	No

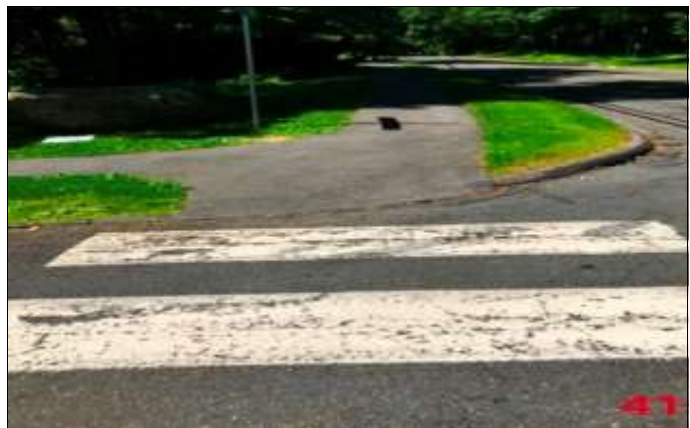
Ramp ID:	41-2
Street:	SQUADRON LINE ROAD
Intersecting Street:	POWDER HORN DRIVE
Ramp Material:	Asphalt
Det. Warning Panel:	No
Panel Damage:	No
Obstructions:	No
Obstruction Type:	None
Condition:	Good
Ramp Pass:	No

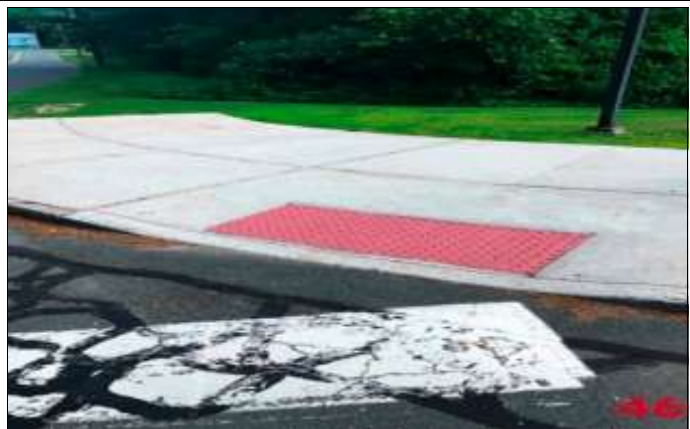
Ramp ID:	46-1
Street:	SQUADRON LINE ROAD
Intersecting Street:	SQUADRON LINE SCHOOL
Ramp Material:	Concrete
Det. Warning Panel:	Yes
Panel Damage:	No
Obstructions:	No
Obstruction Type:	None
Condition:	Good
Ramp Pass:	No

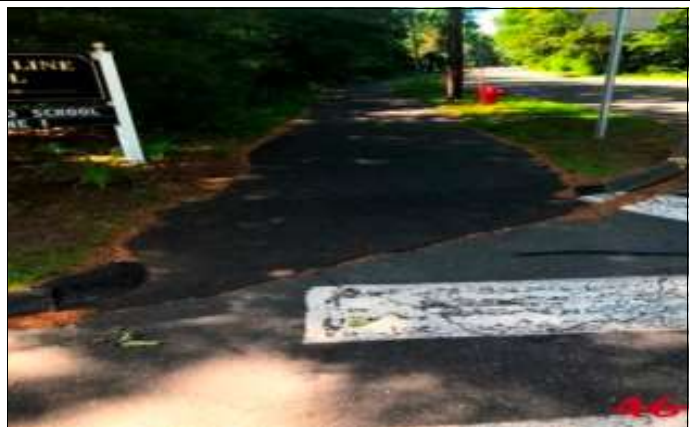
Ramp ID:	46-2
Street:	SQUADRON LINE ROAD
Intersecting Street:	SQUADRON LINE SCHOOL
Ramp Material:	Asphalt
Det. Warning Panel:	No
Panel Damage:	No
Obstructions:	No
Obstruction Type:	None
Condition:	Good
Ramp Pass:	No

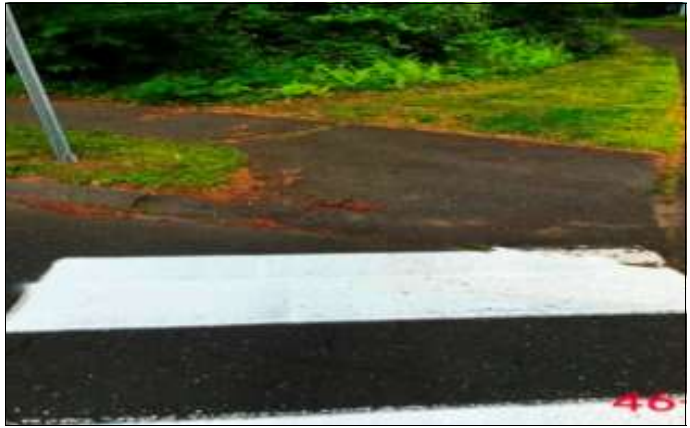
Ramp ID:	46-3
Street:	SQUADRON LINE ROAD
Intersecting Street:	DRIVEWAY #32
Ramp Material:	Asphalt
Det. Warning Panel:	No
Panel Damage:	No
Obstructions:	No
Obstruction Type:	None
Condition:	Good
Ramp Pass:	No

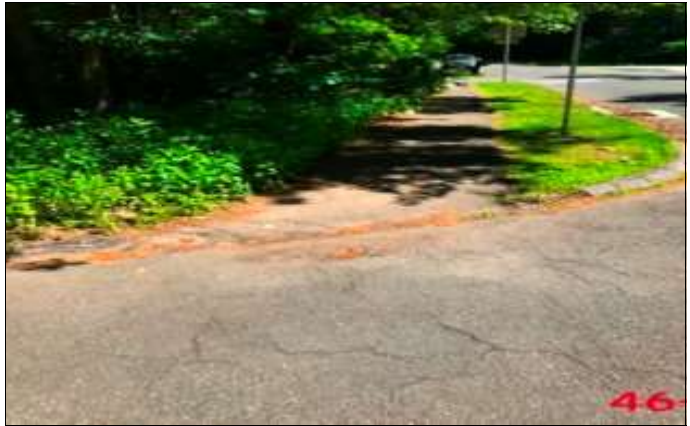
Ramp ID:	46-4
Street:	SQUADRON LINE ROAD
Intersecting Street:	GRETEL LANE
Ramp Material:	Asphalt
Det. Warning Panel:	No
Panel Damage:	No
Obstructions:	No
Obstruction Type:	None
Condition:	Good
Ramp Pass:	No

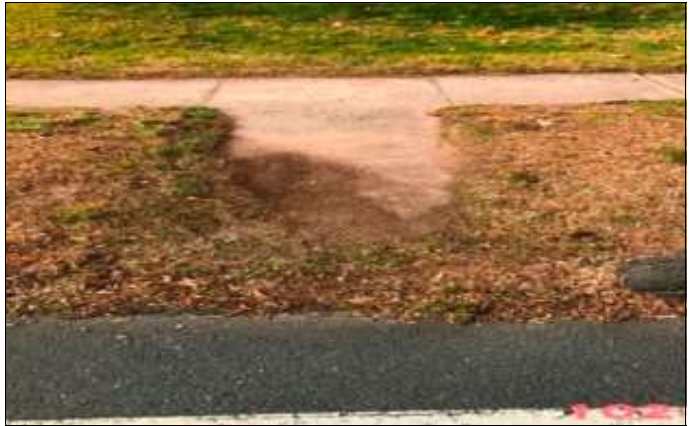
Ramp ID:	102-1
Street:	STATE HWY 189
Intersecting Street:	MAIN STREET
Ramp Material:	Concrete
Det. Warning Panel:	No
Panel Damage:	No
Obstructions:	No
Obstruction Type:	None
Condition:	Fair
Ramp Pass:	No

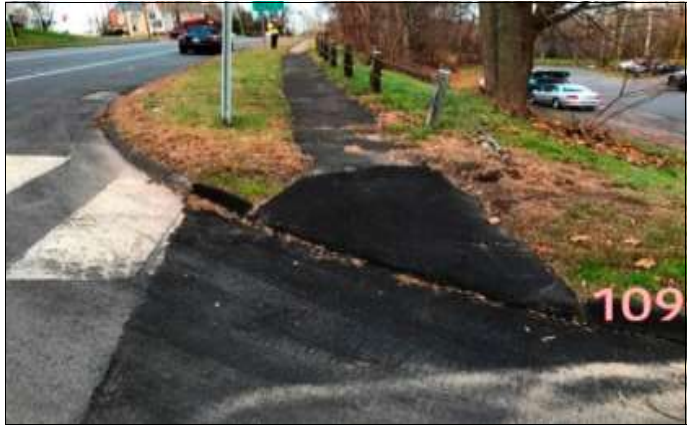
Ramp ID:	109-1
Street:	STATE HWY 189
Intersecting Street:	TUNXIS ROAD
Ramp Material:	Asphalt
Det. Warning Panel:	No
Panel Damage:	No
Obstructions:	No
Obstruction Type:	None
Condition:	Poor
Ramp Pass:	No

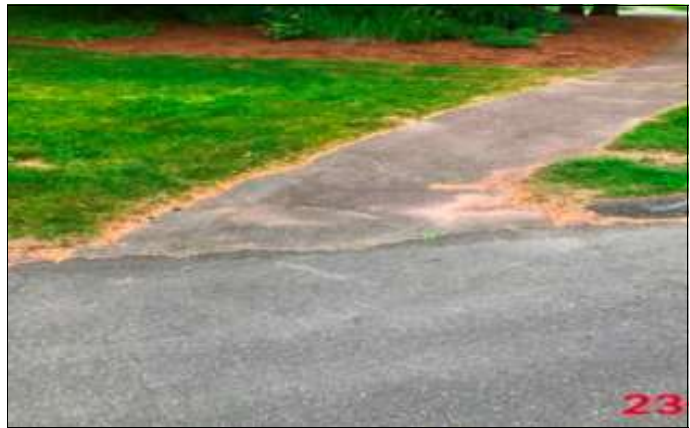
Ramp ID:	23-1
Street:	TIMBER RIDGE DRIVE
Intersecting Street:	ELLIOTT DRIVE
Ramp Material:	Asphalt
Det. Warning Panel:	No
Panel Damage:	No
Obstructions:	No
Obstruction Type:	None
Condition:	Fair
Ramp Pass:	No

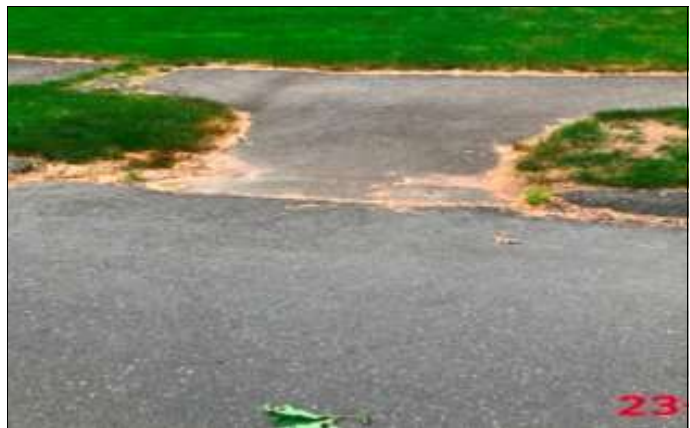
Ramp ID:	23-2
Street:	TIMBER RIDGE DRIVE
Intersecting Street:	ELLIOTT DRIVE
Ramp Material:	Asphalt
Det. Warning Panel:	No
Panel Damage:	No
Obstructions:	No
Obstruction Type:	None
Condition:	Fair
Ramp Pass:	No

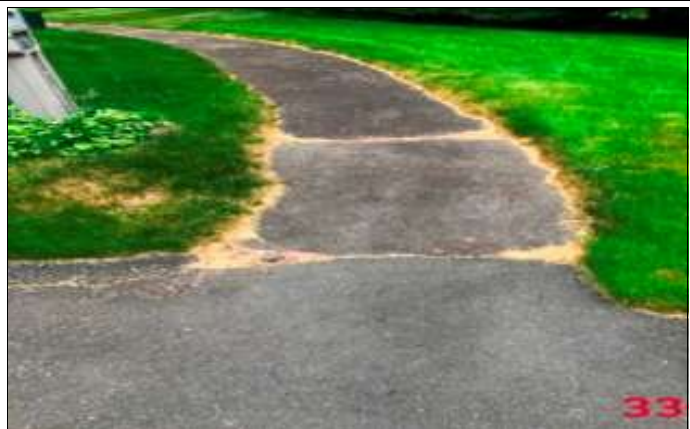
Ramp ID:	33-1
Street:	TIMBER RIDGE DRIVE
Intersecting Street:	TIMBER RIDGE DR
Ramp Material:	Asphalt
Det. Warning Panel:	No
Panel Damage:	No
Obstructions:	No
Obstruction Type:	None
Condition:	Fair
Ramp Pass:	No

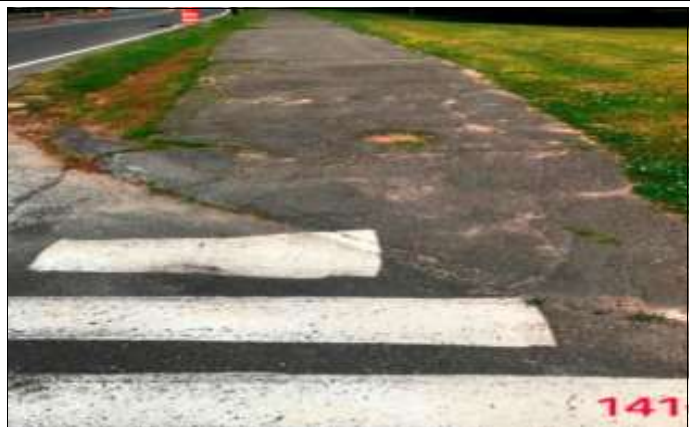
Ramp ID:	141-1
Street:	WEST STREET
Intersecting Street:	FIRETOWN ROAD
Ramp Material:	Asphalt
Det. Warning Panel:	No
Panel Damage:	No
Obstructions:	Yes
Obstruction Type:	Vegetation
Condition:	Fair
Ramp Pass:	No

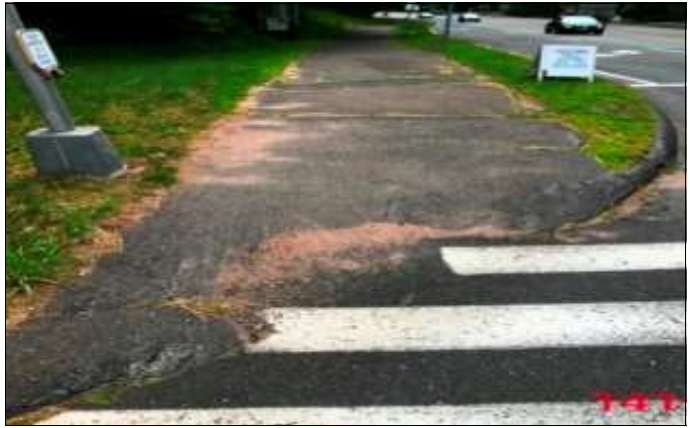
Ramp ID:	141-2
Street:	WEST STREET
Intersecting Street:	FIRETOWN ROAD
Ramp Material:	Asphalt
Det. Warning Panel:	No
Panel Damage:	No
Obstructions:	Yes
Obstruction Type:	Vegetation
Condition:	Fair
Ramp Pass:	No

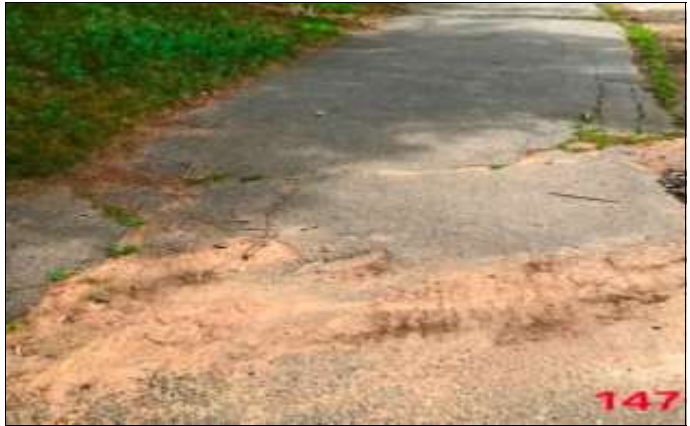
Ramp ID:	147-1
Street:	WEST STREET
Intersecting Street:	MAPLE COURT
Ramp Material:	Asphalt
Det. Warning Panel:	No
Panel Damage:	No
Obstructions:	Yes
Obstruction Type:	Vegetation
Condition:	Poor
Ramp Pass:	No

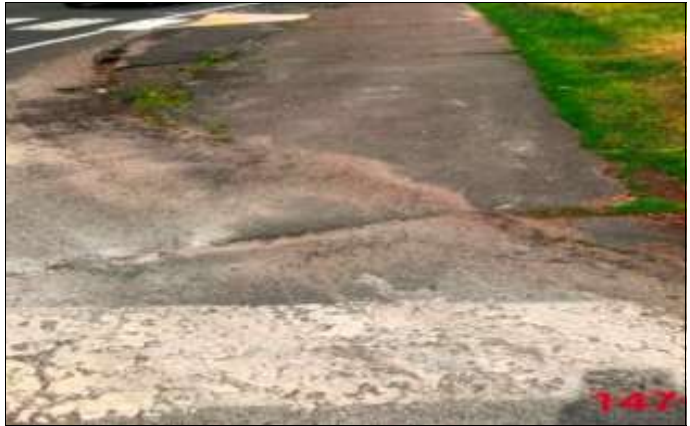
Ramp ID:	147-2
Street:	WEST STREET
Intersecting Street:	MAPLE COURT
Ramp Material:	Asphalt
Det. Warning Panel:	No
Panel Damage:	No
Obstructions:	Yes
Obstruction Type:	Vegetation
Condition:	Fair
Ramp Pass:	No

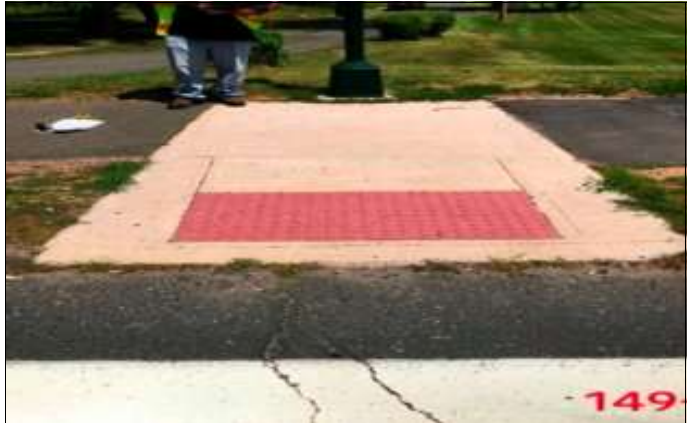
Ramp ID:	149-2
Street:	WEST STREET
Intersecting Street:	BUSHY HILL ROAD
Ramp Material:	Concrete
Det. Warning Panel:	Yes
Panel Damage:	No
Obstructions:	Yes
Obstruction Type:	Curbing
Condition:	Fair
Ramp Pass:	Yes

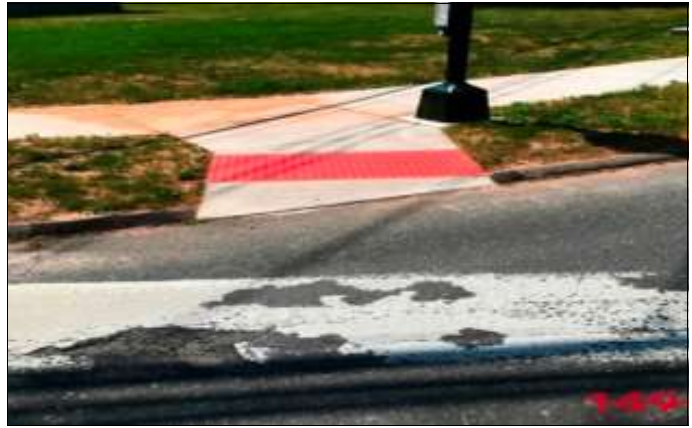
Ramp ID:	149-3
Street:	WEST STREET
Intersecting Street:	BUSHY HILL ROAD
Ramp Material:	Concrete
Det. Warning Panel:	Yes
Panel Damage:	No
Obstructions:	Yes
Obstruction Type:	Curbing
Condition:	Good
Ramp Pass:	Yes

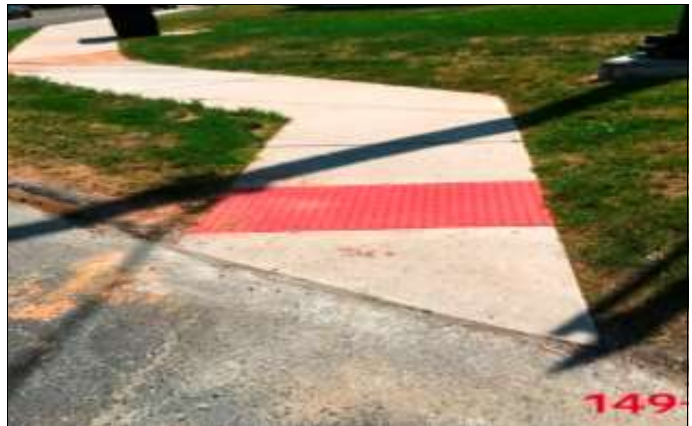
Ramp ID:	149-4
Street:	WEST STREET
Intersecting Street:	BUSHY HILL ROAD
Ramp Material:	Concrete
Det. Warning Panel:	Yes
Panel Damage:	No
Obstructions:	No
Obstruction Type:	None
Condition:	Good
Ramp Pass:	Yes

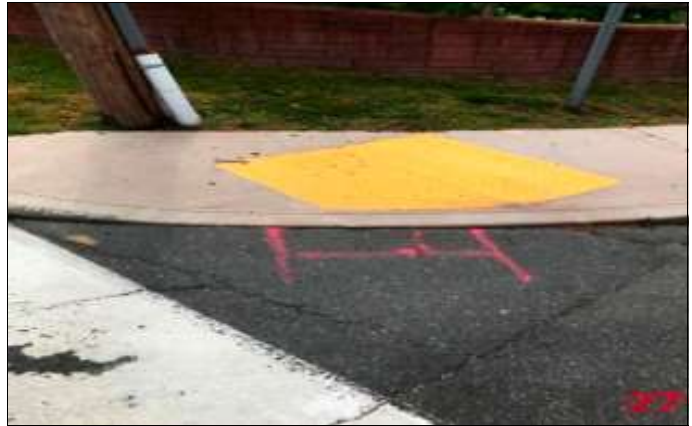
Ramp ID:	27-1
Street:	WEST STREET
Intersecting Street:	GRIST MILL LANE
Ramp Material:	Concrete
Det. Warning Panel:	Yes
Panel Damage:	No
Obstructions:	No
Obstruction Type:	Curbing
Condition:	Fair
Ramp Pass:	No

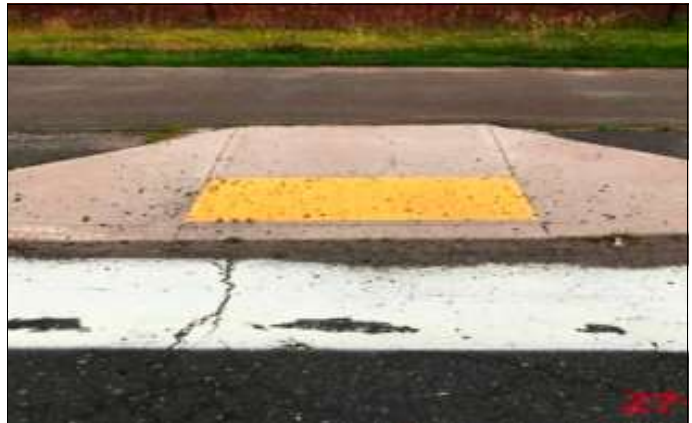
Ramp ID:	27-2
Street:	WEST STREET
Intersecting Street:	GRIST MILL LANE
Ramp Material:	Concrete
Det. Warning Panel:	Yes
Panel Damage:	No
Obstructions:	No
Obstruction Type:	None
Condition:	Good
Ramp Pass:	Yes

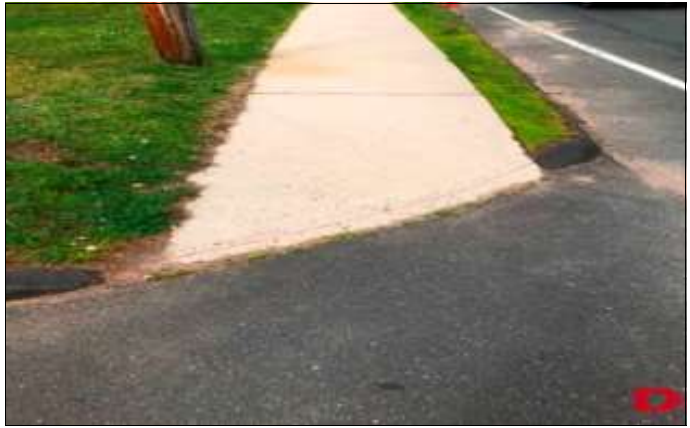
Ramp ID:	D-1
Street:	WEST STREET
Intersecting Street:	DRIVEWAY #135
Ramp Material:	Concrete
Det. Warning Panel:	No
Panel Damage:	No
Obstructions:	No
Obstruction Type:	None
Condition:	Good
Ramp Pass:	No

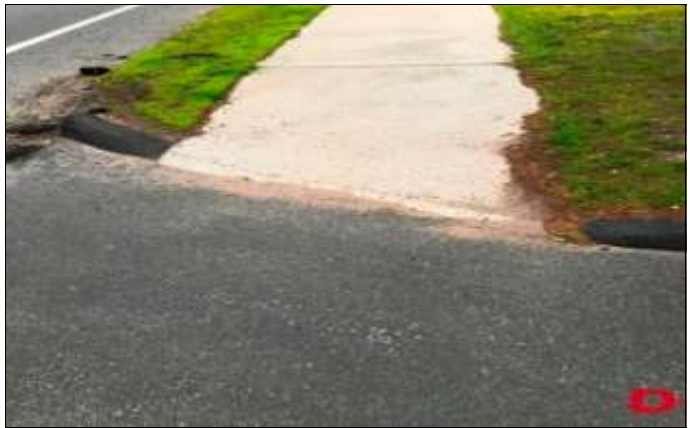
Ramp ID:	D-2
Street:	WEST STREET
Intersecting Street:	DRIVEWAY #135
Ramp Material:	Concrete
Det. Warning Panel:	No
Panel Damage:	No
Obstructions:	No
Obstruction Type:	None
Condition:	Good
Ramp Pass:	No

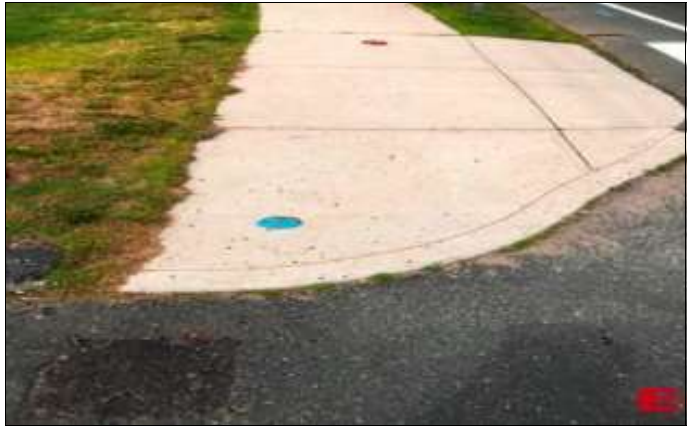
Ramp ID:	E-1
Street:	WEST STREET
Intersecting Street:	DRIVEWAY #125
Ramp Material:	Concrete
Det. Warning Panel:	No
Panel Damage:	No
Obstructions:	Yes
Obstruction Type:	Curbing
Condition:	Good
Ramp Pass:	No

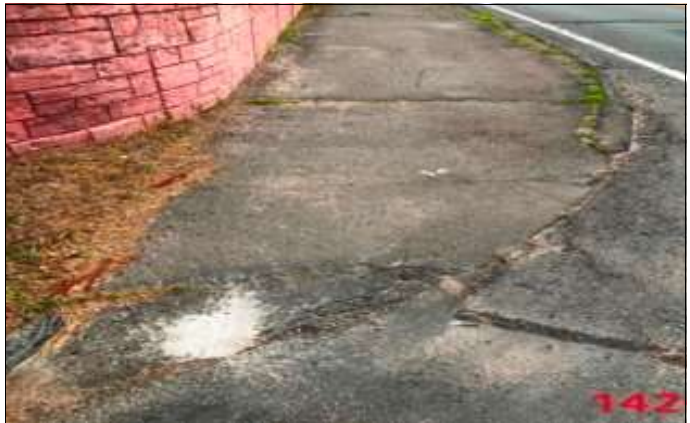
Ramp ID:	142-1
Street:	WESTLEDGE ROAD
Intersecting Street:	OLD MILL COURT
Ramp Material:	Asphalt
Det. Warning Panel:	No
Panel Damage:	No
Obstructions:	No
Obstruction Type:	None
Condition:	Good
Ramp Pass:	No

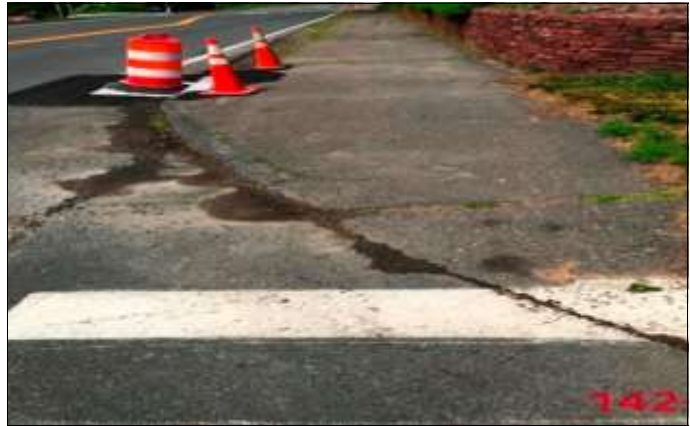
Ramp ID:	142-2
Street:	WESTLEDGE ROAD
Intersecting Street:	OLD MILL COURT
Ramp Material:	Asphalt
Det. Warning Panel:	No
Panel Damage:	No
Obstructions:	Yes
Obstruction Type:	Vegetation
Condition:	Fair
Ramp Pass:	No

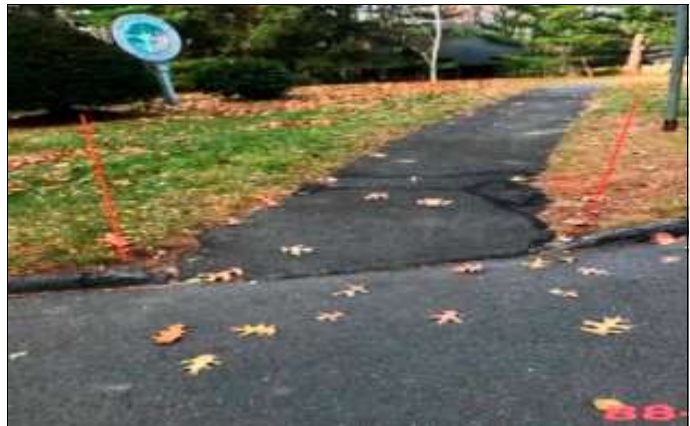
Ramp ID:	88-1
Street:	WHITE WATER TURN
Intersecting Street:	WOOD DUCK LANE
Ramp Material:	Asphalt
Det. Warning Panel:	No
Panel Damage:	No
Obstructions:	No
Obstruction Type:	None
Condition:	Fair
Ramp Pass:	No

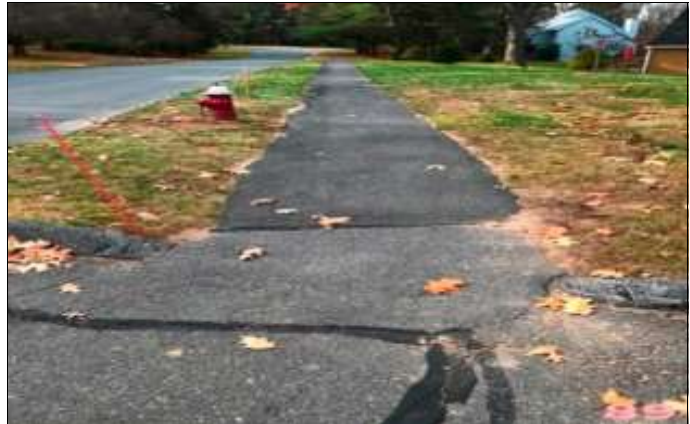
Ramp ID:	89-1
Street:	WHITE WATER TURN
Intersecting Street:	TANAGER CIRCLE
Ramp Material:	Asphalt
Det. Warning Panel:	No
Panel Damage:	No
Obstructions:	No
Obstruction Type:	None
Condition:	Fair
Ramp Pass:	No

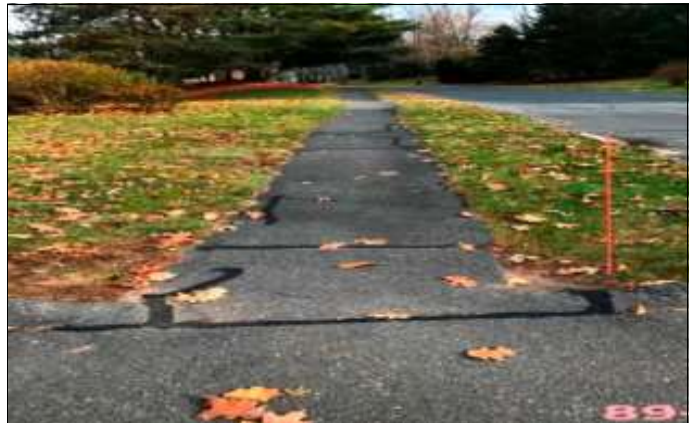
Ramp ID:	89-2
Street:	WHITE WATER TURN
Intersecting Street:	TANAGER CIRCLE
Ramp Material:	Asphalt
Det. Warning Panel:	No
Panel Damage:	No
Obstructions:	No
Obstruction Type:	None
Condition:	Fair
Ramp Pass:	No

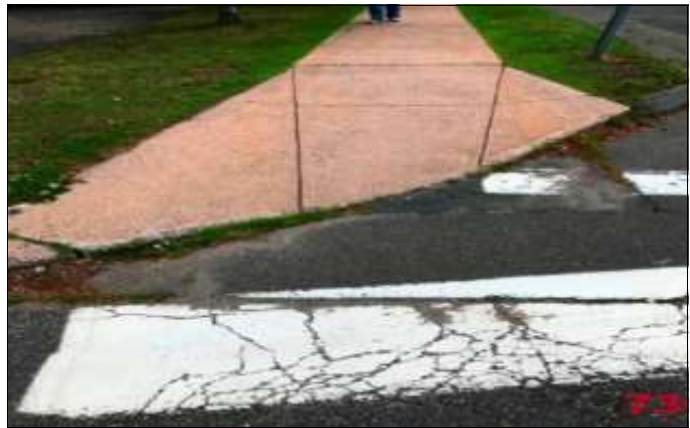
Ramp ID:	73-1
Street:	WILCOX STREET
Intersecting Street:	RAILROAD STREET
Ramp Material:	Concrete
Det. Warning Panel:	No
Panel Damage:	No
Obstructions:	Yes
Obstruction Type:	Curbing
Condition:	Fair
Ramp Pass:	No

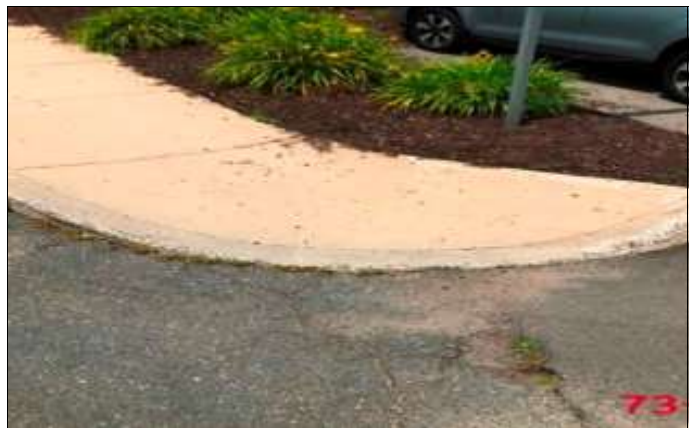
Ramp ID:	73-2
Street:	WILCOX STREET
Intersecting Street:	RAILROAD STREET
Ramp Material:	Concrete
Det. Warning Panel:	No
Panel Damage:	No
Obstructions:	Yes
Obstruction Type:	Curbing
Condition:	Fair
Ramp Pass:	No

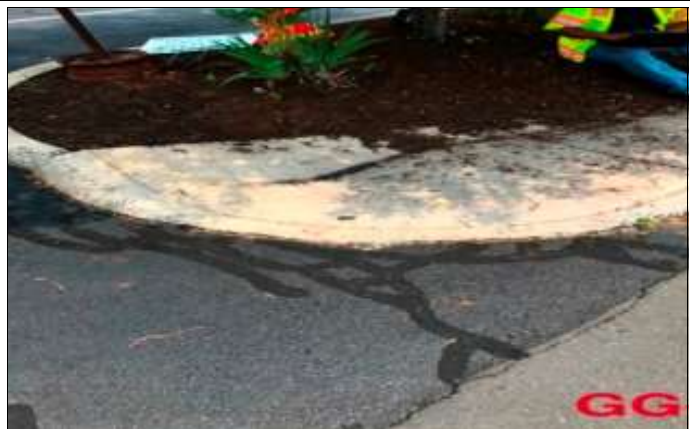
Ramp ID:	GG-1
Street:	WILCOX STREET
Intersecting Street:	DRIVEWAY #750
Ramp Material:	Concrete
Det. Warning Panel:	No
Panel Damage:	No
Obstructions:	Yes
Obstruction Type:	Curbing
Condition:	Good
Ramp Pass:	No

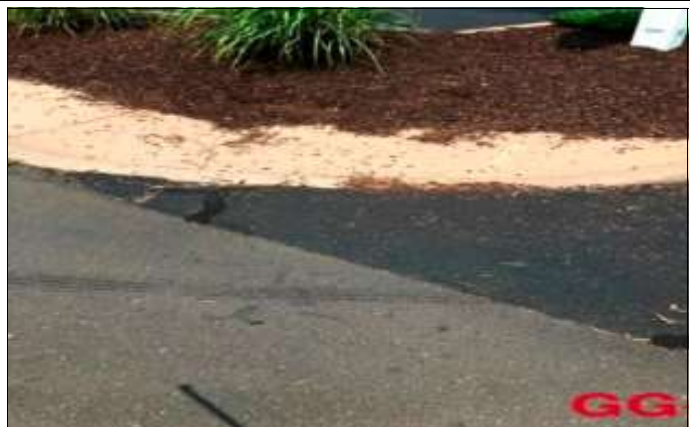
Ramp ID:	GG-2
Street:	WILCOX STREET
Intersecting Street:	DRIVEWAY #750
Ramp Material:	Concrete
Det. Warning Panel:	No
Panel Damage:	No
Obstructions:	No
Obstruction Type:	None
Condition:	Good
Ramp Pass:	No

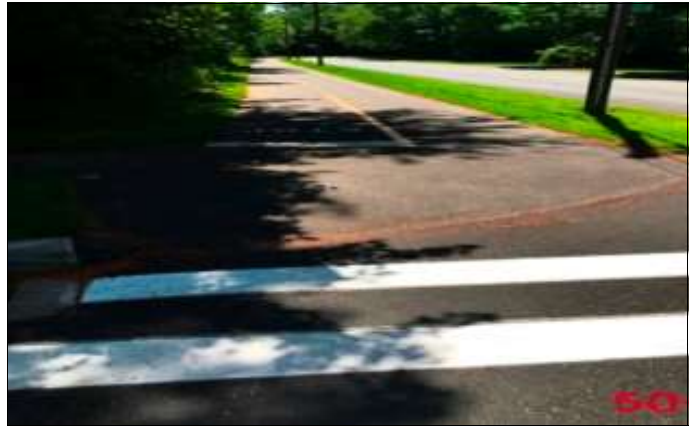
Ramp ID:	50-2
Street:	WINTERSET LANE
Intersecting Street:	EAGLE LANE
Ramp Material:	Asphalt
Det. Warning Panel:	No
Panel Damage:	No
Obstructions:	No
Obstruction Type:	None
Condition:	Good
Ramp Pass:	No

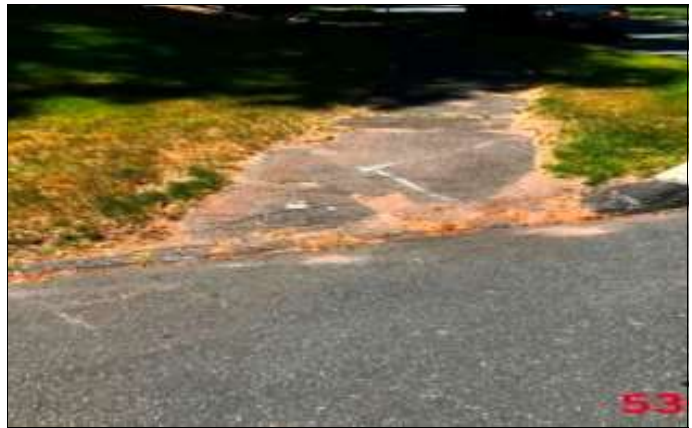
Ramp ID:	53-1
Street:	WINTERSET LANE
Intersecting Street:	WINTERSET LANE
Ramp Material:	Asphalt
Det. Warning Panel:	No
Panel Damage:	No
Obstructions:	No
Obstruction Type:	None
Condition:	Good
Ramp Pass:	No

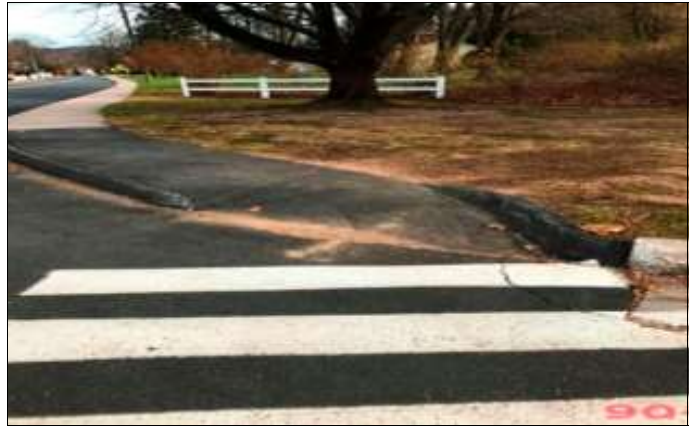
Ramp ID:	90-2
Street:	WINTHROP STREET
Intersecting Street:	WOOD DUCK LANE
Ramp Material:	Asphalt
Det. Warning Panel:	No
Panel Damage:	No
Obstructions:	No
Obstruction Type:	None
Condition:	Fair
Ramp Pass:	No

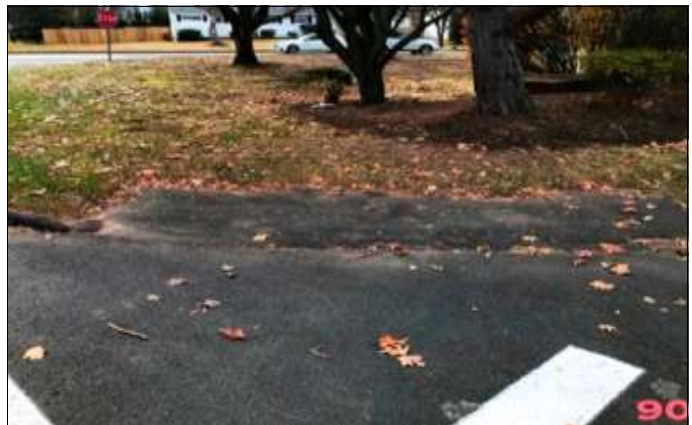
Ramp ID:	90-3
Street:	WINTHROP STREET
Intersecting Street:	WOOD DUCK LANE
Ramp Material:	Asphalt
Det. Warning Panel:	No
Panel Damage:	No
Obstructions:	No
Obstruction Type:	None
Condition:	Fair
Ramp Pass:	No

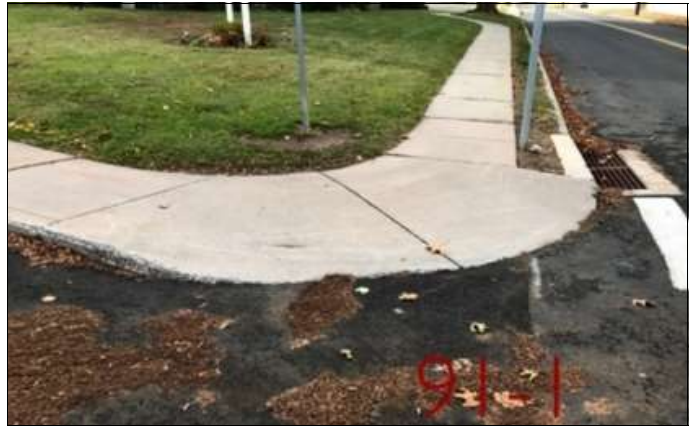
Ramp ID:	91-1
Street:	WINTHROP STREET
Intersecting Street:	MAPLE STREET
Ramp Material:	Concrete
Det. Warning Panel:	No
Panel Damage:	No
Obstructions:	No
Obstruction Type:	None
Condition:	Good
Ramp Pass:	No

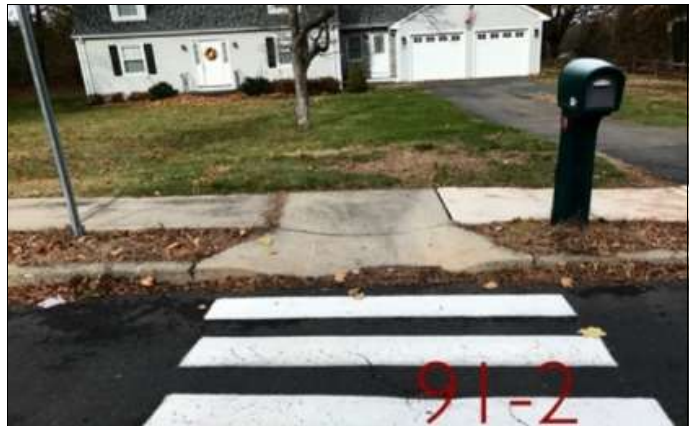
Ramp ID:	91-2
Street:	WINTHROP STREET
Intersecting Street:	WINTHROP STREET
Ramp Material:	Concrete
Det. Warning Panel:	No
Panel Damage:	No
Obstructions:	No
Obstruction Type:	None
Condition:	Good
Ramp Pass:	No

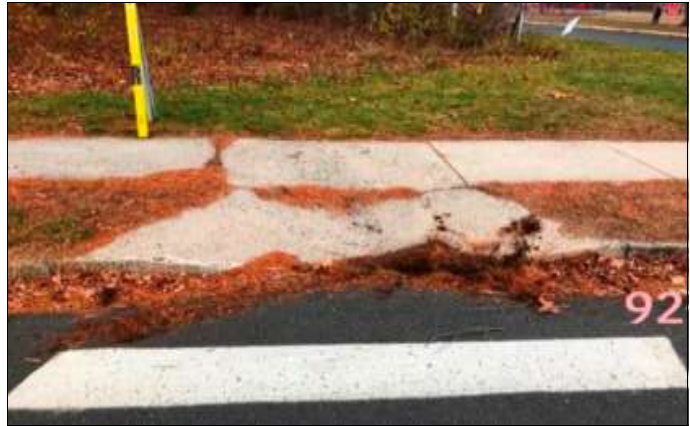
Ramp ID:	92-2
Street:	WINTHROP STREET
Intersecting Street:	CHURCH STREET
Ramp Material:	Concrete
Det. Warning Panel:	No
Panel Damage:	No
Obstructions:	No
Obstruction Type:	None
Condition:	Good
Ramp Pass:	No

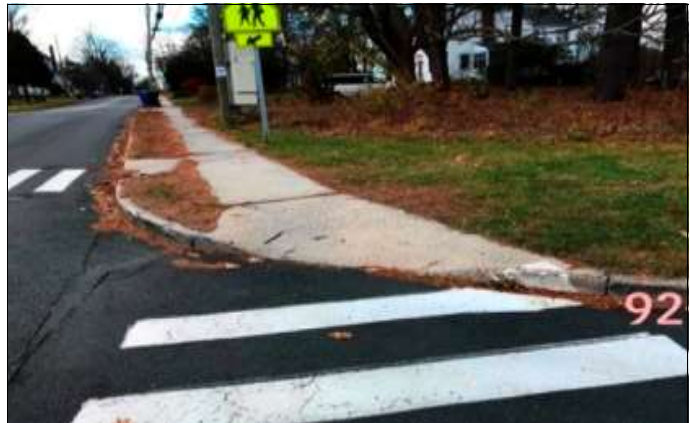
Ramp ID:	92-3
Street:	WINTHROP STREET
Intersecting Street:	CHURCH STREET
Ramp Material:	Concrete
Det. Warning Panel:	No
Panel Damage:	No
Obstructions:	No
Obstruction Type:	None
Condition:	Good
Ramp Pass:	No

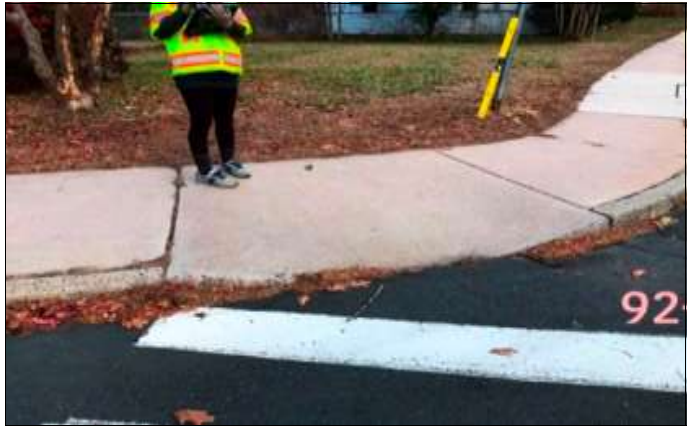
Ramp ID:	92-4
Street:	WINTHROP STREET
Intersecting Street:	WINTHROP STREET
Ramp Material:	Concrete
Det. Warning Panel:	No
Panel Damage:	No
Obstructions:	No
Obstruction Type:	None
Condition:	Good
Ramp Pass:	No

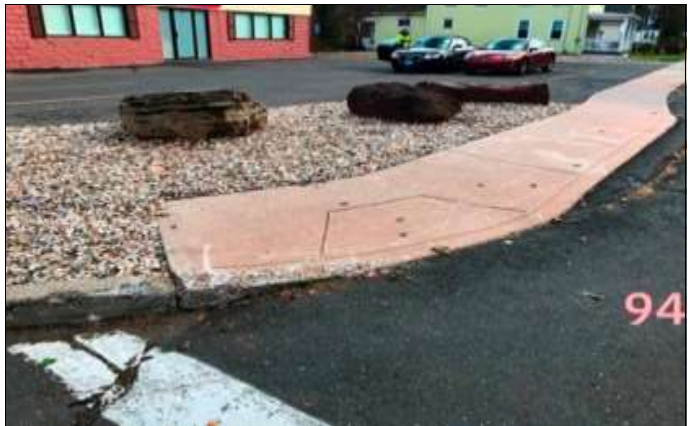
Ramp ID:	94-1
Street:	WINTHROP STREET
Intersecting Street:	CENTER STREET
Ramp Material:	Concrete
Det. Warning Panel:	No
Panel Damage:	No
Obstructions:	No
Obstruction Type:	None
Condition:	Fair
Ramp Pass:	No

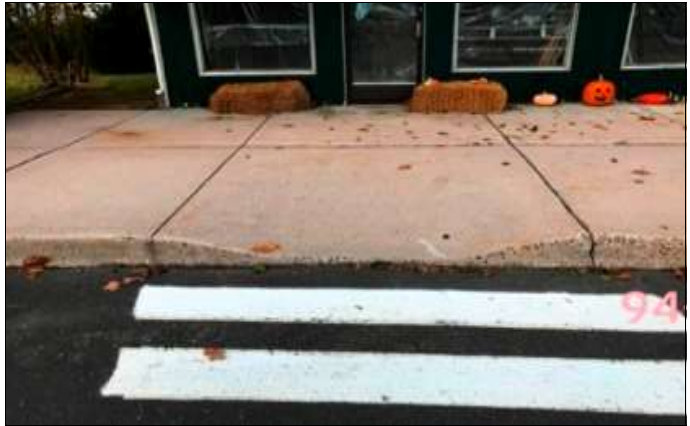
Ramp ID:	94-2
Street:	WINTHROP STREET
Intersecting Street:	CENTER STREET
Ramp Material:	Concrete
Det. Warning Panel:	No
Panel Damage:	No
Obstructions:	No
Obstruction Type:	None
Condition:	Poor
Ramp Pass:	No

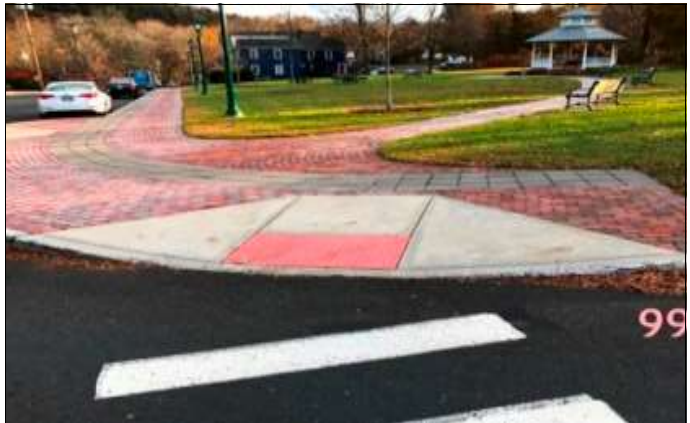
Ramp ID:	99-1
Street:	WINTHROP STREET
Intersecting Street:	MAIN STREET
Ramp Material:	Concrete
Det. Warning Panel:	Yes
Panel Damage:	No
Obstructions:	No
Obstruction Type:	None
Condition:	Good
Ramp Pass:	No

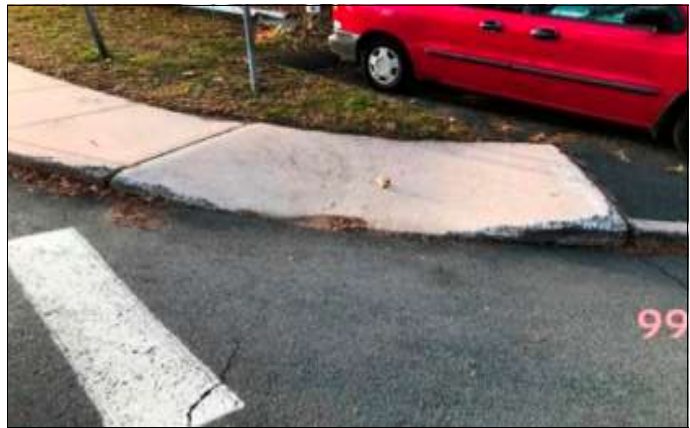
Ramp ID:	99-2
Street:	WINTHROP STREET
Intersecting Street:	MAIN STREET
Ramp Material:	Concrete
Det. Warning Panel:	No
Panel Damage:	No
Obstructions:	No
Obstruction Type:	None
Condition:	Good
Ramp Pass:	No

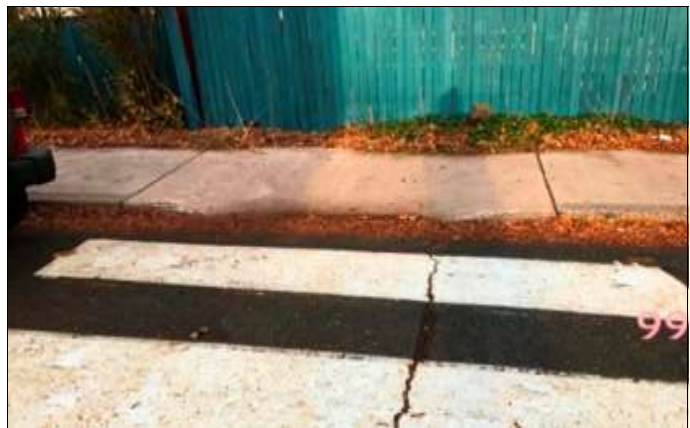
Ramp ID:	99-3
Street:	WINTHROP STREET
Intersecting Street:	MAIN STREET
Ramp Material:	Concrete
Det. Warning Panel:	No
Panel Damage:	No
Obstructions:	No
Obstruction Type:	None
Condition:	Good
Ramp Pass:	No

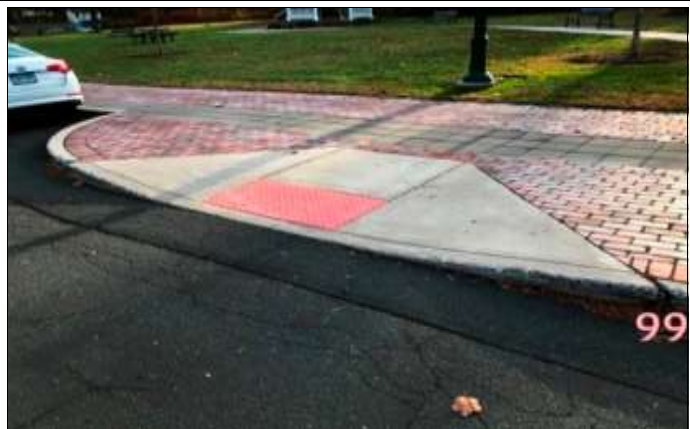
Ramp ID:	99-4
Street:	WINTHROP STREET
Intersecting Street:	MAIN STREET
Ramp Material:	Concrete
Det. Warning Panel:	Yes
Panel Damage:	No
Obstructions:	No
Obstruction Type:	None
Condition:	Good
Ramp Pass:	Yes

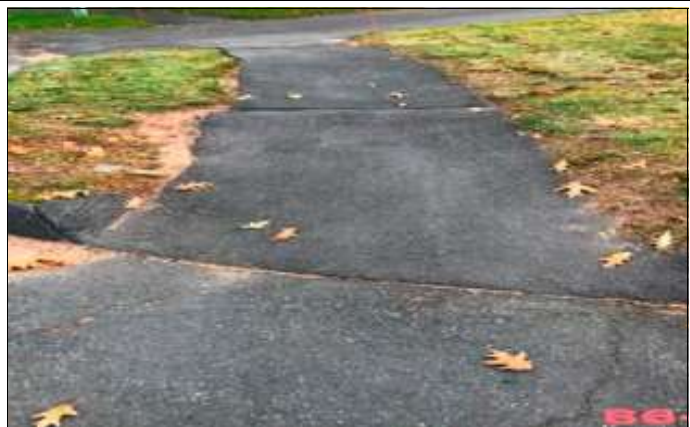
Ramp ID:	86-1
Street:	WOOD DUCK LANE
Intersecting Street:	WOOD DUCK LANE
Ramp Material:	Asphalt
Det. Warning Panel:	No
Panel Damage:	No
Obstructions:	No
Obstruction Type:	None
Condition:	Fair
Ramp Pass:	No

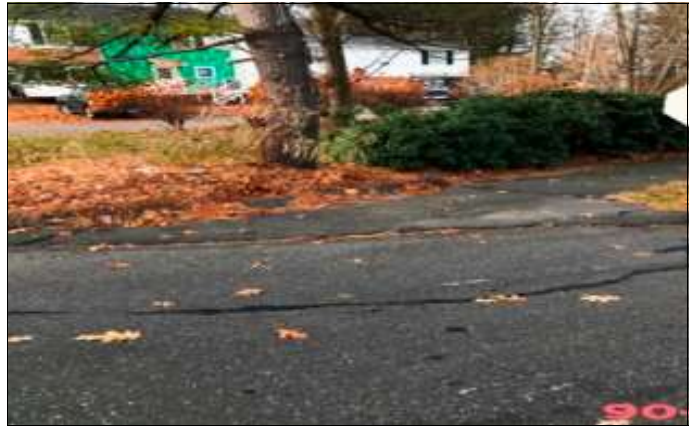
Ramp ID:	90-1
Street:	WOOD DUCK LANE
Intersecting Street:	WINTHROP STREET
Ramp Material:	Asphalt
Det. Warning Panel:	No
Panel Damage:	No
Obstructions:	No
Obstruction Type:	None
Condition:	Good
Ramp Pass:	No

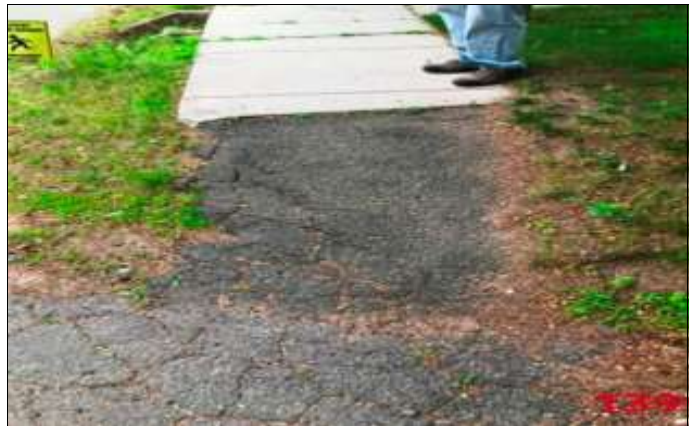
Ramp ID:	139-1
Street:	WOODLAND STREET
Intersecting Street:	DRIVEWAY #39
Ramp Material:	Asphalt
Det. Warning Panel:	No
Panel Damage:	No
Obstructions:	Yes
Obstruction Type:	Vegetation
Condition:	Poor
Ramp Pass:	No

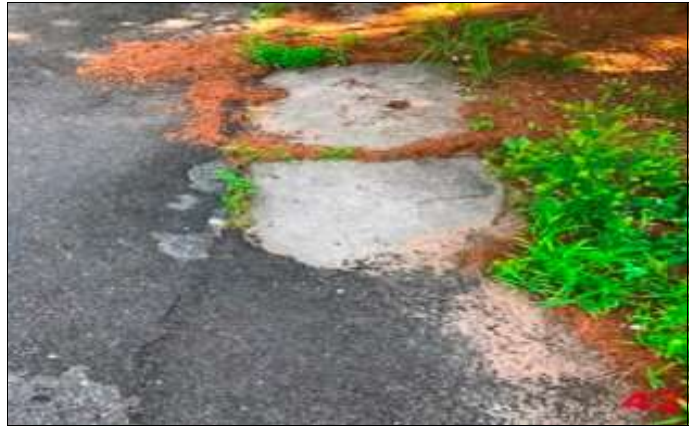
Ramp ID:	43-1
Street:	WOODLAND STREET
Intersecting Street:	WOODLAND PLACE
Ramp Material:	Concrete
Det. Warning Panel:	No
Panel Damage:	No
Obstructions:	Yes
Obstruction Type:	Vegetation
Condition:	Fair
Ramp Pass:	No

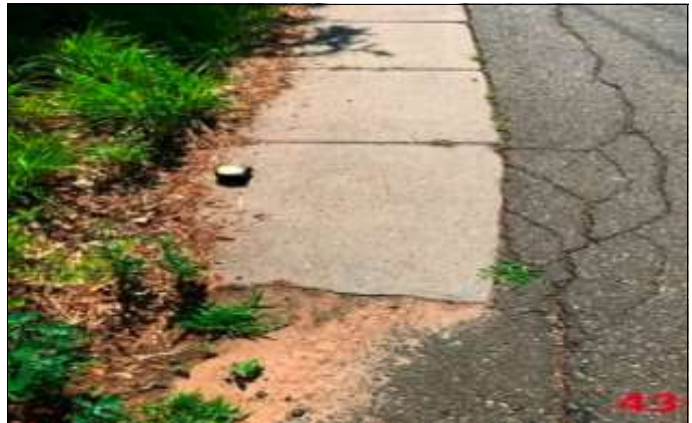
Ramp ID:	43-2
Street:	WOODLAND STREET
Intersecting Street:	WOODLAND PLACE
Ramp Material:	Concrete
Det. Warning Panel:	No
Panel Damage:	No
Obstructions:	Yes
Obstruction Type:	Vegetation
Condition:	Fair
Ramp Pass:	No
