TOWN OF SIMSBURY

**ON-CALL PROFESSIONAL SERVICES:
SIMSBURY FLOWER BRIDGE REHABILITATION
DPW-RFP 2022-#03**

This Rehabilitation Study Report (RSR) describes the findings of a detailed evaluation of the condition of the bridge and presents recommendations for rehabilitation to ensure its structural and functional adequacy, as well as to extend its service life. Due to the historic nature of the bridge and the unique structure type, evaluation of multiple alternates for rehabilitation was not considered.

PROJECT TITLE:	<div>REHABILITATION OF BRIDGE NO. 03984 OLD DRAKE HILL ROAD BRIDGE (FLOWER BRIDGE) OVER FARMINGTON RIVER SIMSBURY, CT</div>

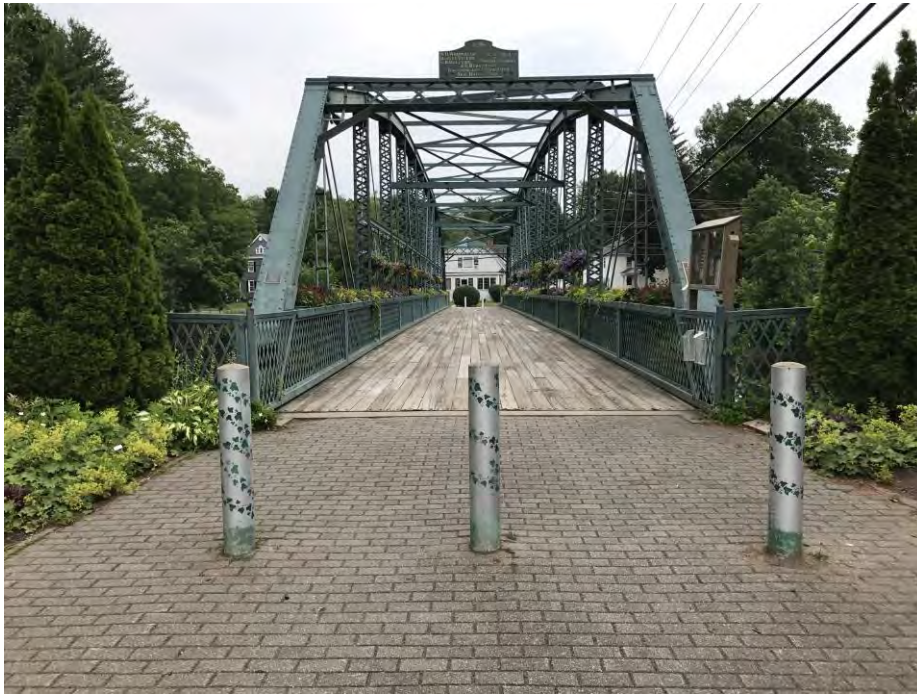
Photo # 1: Bridge from West approach.

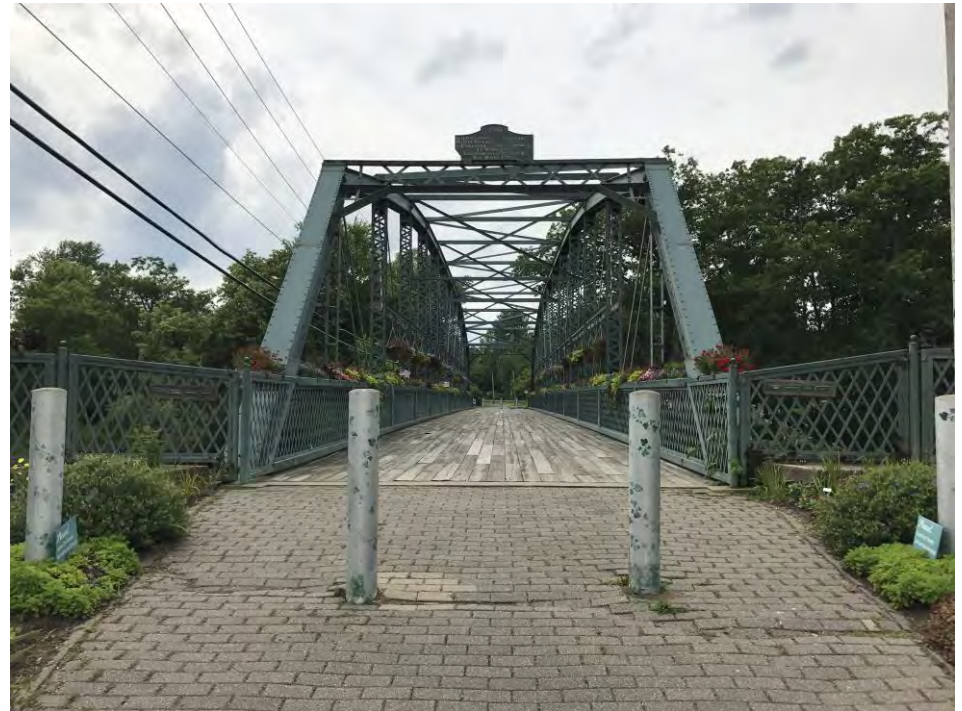
Photo # 2: Bridge from East approach.

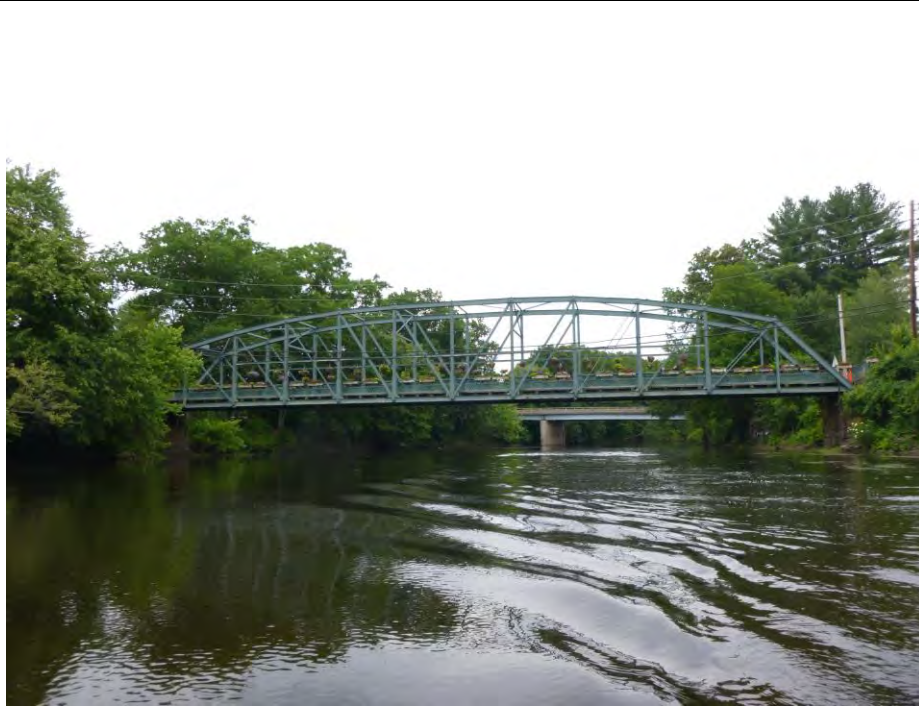
Photo # 3: Upstream elevation.

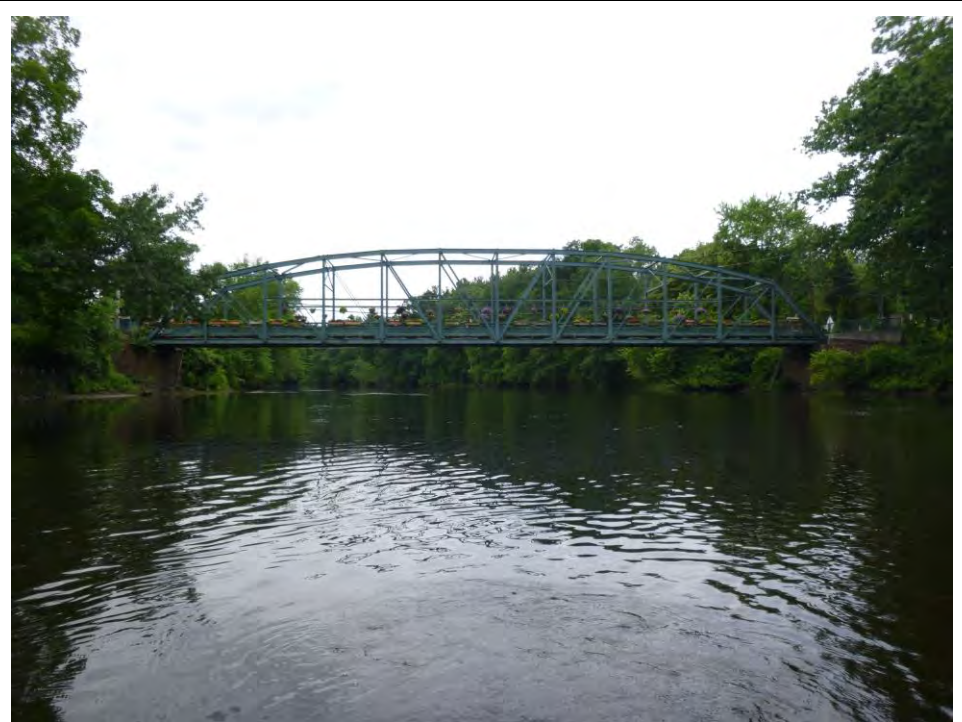
Photo # 4: Downstream elevation.

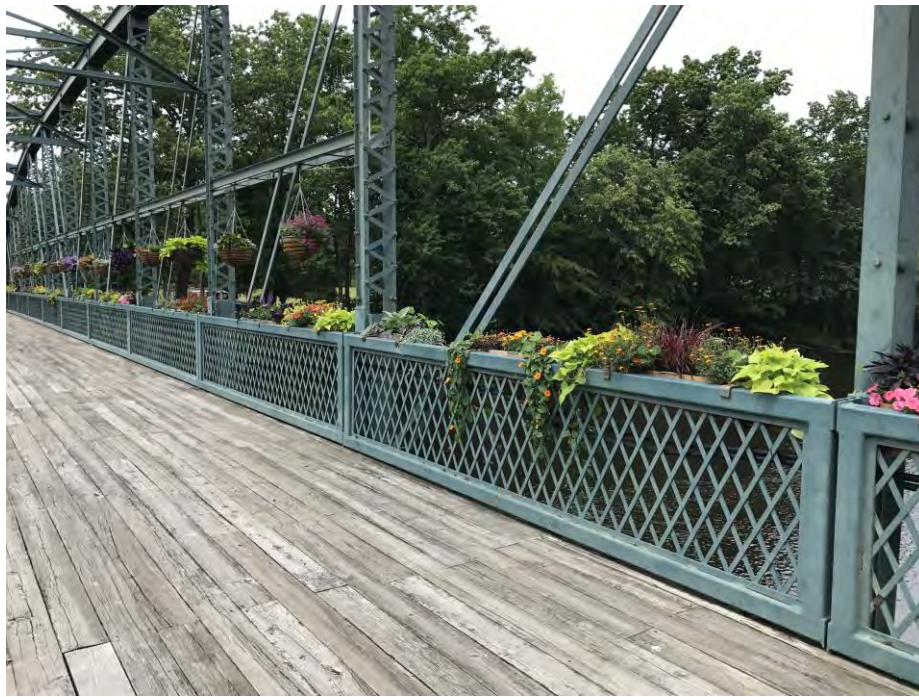
Photo # 5: Railing and flower pots on the bridge.

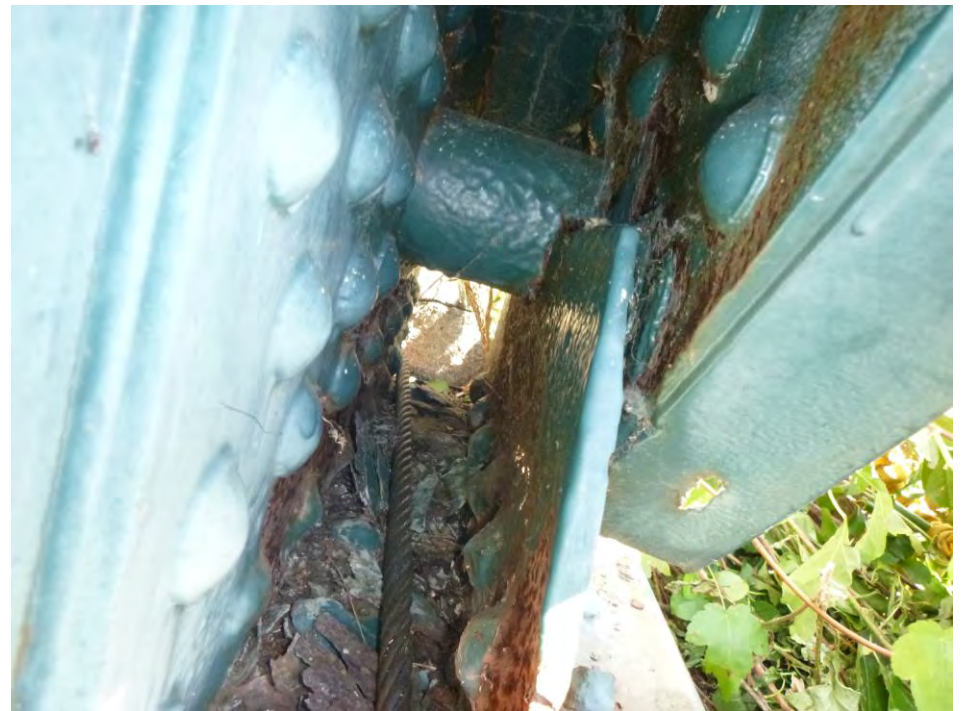
Photo # 6: Typical bearing elevation.

The original roller assembly bearings have been replaced with steel laminated elastomeric bearing pads during the 1994 rehabilitation.

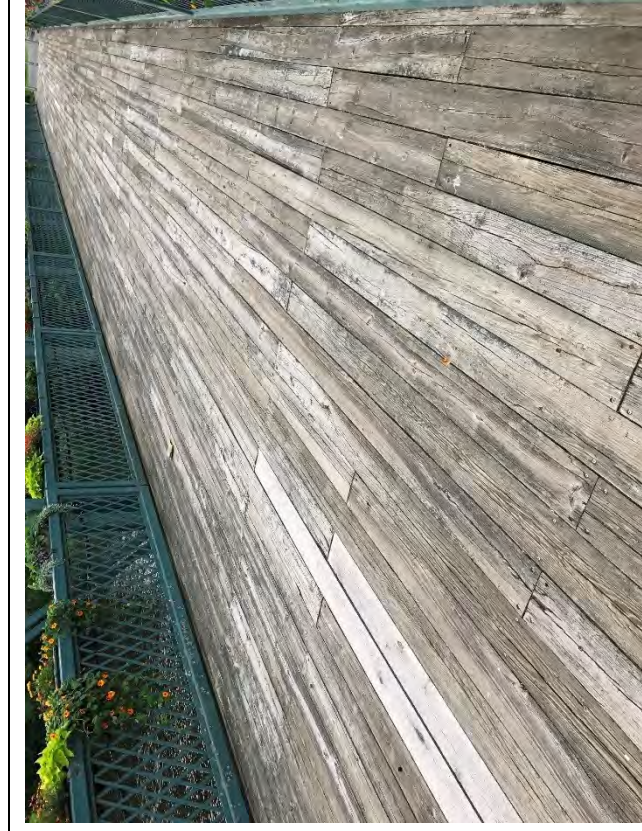
Photo # 7: View of the top side of timber deck.

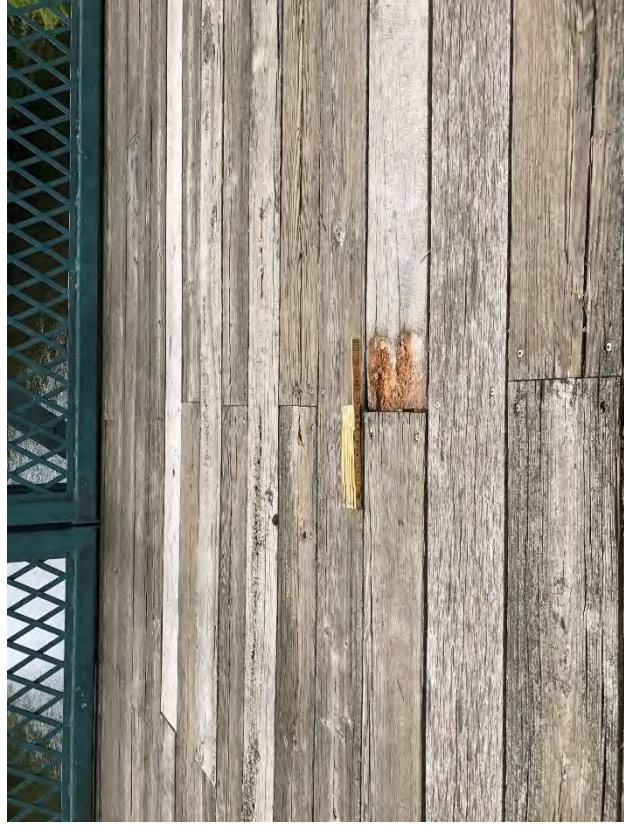
Photo # 8: Isolated timber rot in the deck near midspan with exposed nails.

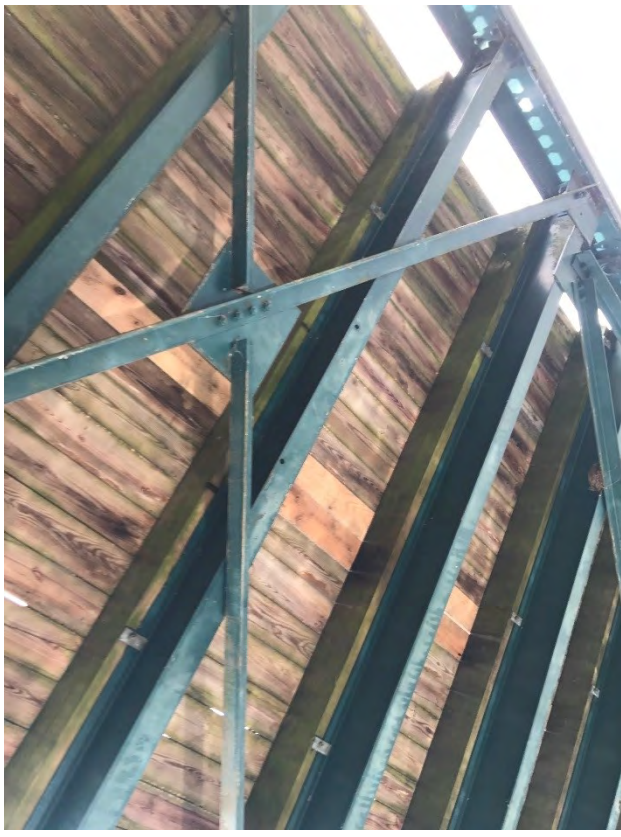
Photo # 10: View of the underside of timber deck between L1 & L2.

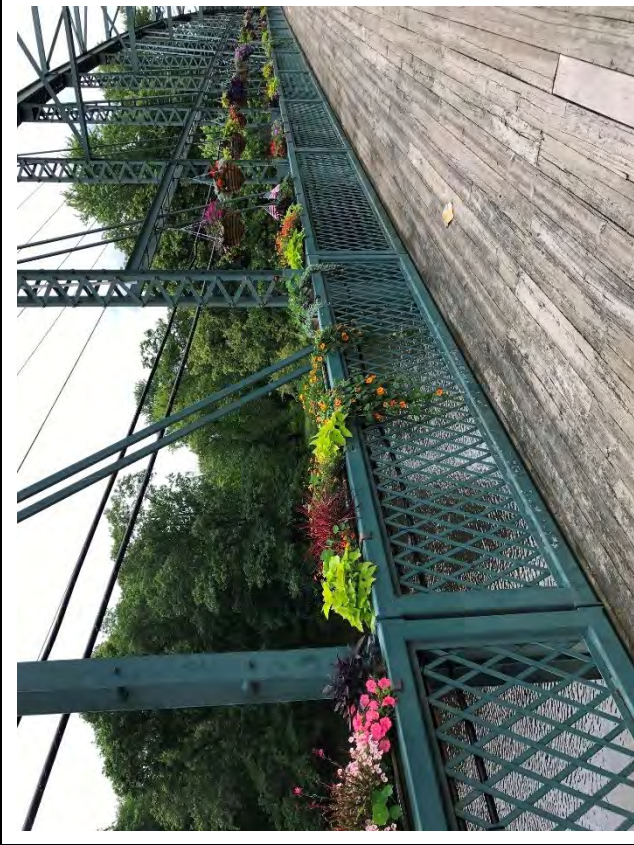
Photo # 11: Bridge railing and flower beds along the south fascia.

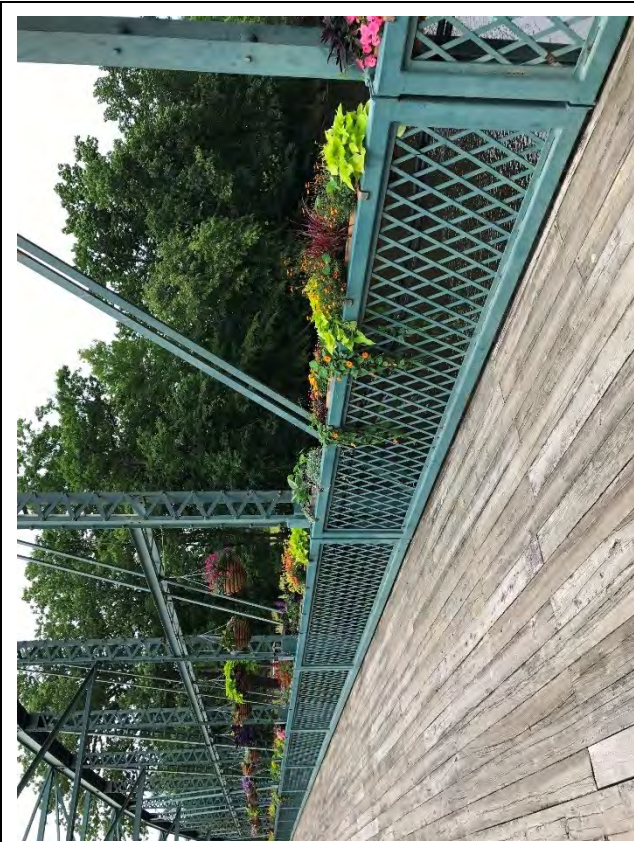
Photo # 12: Bridge railing and flower beds along the north fascia.

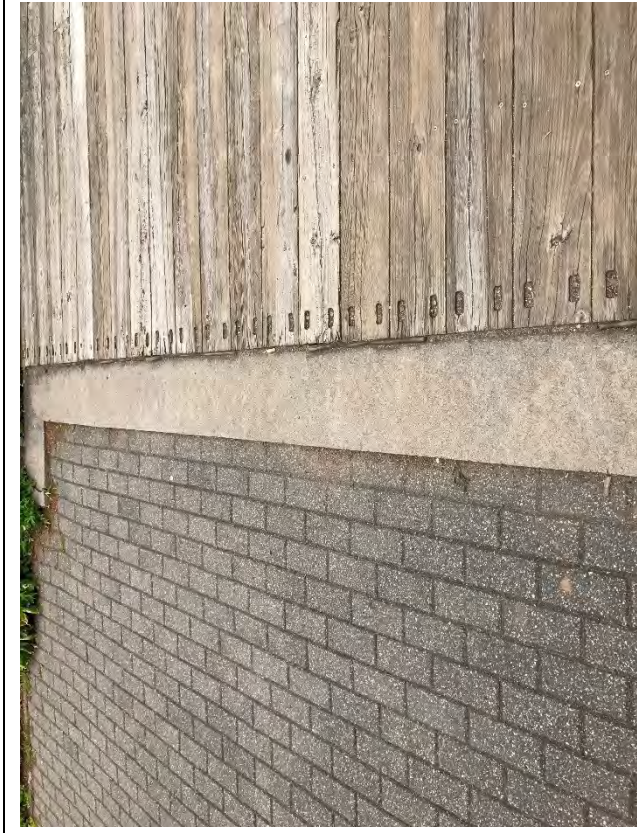
Photo # 13: Deck end joint at West Abutment. Note the deteriorating joint sealant material.

(See Photo Nos. 11 - 12)
Construction Joints	N	
Expansion Joints	6	<p>There is joint sealant material between the timber deck ends and concrete headers at both abutments, which exhibits the following deficiencies:</p> <ul style="list-style-type: none"> • Deteriorating joint sealant material at random locations. • Minor accumulation of sand along the joints. <p>(See Sketch No. 2 and Photo No. 13)</p>

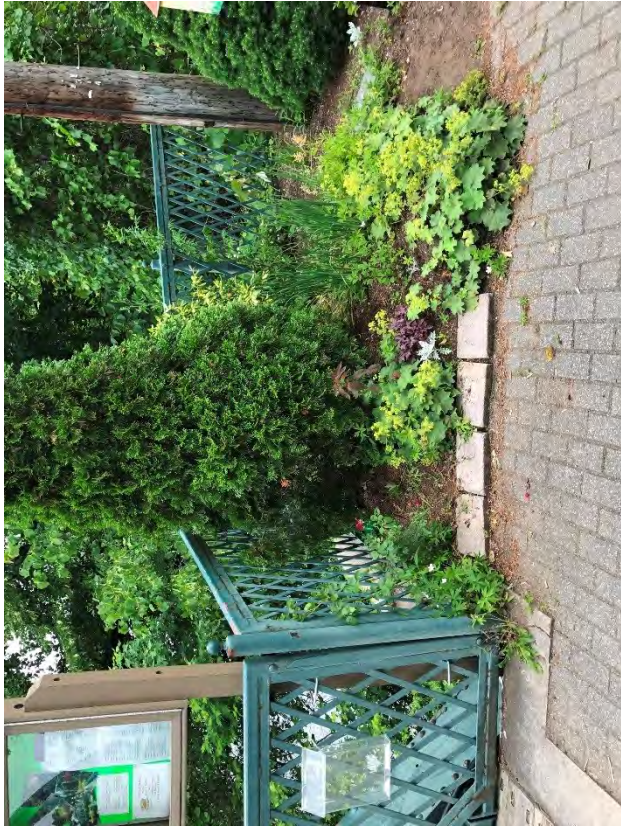
Photo # 14: Southwest approach railing.

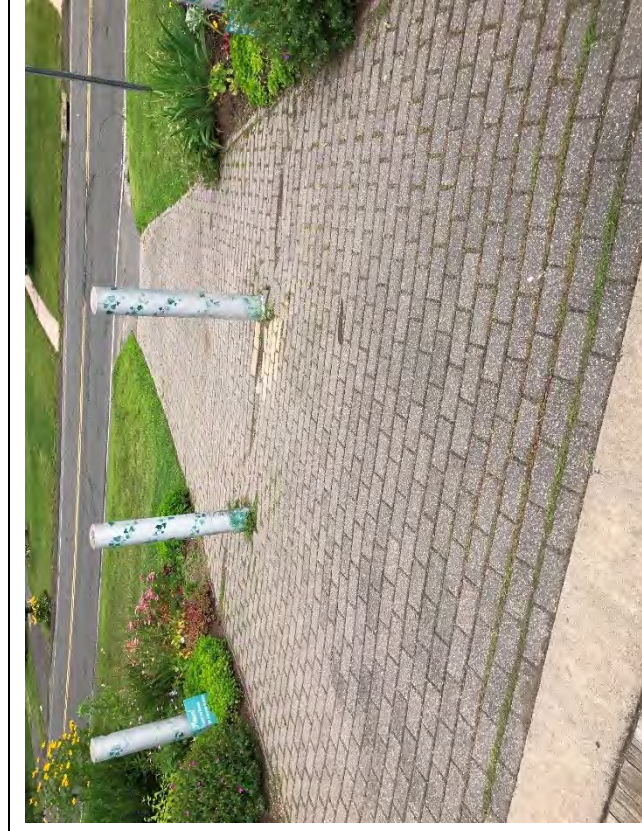
Photo # 15: East approach pavement. Note the depressed area.

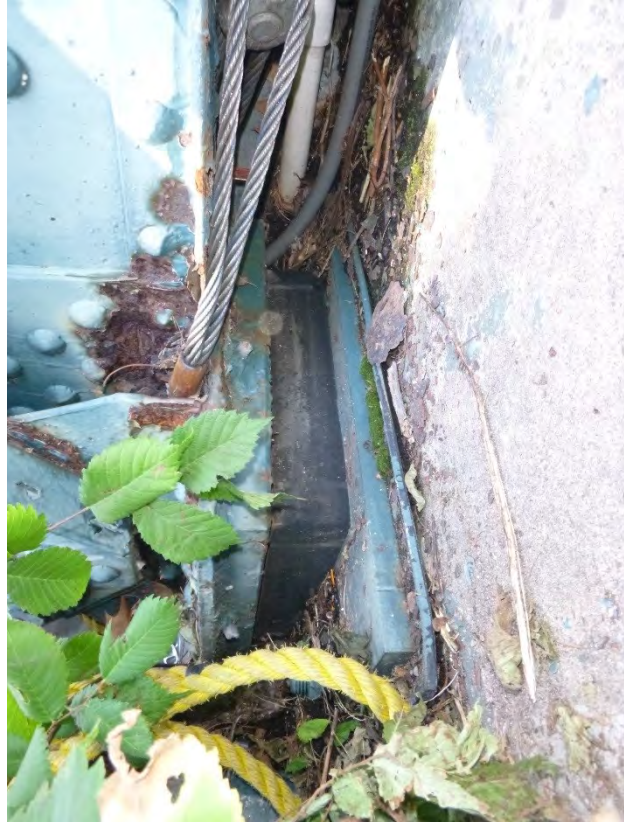
Photo # 16: Expansion bearing for South Truss at West Abutment.

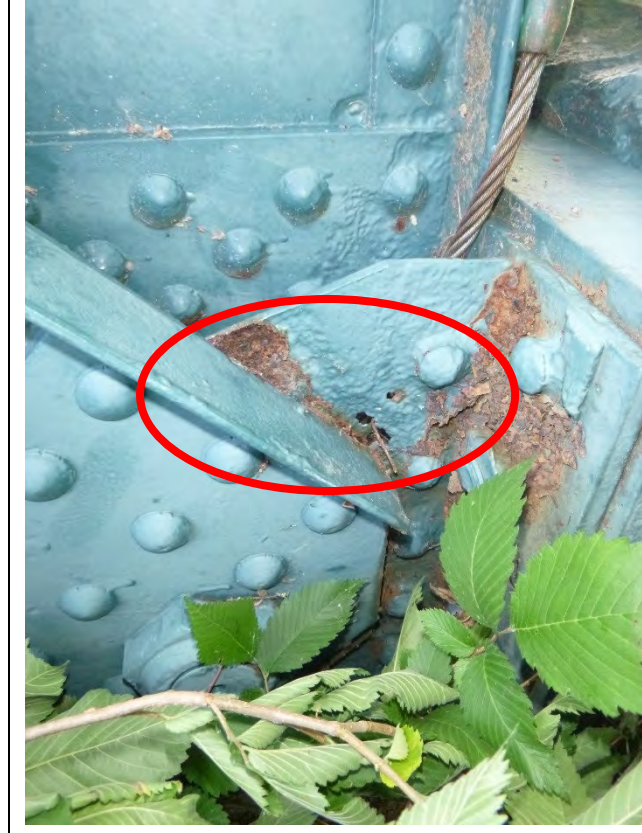
Photo # 17: Fixed bearing for North Truss at East Abutment. Note the section loss with rust holes.

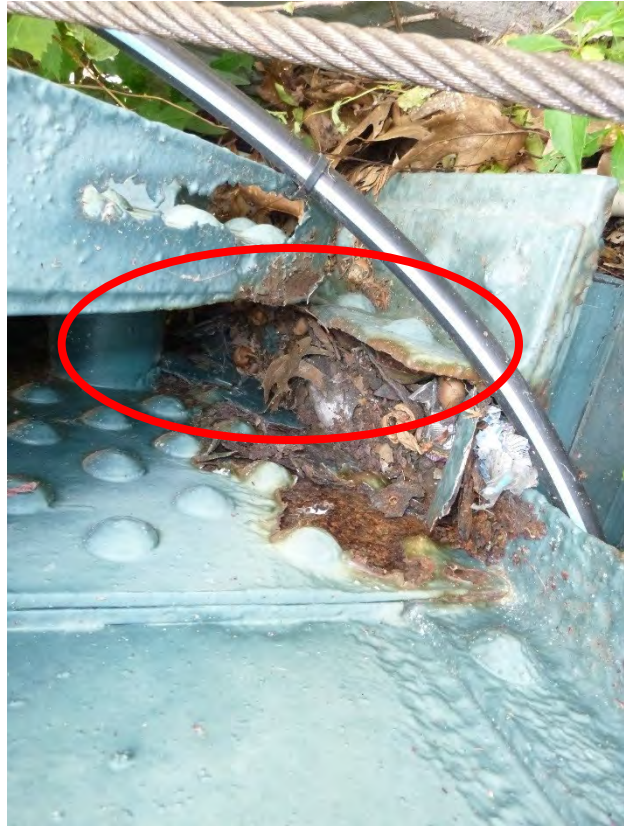
Photo # 18: Expansion bearing for North Truss at West Abutment. Note the missing gusset plate. Also, note the rust hole in horizontal leg of top chord bottom angle.

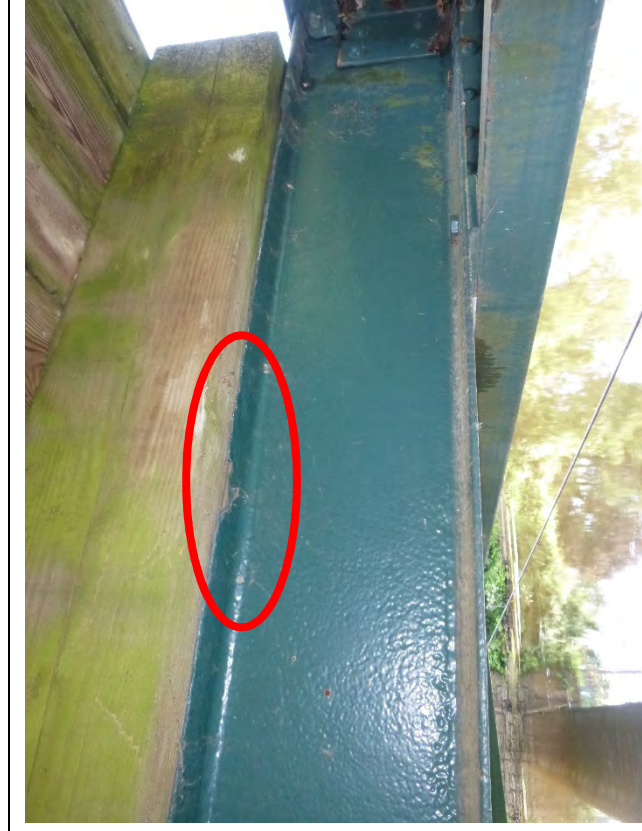
Photo # 19: Floorbeam FB3 between L1 & L2 in South Truss. Note the section loss with rust hole in top flange of the floorbeam.

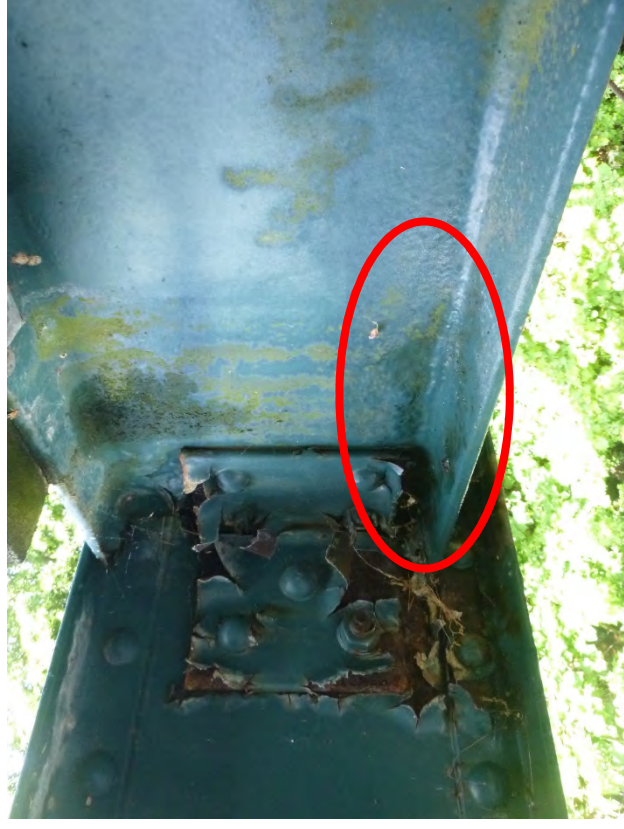
Photo # 20: Clip angle at Floorbeam FB2 between L1 & L2. Note peeling paint with rust. Also, note the painted over pitting along the bottom of floorbeam web.

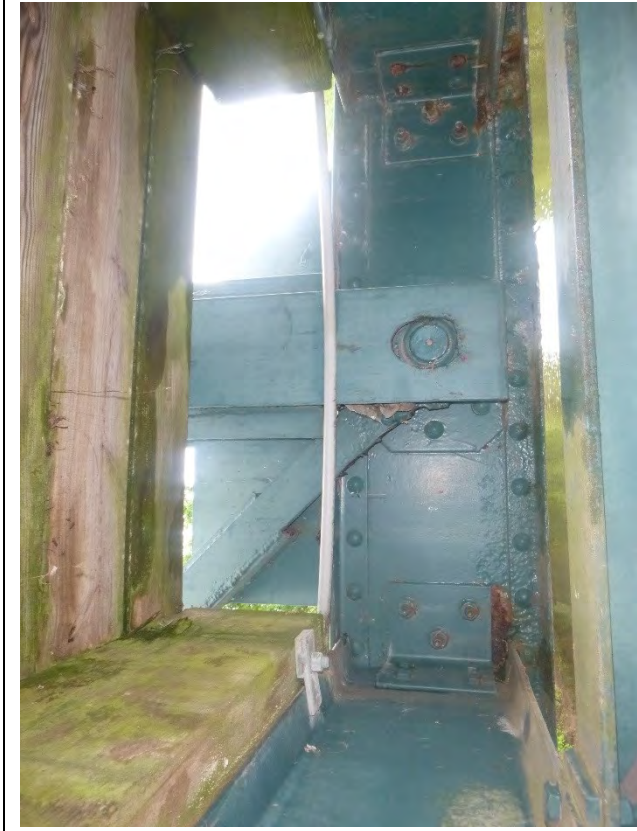
Photo # 21: Interior view of the bottom chord at L2 in North Truss. Note the deterioration along the pin connection and the repair plates.

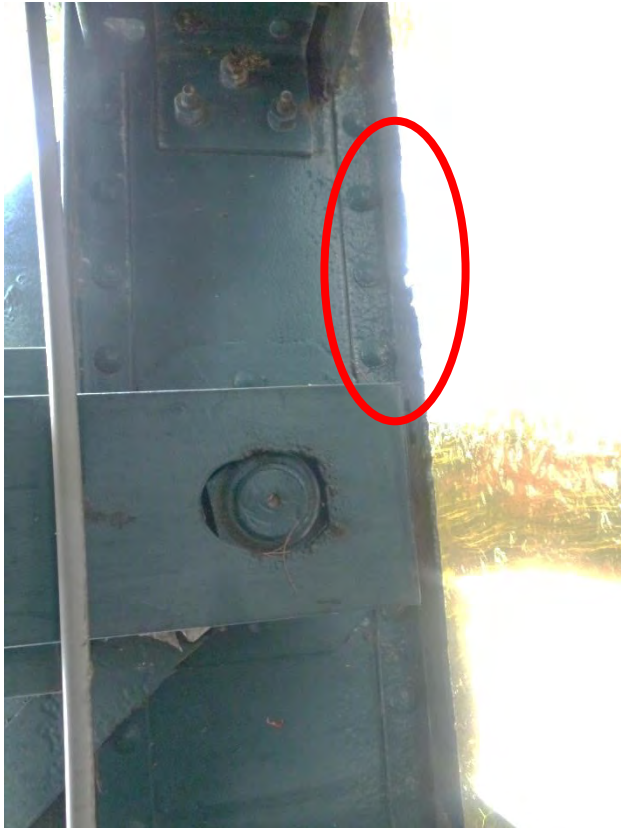
Photo # 22: Interior view of the bottom chord at L2 in North Truss. Note the pitting along the interior bottom angle.

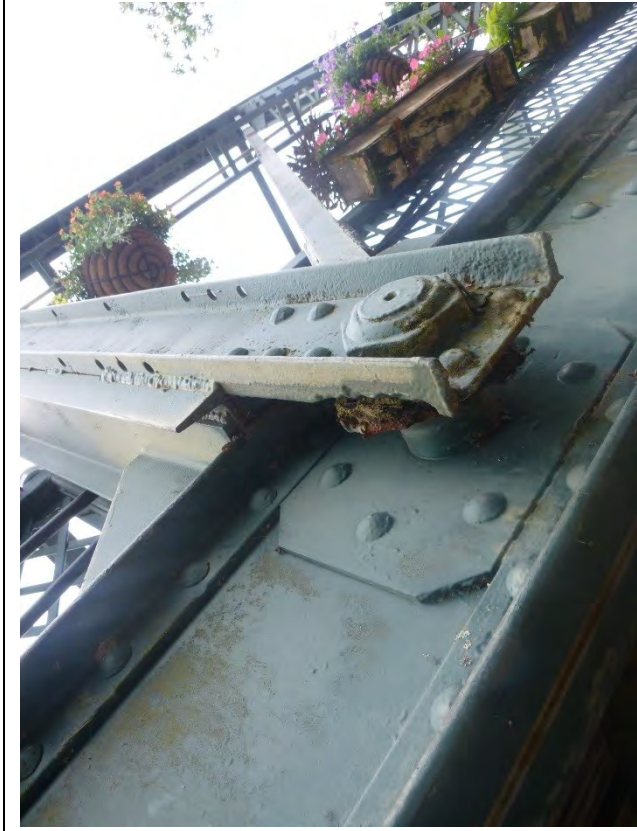
Photo # 23: Exterior view of bottom chord at L3 in North Truss. Note the deterioration along the pin connection.

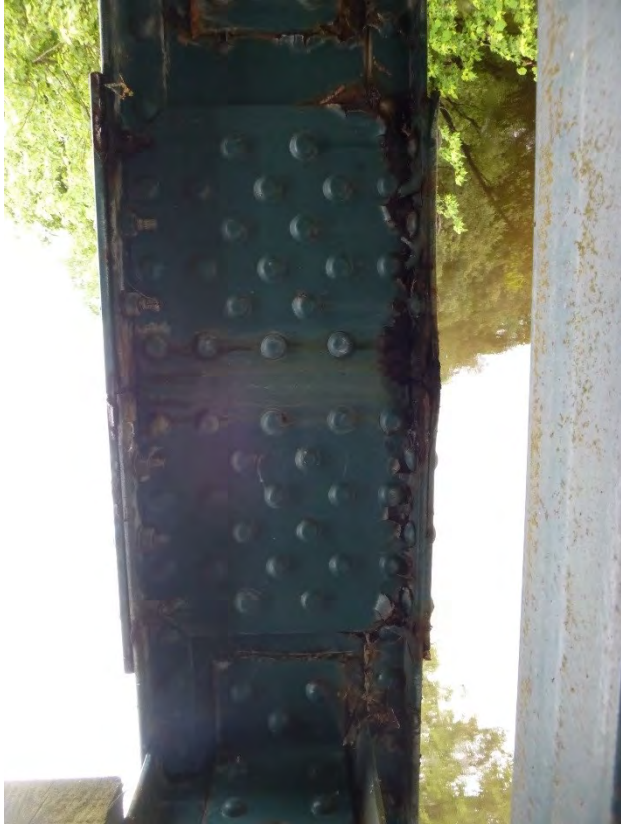
Photo # 24: Bottom chord splice connection between L2 & L3 in South Truss.

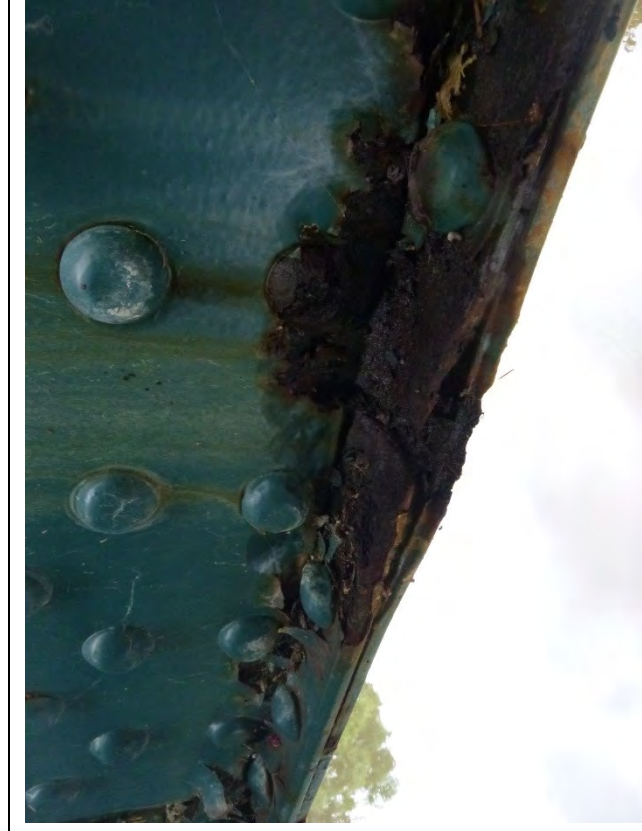
Photo # 25: Pack rust and section loss at the bottom chord splice connection between L2 & L3 in South Truss.

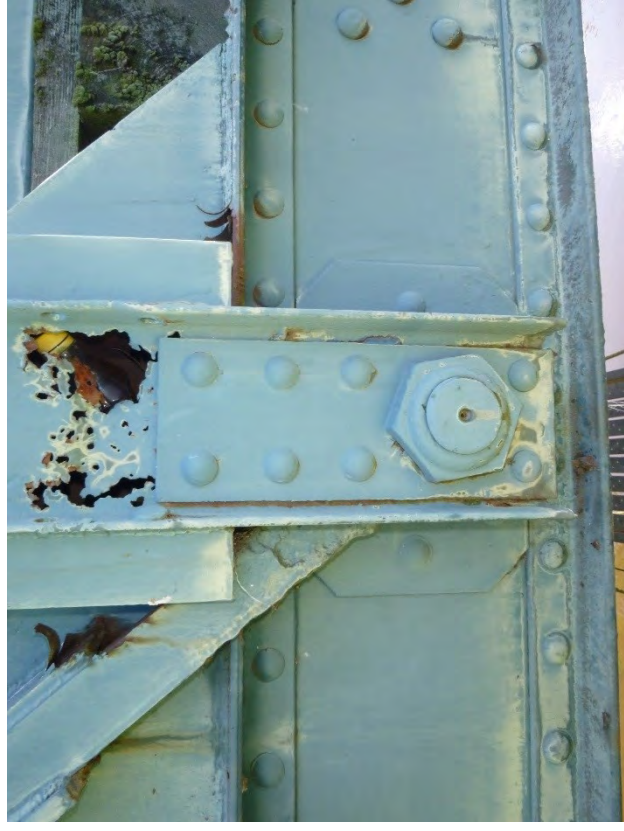
Photo # 26: South elevation of vertical member in South Truss at L3. Note the section loss in the diagonal eye bar and web of truss vertical member. Also, note the repair plates and channel atop the bottom chord.

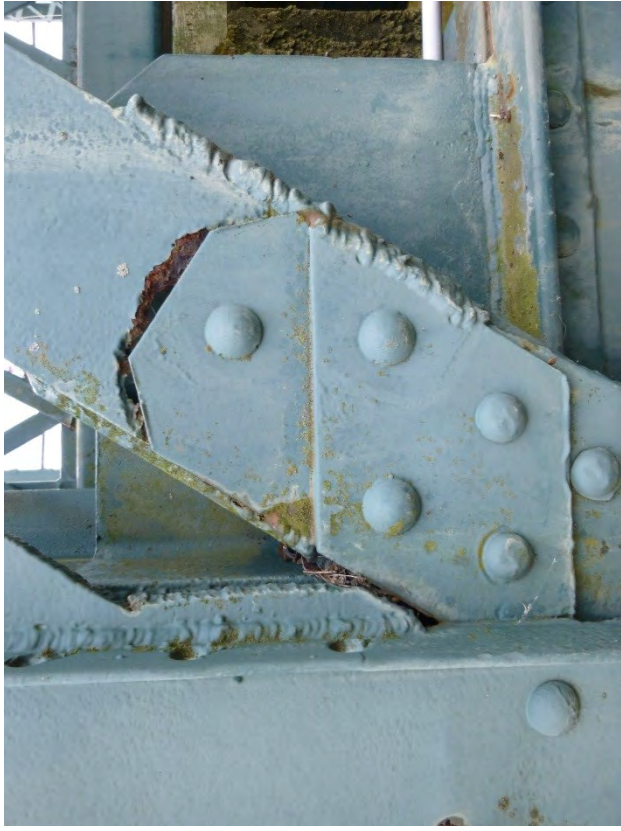
Photo # 28: North elevation of North Truss diagonal member L6-U5 at L6. Note the section loss and rust hole at the connection plates (typical). Also, note the repair plates and retrofitted gusset plate.

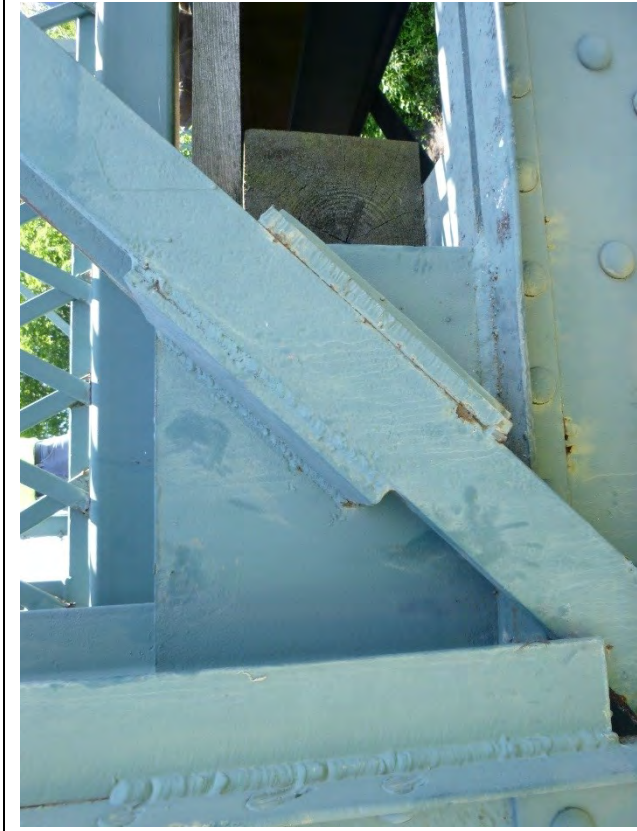
Photo # 31: South elevation of typical repair for eye bar at L10 in South Truss.

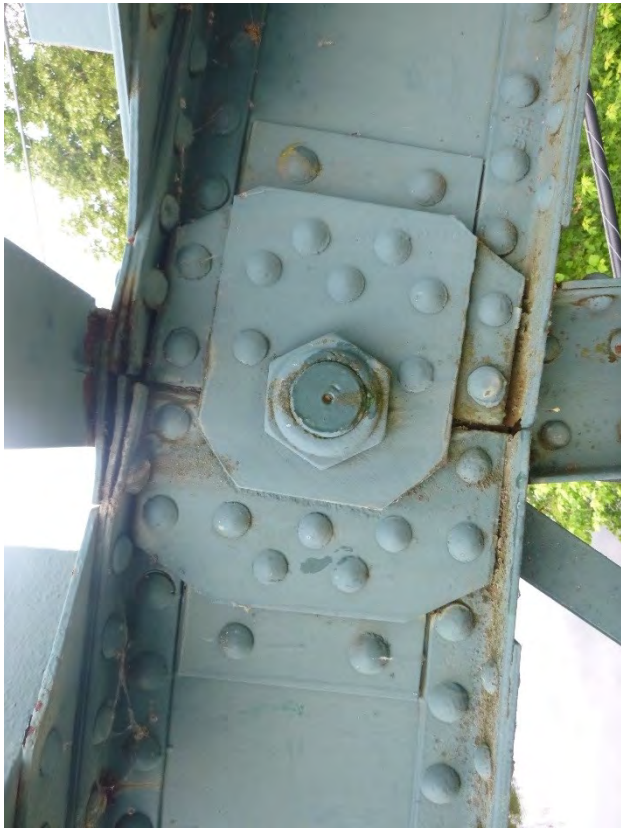
Photo # 32: North elevation of top chord member in South Truss at U2. Note the bent down top angles at the connection due to pack rust (typical).

Photo # 32: North elevation of top chord member in South Truss at U2. Note the bent down top angles at the connection due to pack rust (typical).

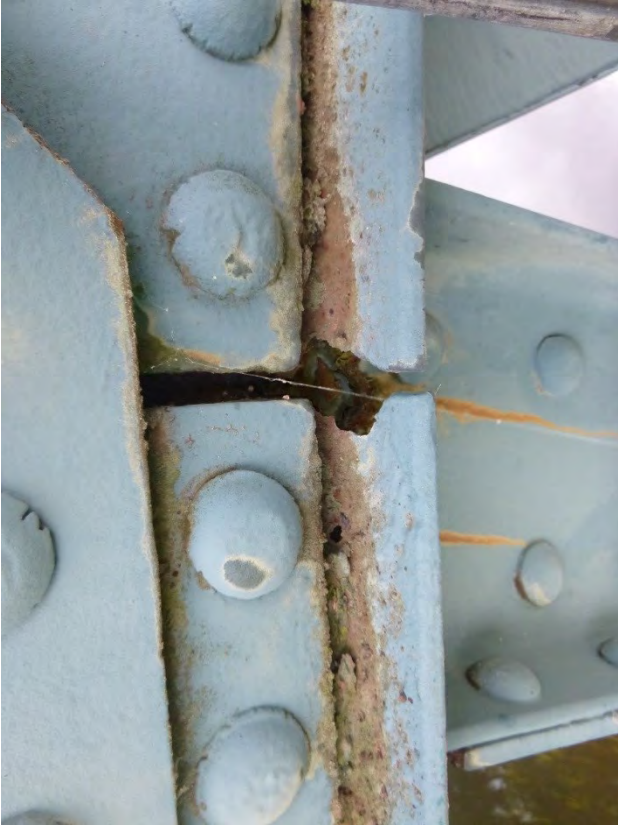
<p>Photo # 33: View of the bottom angles of top chord connection at U3 in North Truss. Note the edge rust holes in the horizontal leg (typical).</p>	<p>Photo # 34: U6 in North Truss. Note the gap behind the pin nut.</p>

<p>Photo # 33: View of the bottom angles of top chord connection at U3 in North Truss. Note the edge rust holes in the horizontal leg (typical).</p>	<p>Photo # 34: U6 in North Truss. Note the gap behind the pin nut.</p>

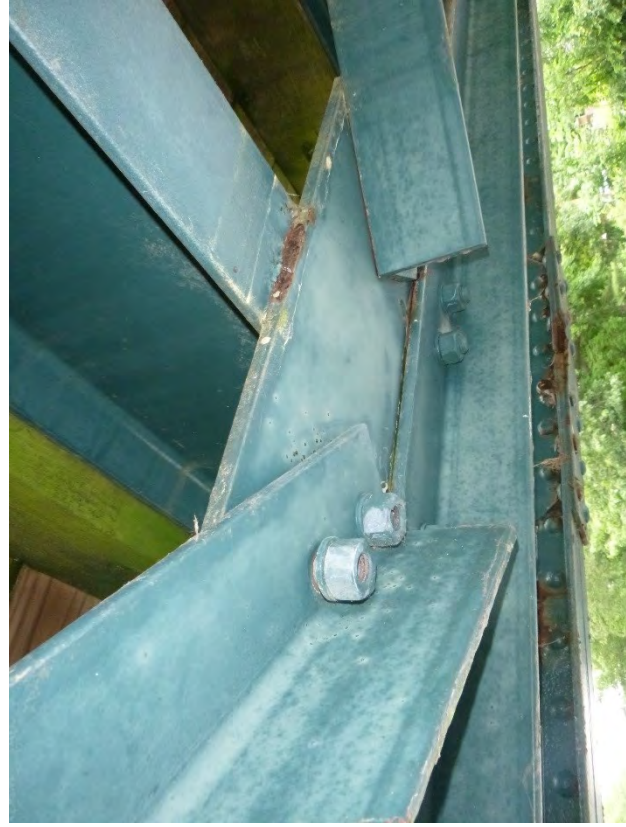
Photo # 35: Bottom lateral bracing connection near L7 in North Truss. Note the short bolts.

<p>Photo # 35: Bottom lateral bracing connection near L7 in North Truss. Note the short bolts.</p>	<p>Photo # 36: View of the top strut, sway bracing and lateral bracing between north and south trusses.</p>

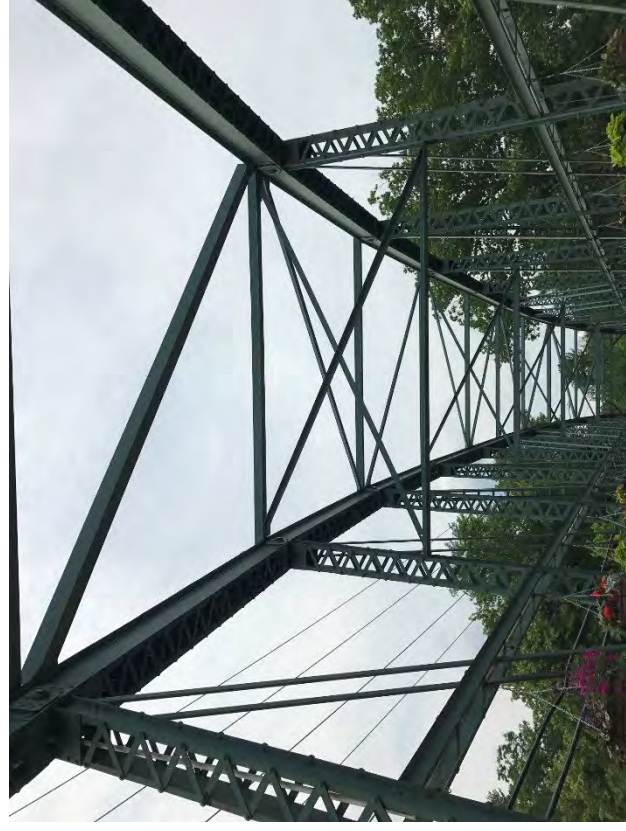
Photo # 36: View of the top strut, sway bracing and lateral bracing between north and south trusses.

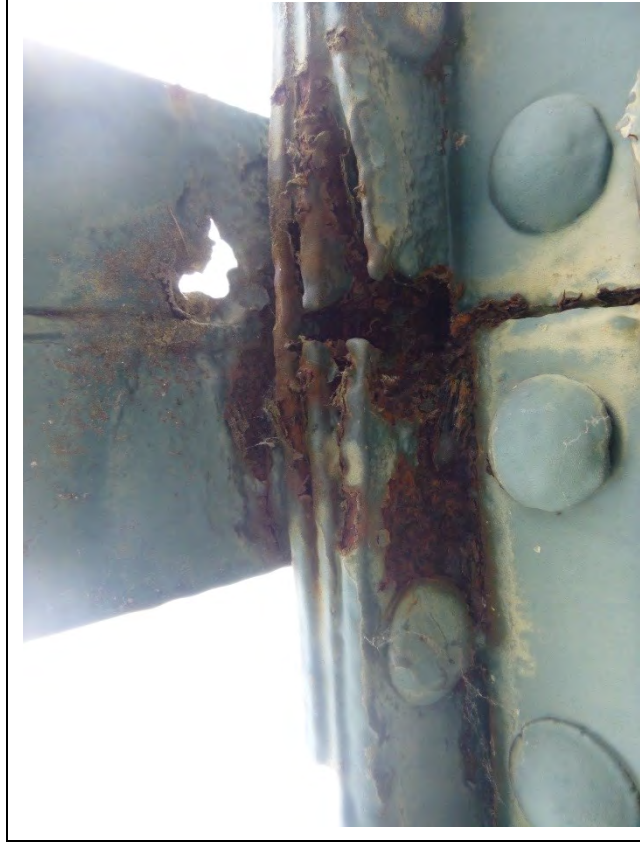
Photo # 37: Bottom of top strut at North Truss above U4.

Photo # 37: Bottom of top strut at North Truss above U4.

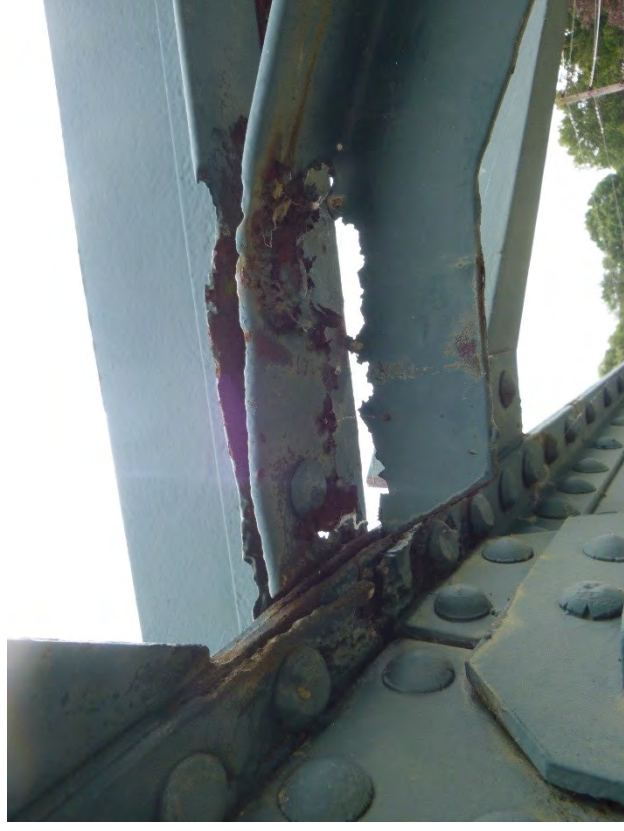
Photo # 38: Sway bracing at U7 above North Truss. Note the section loss with rust holes.

Photo # 38: Sway bracing at U7 above North Truss. Note the section loss with rust holes.

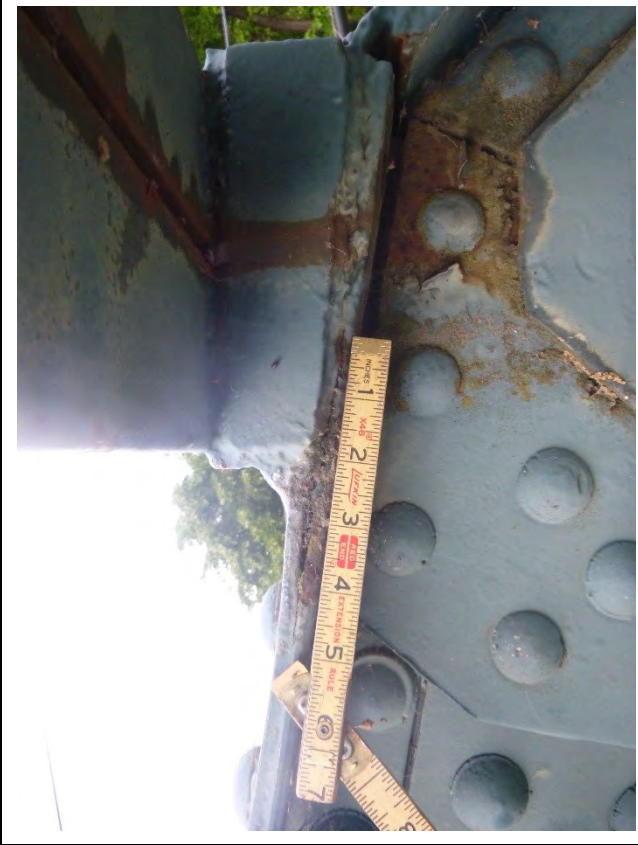
Photo # 39: North side of U1 in South Truss. Note the crack in the weld.

Paint	7	<p>Less than 10% of the painted surfaces are peeling with light to moderate rust.</p> <p>See items above entitled "Bearing Devices", "Floor Beams", "Trusses-General", "Trusses-Portal" and "Trusses-Bracing".</p>
Rust	4	<p>See items above entitled "Bearing Devices", "Floor Beams", "Trusses-General", "Trusses-Portal" and "Trusses-Bracing".</p>
Machinery Mov. Span	N	
Rivets and Bolts	6	<p>The rivets in the structure exhibit the following deficiencies:</p> <ul style="list-style-type: none"> • Random rivets with peeling paint and light to moderate rust. • Isolated rivet heads with up to 50% head loss. <p>See item above entitled "Trusses-Bracing".</p> <p>(See Sketch No. 3 - 62 and Photo Nos. 18, 24 - 25, & 37 - 38)</p>
Welds and Cracks	6	<p>There are repair welds in the structure, which exhibit the following deficiencies:</p> <ul style="list-style-type: none"> • A 2-1/2" long horizontal crack between the top chord and strut at node U1 north side of South Truss (non-critical zone). • Sloppy welds in the repair plates attached to the diagonal truss element. <p>(See Sketch No. 40 and Photo No. 39)</p>

Photo # 39: North side of U1 in South Truss. Note the crack in the weld.

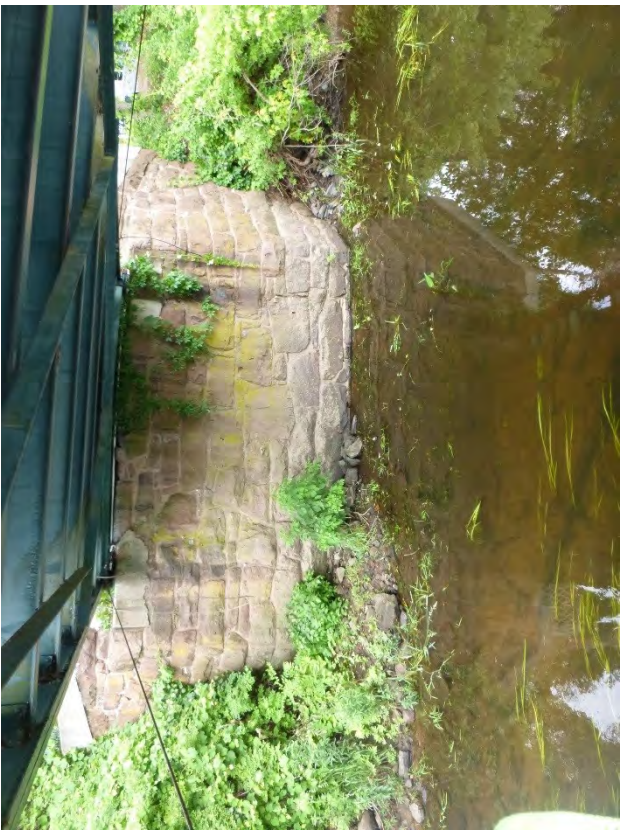
Photo # 40: West Abutment elevation.

Photo # 40: West Abutment elevation.

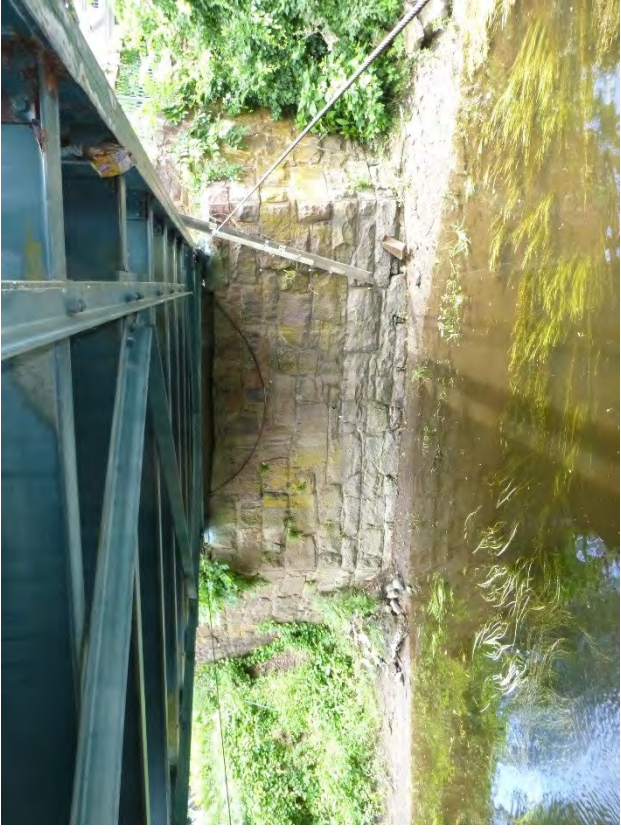
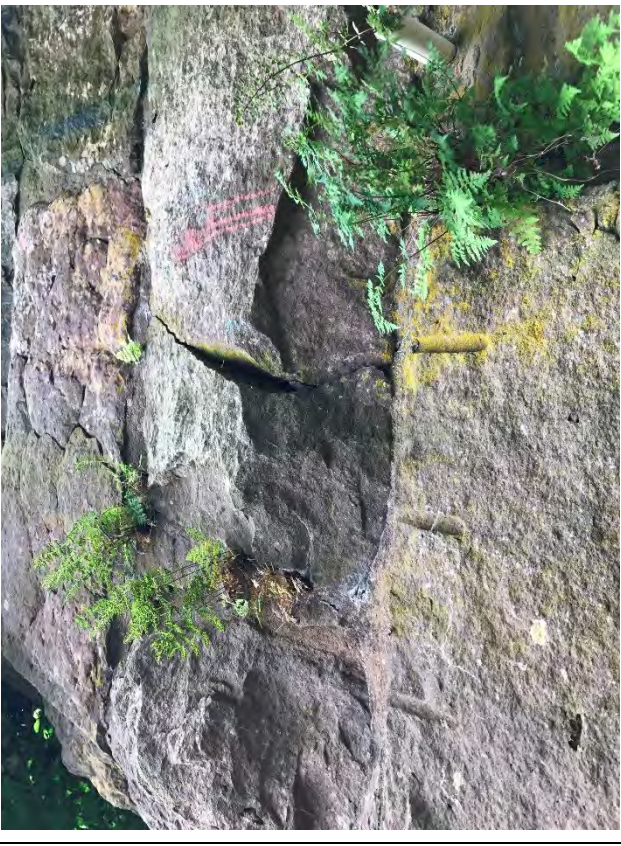
<p>Photo # 41: East Abutment elevation.</p>	<p>Photo # 42: Crack in the stone masonry at East Abutment.</p>

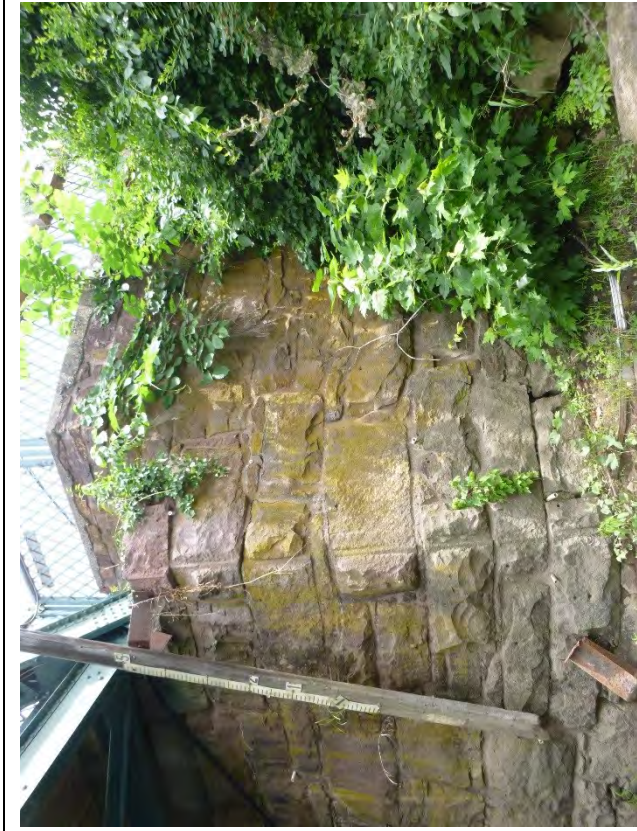
Photo # 43: Southeast Wingwall elevation.

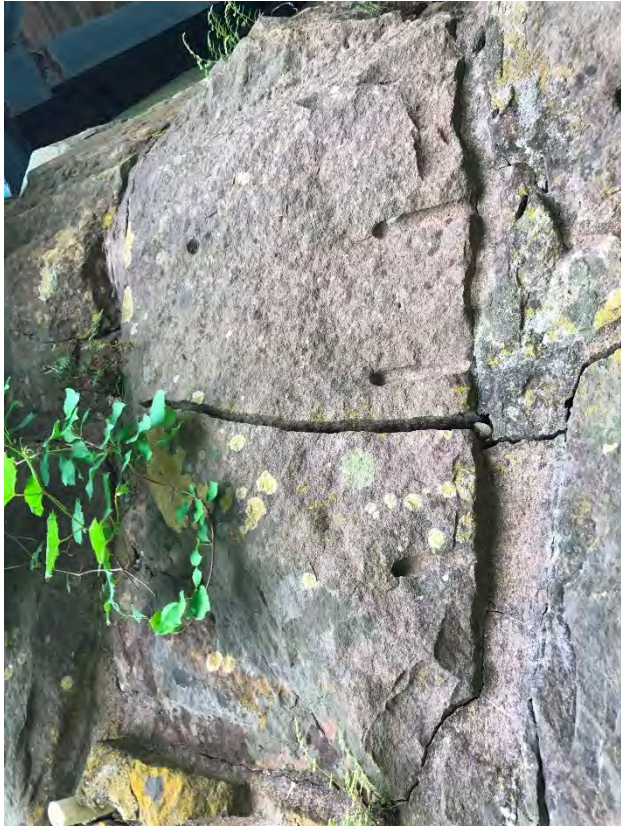
Photo # 44: Crack in the stone masonry at Northeast Wingwall.
