TOWN OF SIMSBURY

**ON-CALL PROFESSIONAL SERVICES:
SIMSBURY FLOWER BRIDGE REHABILITATION
DPW-RFP 2022-#03**

This Rehabilitation Study Report (RSR) describes the findings of a detailed evaluation of the condition of the bridge and presents recommendations for rehabilitation to ensure its structural and functional adequacy, as well as to extend its service life. Due to the historic nature of the bridge and the unique structure type, evaluation of multiple alternates for rehabilitation was not considered.

PROJECT TITLE:	<div>REHABILITATION OF BRIDGE NO. 03984 OLD DRAKE HILL ROAD BRIDGE (FLOWER BRIDGE) OVER FARMINGTON RIVER SIMSBURY, CT</div>

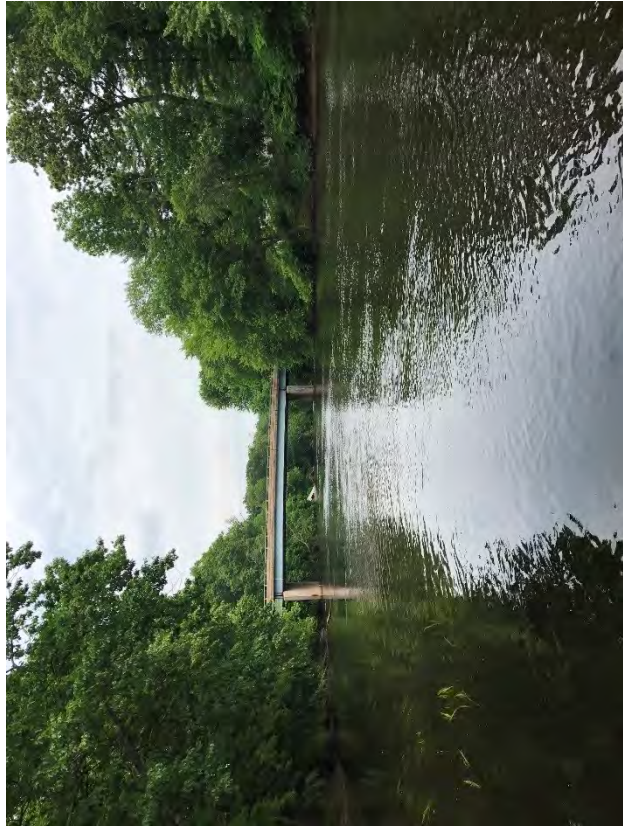
Photo # 46: Downstream view of the channel.

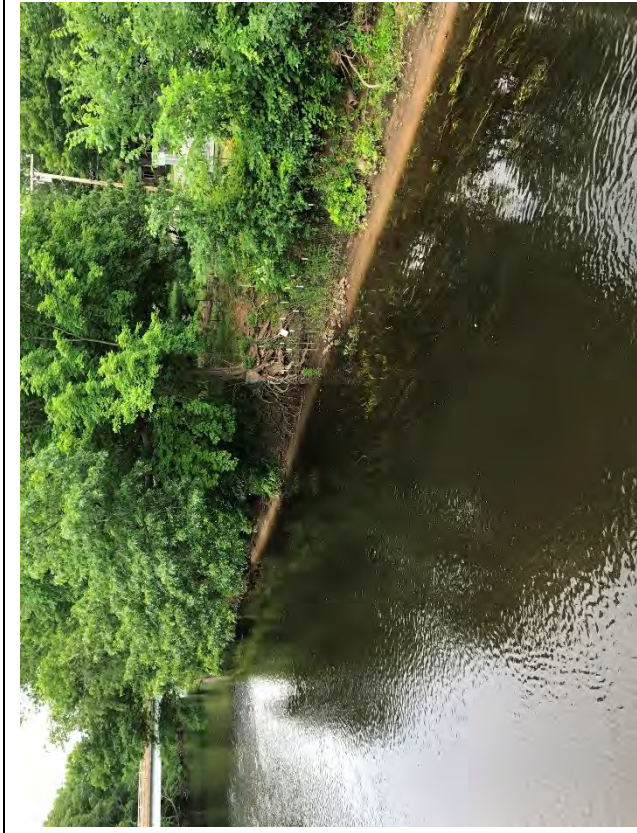
Photo # 47: Northeast embankment.

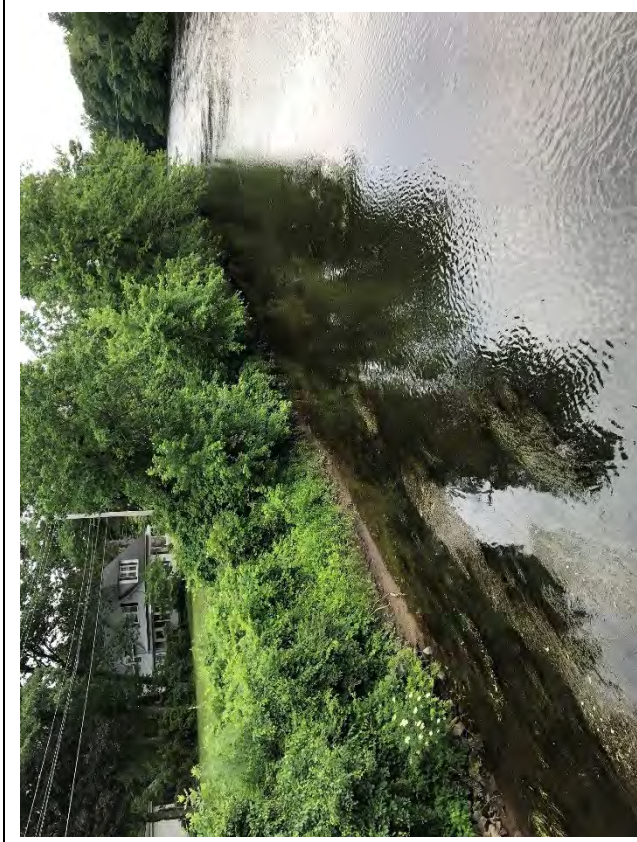
Photo # 48: Southeast embankment.

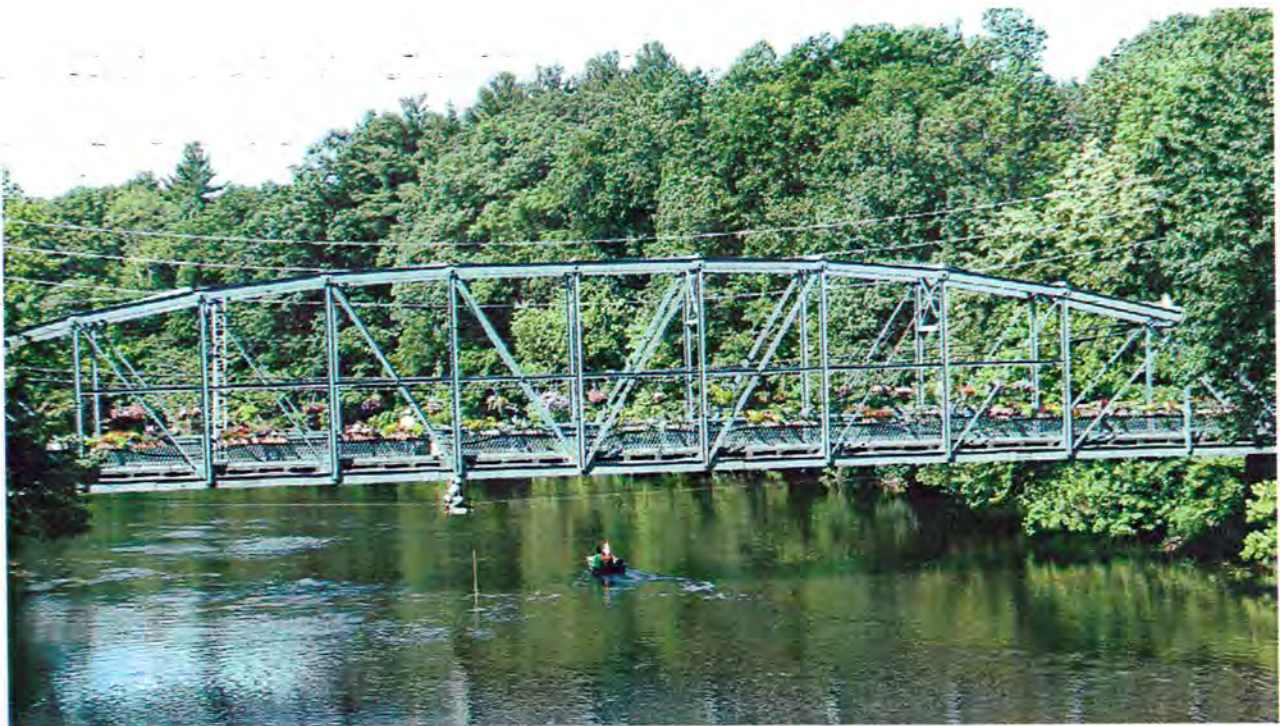
Photo 1 –General view of bridge.

Photo 1 –General view of bridge.

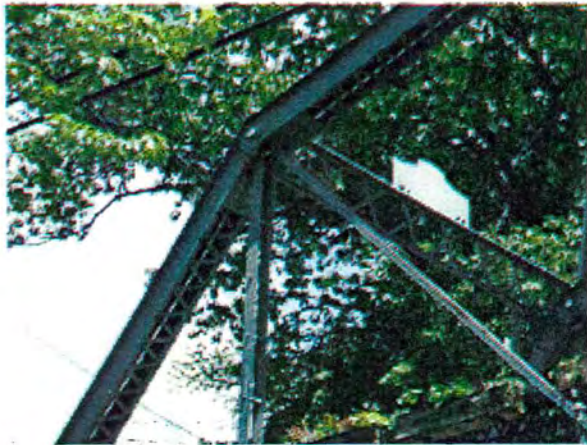
Photo 2 –Typical view of truss.

Spot corrosion on the truss members typically ranged from approximately 0.3% to 1% of the surface area. There were several isolated areas with spot corrosion on the North truss ranging from 1% to 3%. Areas of spot corrosion were scattered across the length and most often occurring at the connections. Conditions were typical for upper and lower truss chords, verticals, diagonals, and bracing members. See Photographs 2 through 11 below.

Photo 2 –Typical view of truss.

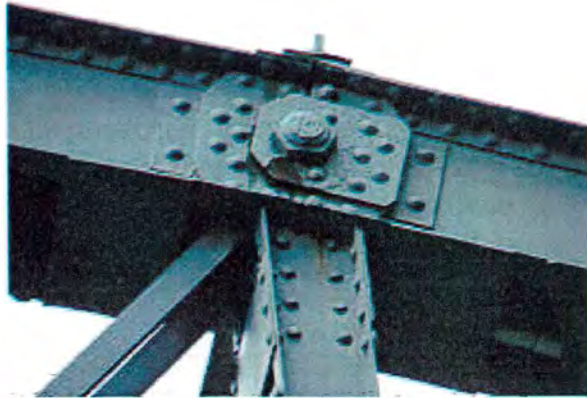
Photo 3 –Spot corrosion on truss connection.

Photo 3 –Spot corrosion on truss connection.

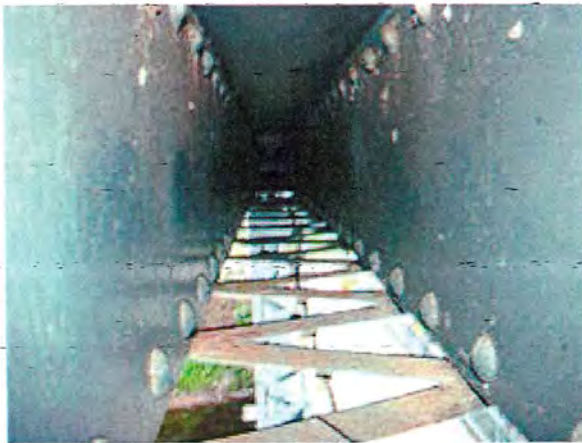
Photo 4 –Typical view of interior truss top chord.

Photo 4 –Typical view of interior truss top chord.

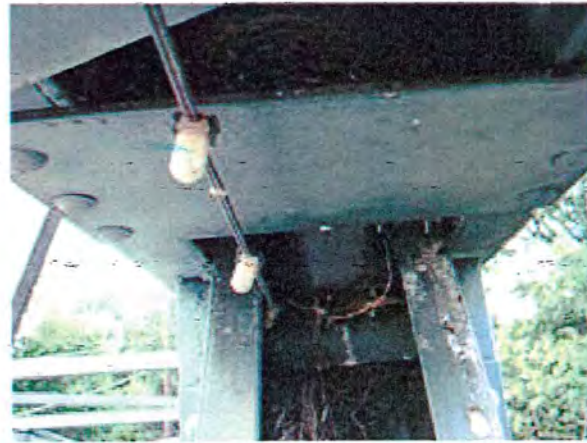
Photo 5 –Bird nest in truss top chord.

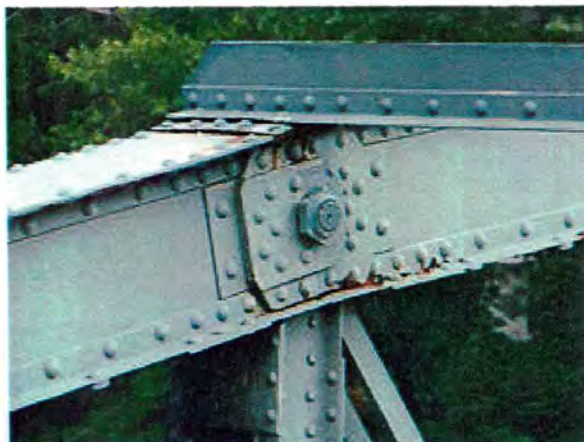
Photo 6 –Spot corrosion at truss connection.

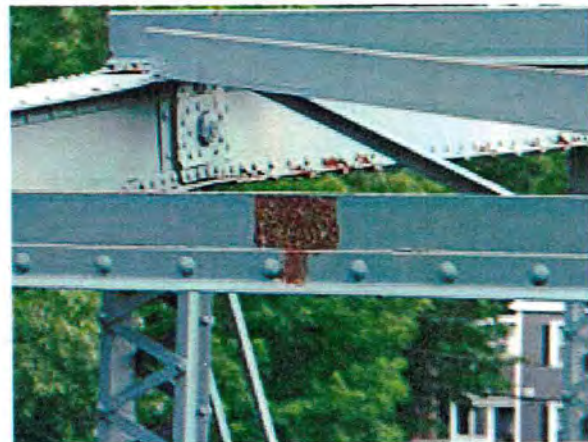
Photo 7 –Spot corrosion on truss bracing.

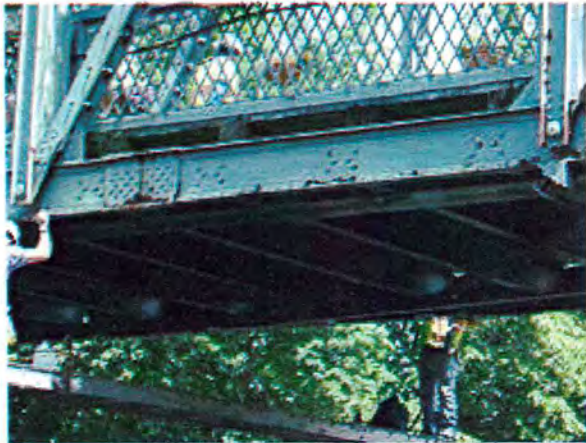
Photo 8 – Spot corrosion on truss lower chord.

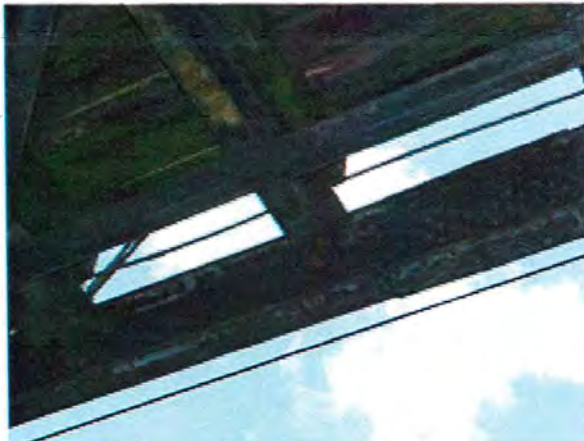
A white discoloration was observed on the lower truss and adjacent steel. The discolored areas had the appearance of salt deposits. The discoloration may also be caused by runoff from the flower boxes.

Photo 10 – White stain on lower chord.

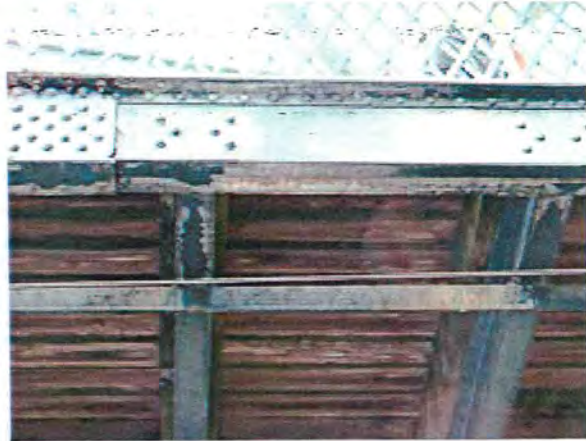
Photo 11 – White stain on lower chord.

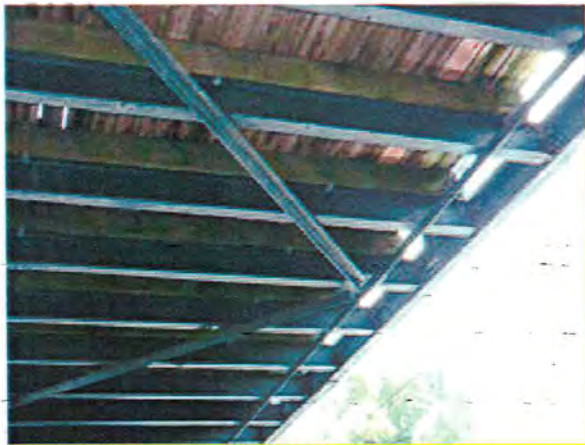
Coating deterioration on the floor beams ranged from approximately 0.3% to 1% of the surface area. Higher levels of corrosion were typically observed at the connections with the lower chords.

Photo 12 – Typical condition of floor beams.

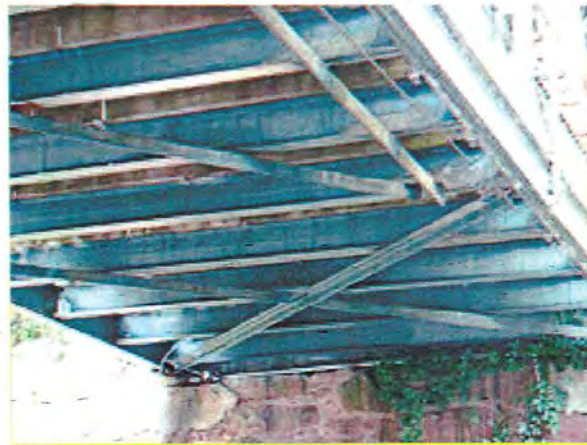
Photo 13 – Typical condition of floor beams.

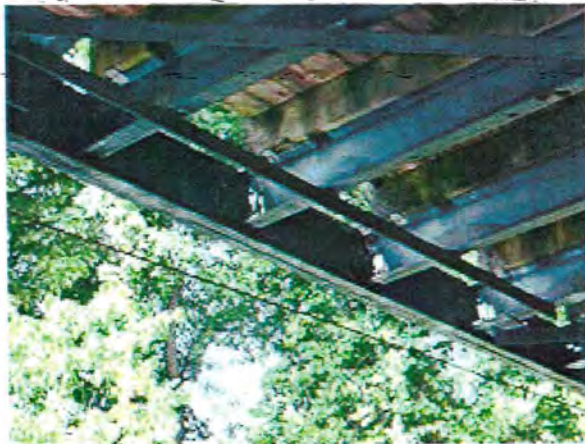
Photo 14 – Typical condition of floor beams.

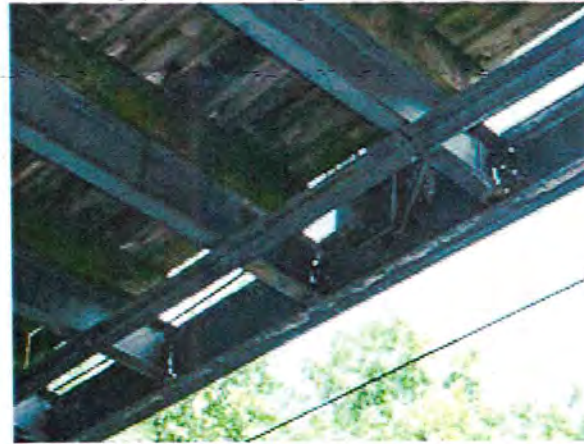
Photo 15 – Typical condition of floor beams.

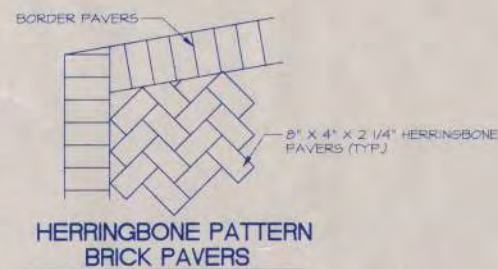
HERRINGBONE PATTERN BRICK PAVERS
SCALE: 3/4" = 1'-0"

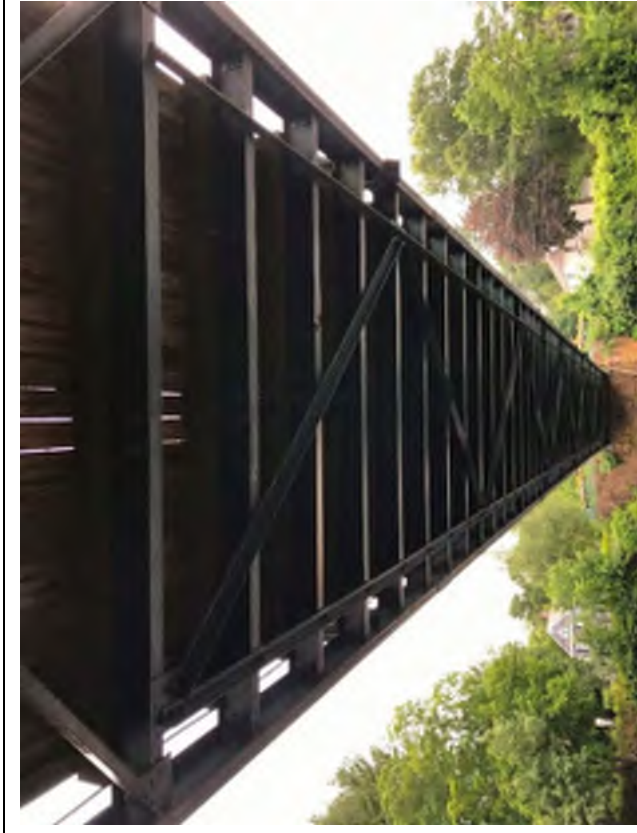
Photo # 9: View of the underside of deck and framing. Note the gaps between the deck planks.

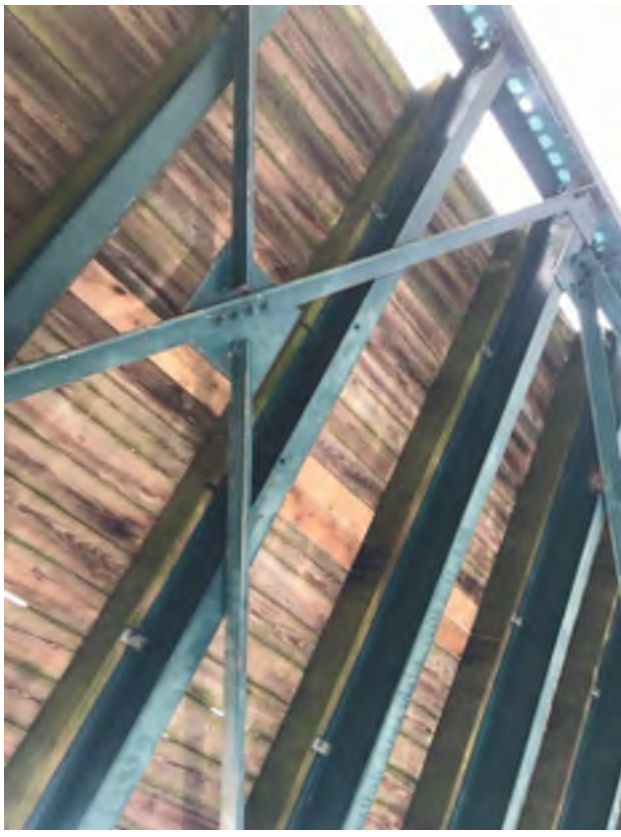
Photo # 10: View of the underside of timber deck between L1 & L2.

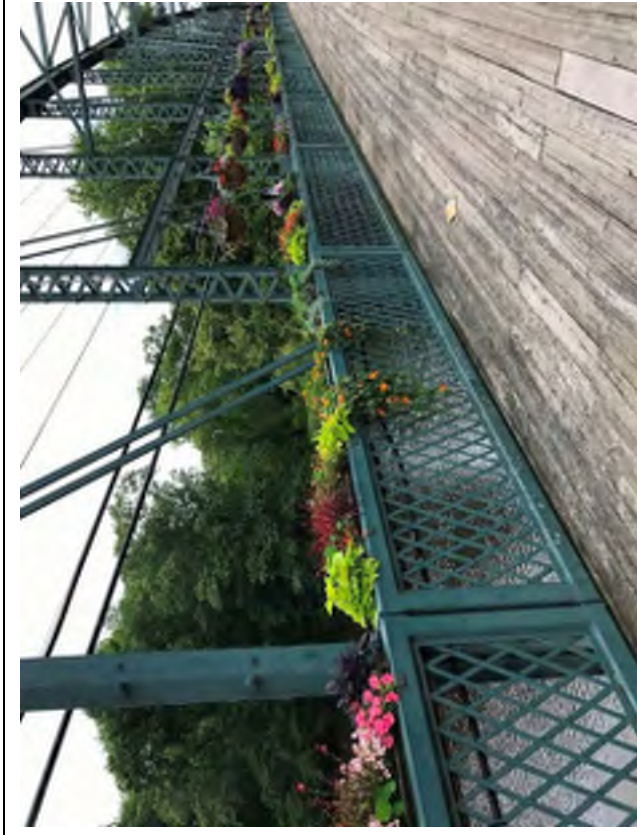
Photo # 11: Bridge railing and flower beds along the south fascia.

(See Photo Nos. 11 - 12)
Construction Joints	N	
Expansion Joints	6	<p>There is joint sealant material between the timber deck ends and concrete headers at both abutments, which exhibits the following deficiencies:</p> <ul style="list-style-type: none"> • Deteriorating joint sealant material at random locations. • Minor accumulation of sand along the joints. <p>(See Sketch No. 2 and Photo No. 13)</p>

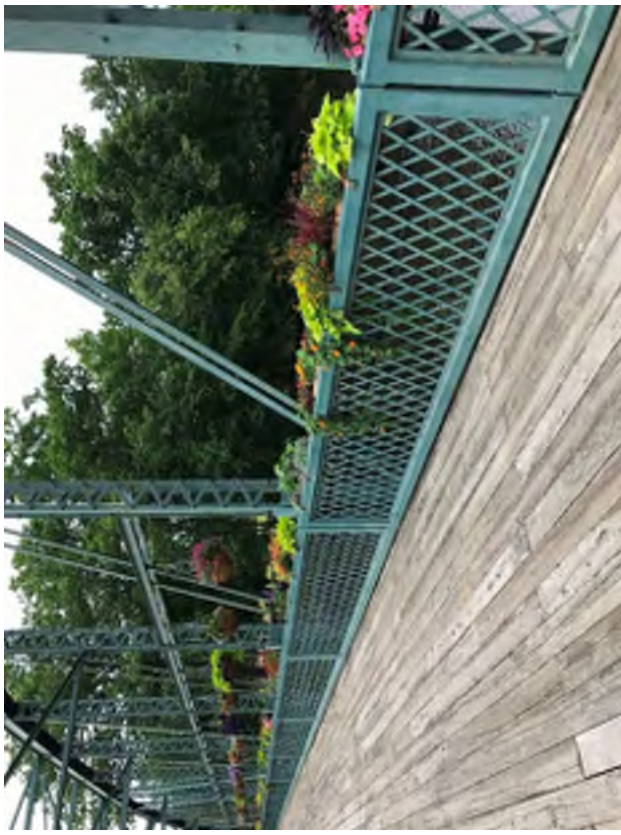
Photo # 12: Bridge railing and flower beds along the north fascia.

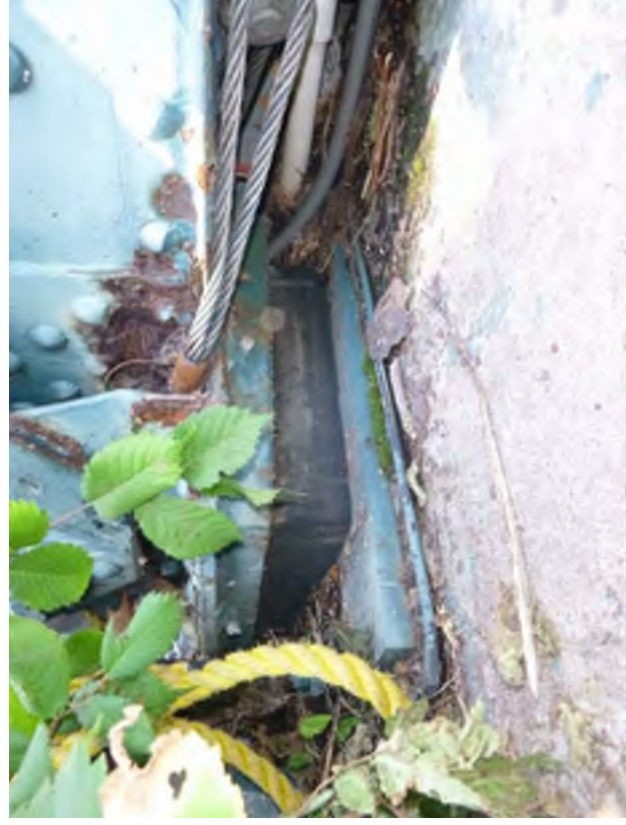
Photo # 16: Expansion bearing for South Truss at West Abutment.

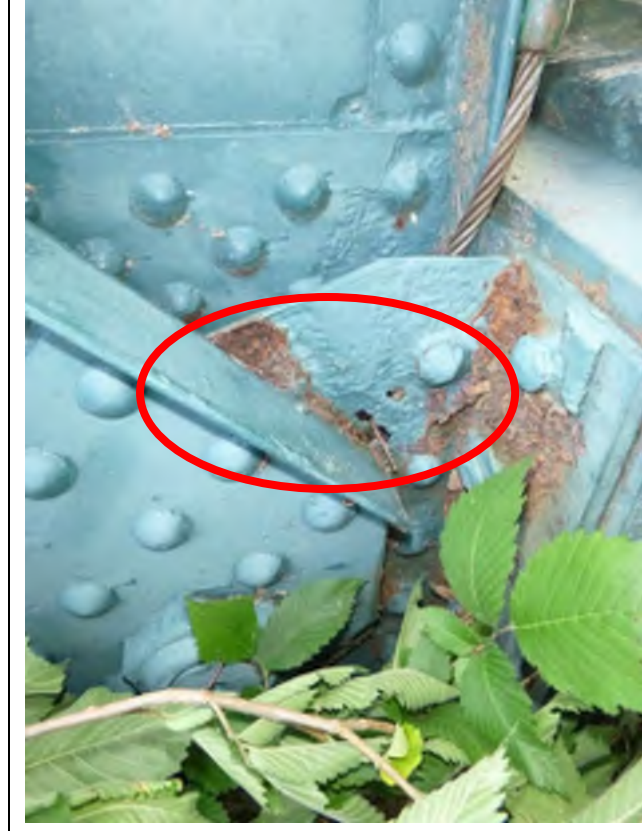
Photo # 17: Fixed bearing for North Truss at East Abutment. Note the section loss with rust holes.

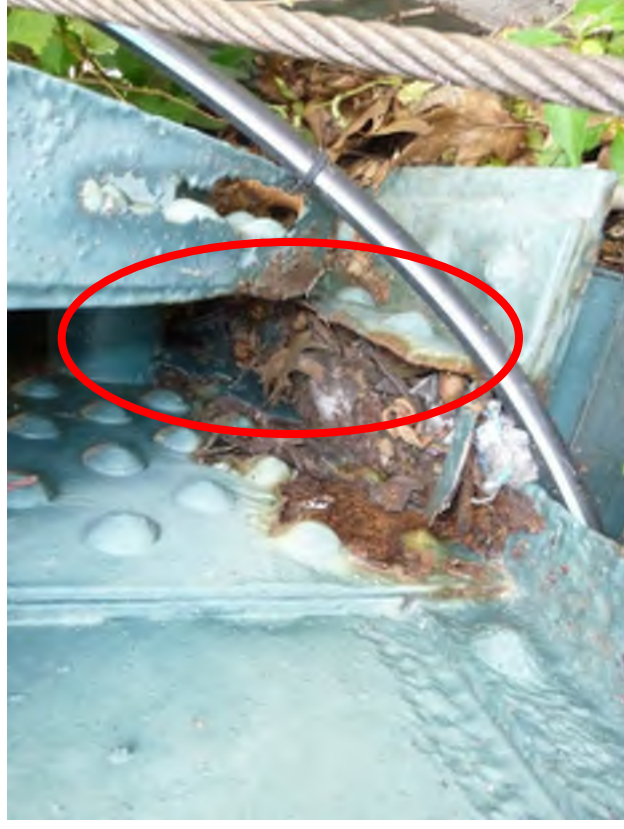
Photo # 18: Expansion bearing for North Truss at West Abutment. Note the missing gusset plate. Also, note the rust hole in horizontal leg of top chord bottom angle.

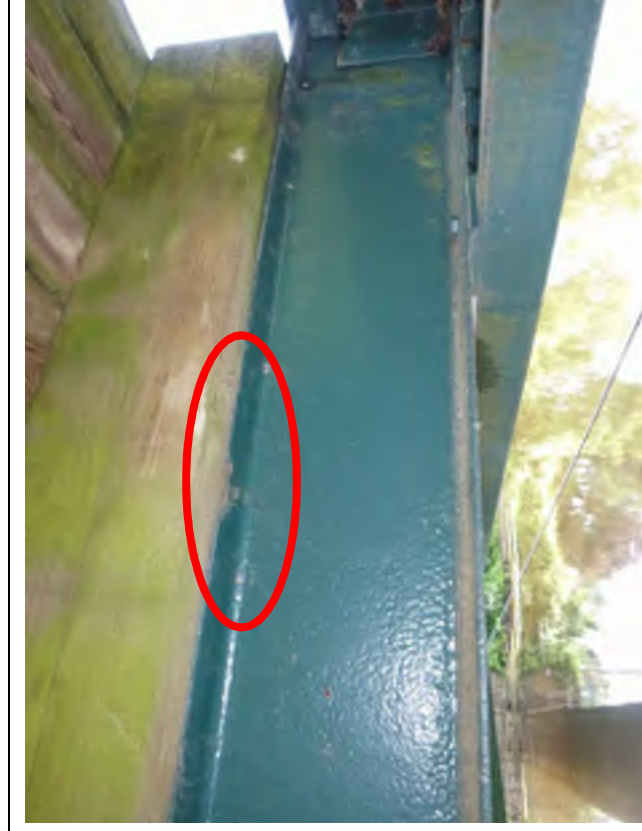
Photo # 19: Floorbeam FB3 between L1 & L2 in South Truss. Note the section loss with rust hole in top flange of the floorbeam.

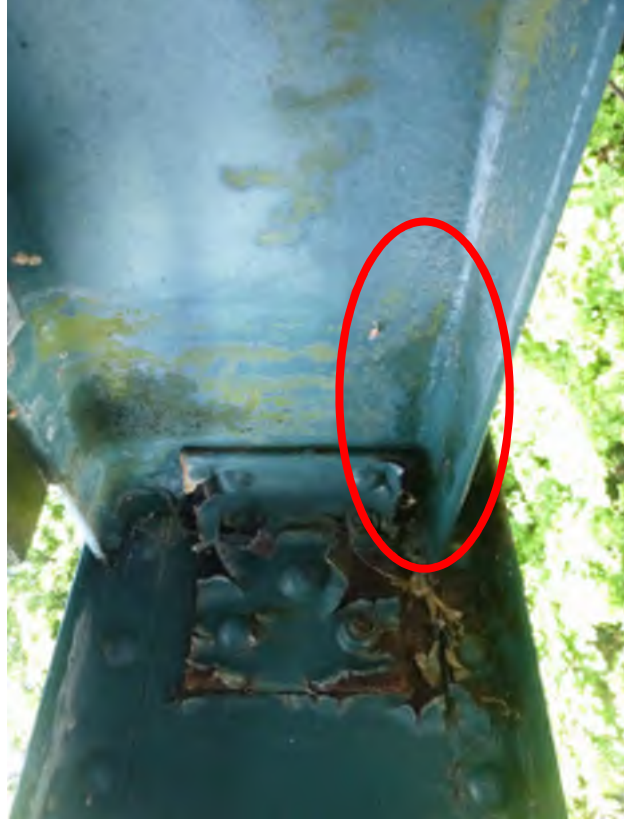
Photo # 20: Clip angle at Floorbeam FB2 between L1 & L2. Note peeling paint with rust. Also, note the painted over pitting along the bottom of floorbeam web.

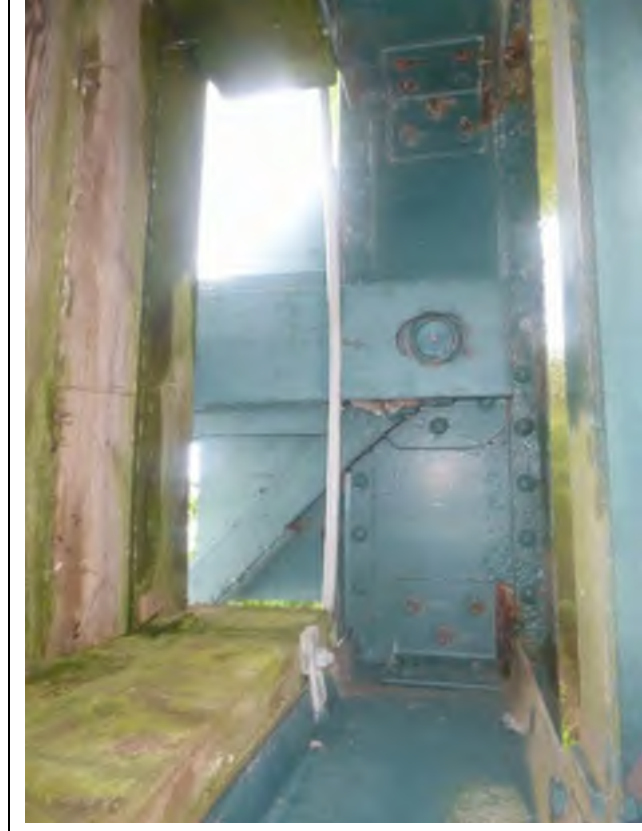
Photo # 21: Interior view of the bottom chord at L2 in North Truss. Note the deterioration along the pin connection and the repair plates.

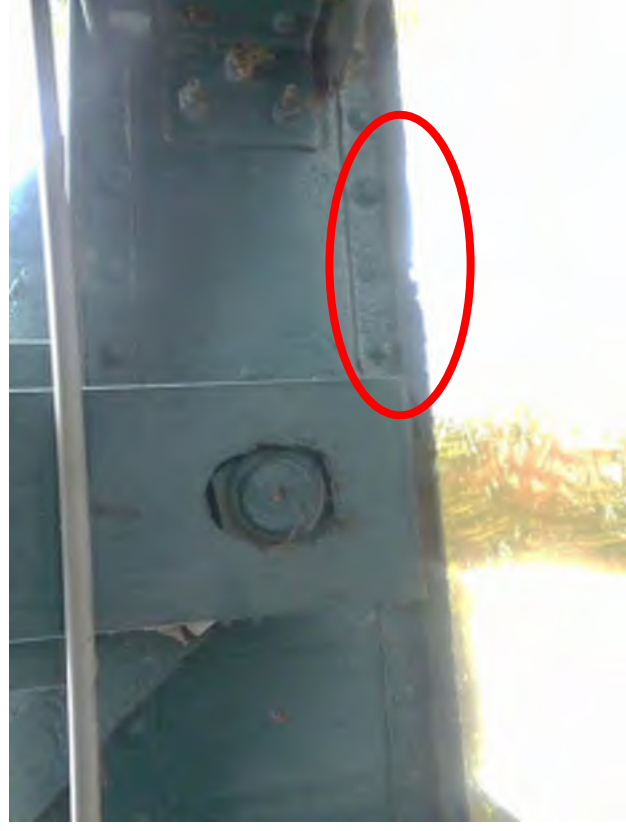
Photo # 22: Interior view of the bottom chord at L2 in North Truss. Note the pitting along the interior bottom angle.

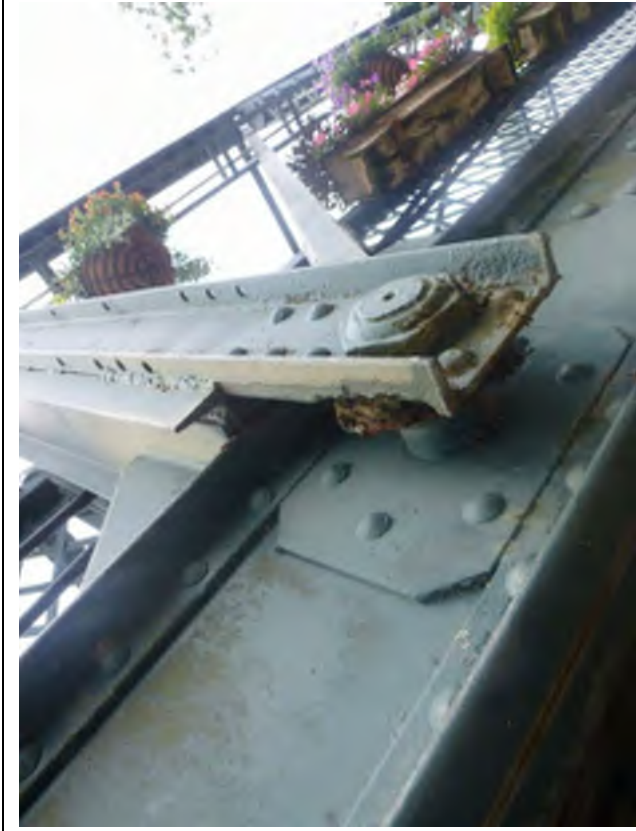
Photo # 23: Exterior view of bottom chord at L3 in North Truss. Note the deterioration along the pin connection.

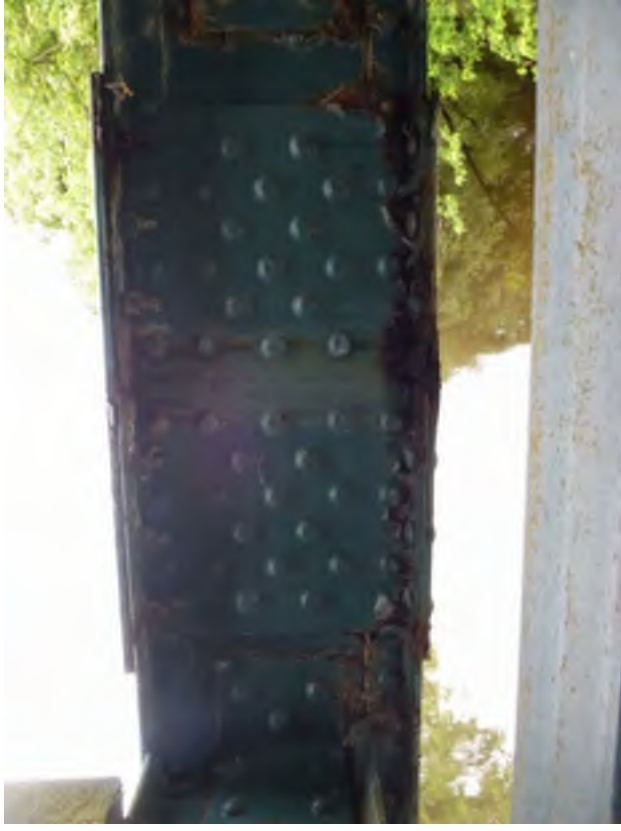
Photo # 24: Bottom chord splice connection between L2 & L3 in South Truss.

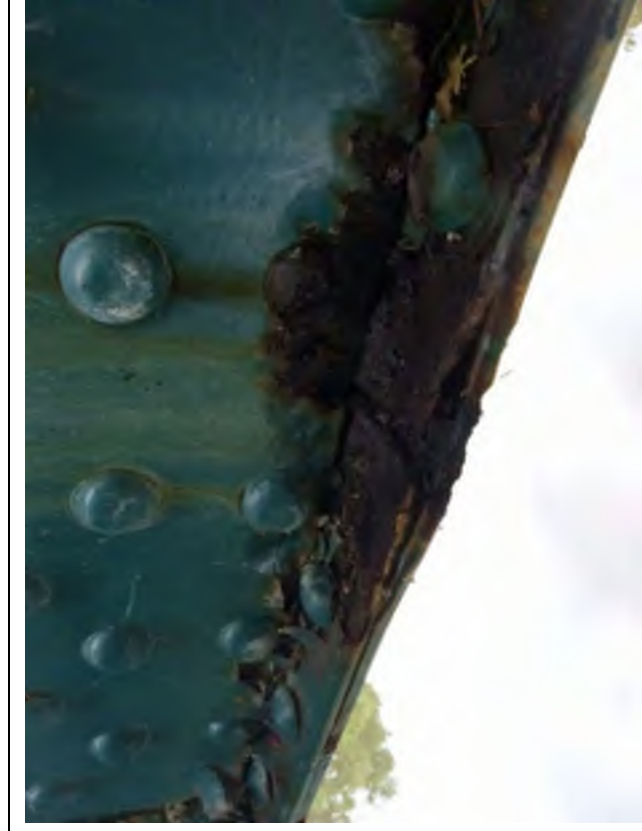
Photo # 25: Pack rust and section loss at the bottom chord splice connection between L2 & L3 in South Truss.

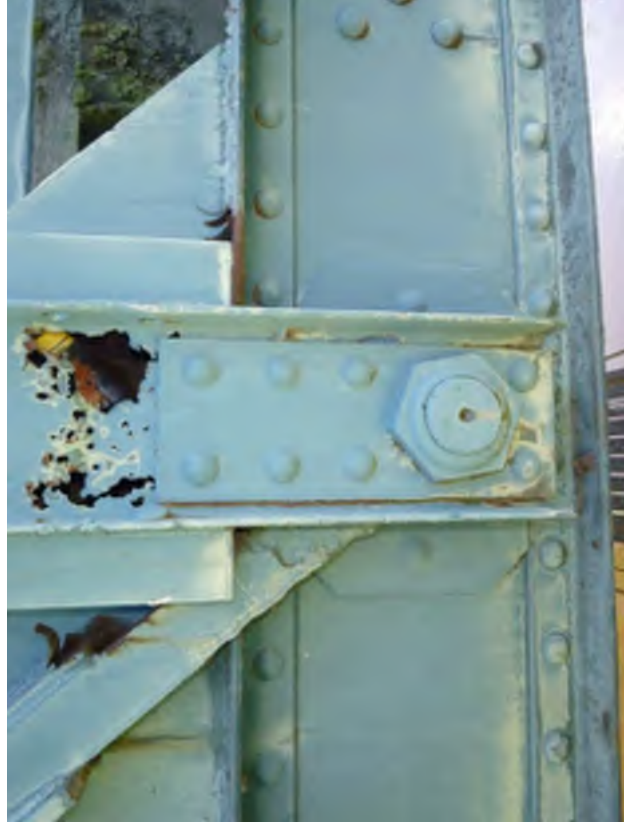
Photo # 26: South elevation of vertical member in South Truss at L3. Note the section loss in the diagonal eye bar and web of truss vertical member. Also, note the repair plates and channel atop the bottom chord.

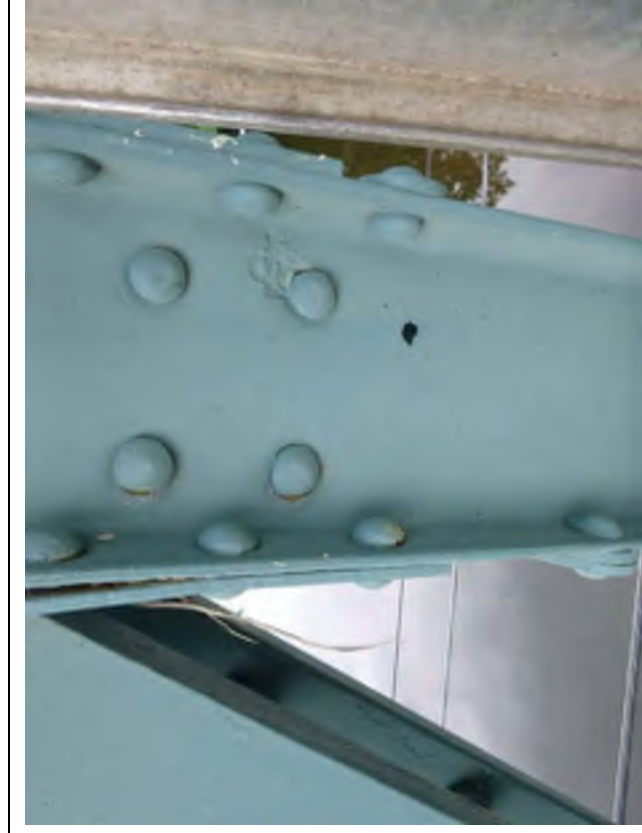
Photo # 27: Vertical member in U5 South Truss. Note the rust hole.

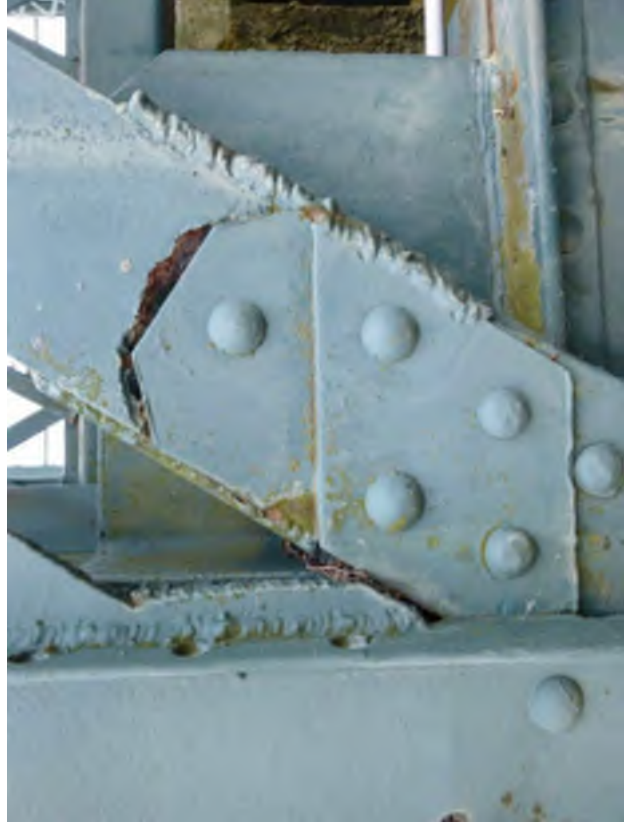
Photo # 28: North elevation of North Truss diagonal member L6-U5 at L6. Note the section loss and rust hole at the connection plates (typical). Also, note the repair plates and retrofit gusset plate.

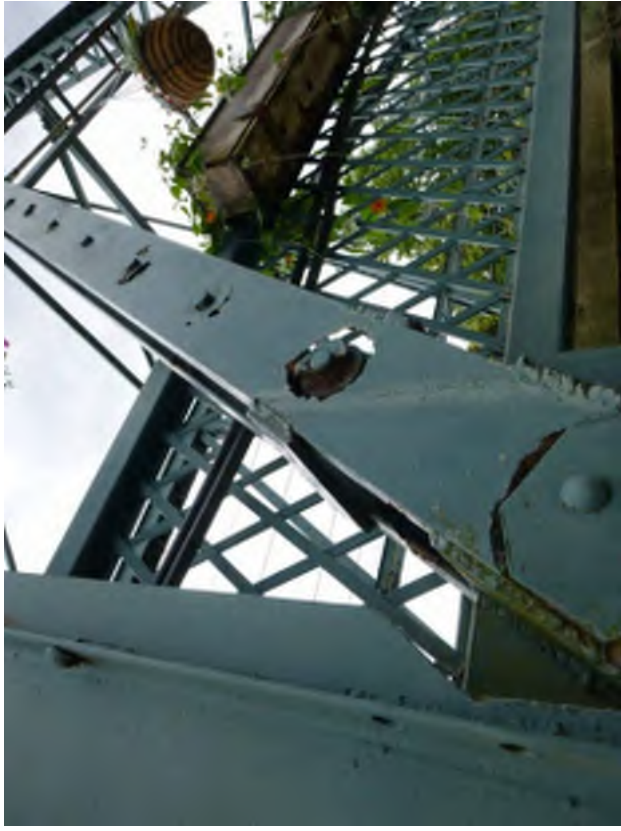
Photo # 30: North elevation of North Truss diagonal member L6-U5 at L6. Note the section loss with rust holes in the channel web.

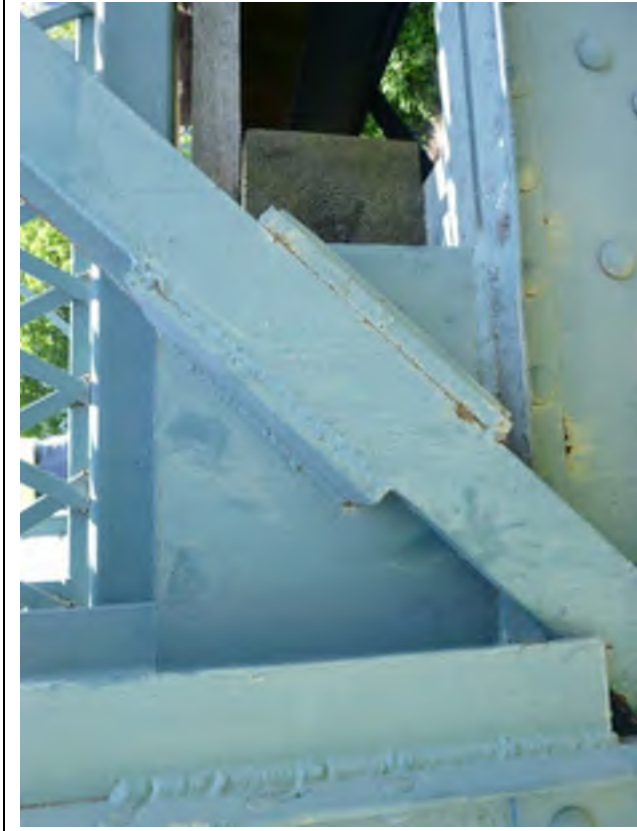
Photo # 31: South elevation of typical repair for eye bar at L10 in South Truss.

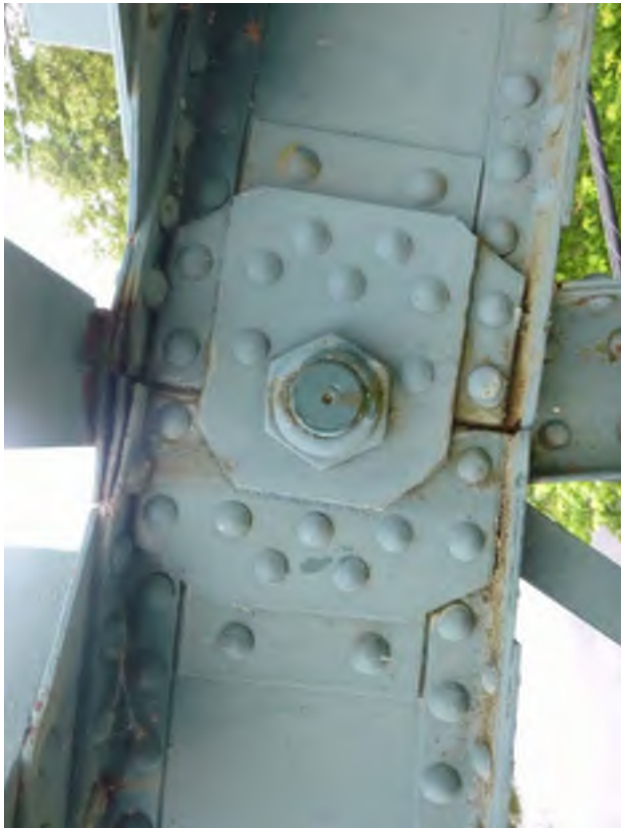
Photo # 32: North elevation of top chord member in South Truss at U2. Note the bent down top angles at the connection due to pack rust (typical).

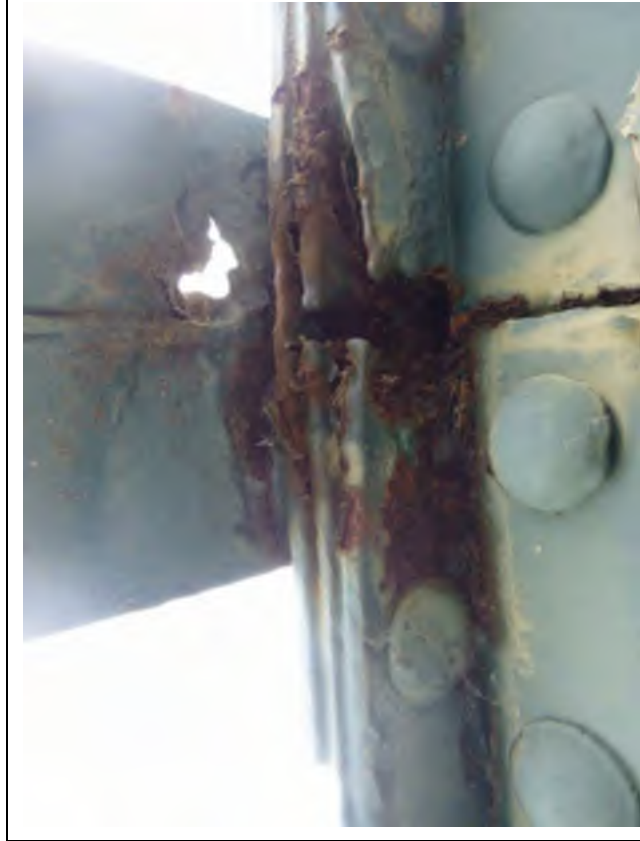
Photo # 37: Bottom of top strut at North Truss above U4.

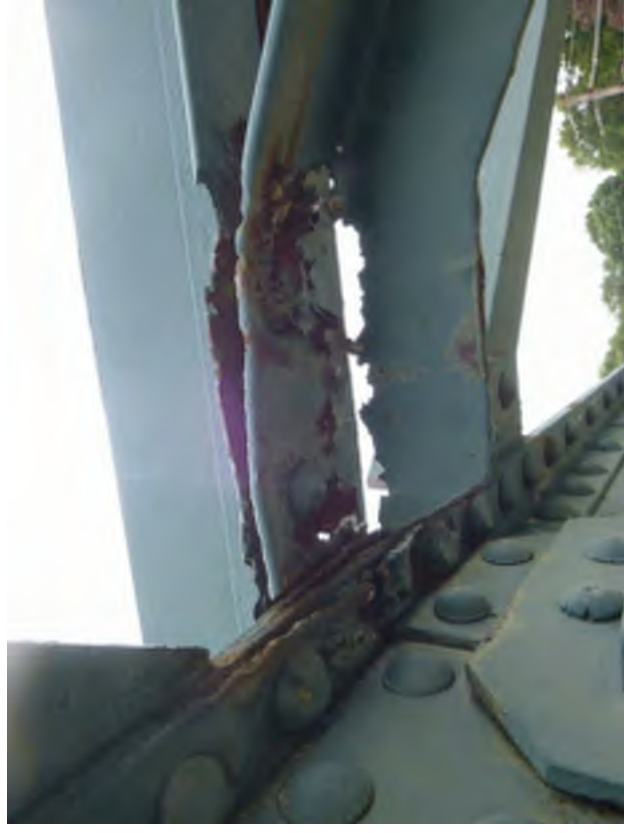
Photo # 38: Sway bracing at U7 above North Truss. Note the section loss with rust holes.

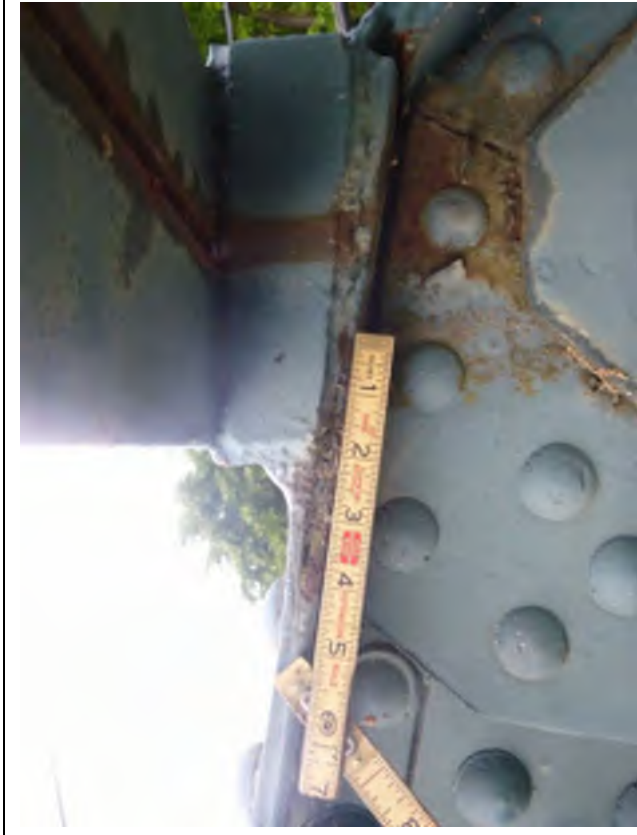
Photo # 39: North side of U1 in South Truss. Note the crack in the weld.

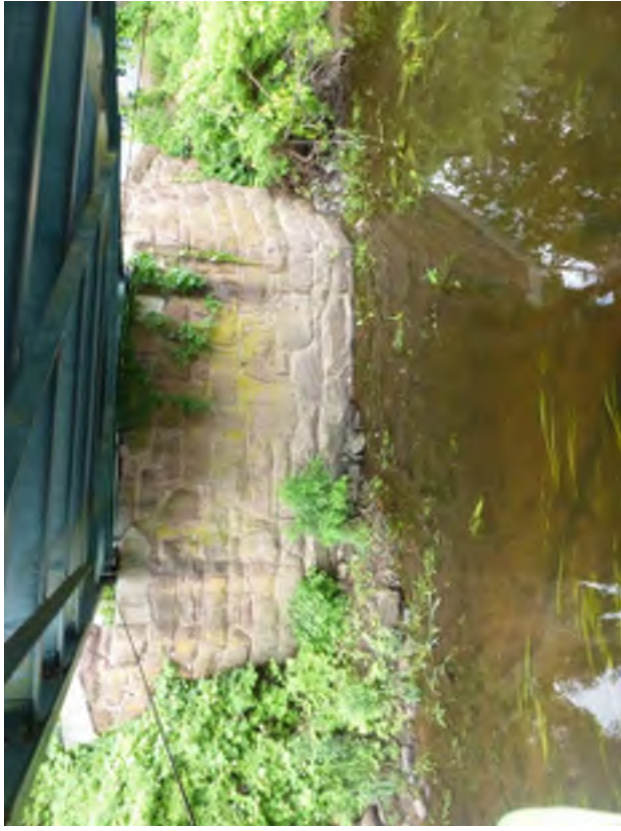
Photo # 40: West Abutment elevation.

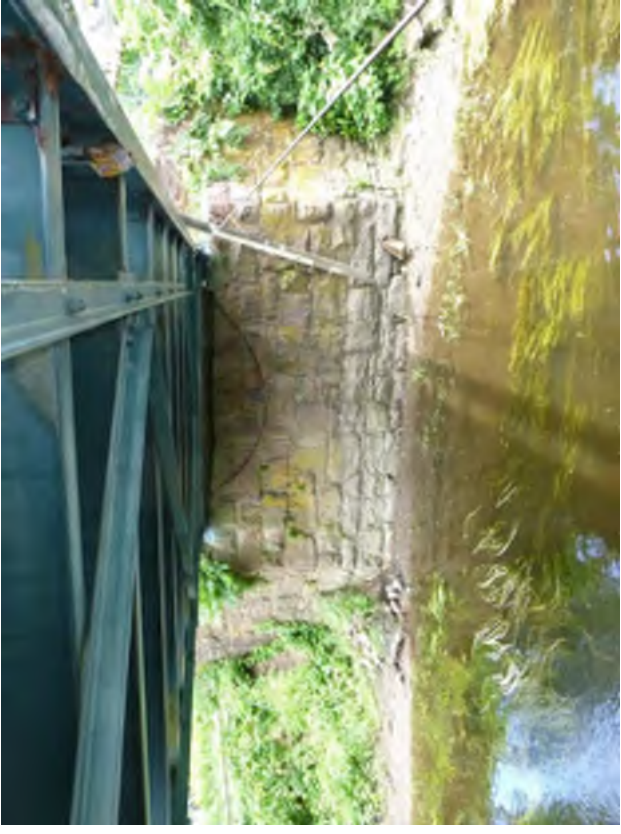
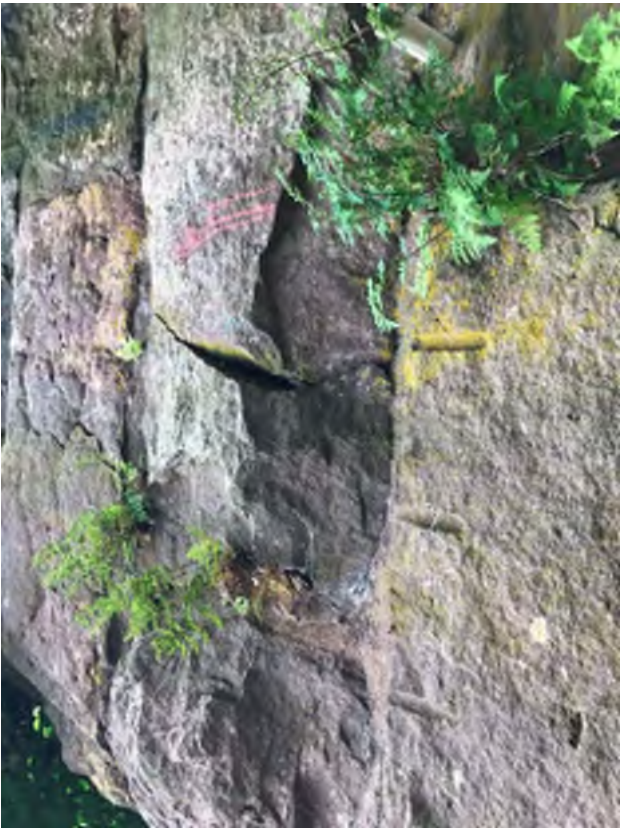
<p>Photo # 41: East Abutment elevation.</p>	<p>Photo # 42: Crack in the stone masonry at East Abutment.</p>

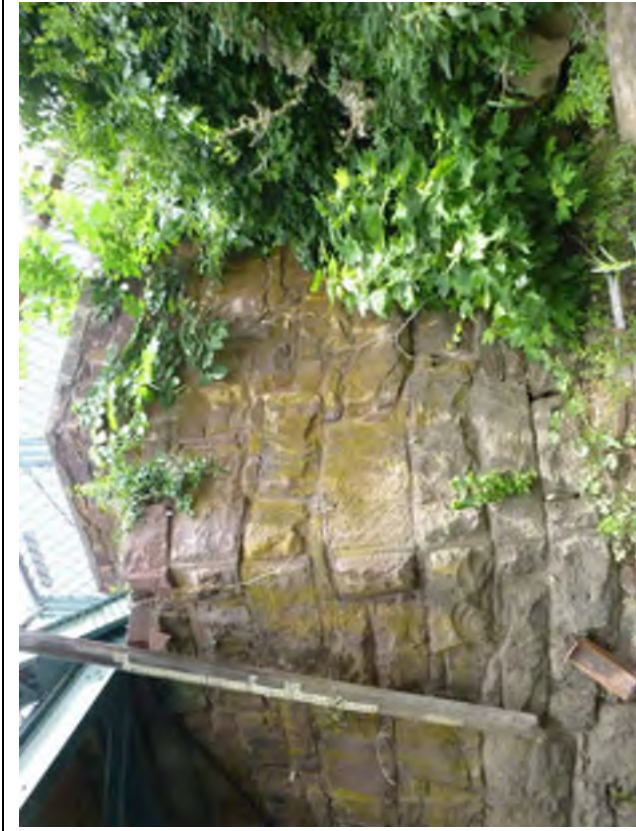
Photo # 43: Southeast Wingwall elevation.

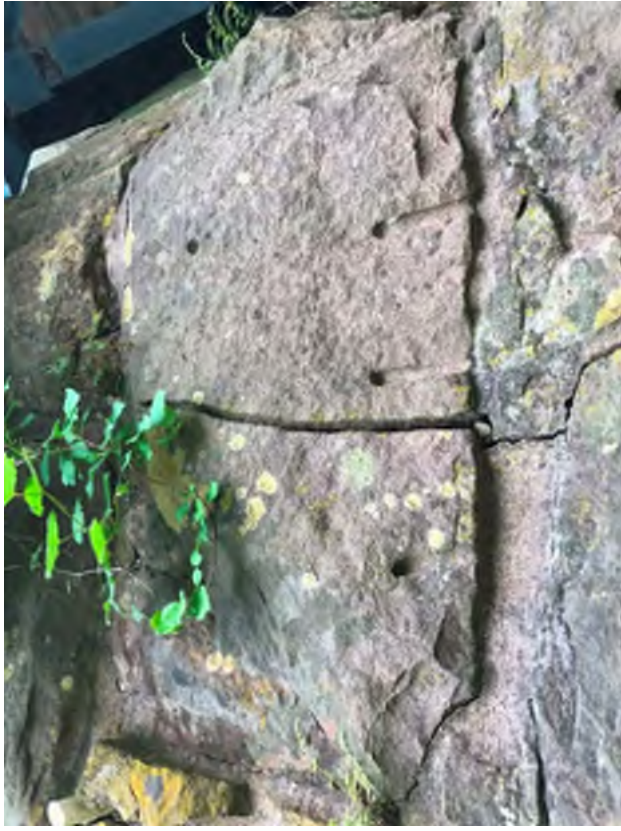
Photo # 44: Crack in the stone masonry at Northeast Wingwall.

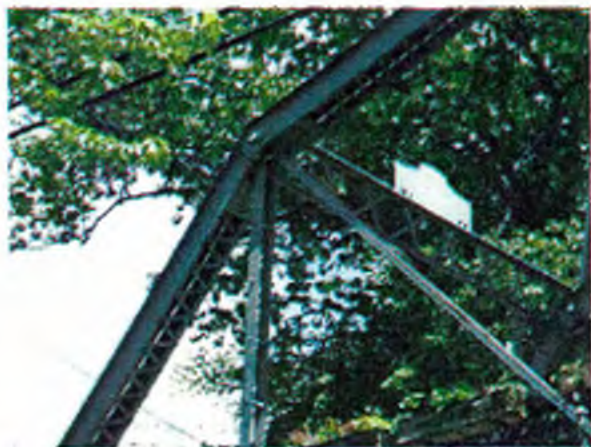
Photo 2 -Typical view of truss.

Spot corrosion on the truss members typically ranged from approximately 0.3% to 1% of the surface area. There were several isolated areas with spot corrosion on the North truss ranging from 1% to 3%. Areas of spot corrosion were scattered across the length and most often occurring at the connections. Conditions were typical for upper and lower truss chords, verticals, diagonals, and bracing members. See Photographs 2 through 11 below.

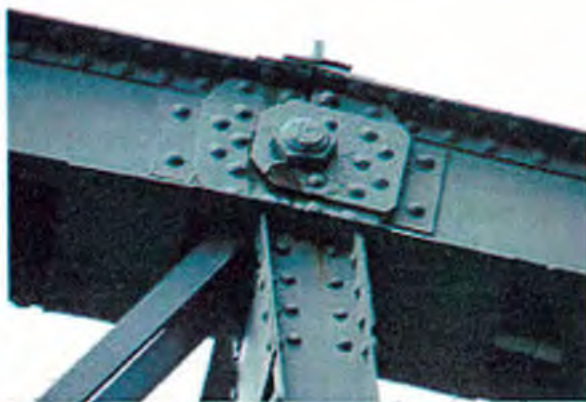
Photo 3 -Spot corrosion on truss connection.

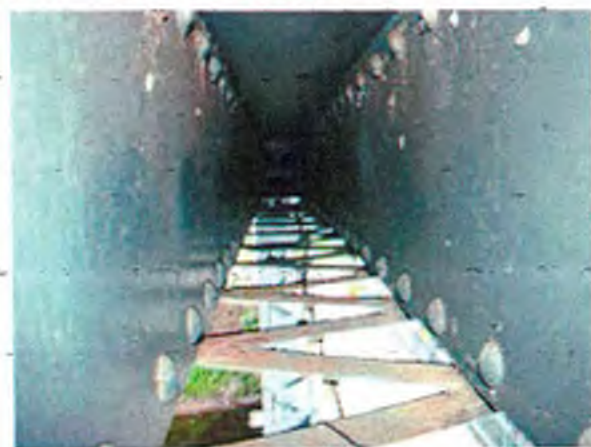
Photo 4 -Typical view of interior truss top chord.
