TOWN OF SIMSBURY

**ON-CALL PROFESSIONAL SERVICES:
SIMSBURY FLOWER BRIDGE REHABILITATION
DPW-RFP 2022-#03**

This Rehabilitation Study Report (RSR) describes the findings of a detailed evaluation of the condition of the bridge and presents recommendations for rehabilitation to ensure its structural and functional adequacy, as well as to extend its service life. Due to the historic nature of the bridge and the unique structure type, evaluation of multiple alternates for rehabilitation was not considered.

PROJECT TITLE:	<div>REHABILITATION OF BRIDGE NO. 03984 OLD DRAKE HILL ROAD BRIDGE (FLOWER BRIDGE) OVER FARMINGTON RIVER SIMSBURY, CT</div>

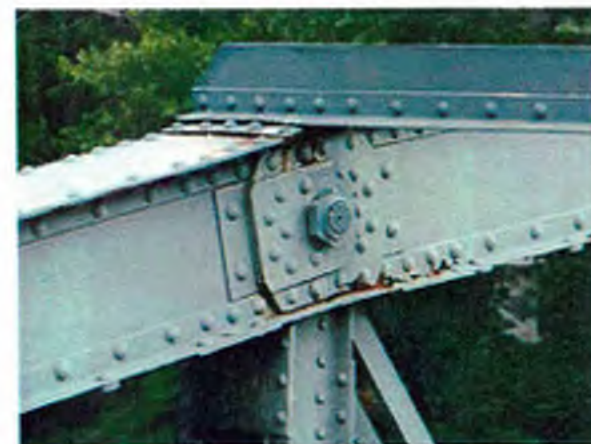
Photo 6 -Spot corrosion at truss connection.

Spot corrosion on the truss members typically ranged from approximately 0.3% to 1% of the surface area. There were several isolated areas with spot corrosion on the North truss ranging from 1% to 3%. Areas of spot corrosion were scattered across the length and most often occurring at the connections. Conditions were typical for upper and lower truss chords, verticals, diagonals, and bracing members. See Photographs 2 through 11 below.

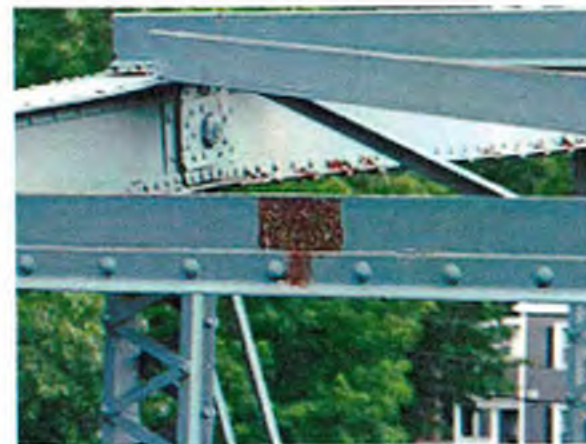
Photo 7 -Spot corrosion on truss bracing.

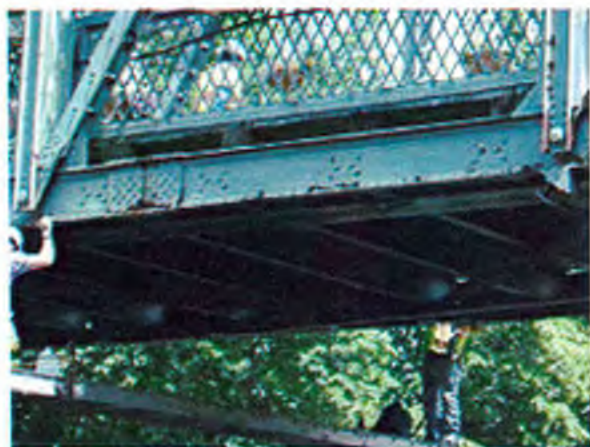
Photo 8 – Spot corrosion on truss lower chord.

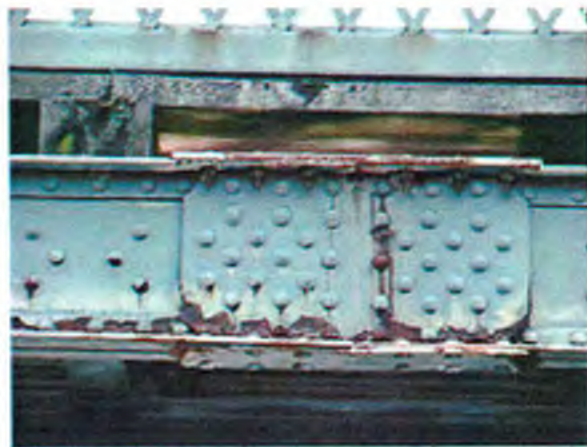
Photo 9 – Spot corrosion on truss lower chord.

Photo 9 – Spot corrosion on truss lower chord.

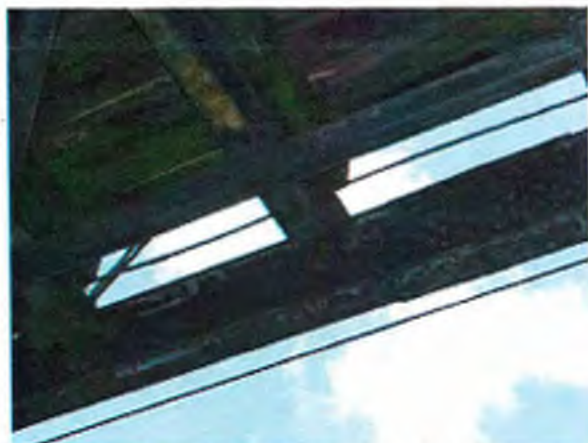
A white discoloration was observed on the lower truss and adjacent steel. The discolored areas had the appearance of salt deposits. The discoloration may also be caused by runoff from the flower boxes.

Photo 10 – White stain on lower chord.

Photo 10 – White stain on lower chord.

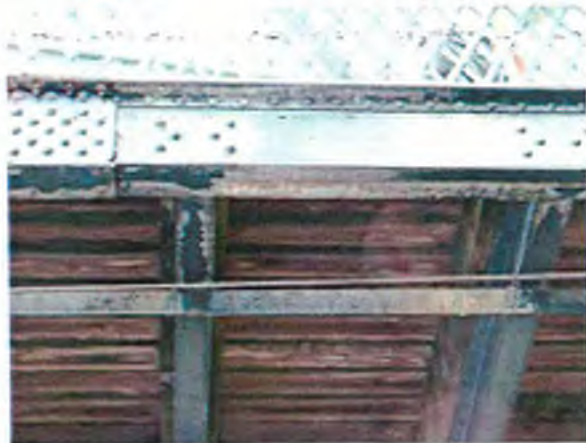
Photo 11 – White stain on lower chord.

Photo 11 – White stain on lower chord.

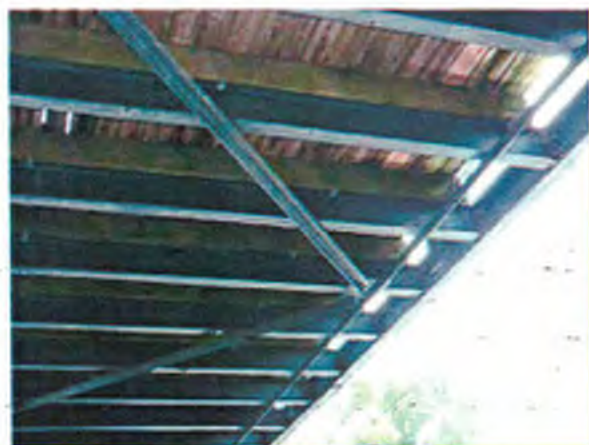
Coating deterioration on the floor beams ranged from approximately 0.3% to 1% of the surface area. Higher levels of corrosion were typically observed at the connections with the lower chords.

Photo 12 – Typical condition of floor beams.

Photo 12 – Typical condition of floor beams.

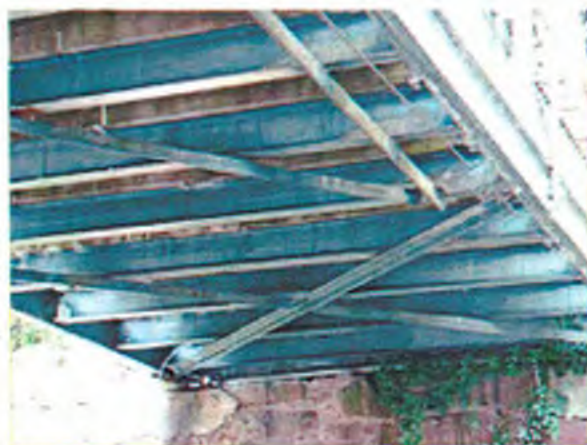
Photo 13 – Typical condition of floor beams.

Photo 13 – Typical condition of floor beams.

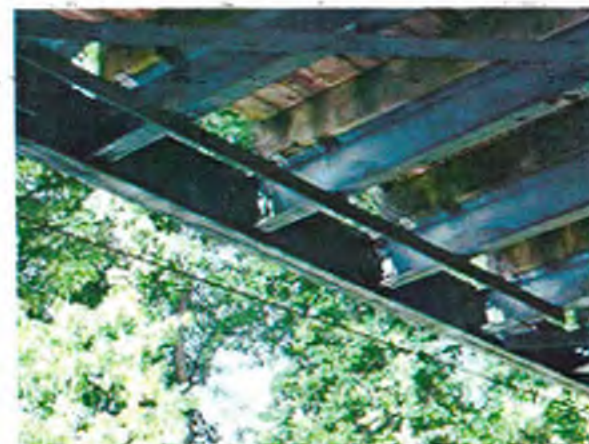
Photo 14 – Typical condition of floor beams.

Photo 14 – Typical condition of floor beams.

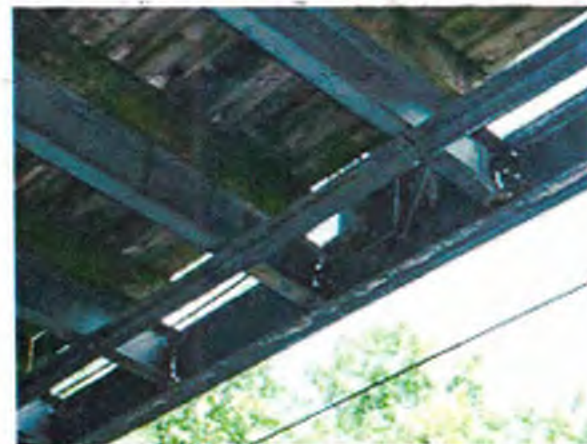
Photo 15 – Typical condition of floor beams.

Photo 15 – Typical condition of floor beams.

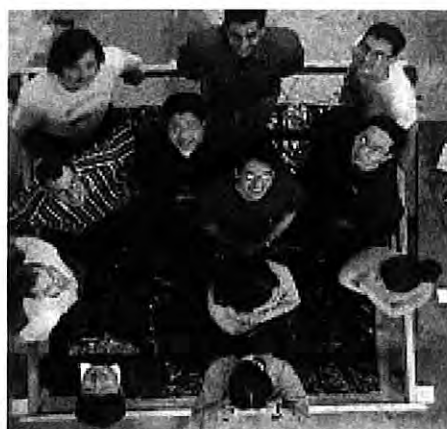
Figure C3.1-1—Live Load of 50 psf

Consideration might be given to the maximum credible pedestrian loading. There is a physical limit on how much load can be applied to a bridge from the static weight of pedestrians. It appears that this load is around 150 psf, based on work done by Nowak (2000) from where Figures C1 through C3 were taken. Although there does not appear to be any available information relating to the probabilistic distribution of pedestrian live loading, knowing the maximum credible load helps to define the limits of the upper tail of the distribution of load. The use of a 90 psf nominal live load in combination with a load factor of 1.75 results in a loading of 158 psf, which provides a marginal, but sufficient, reserve compared with the maximum credible load of 150 psf.

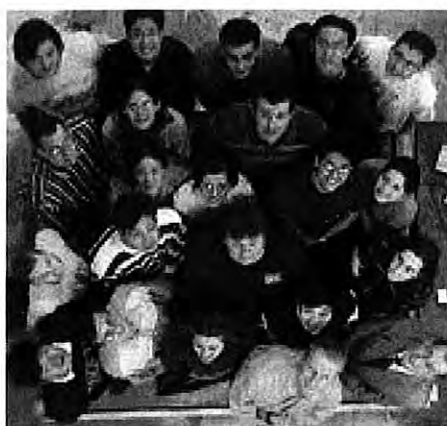
Figure C3.1-2—Live Load of 100 psf

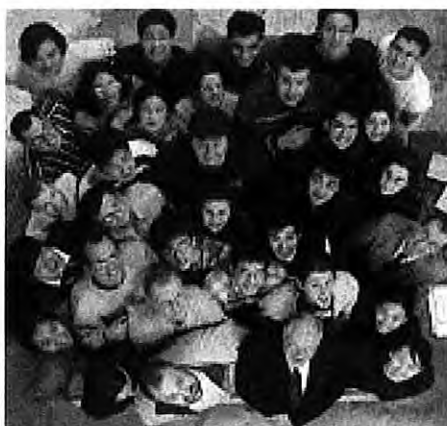
Figure C3.1-3—Live Load of 150 psf

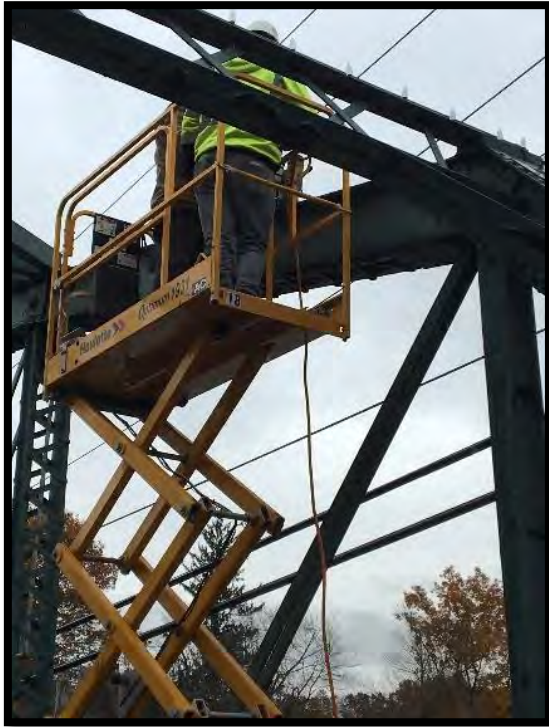
Photo 1: Coupons extraction operations

Independent Materials Testing Laboratory Testing, Inc. (IMTL) was retained to extract a total of two (2) steel coupons from the top plate of the top chord of both the north and south truss and perform tensile tests. The schematic below shows the locations of the steel coupons extraction.

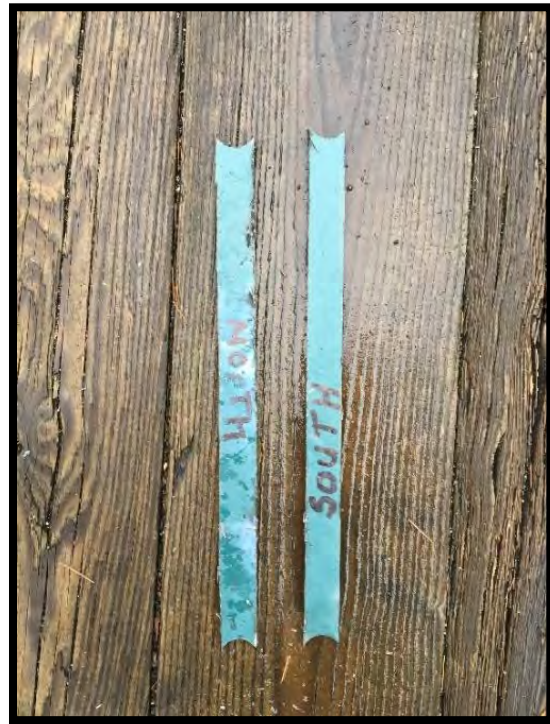
Photo 2: Extracted steel coupons

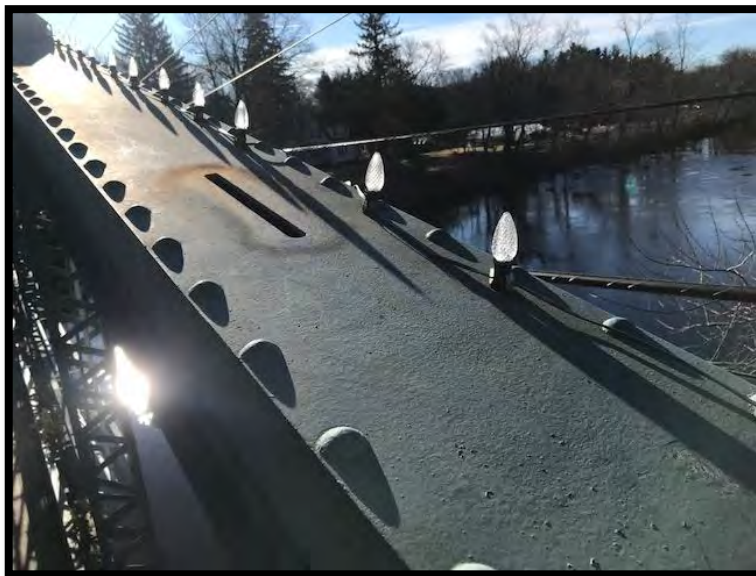
Photo 3: Top plate of top chord after coupon extraction.
