Town of Simsbury

To: Simsbury Historic District
Commission

RE: Application #23-03 of Robert Pomeroy, Owner/Applicant for a Certificate of Appropriateness to replace 6 windows with aluminum-clad wood windows and replace the roof with fiberglass asphalt shingles on the property located at 16 East Weatogue Street (Assessor's Map H14, Block 109, Lot 015), zone R-40.

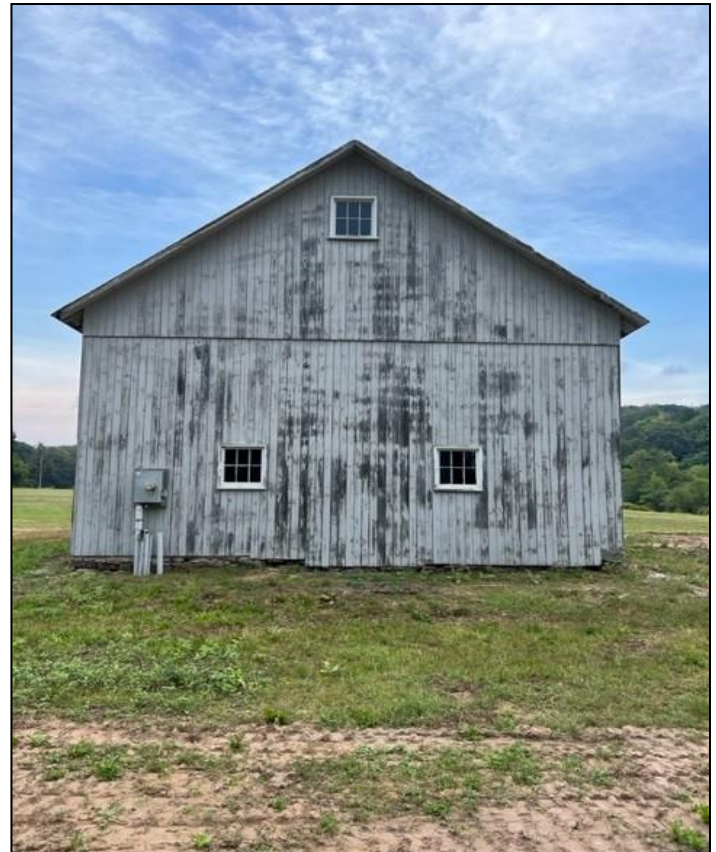
The applicant is proposing the replacement of the asphalt shingles on the roof and the replacement/installation of 7 wooden windows at the barn on the property (The applicant noted the number of windows was incorrect on the original application, the barn features 7 windows instead of 6). The existing asphalt roof shingles will be replaced with matching asphalt materials. The wood windows are being replaced to match the existing in color, grille style, and size. According to the application, the location and number of windows on the barn is not changing. The applicant explained the wood windows will be ordered in white and will feature muntin that protrude through both sides of the glass in the window to match the existing. Pictures of the existing windows are shown in "Attachment A". Pictures and specifications of the proposed window style can be found in "Attachment B" attached to this report. The proposed roof shingles are included as "Attachment C" below.

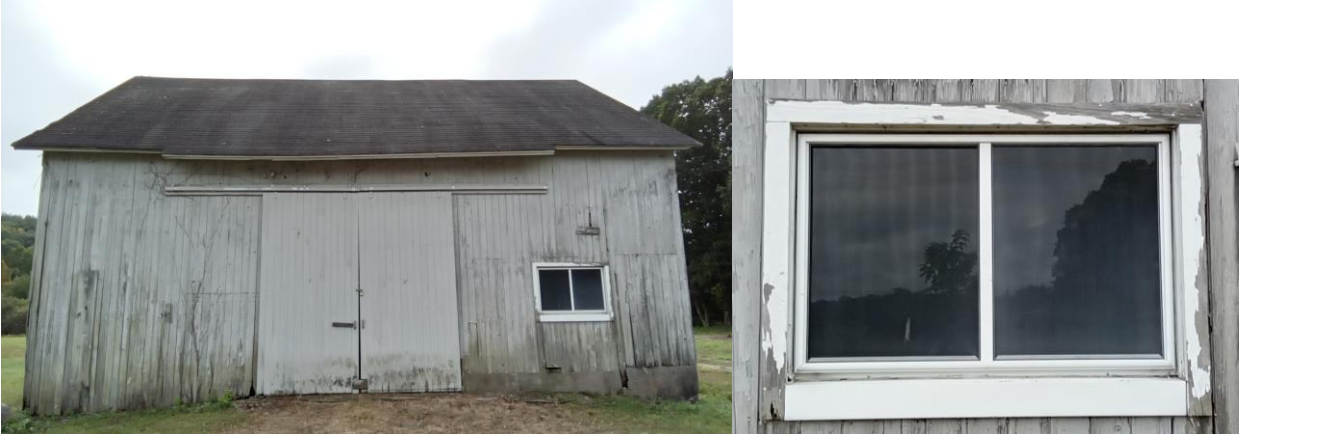
Quantity	Existing Window Condition
1	<p data-bbox="240 365 1019 401">51" x 32" Window – Front Side of Barn to the Right of Door</p>

Quantity	Specifications (Color/Grille Patterns Will Match Existing)
1	51” x 32” Window – Front Side of Barn to the Right of Door

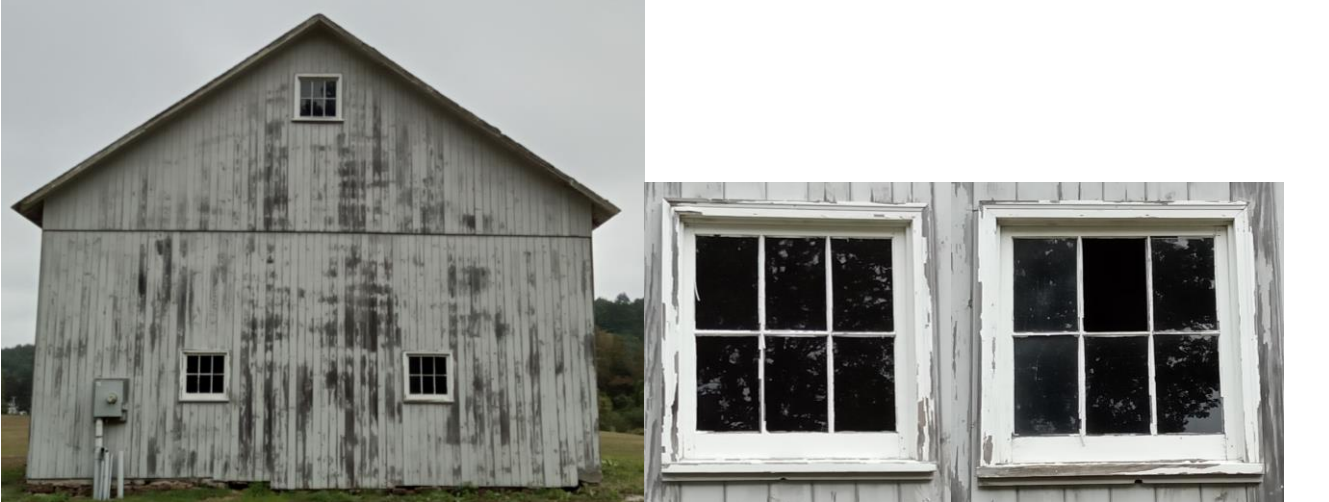
2	<p data-bbox="240 837 1024 873">28" x 28" Windows – Right Side of Barn on the Lower Level</p>

2	28” x 28” Windows – Right Side of Barn on the Lower Level

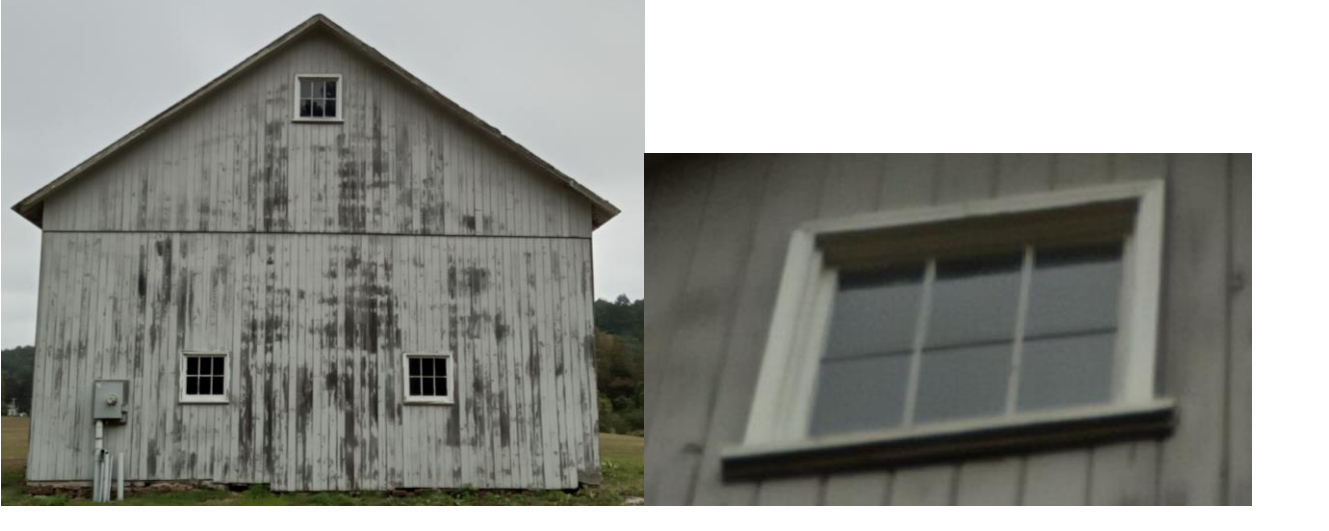
1	<p data-bbox="240 1377 1008 1413">24" x 24" Window – Right Side of Barn on the Upper Level</p>

1	24” x 24” Window – Right Side of Barn on the Upper Level

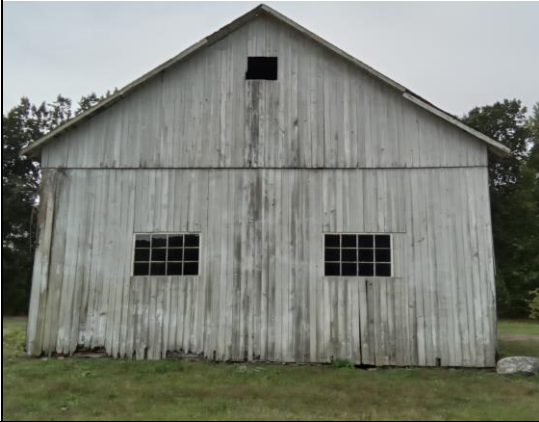
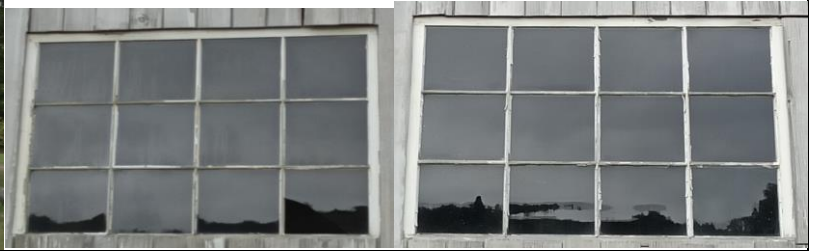
57" x 38" Windows – Left Side of Barn on the Lower Level

2	57” x 38” Windows – Left Side of Barn on the Lower Level

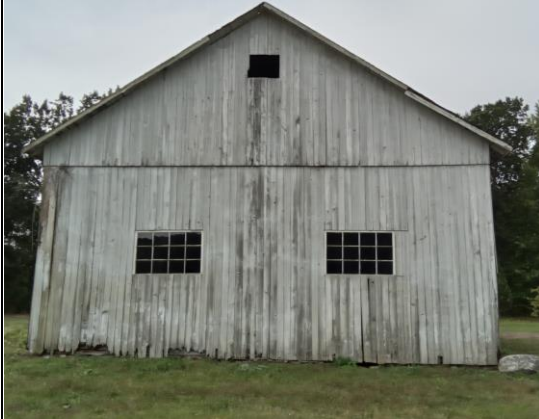
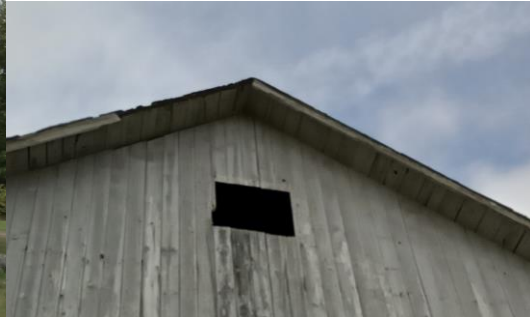
24" x 24" Window (Missing) – Left Side of Barn on the Upper Level

1	24” x 24” Window – Left Side of Barn on the Upper Level
