## MS4 Annual Report Transmittal Form

### For the General Permit to Discharge Stormwater from Small Municipal Separate Storm Sewer Systems (MS4)

1. Registrant (Name of Municipality or State or Federal Institution/Agency): <u>Town of Simsbury</u>	
Mailing Address: <u>933 Hopmeadow Street</u>	
City/Town: <u>Simsbury</u>	State: <u>CT</u> Zip Code: <u>06070</u>
Business Phone: <u>860-658-3200</u>	ext.:
Contact Person: <u>Tom Roy</u>	Phone: <u>860-658-3200</u> ext.
*E-mail: <u>troy@simsbury-ct.gov</u>	
*By providing this e-mail address you are agreeing to receive official correspondence from DEEP, at this electronic address, concerning the subject registration. Please remember to check your security settings to be sure you can receive e-mails from "ct.gov" addresses. Also, please notify DEEP if your e-mail address changes.

This report documents the Town of Simsbury’s efforts to comply with the conditions of the MS4 General Permit to the maximum extent practicable (MEP) from January 1, 2021 to December 31, 2021.

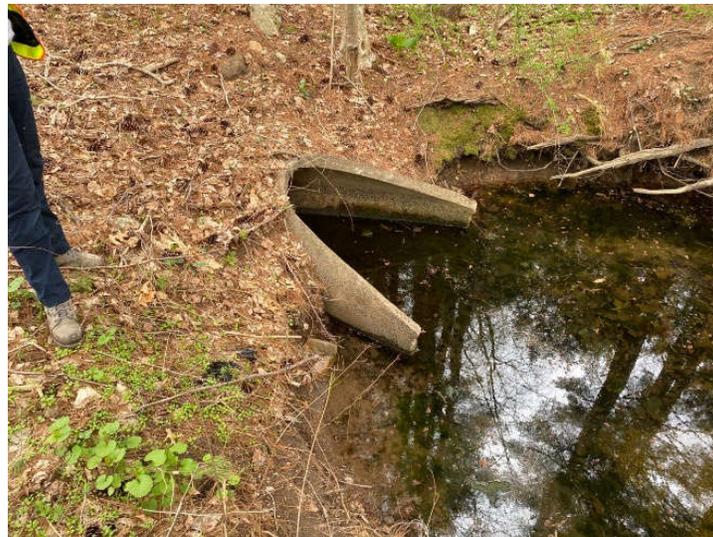
Culverted stream under road. Heavily eroded around outfall.

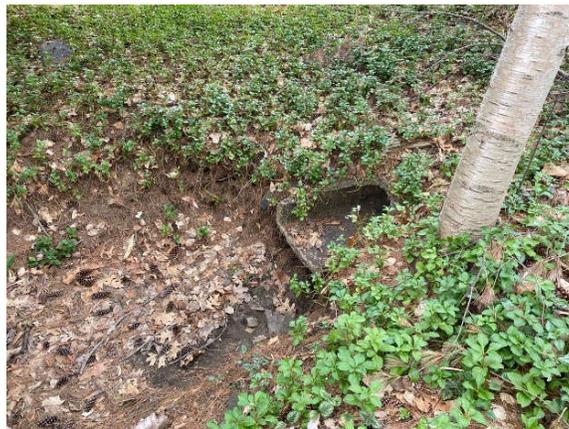
Slightly eroded beneath outfall.

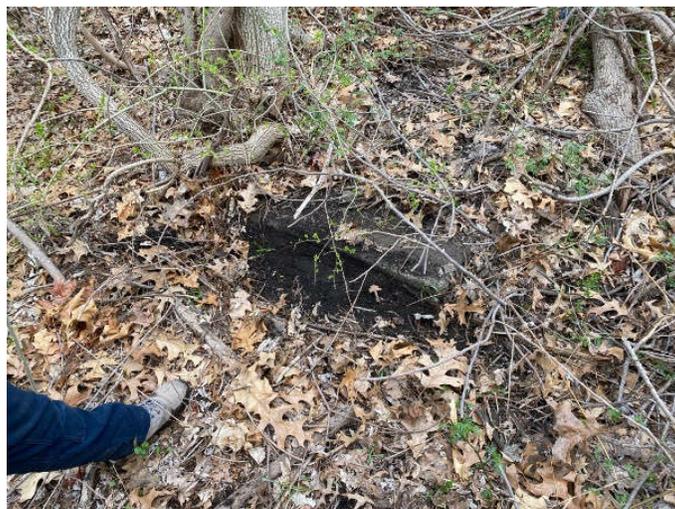
Outfall completely silted in/buried. Only top of concrete end wall exposed.

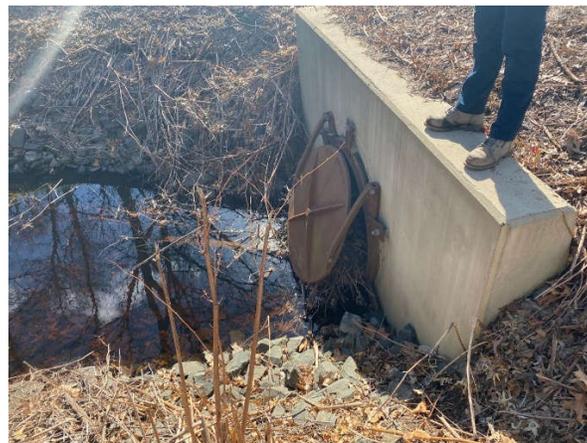
Large culvert with metal water gate. Sticks/leaves wedged in cap opening. Needs to be cleaned.

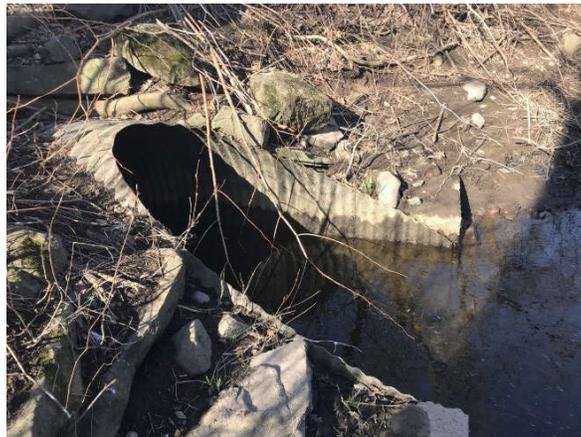
Outfall is corrugated metal pipe. Fall is also a culvert. Discharges from stream directly into Farmington river.

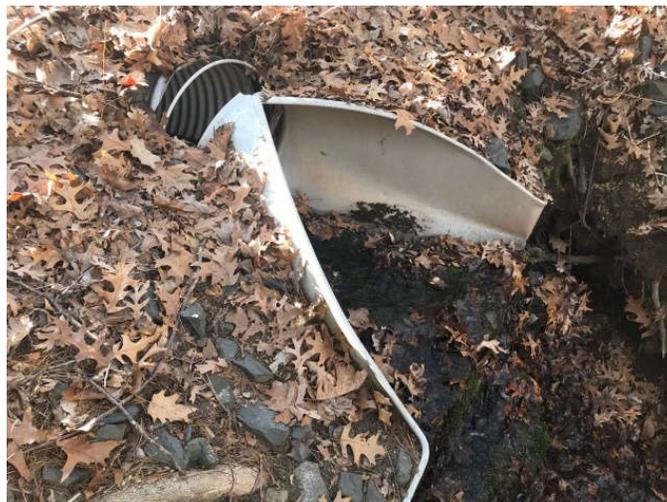
Flared end of outfall is almost completely disconnected. Riprap is not visible, high erosion rates along discharge channel. High flow of discharge.

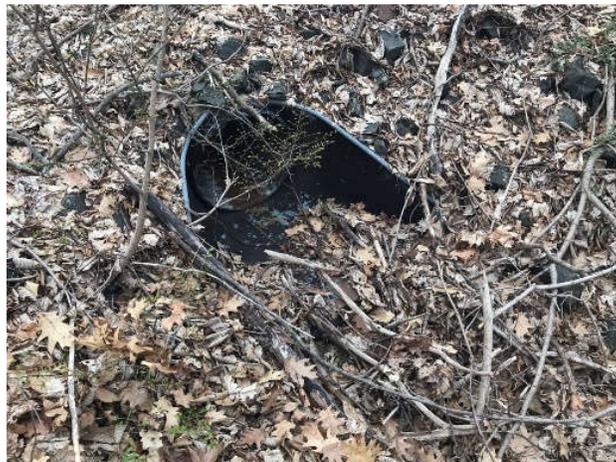
Outfall discharges to a stream. Some leaf litter and tree branches covering riprap channel. Outfall 122 is connected/is a culvert that runs to Outfall 123, discharging to small stream.

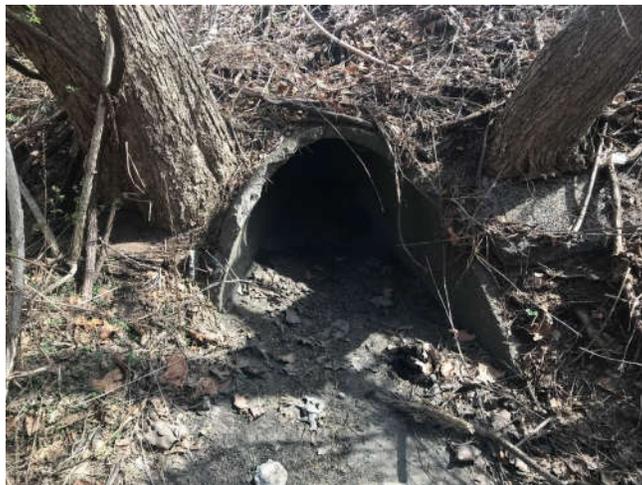
Erosion control adequate. Flared and partially separated from outfall pipe.

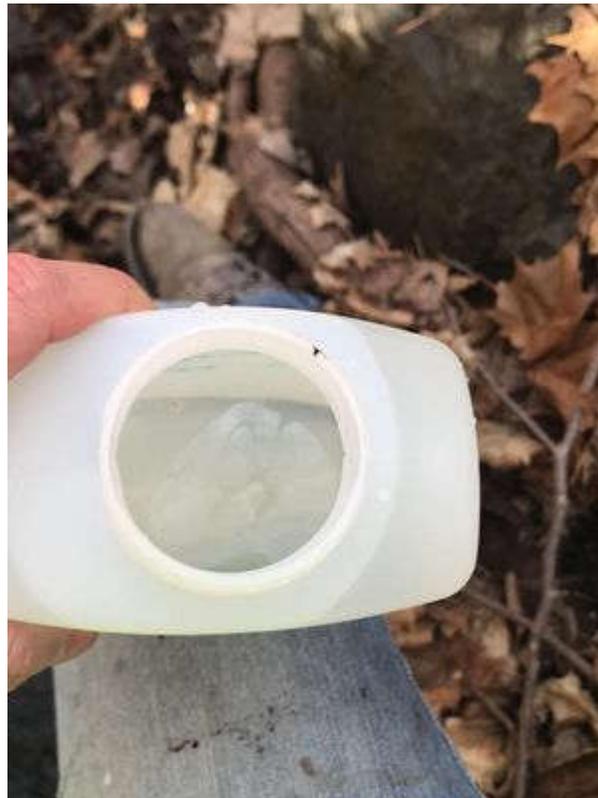
High flow discharge. No foam. Little floating particulates. Slight yellow tint.

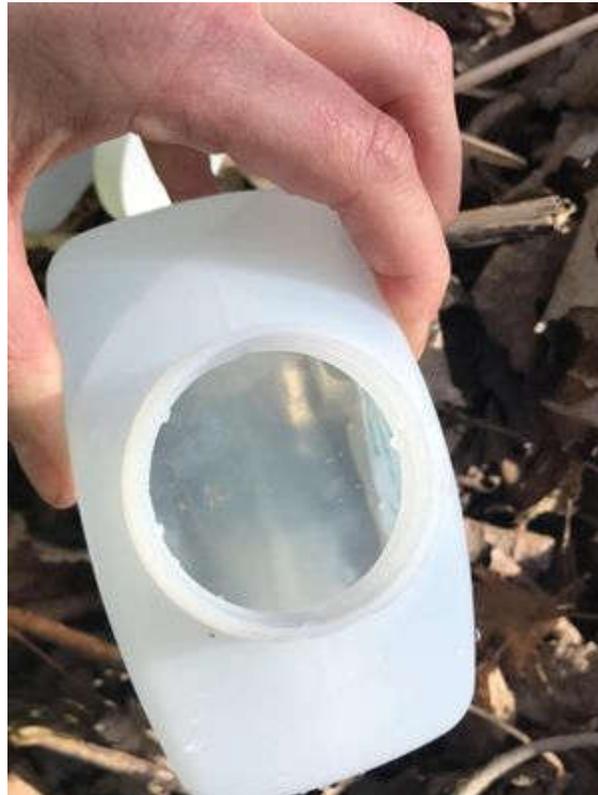
Catch basins Connected to this outfall and surrounding out falls come from a steeped area, possible ground water infiltrating outfall pipe.

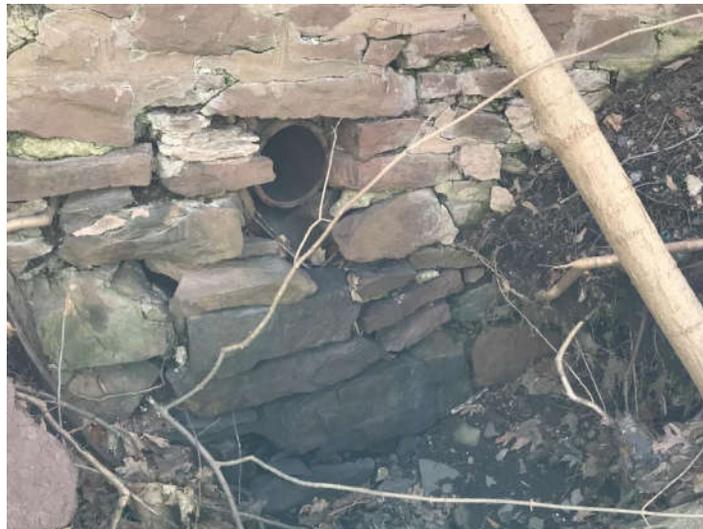
Outfall is made from a clay pipe. Much of the riprap channel is washed away.

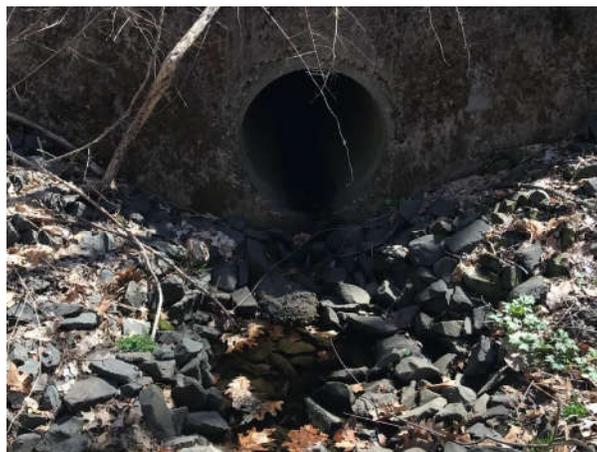
Channel has formed above concrete pipe from the condo area. Riprap channel contains high amounts of dog waste bags. Owner of home next to outfall believes there may be a gap in the pipe, due to a sinkhole following along the pipe path.

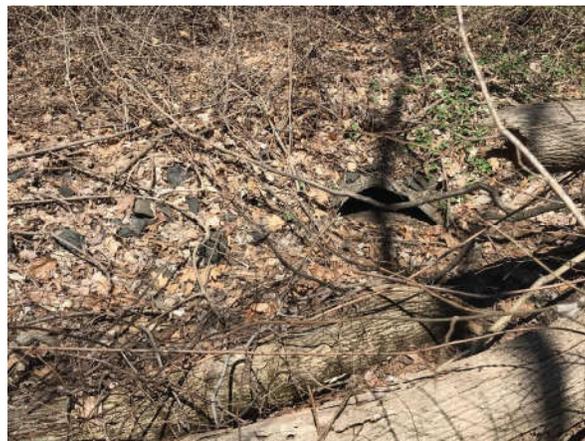
Outfall is partially covered with sediment. Flow may be disrupted due to sediment.  
Pet waste baggies observed in flow channel of outfall.

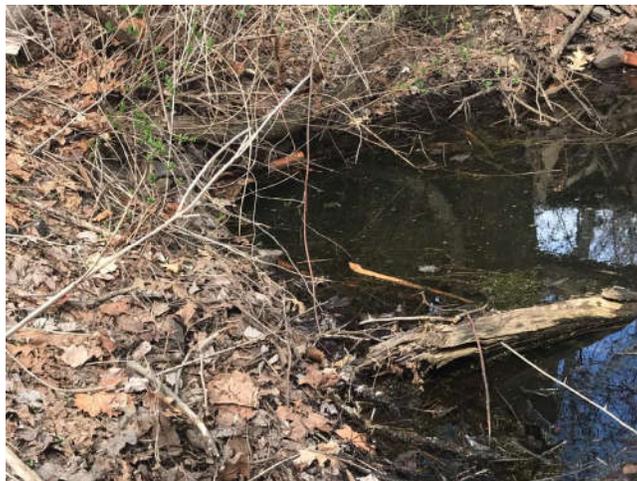
Outfall is completely submerged under retention pond.

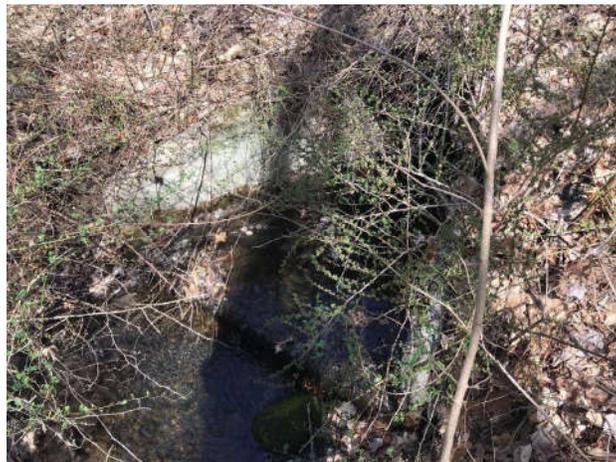
Outfall did have a discharge, however after further investigation the outfall was found to be connected to a culvert. A stream runs through this culvert. Two sink holes were found above the outfall as well.

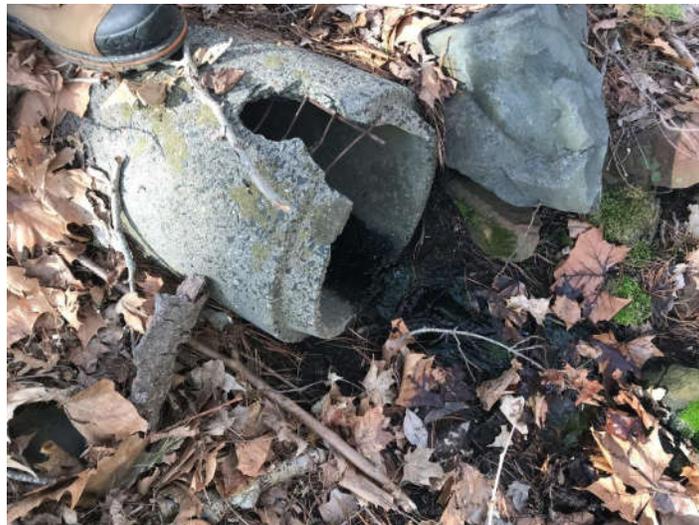
Pipe chipped. Slight discharge.

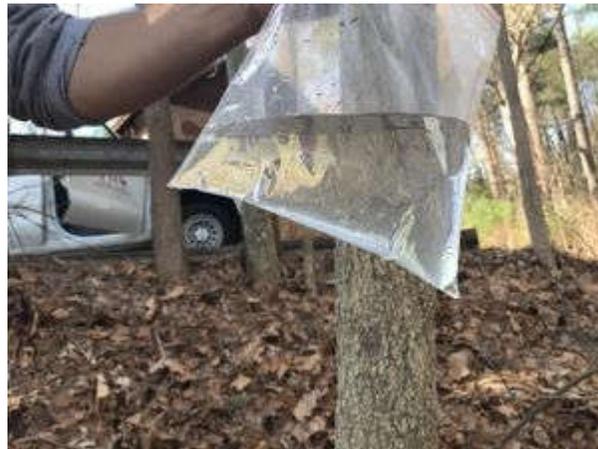
No odor, clear, no foam, no floating particulates.

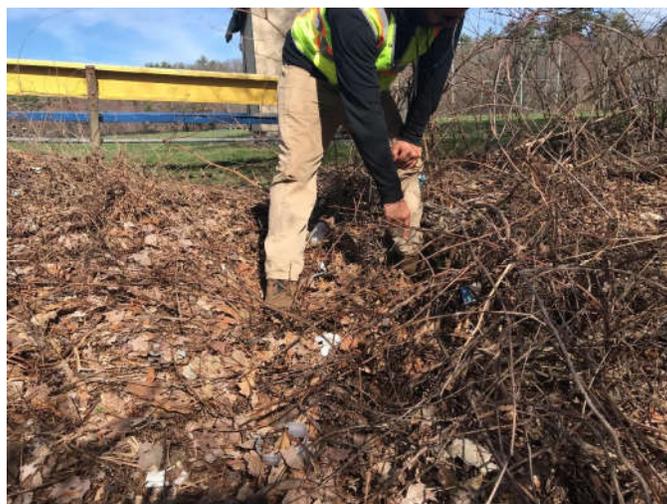
Surrounding area of outfall has refuse. Outfall needs to be uncovered and refuse picked up.

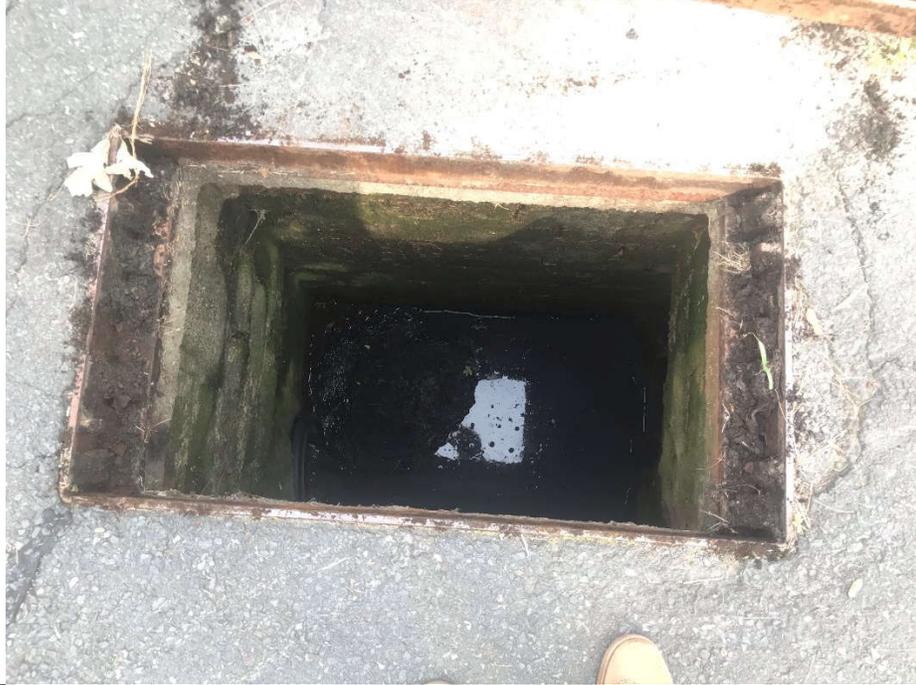
## Photograph #5

**Description:**  
*Final catch basin of  
water mixture flow,  
with some sediment  
accumulation, of which  
was vacuumed out.*

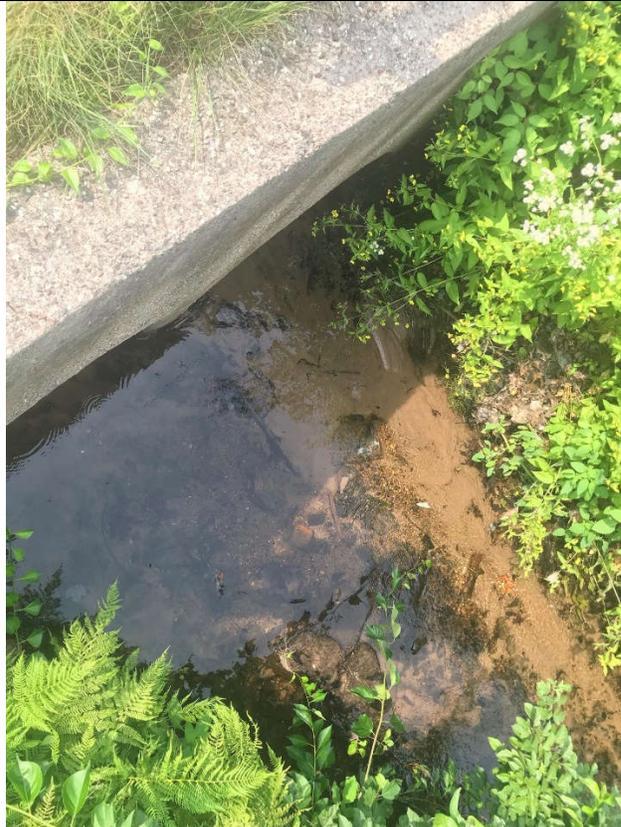
## Photograph #6

**Description:**  
*Russell Brook- where  
the water mixture  
discharged an  
unknown amount.*
